| 26008/R1 | April 2026 |
| Project<br><b>CEFN LODGE CARE HOME, SKEWEN – SOAKAWAY INFILTRATION<br/>INVESTIGATION</b> | |
| Client | <b>BP Khanal</b> |

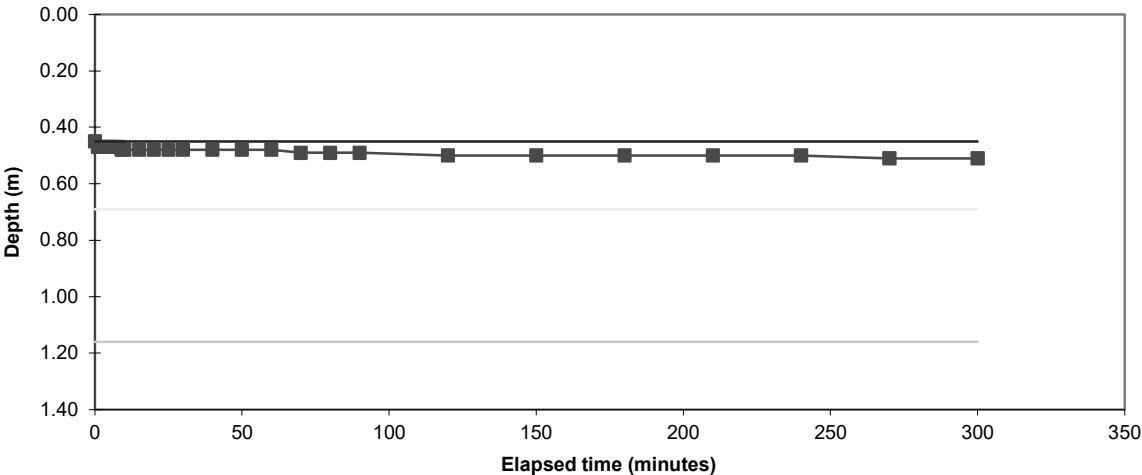
Test incomplete as 25% effective depth not achieved. Unable to reliably determine soil infiltration rate

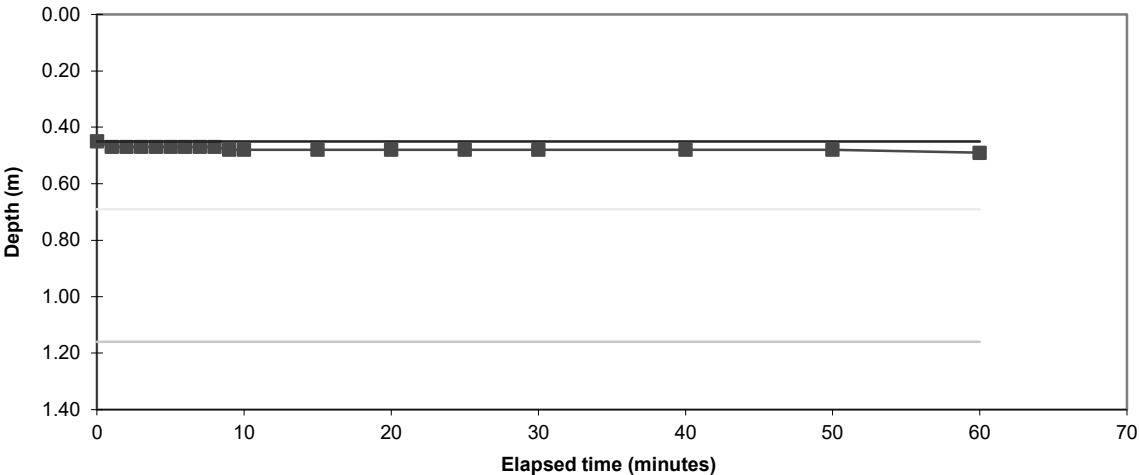
Figure  
SA01\_2

Test incomplete as 25% effective depth not achieved. Unable to reliably determine soil infiltration rate

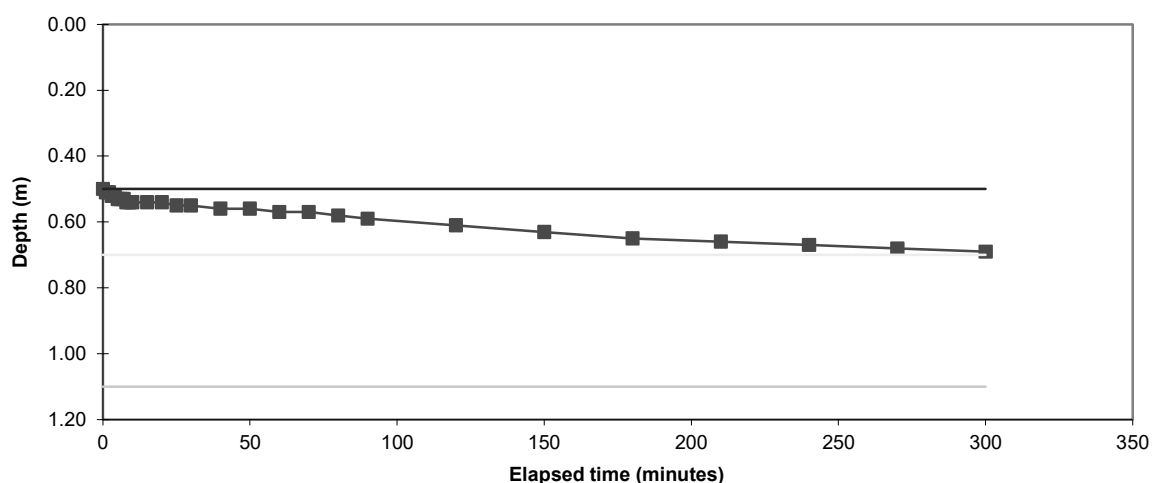
Figure  
**SA02\_1**

**Soil infiltration rate (m/s):**      **Test incomplete as 25% effective depth not achieved. Unable to reliably determine soil infiltration rate**

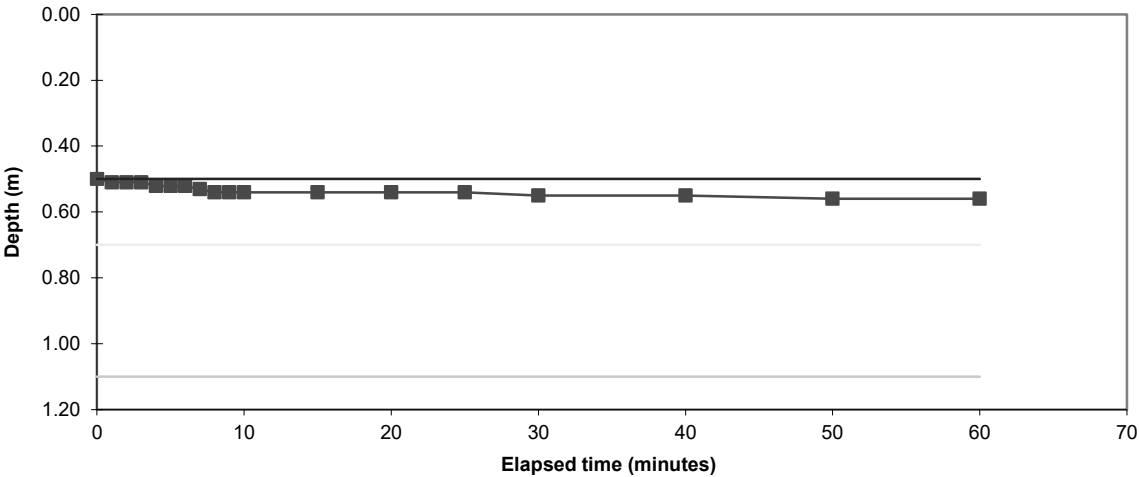
Figure  
SA02\_3

Test incomplete as 25% effective depth not achieved. Unable to reliably determine soil infiltration rate

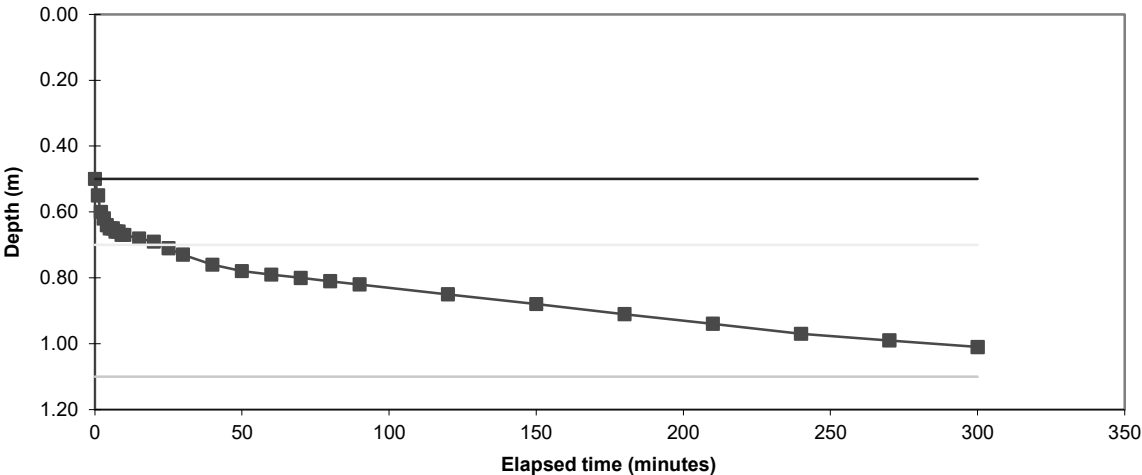
Test incomplete as 25% effective depth not achieved. Unable to reliably determine soil infiltration rate

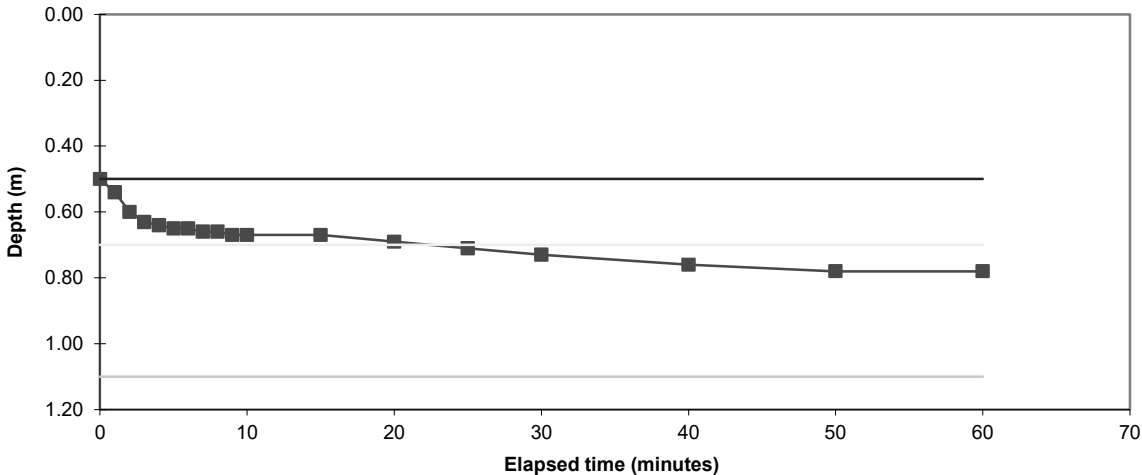
Test incomplete as 25% effective depth not achieved. Unable to reliably determine soil infiltration rate

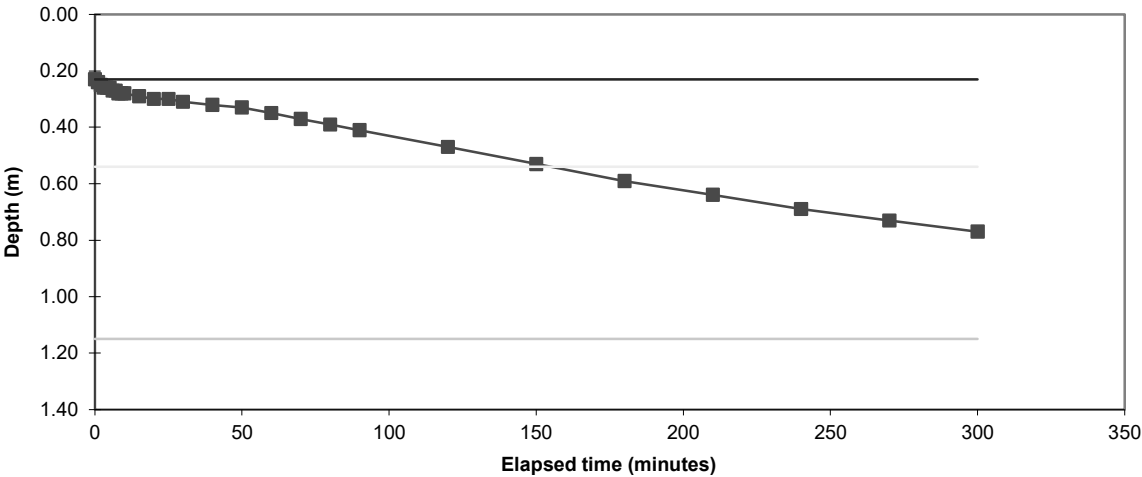
Test incomplete as 25% effective depth not achieved. Unable to reliably determine soil infiltration rate

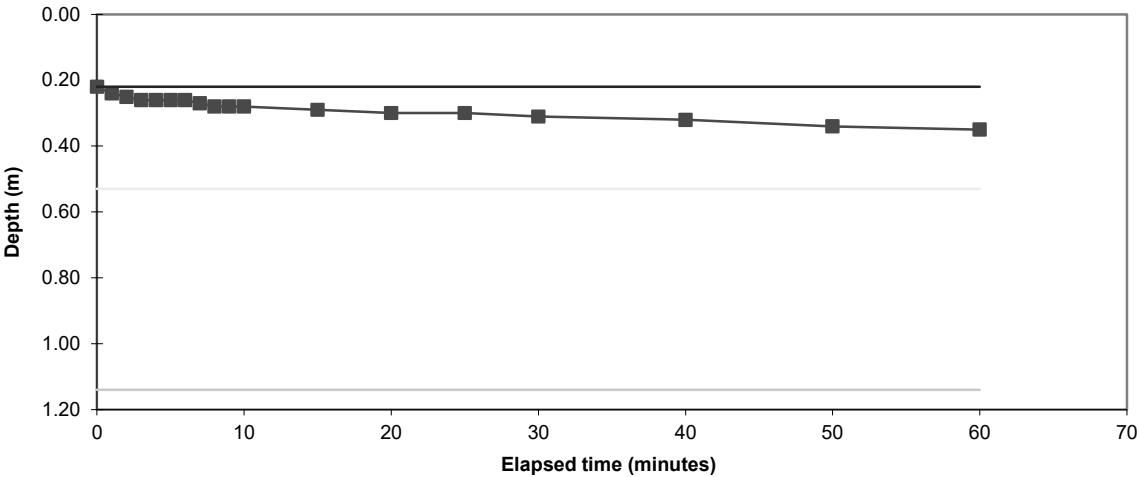
Test incomplete as 25% effective depth not achieved. Unable to reliably determine soil infiltration rate

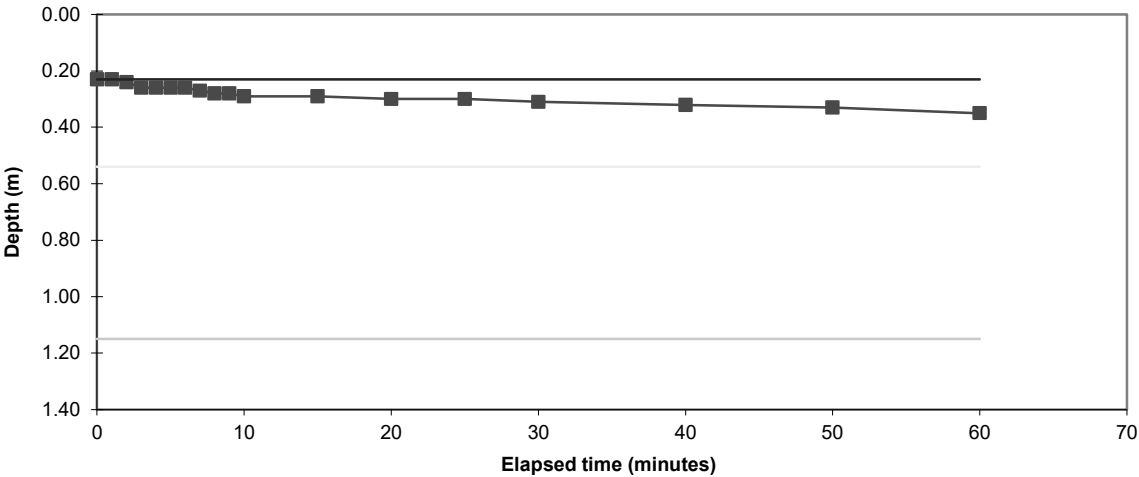
Test incomplete as 25% effective depth not achieved. Unable to reliably determine soil infiltration rate

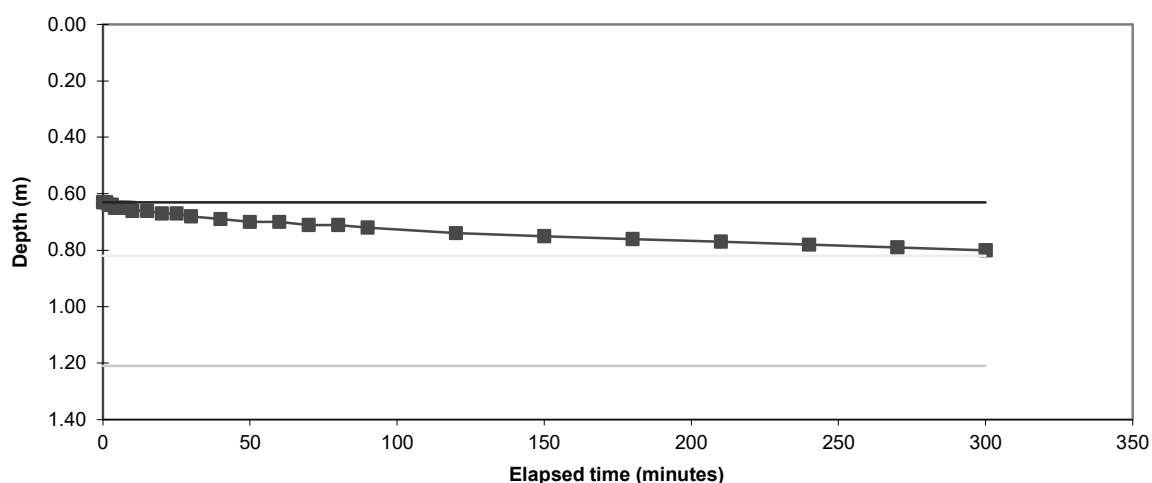
**Soil infiltration rate (m/s):** Test incomplete as 25% effective depth not achieved. Unable to reliably determine soil infiltration rate

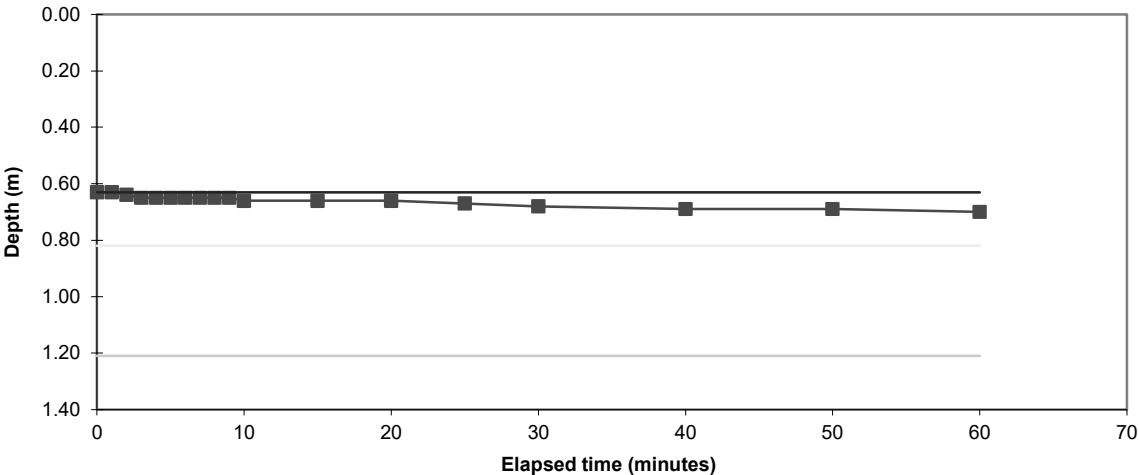
Test incomplete as 25% effective depth not achieved. Unable to reliably determine soil infiltration rate
