## **Land to Rear of Pine Valley**

### **Pre-Development BS5837 Tree Survey**

**December 2013**

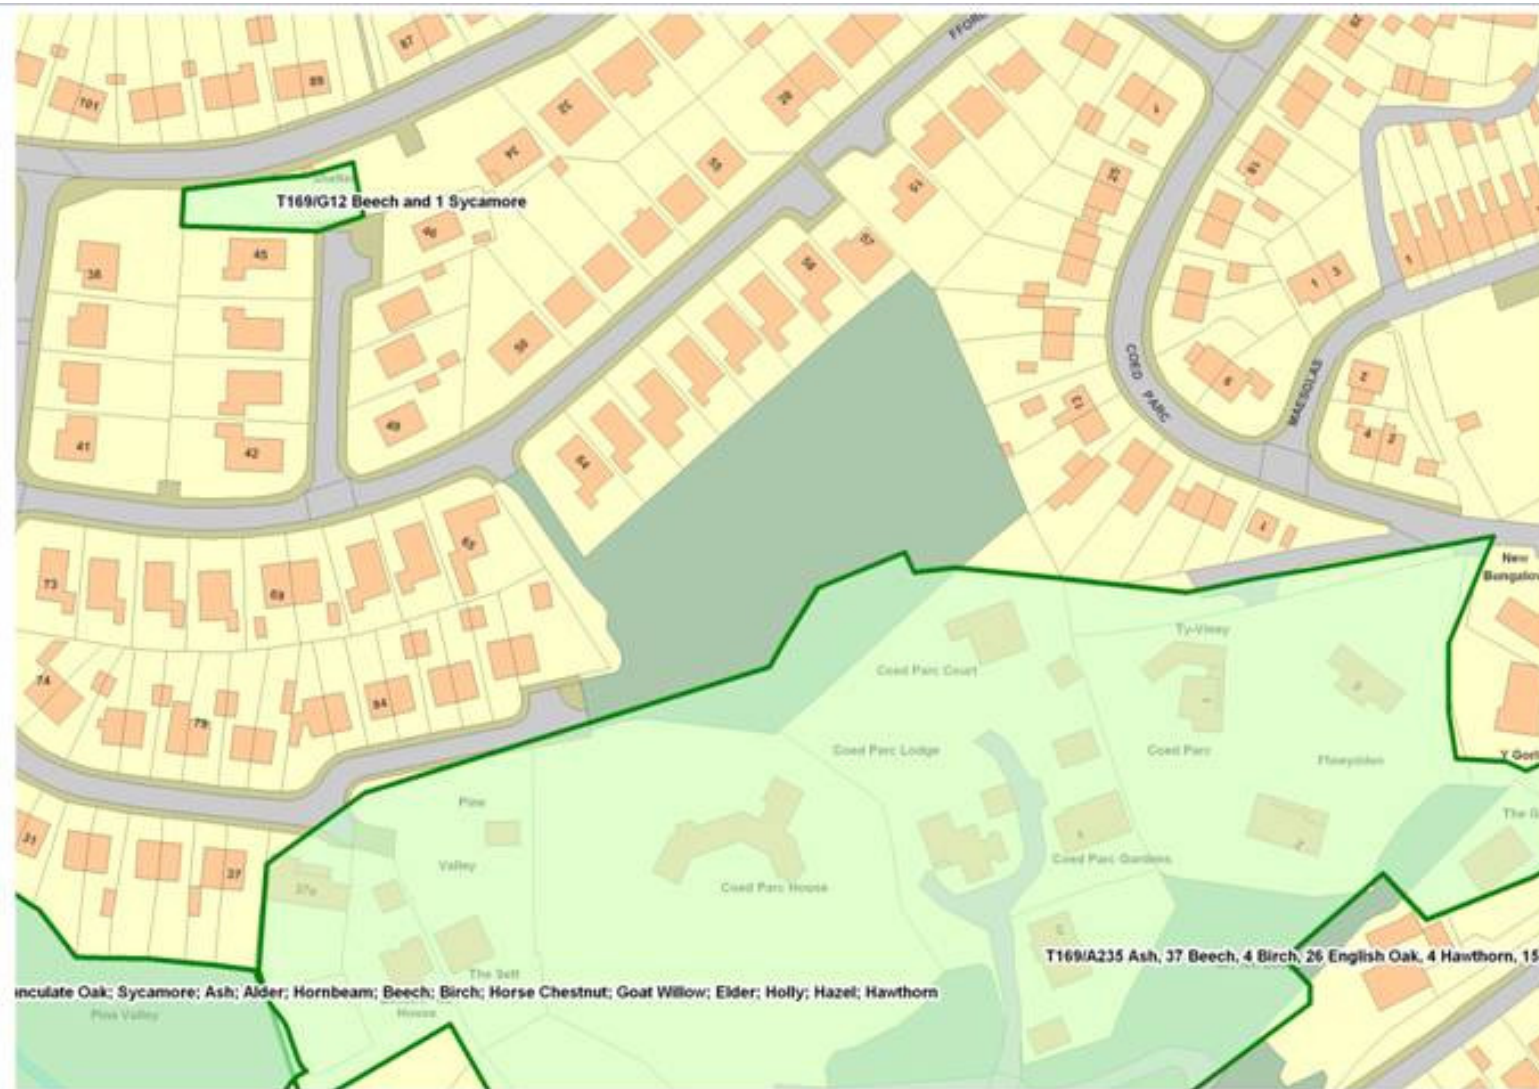
## PLAN 4: Tree Preservation Orders

The Planning Department of Neath Port Talbot Council confirmed that the area to the south of the site is a Tree Protection Order. This appears to include the trees within the site (see Plan 4). However, as the trees will be considered in the context of a planning application, the planning permission would over-ride the TPO and it would not be considered as an impediment to the planning process.

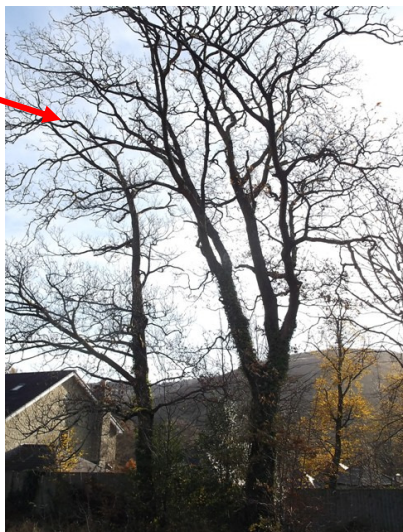
T4 is a Turkey Oak, and its crown shape and adjacent dip in ground level suggest that another tree once stood to the South West of it. As a result, it has an oval shaped crown, and significantly overshadows T3.

| Tree<br>Tag No. | Species | Height<br>m | Stem<br>diameter<br>mm | Height<br>crown<br>clearance /<br>m | Age<br>Class | Branch spread (m) | | | | Physiological<br>Condition | Structural condition | Recommended<br>Works | Est<br>remain<br>years | Category<br>grading | RPA<br>radius<br>m |
|---|---|---|---|---|---|---|---|---|---|---|---|---|---|---|---|
| T3 | English Oak | 12 | 530 | 1.5 | Mi | 10 | 8 | 10 | 1 | FAIR | <ul style="list-style-type: none"> <li>Severely suppressed and overshadowed by T4</li> <li>All of crown out to North East</li> <li>Small thicket of Holly and Beech saplings around base</li> <li>No other visible defects</li> </ul> | <b>Would have to be removed to facilitate development</b> | 40 | <b>C</b> | 6.4 |

T3 & T4 – View of crown suppression of T3 (red arrow)

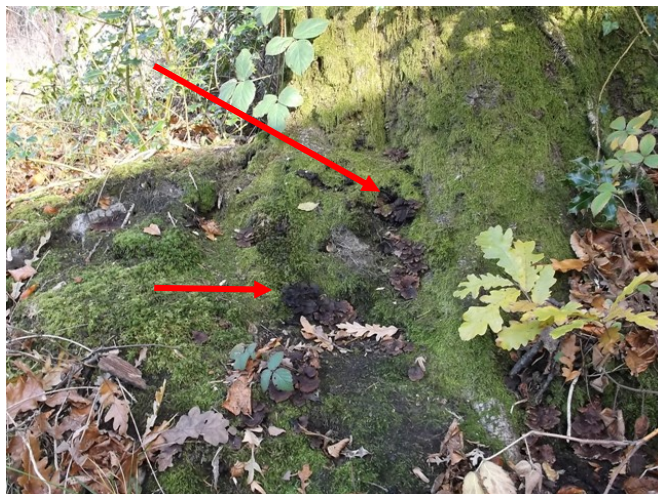
In addition, the remains of fungal fruiting bodies of the root decaying pathogen *Meripilus giganteus* were visible at the base of the tree to the South West. As the roots decay below ground, the risk of unexpected failure during severe weather increases, and therefore this tree has been recommended for removal.

| Tree<br>Tag No. | Species | Height<br>m | Stem<br>diameter<br>mm | Height<br>crown<br>clearance /<br>m | Age<br>Class | Branch spread (m) | | | | Physiological<br>Condition | Structural condition | Recommended<br>Works | Est<br>remain<br>years | Category<br>grading | RPA<br>radius<br>m |
|---|---|---|---|---|---|---|---|---|---|---|---|---|---|---|---|
| T4 | Turkey Oak | 14 | 780 | 2.5 | Mi | 9 | 10 | 8 | 2 | POOR | <ul style="list-style-type: none"> <li>Forks at 4m into co-dominant stems</li> <li>West stem forks again at 5m</li> <li>Oval shaped crown on NW – SE axis</li> <li>Crown shape suggests it was suppressed to South West in past</li> <li>Remains of fungal fruiting bodies of <i>Meripilus giganteus</i> at base West</li> <li>Stem leaning to North at 70° angle</li> <li>Large waterlogged dip in ground at base of tree to South West</li> </ul> | <b>FELL</b> | 0 | <b>U</b> | 9.4 |

T4 – View of remains of fungal fruiting bodies of *Meripilus giganteus* at base (red arrows)

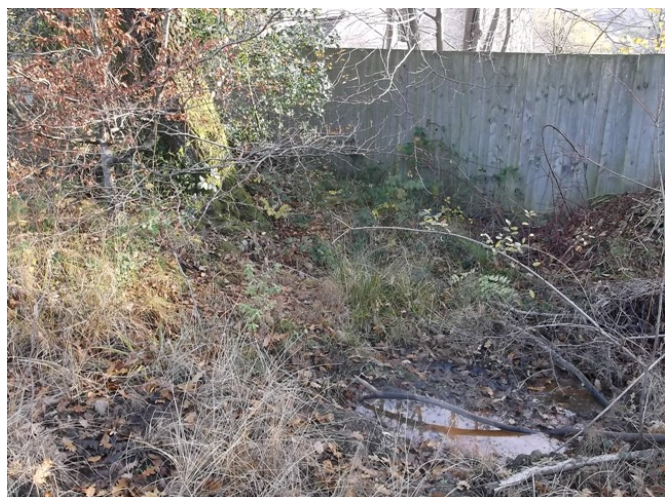
T4 – View of waterlogged ground to West side of tree

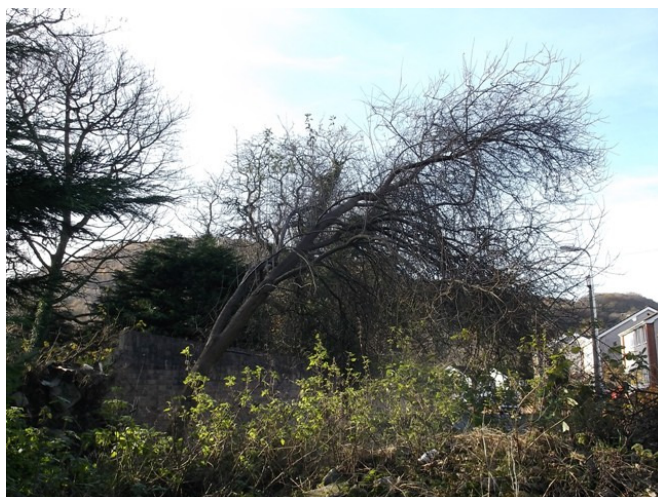
T5 is a small tree of the *Prunus* species, and has been severely suppressed. The majority of its crown is out to the West and North West, and it is leaning at an acute angle to the North West. There is a large Canker on the underside of the trunk, immediately below the fork, and this tree has been recommended for removal.

T5 – View of stem severely leaning to North

| Tree<br>Tag No. | Species | Height<br>m | Stem<br>diameter<br>mm | Height<br>crown<br>clearance /<br>m | Age<br>Class | Branch spread (m) | | | | Physiological<br>Condition | Structural condition | Recommended<br>Works | Est<br>remain<br>years | Category<br>grading | RPA<br>radius<br>m |
|---|---|---|---|---|---|---|---|---|---|---|---|---|---|---|---|
| T5 | Prunus sp. | 4 | 210 | 0.5 | Mi | 5 | 0 | 0 | 4 | POOR | <ul style="list-style-type: none"> <li>Was severely overshadowed and suppressed in past by T6 to SE</li> <li>All of crown out to NW</li> <li>Leaning at 45° angle to NW</li> <li>Forks at 2m into co-dominant stems</li> <li>Large Canker below fork on NW side of trunk</li> </ul> | <b>FELL</b> | 10 | <b>C</b> | 2.5 |

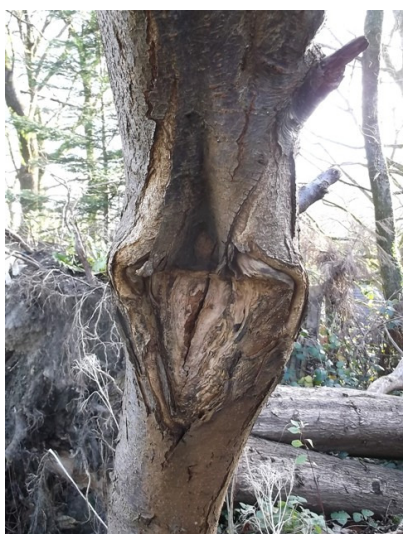
T5 – View of extensive Canker on trunk North side

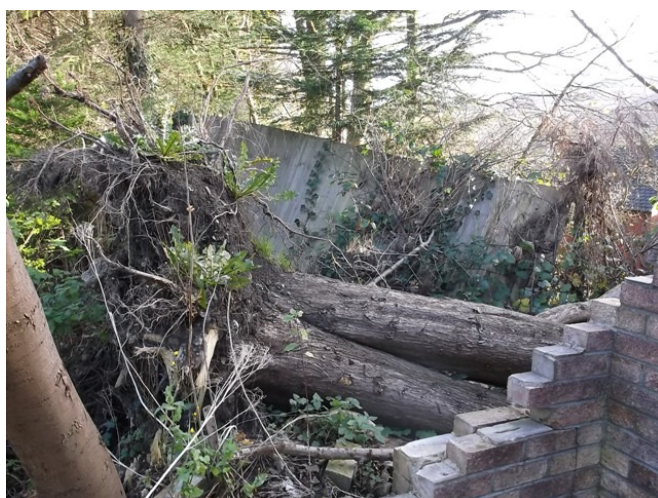
T6 has recently blown over and fallen to the South through the boundary fence. Before that, it significantly overshadowed and suppressed T5.

T6 – View of stems fallen through boundary fence

| Tree<br>Tag No. | Species | Height<br>m | Stem<br>diameter<br>mm | Height<br>crown<br>clearance /<br>m | Age<br>Class | Branch spread (m) | | | | Physiological<br>Condition | Structural condition | Recommended<br>Works | Est<br>remain<br>years | Category<br>grading | RPA<br>radius<br>m |
|---|---|---|---|---|---|---|---|---|---|---|---|---|---|---|---|
| T6 | Cypress sp. | 10 | 550 | n/a | M | n/a | n/a | n/a | n/a | <b>DEAD</b> | <ul style="list-style-type: none"> <li>Has uprooted in recent past</li> <li>Fallen to South through boundary fence</li> <li>Twin stemmed from base</li> </ul> | <b>Cut up and remove<br/>Re-instate boundary fence</b> | 0 | <b>U</b> | 6.6 |

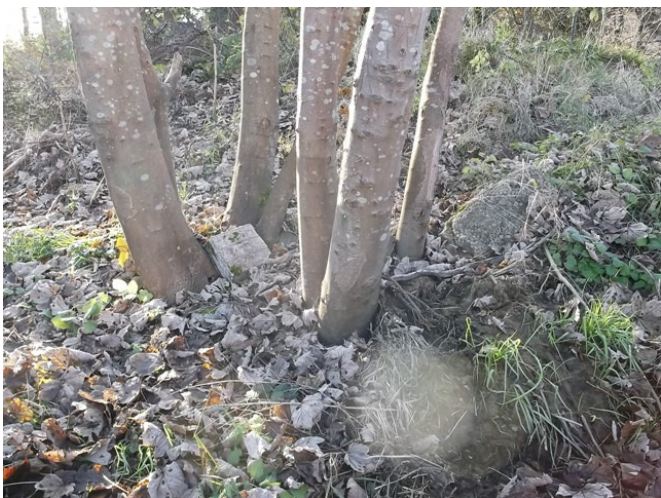
T7 is a young multi-stem tree. However, a large heap of soil and rubble has been piled up around the base of the tree, with associated bark damage at the base of some of the stems. Further damage is likely to occur as the soil and rubble are removed during the course of development.

| Tree<br>Tag No. | Species | Height<br>m | Stem<br>diameter<br>mm | Height<br>crown<br>clearance /<br>m | Age<br>Class | Branch spread (m) | | | | Physiological<br>Condition | Structural condition | Recommended<br>Works | Est<br>remain<br>years | Category<br>grading | RPA<br>radius<br>m |
|---|---|---|---|---|---|---|---|---|---|---|---|---|---|---|---|
| T7 | Sycamore | 8 | 397 | 1.8 | Y | 4 | 4 | 4 | 4 | FAIR | <ul style="list-style-type: none"> <li>Multi-stemmed x 7</li> <li>Large heap of rubble and soil piled up around base of tree</li> <li>Some damage to bark at base of stems</li> <li>No other visible defects</li> </ul> | <b>Would have to be removed to facilitate development</b> | 20 – 40 | <b>C</b> | 4.8 |

T7 – View of multi-stems and rubble heaped around base

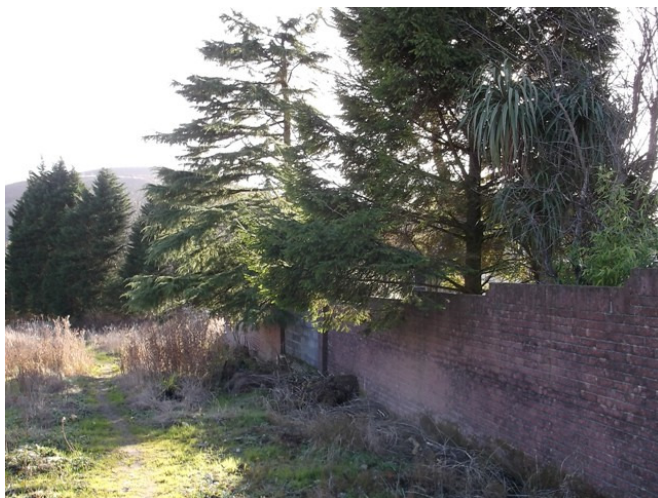
T8 and T9 are beyond the site boundary in the rear garden of 65 Pine Valley. There is a low concrete retaining wall with brick boundary wall on top along the boundary line, suggesting that the ground level is higher beyond the boundary.

No cracks were visible in the boundary wall, and it is considered unlikely that major structural roots would have extended far into the site. Some of the lowest branches do overhang the proposed site entrance, and these would require pruning back to facilitate the development.

T8 & T9 – View of lower crowns overhanging site entrance

| Tree Tag No. | Species | Height m | Stem diameter mm | Height crown clearance / m | Age Class | Branch spread (m) | | | | Physiological Condition | Structural condition | Recommended Works | Est remain years | Category grading | RPA radius m |
|---|---|---|---|---|---|---|---|---|---|---|---|---|---|---|---|
| T8 | Deodar Cedar | 8 | 300 | 1.0 | Y | 3.5 | 3.5 | 4 | 2.5 | FAIR | <ul style="list-style-type: none"> <li>Has been recently topped</li> <li>One sided crown growth out to East</li> <li>Suppressed by Willow to West</li> <li>Lower limbs overhang site entrance</li> <li>No other visible defects</li> </ul> | <b>Lower crown would have to be pruned back to facilitate development</b> | 20 – 40 | <b>C</b> | 3.6 |
| T9 | Norway Spruce | 6 | 230 | 1.2 | Y | 2 | 3 | 3 | 2 | GOOD | <ul style="list-style-type: none"> <li>Has been recently topped</li> <li>Lower limbs overhang site entrance</li> <li>No other visible defects</li> </ul> | <b>Lower crown would have to be pruned back to facilitate development</b> | 20 | <b>C</b> | 2.8 |
