# Tidal Lagoon Swansea Bay

## Data Review for Phase 7A Works

Swansea Bay Tidal Lagoon plc

May 2020

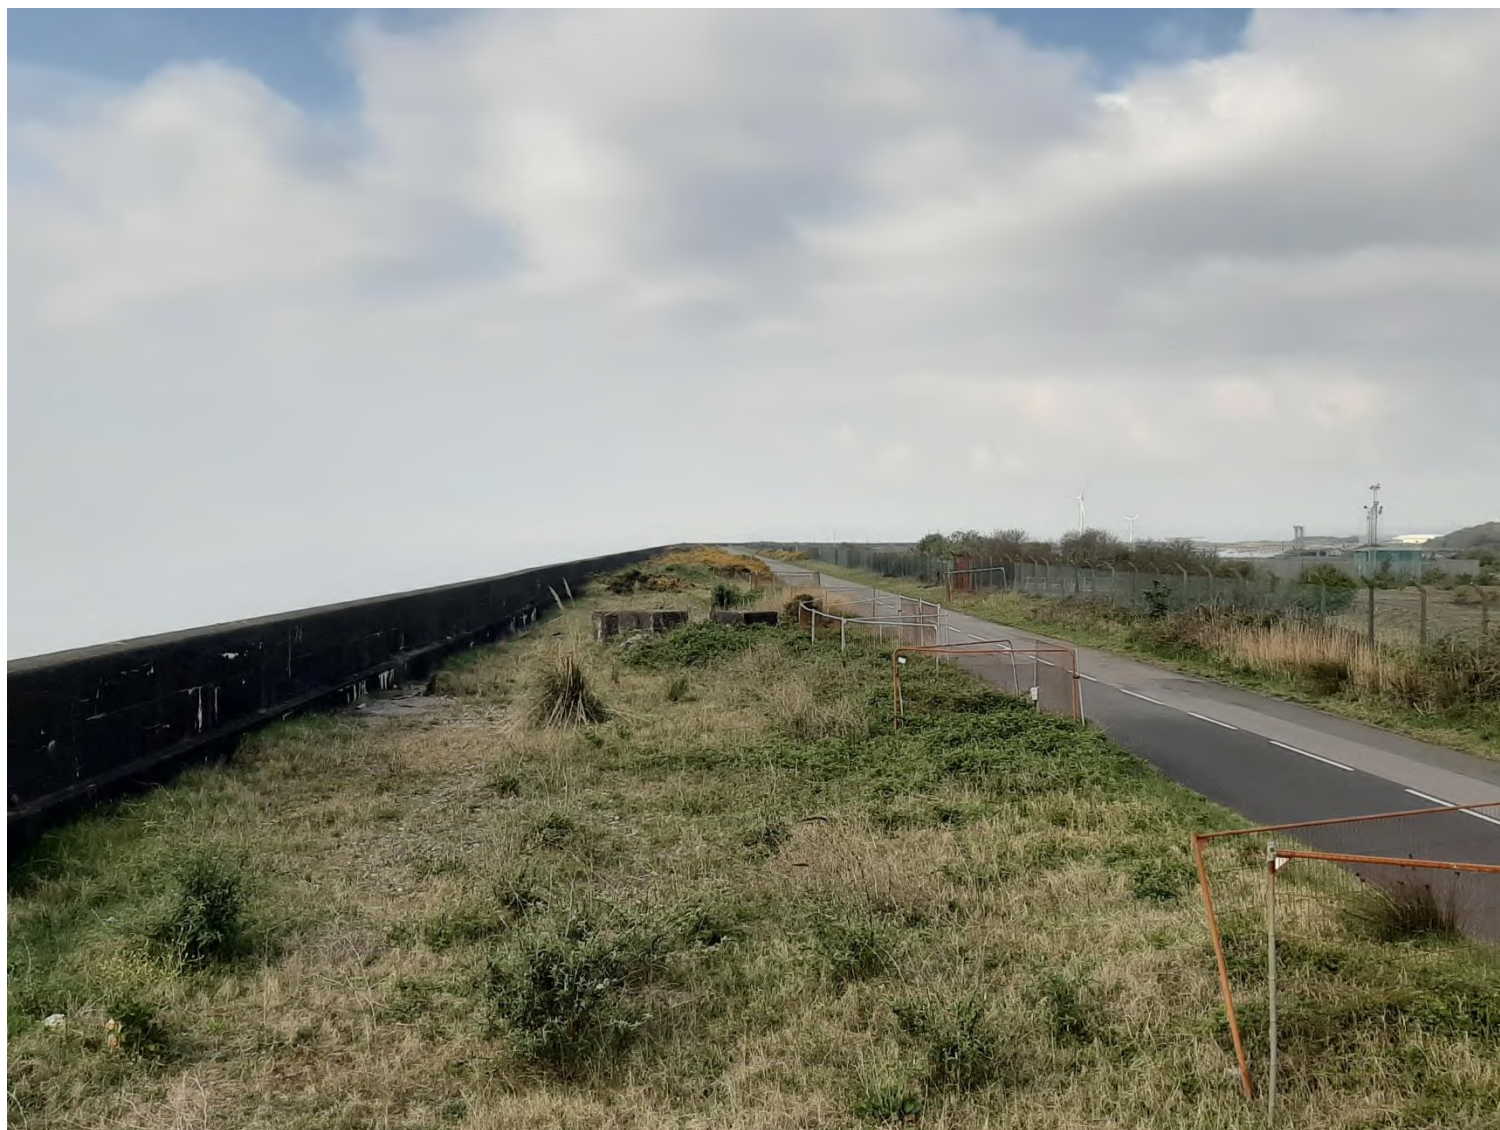
Photo along the seawall of the Western Landfall Access Road (view – south west)

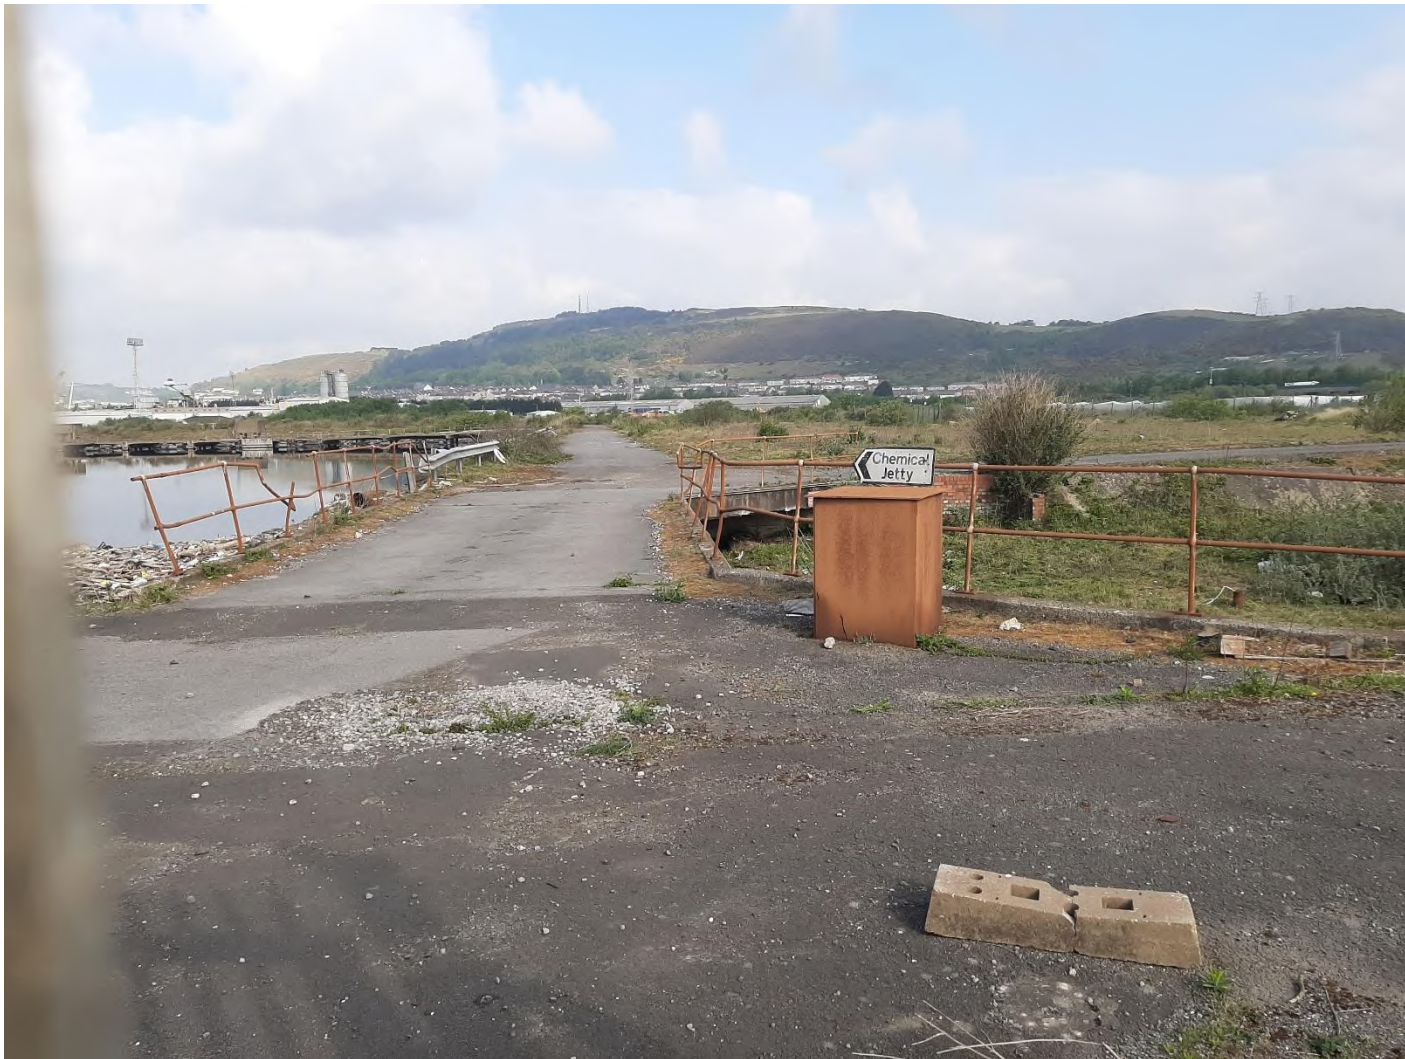
**Photo of land near Inset B (view – north west)**

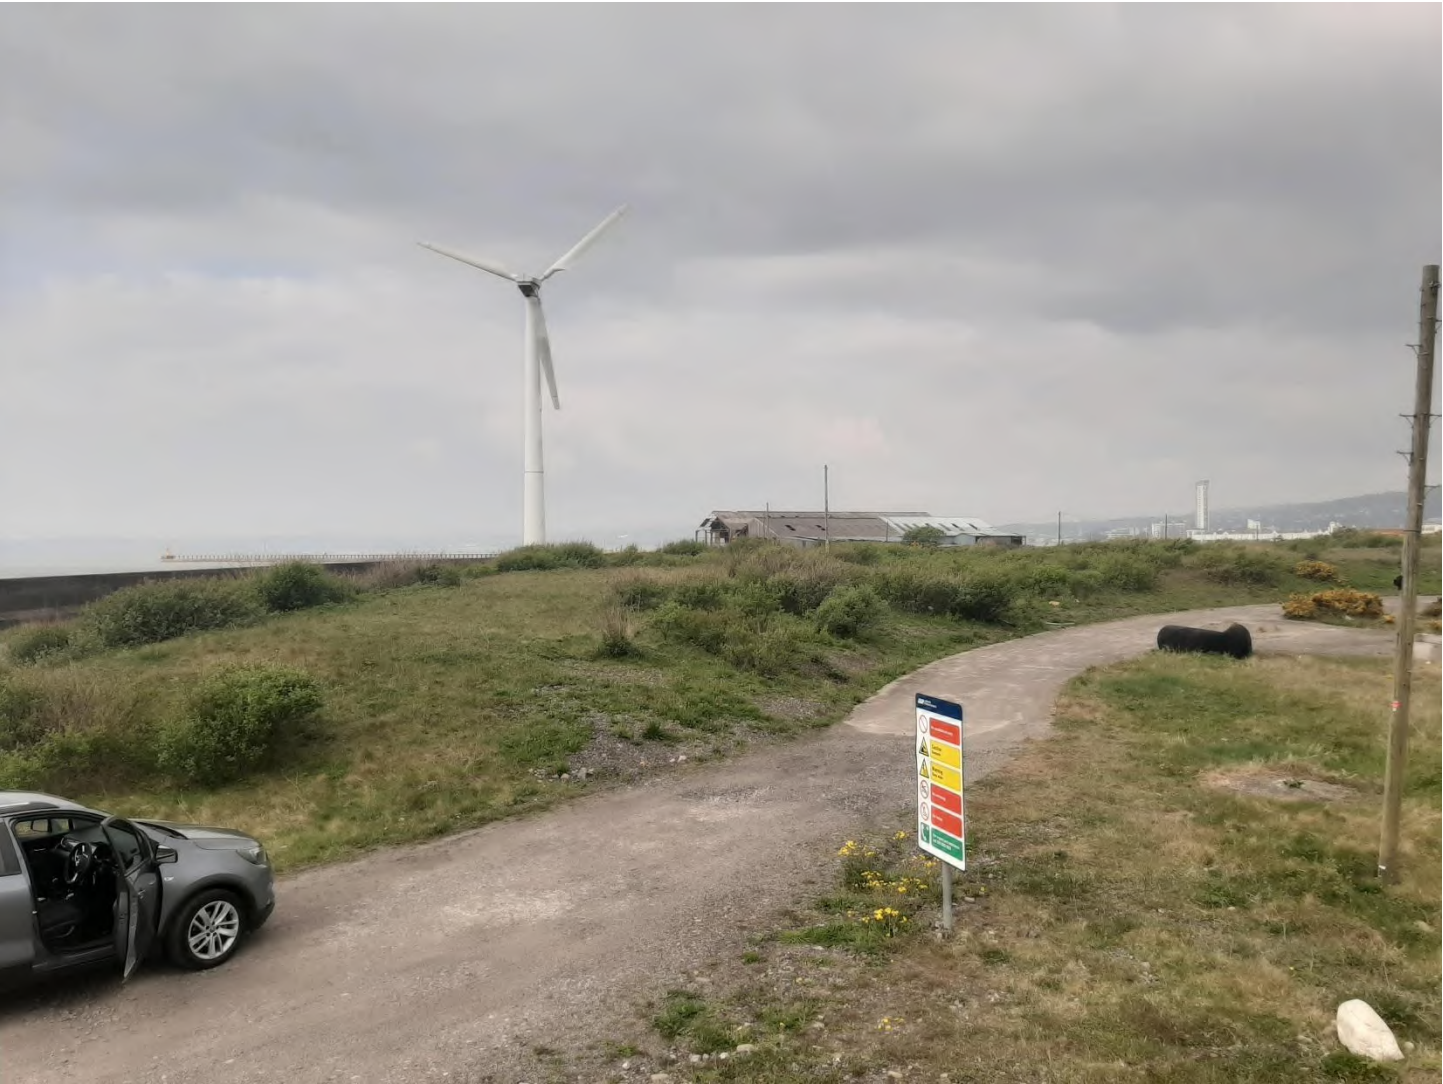
Photo of Western Landfall Area and stockpile (view – south west)

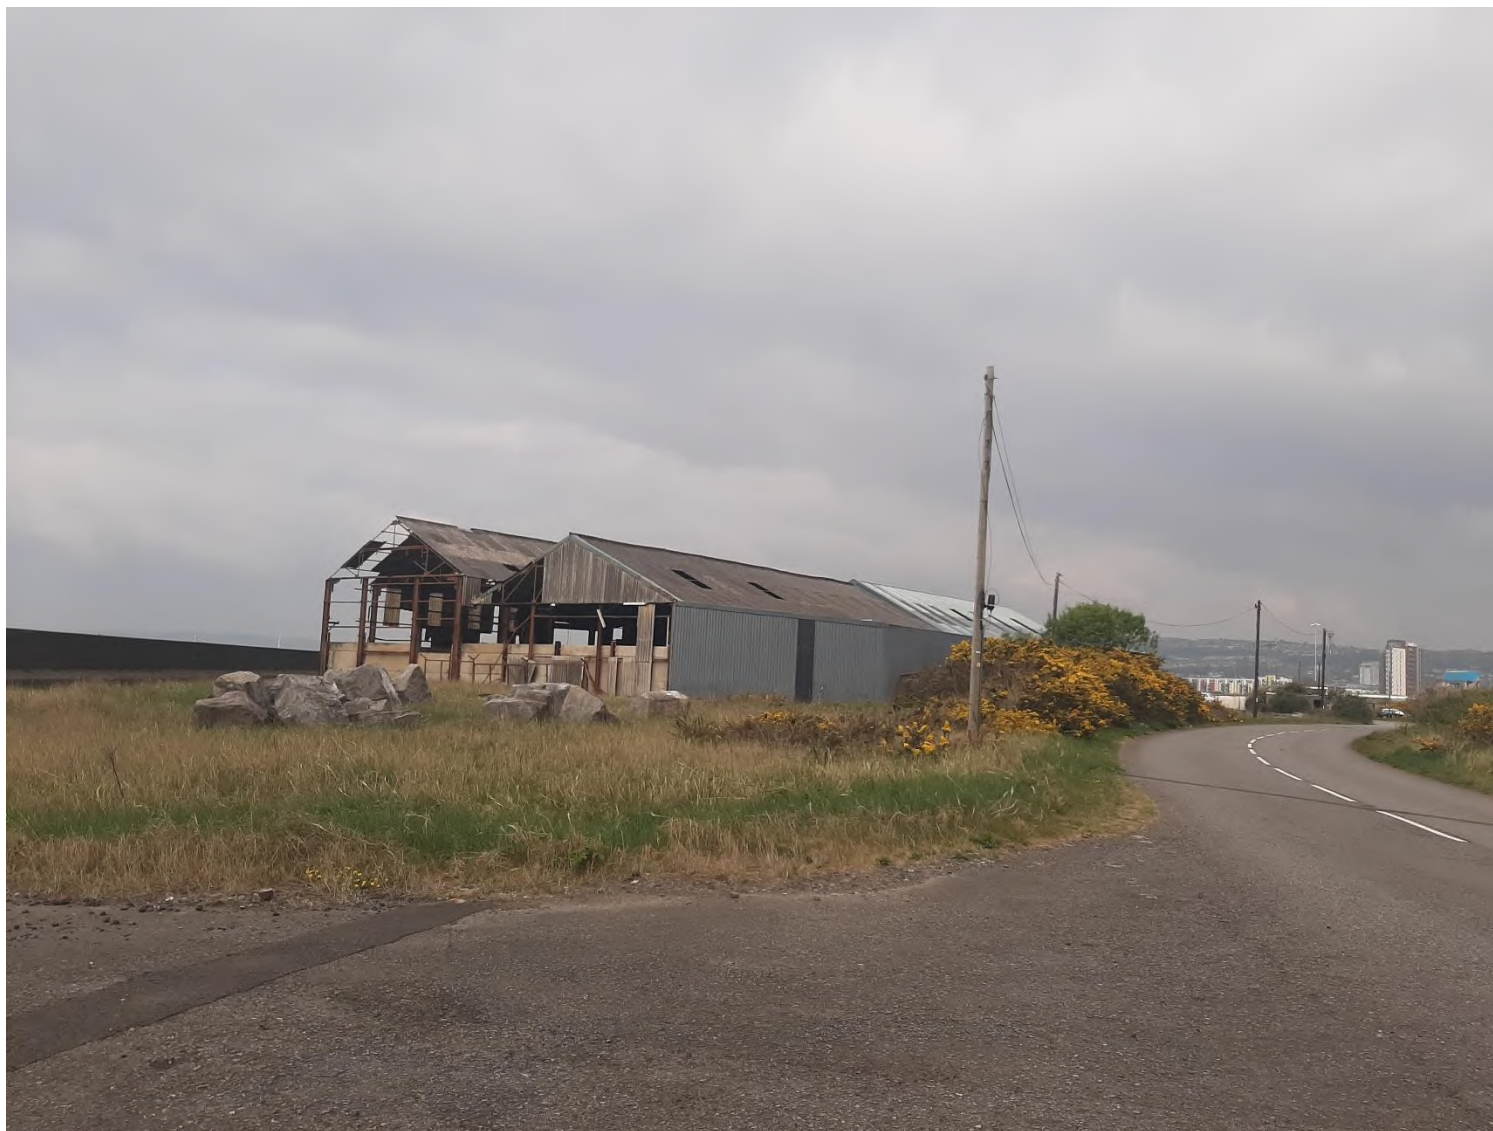
**Photo of derelict building along the Western Landfall Area adjacent to Inset C (view – west)**

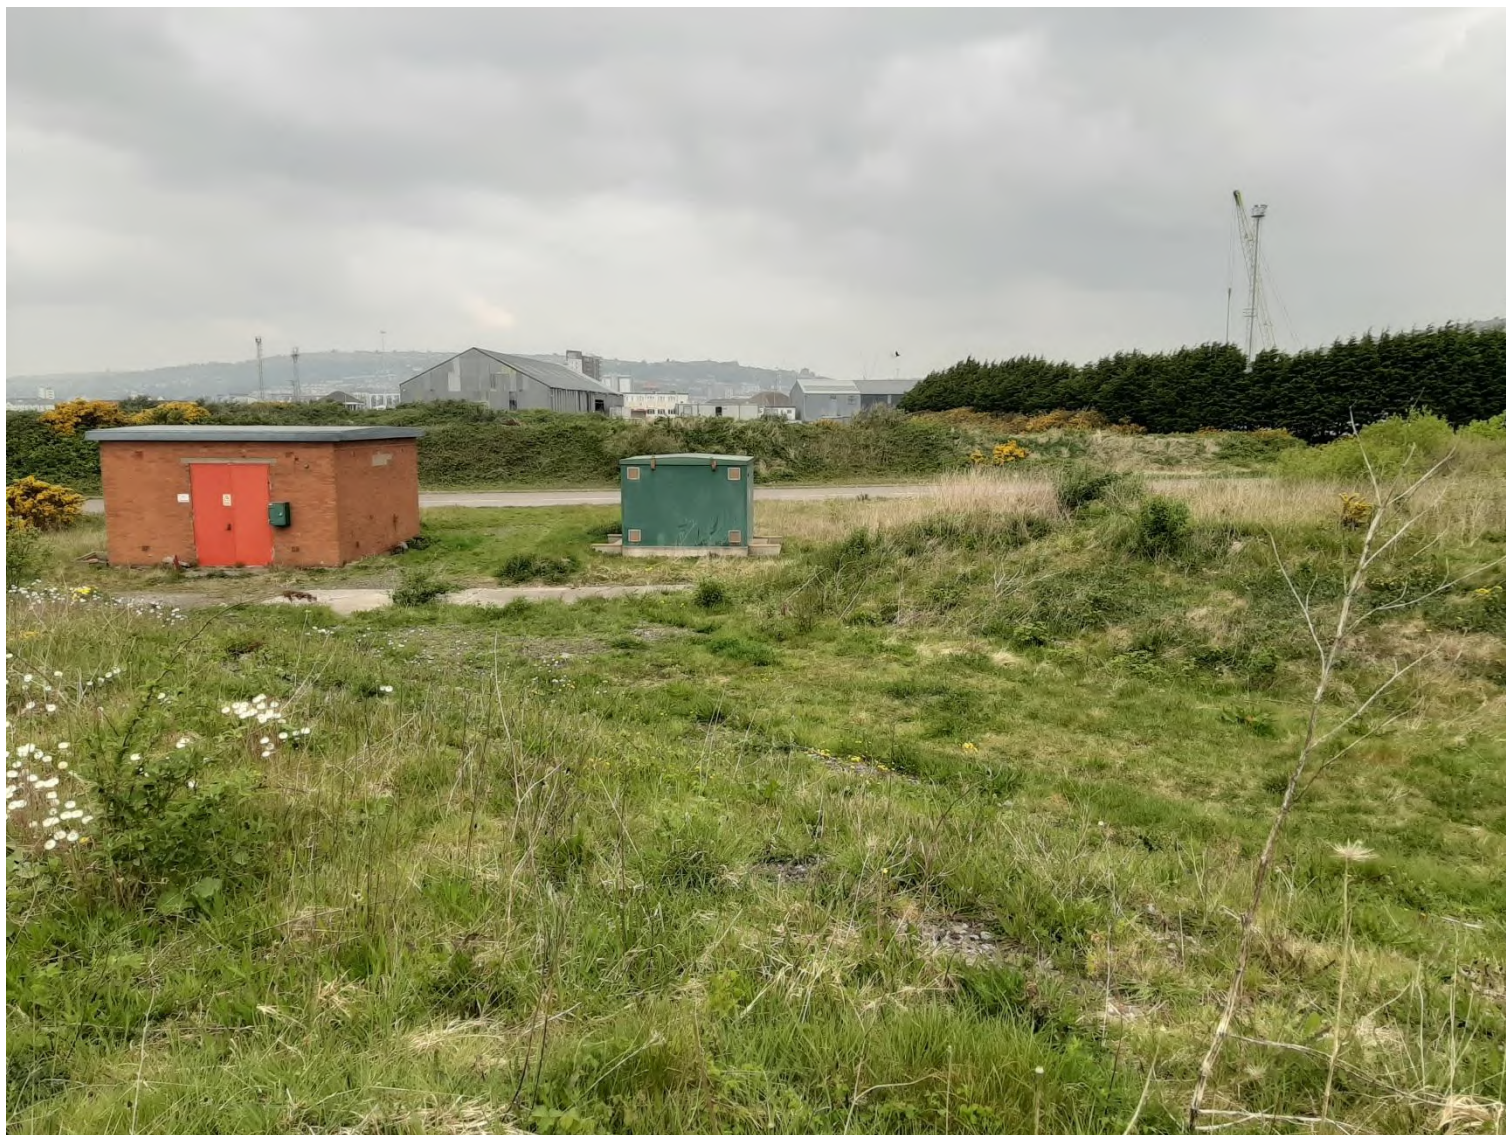
**Photo of Inset C on the Western Landfall Area (view – south west)**
