Tidal Lagoon (Swansea Bay) Plc

# **Tidal Lagoon Swansea Bay Onshore Works**

Ground Conditions Desk Study Report

19<sup>th</sup> April 2016

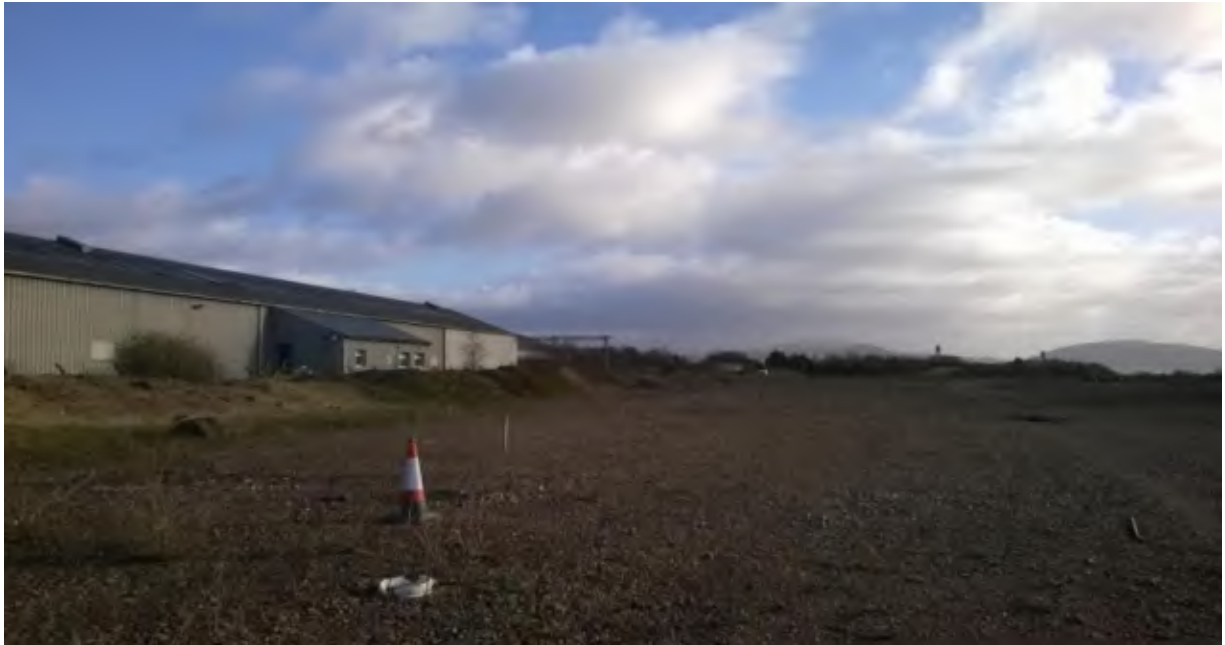
1

Further to the west there is an open area of former railway ballast which is intended to be used for site offices during the construction phase (Plate 1). A few items of scrap metal were noted across this area but there was no notable evidence of potential surface contamination. The area is raised approximately 2m higher than the adjacent dockside and shares a boundary, marked by a palisade fence, with the former Swansea Coach works to the immediate north. It is proposed that a new access route for the construction phase offices is made from this area onto Langdon Road to the northwest. This route will in turn become the new access road for the proposed Western Landfall Building.

Former Rail Sidings

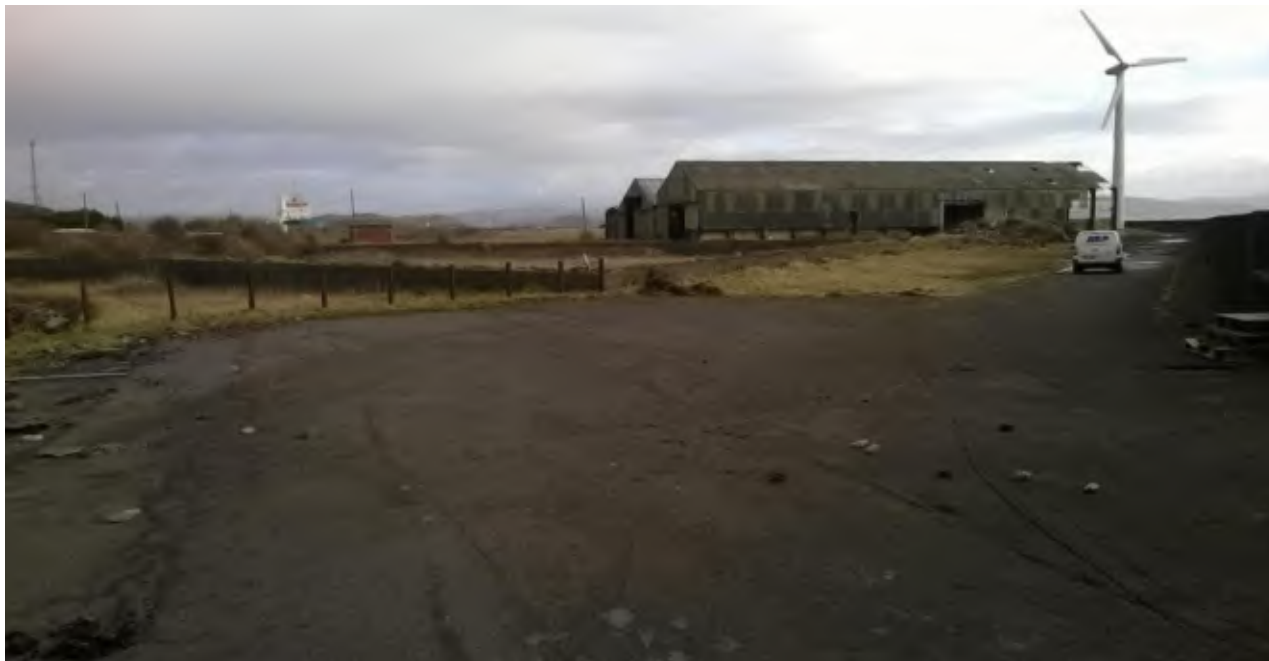
3

At the western terminus of the road the site is occupied by docks, hardstanding and a derelict building noted to include asbestos cement sheeting in a poor state of repair (Plate 3). There are areas of hardstanding and open ground present which were anecdotally reported by the Client to have been occupied by oil tanks. A recently constructed wind turbine is present (Plate 3).

Western Landfall - view east

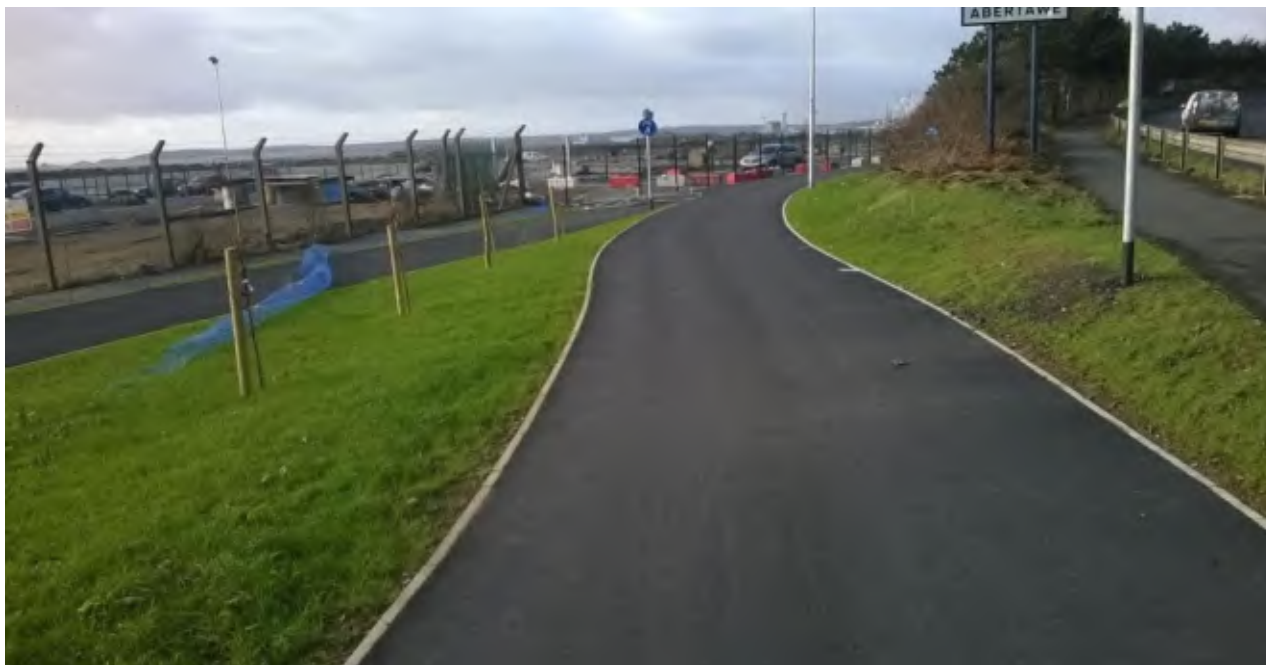
5

New Footpath along Fabian Way (Former BP Transit Site)

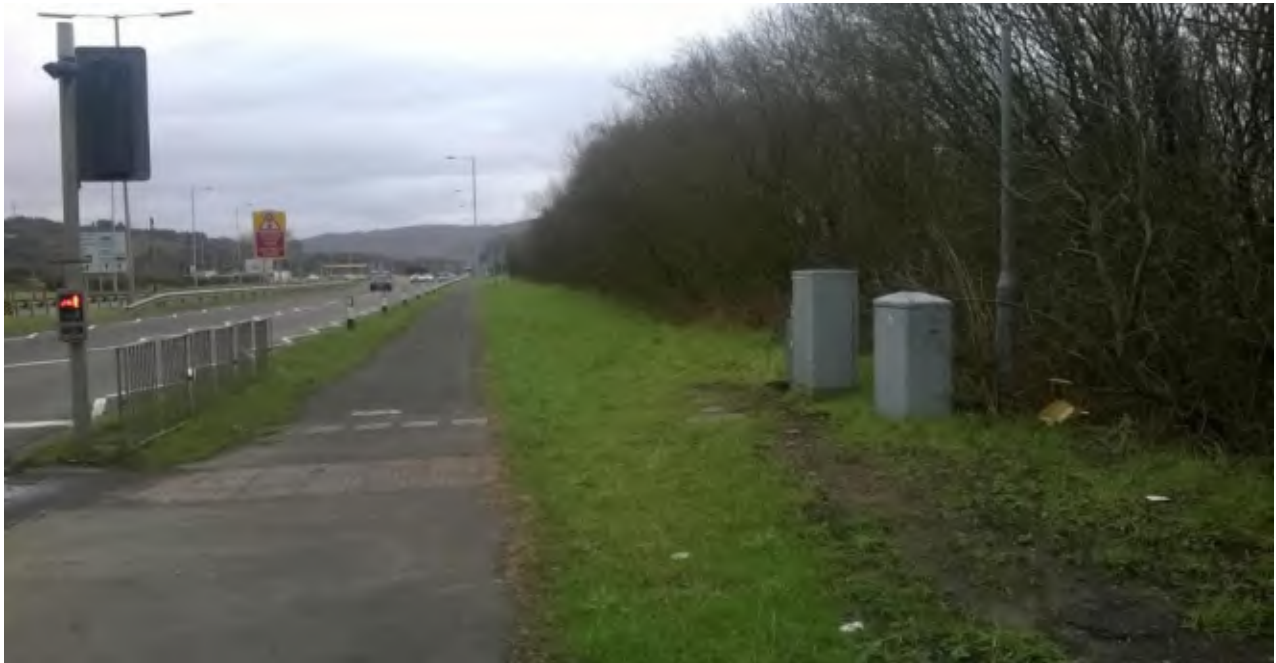
7

Fabian Way - view east

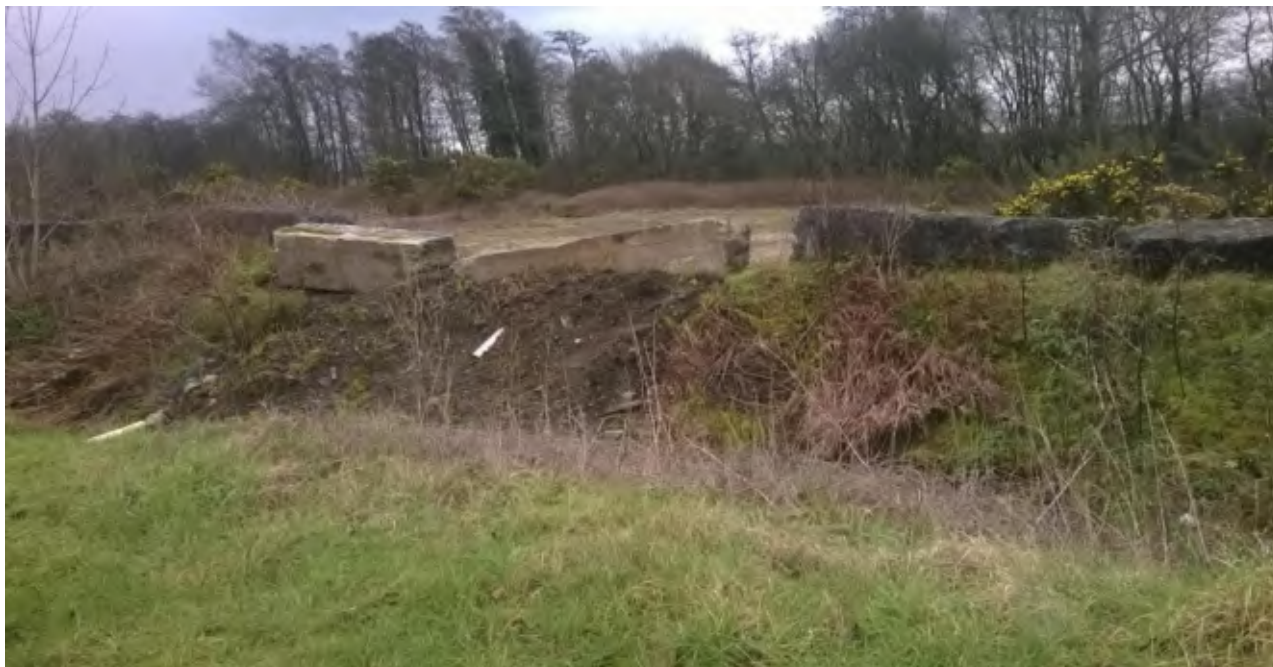
There are a series of swales and drainage ditches (Plate 9) containing some small amounts of litter, running alongside the footpath, though no evidence of contamination was noted in the water present in these features. During the site walkover the presence of a large number of utility service manhole covers was noted in the Fabian Way footpath. Therefore, a potential secondary option of running the cable through Crymlyn Burrows is also being considered to avoid conflict with existing services.

| Plate Title | Drainage Ditch on South Side of Fabian Way | Plate No | 9 |

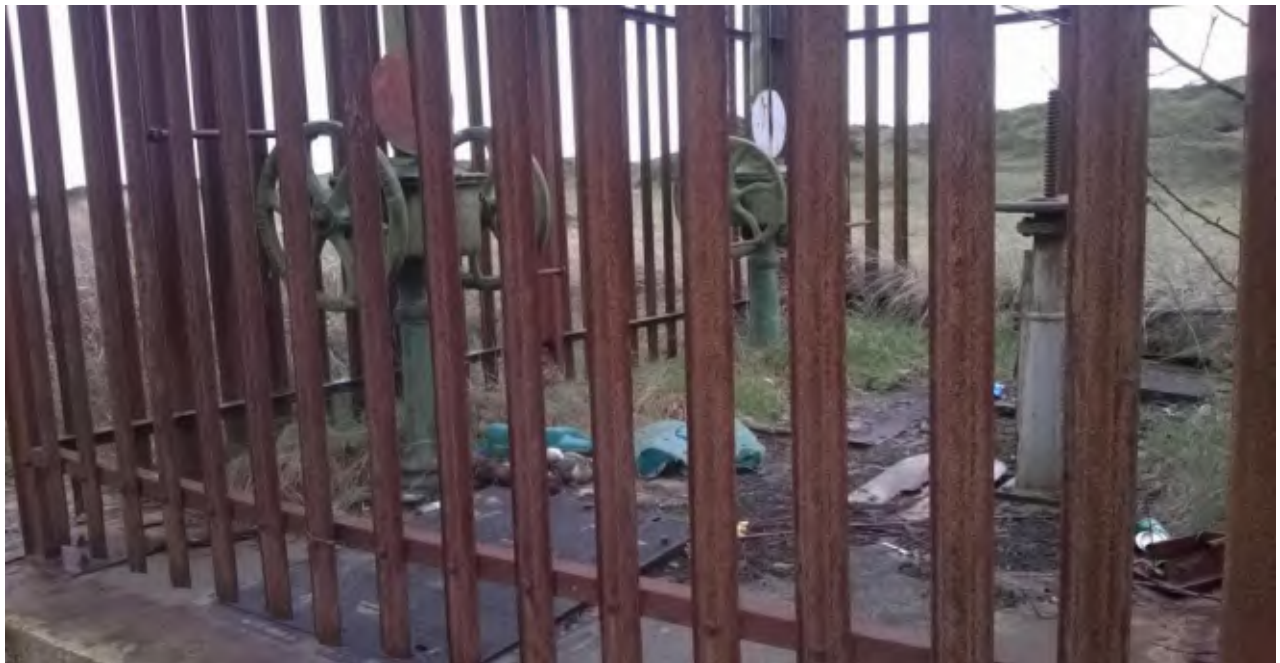
| Plate Title | Relic Infrastructure Present in Crymlyn Burrows | Plate No | 11 |

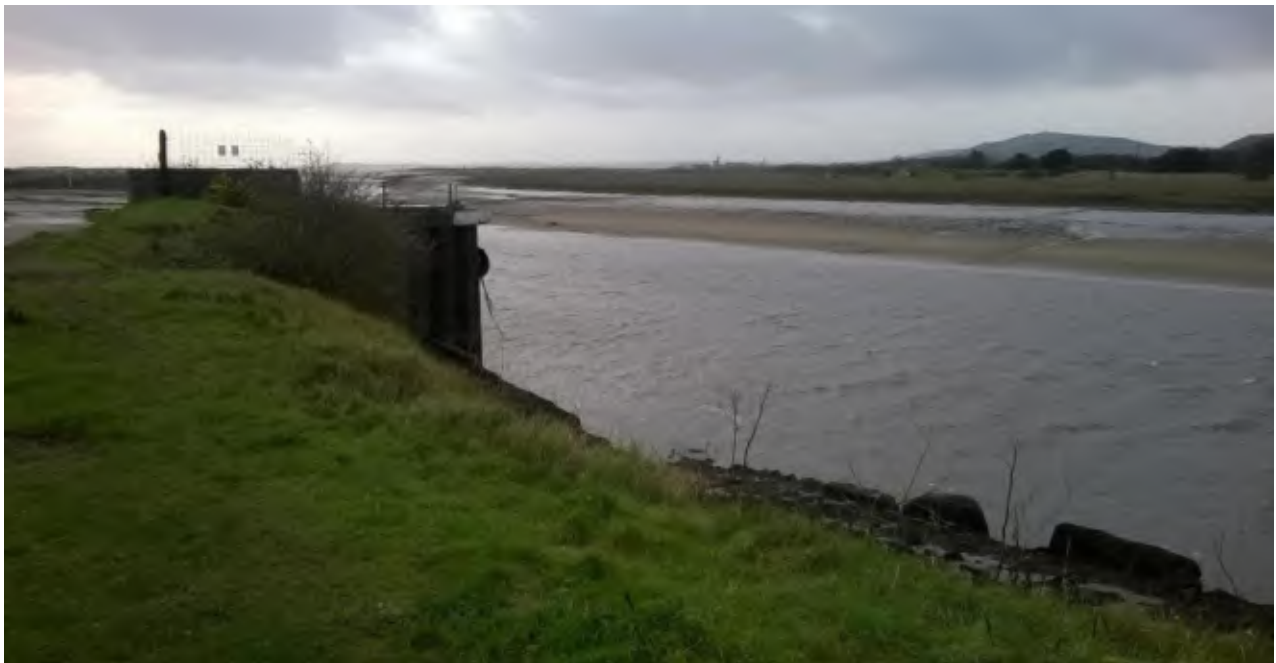
part of the former BP Chemical plant at Baglan Bay. It is noted that eastern bank of the River Neath in this location is significantly elevated in relation to the ground level at Crymlyn Burrows and includes a built up river wall (Plate 12).

| WYG Environment<br>5 <sup>th</sup> Floor, Longcross Court, 47 Newport Road, Cardiff<br>Tel: 02920 829200<br>Fax: 02920 455321<br>Environmental Consultancy<br>Ground Engineering Services | Project | Tidal Lagoon Swansea Bay - Onshore Works | | Plate Title<br>View West Towards Crymlyn Burrows Over River Neath | |

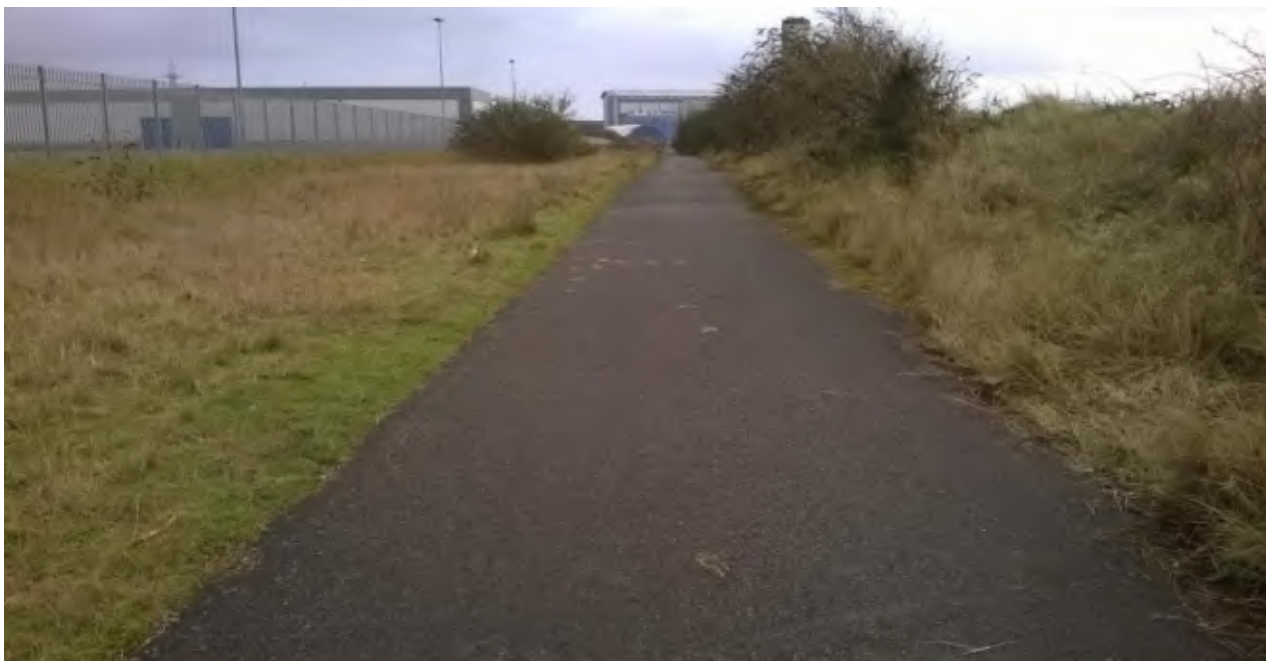
| Plate Title | View Southeast Towards Baglan Energy Park | Plate No | 13 |
