**Building scoping survey &  
Preliminary Roost Assessment  
for presence of Bat Roost sites**

**Gospel Hall,**

**Ynys Street,**

**Port Talbot**

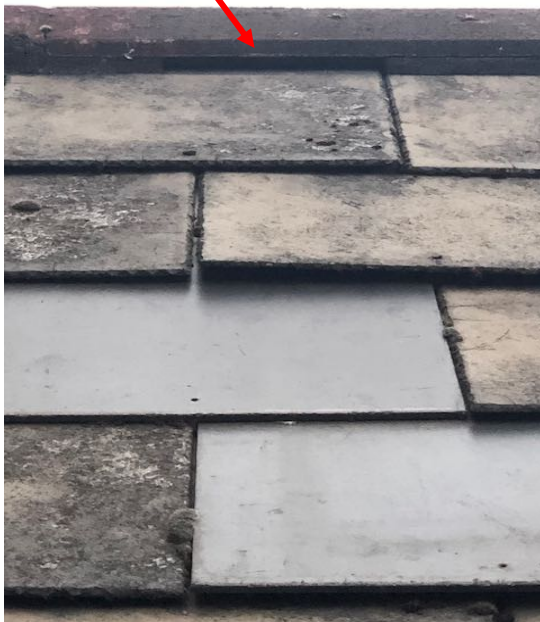
Slight 10-15mm gap under ridge tiles

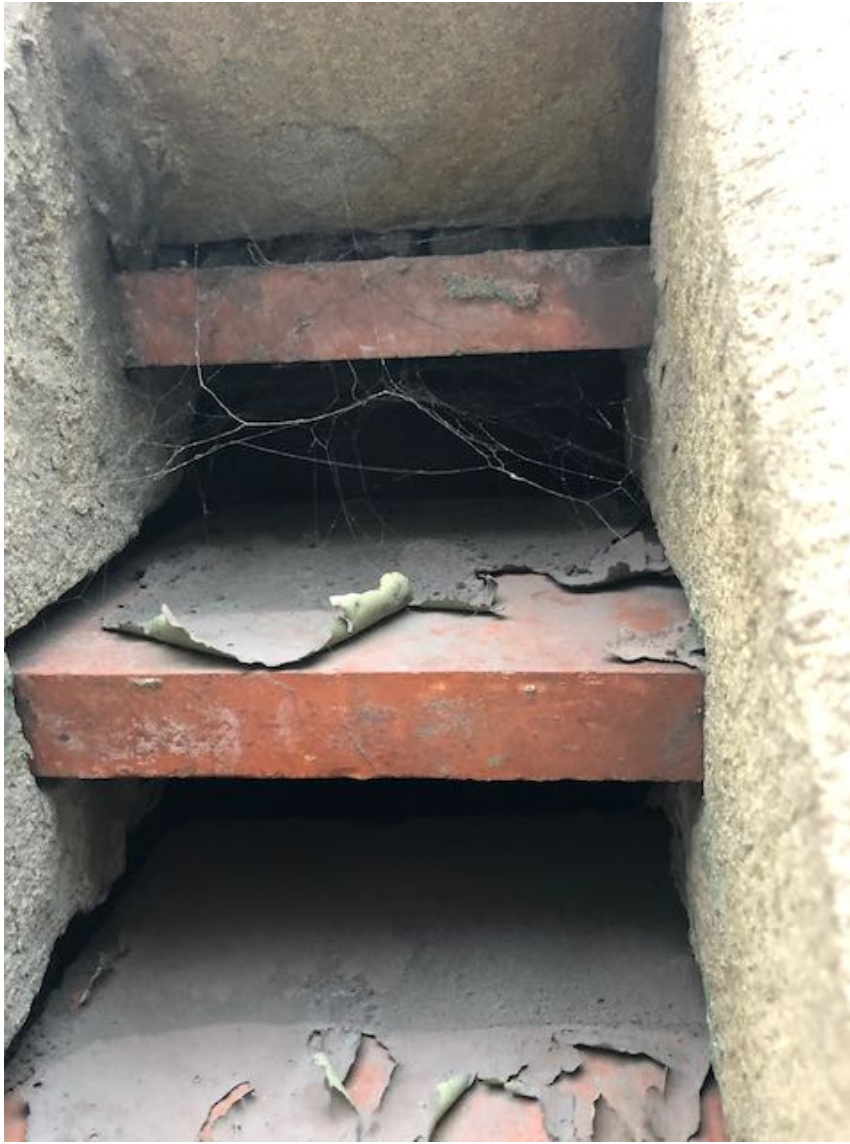
- 1.5. During the **external inspections**, no evidence of bat activity was found such as staining or polishing of roof material or around the louvered vent which also had some

spider's webs over the openings indicating no recent use of the openings. Nor was any evidence found between the gaps of the roof tiles or the ridge tiles and no incidental evidence such as droppings or insect fragments in the immediate vicinity of these features.

**Louvered air vent under roof apex of porch**

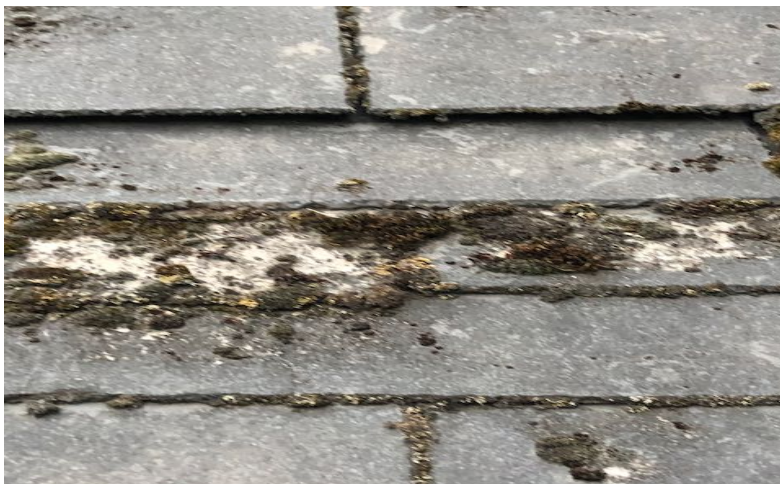
**Raised tiles**
