# Coal Mining Risk Assessment

Wern Ddu, Plot 1, Tyllwyd, Neath, Port Talbot, SA10 7DZ

Single detached residential dwelling

Assessment Summary

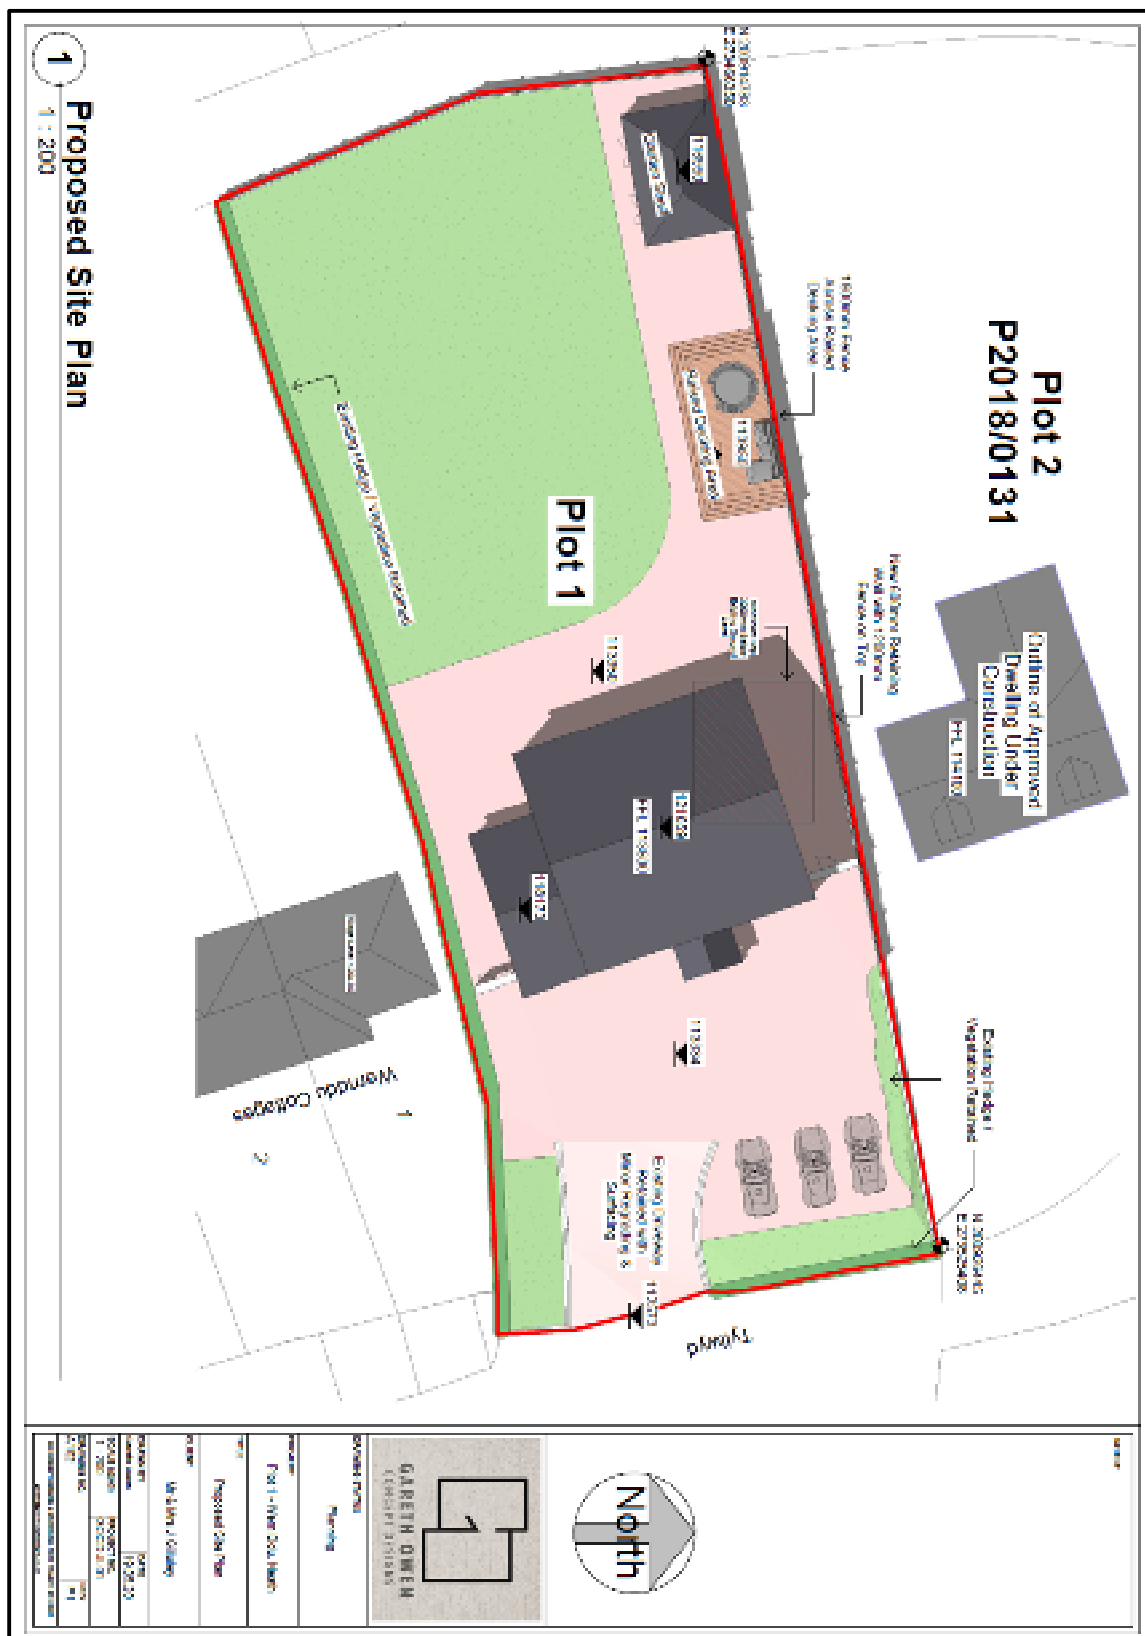
## Appendix A – Plan showing proposed development layout

| Coal mining issue | Reported | | Risk assessment | |
|---|---|---|---|---|
| c) Mine entries (shafts and adits) | X | | High risk | Mine entry 273200-022 is located within the site boundary and is located beneath the currently proposed property footprint |

Due to the location of the shaft below the proposed property and with the uncertainty as to the depth, nature and competency of fill and the suitability of the capping structure for the proposed development it is considered that the risk to this development is currently high. Subject to appropriate calculations/designs being provided confirming the shaft treatment being appropriate for the size and nature of development, this risk may subsequently be revised.

The coal mining legacy issues outlined in this report, particularly the presence of mine entry 273200-022 beneath the proposed development footprint, will have implications for layout in the proposed development outlined in Appendix A. As discussed above, it is recommended that the property footprint and any other development structures be located away from the mine entry and its zone of influence where possible. Calculations will be required to prove the appropriateness of the current remedial solution, in light of the development proposals.

Due to the presence of mine entry 273200-022 beneath the proposed development footprint, the Coal Authority would recommend consulting a structural engineer as to confirm the suitability of existing mine shaft treatment for the proposed development and as to whether the risk of ground instability can be mitigated within the design of the foundations for the proposed development. Irrespective of this, efforts should be sought to locate the proposed building and any associated car parking or driveway should be avoided above the mine entry, or within its zone of influence, where possible. In the event that the risk cannot be accommodated within the foundation design/shaft treatment design an alternative solution may need to be provided, which may include further investigation and treatment to the mine entry or relocation of the proposed development location within the site boundary.
