*Report No. BC/MB/05.20.03.*

# **Coal Mining Risk Assessment: Land at Tyn y Caeau, Margam.**

***Recycling Plant and Machinery Ltd***

***Report Date 22<sup>nd</sup> May 2020.***

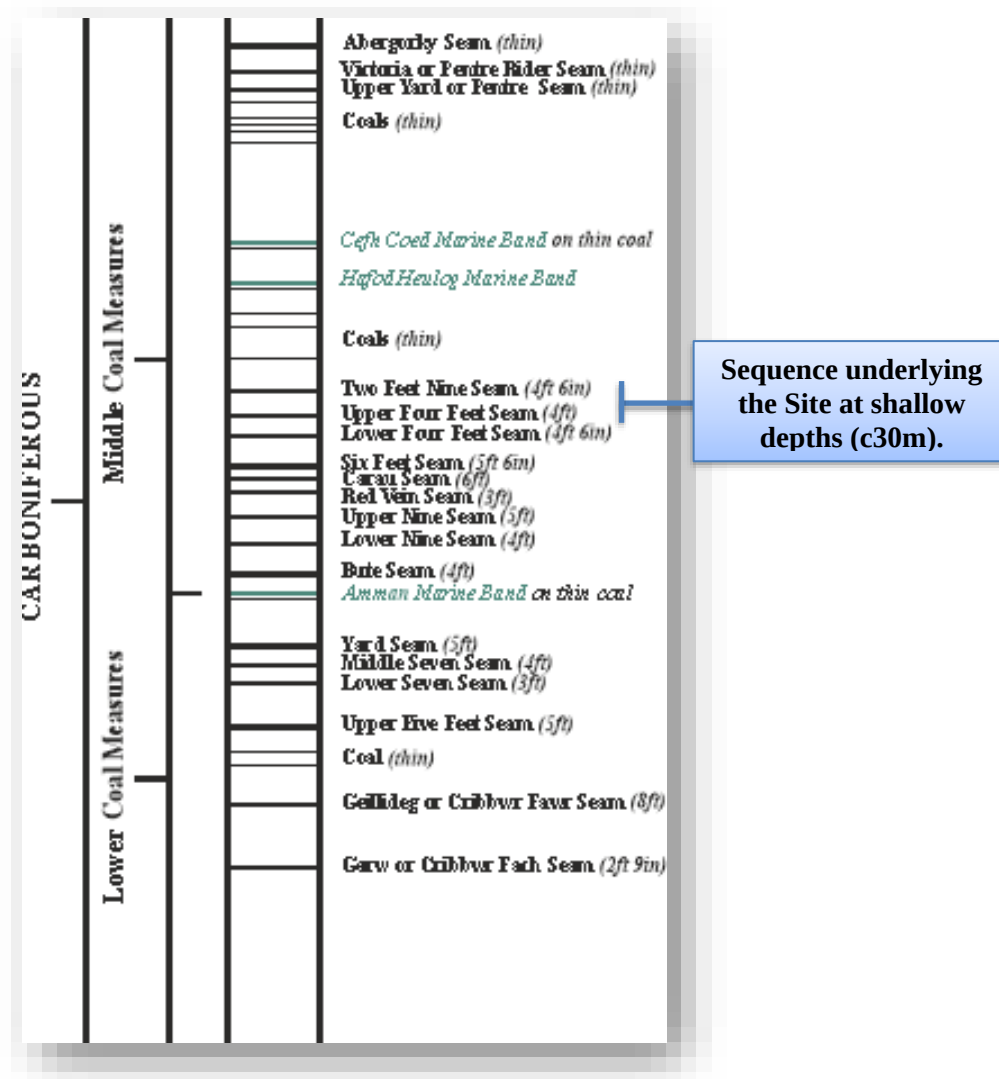
**Figure 2**  
**Indicative Stratigraphic Column.**

The Site is situated at the southern margins of the former South Wales Coalfield and is underlain at shallow depths by strata assigned to the Middle Coal Measures, which are of Upper Carboniferous age. The most recently published geological sheet at the 1:10,560 scale (Sheet SS 78 NE) shows the conjectural outcrop of the Two Feet Nine Seam to pass through the Site and the conjectural outcrop of the Upper Four Feet Seam to pass through the south-west corner of the Site (see *Geology Plan, drawing no. BC/MB/05.20.03.02*). A number of other conjectural outcrops are present to the south of the Site, all the outcrops have an east-south-easterly trend. The regional dip of the coal measures is northerly such that the published geological sheet indicates that the Two Feet Nine and Upper Four Feet Seams variously underlie parts of the Site at shallow depths. The Lower Four Feet is estimated to be at a depth below the Site that is greater than 30m.

Borehole records held by The British Geological Survey (BGS) include those of two deep boreholes drilled close to the south-west corner of the Site, Margam 1 and Morfa 1. Each of the two boreholes prove that there are no coal seams at shallow depths that are thick enough to have supported underground mining operations (see Appendix I).

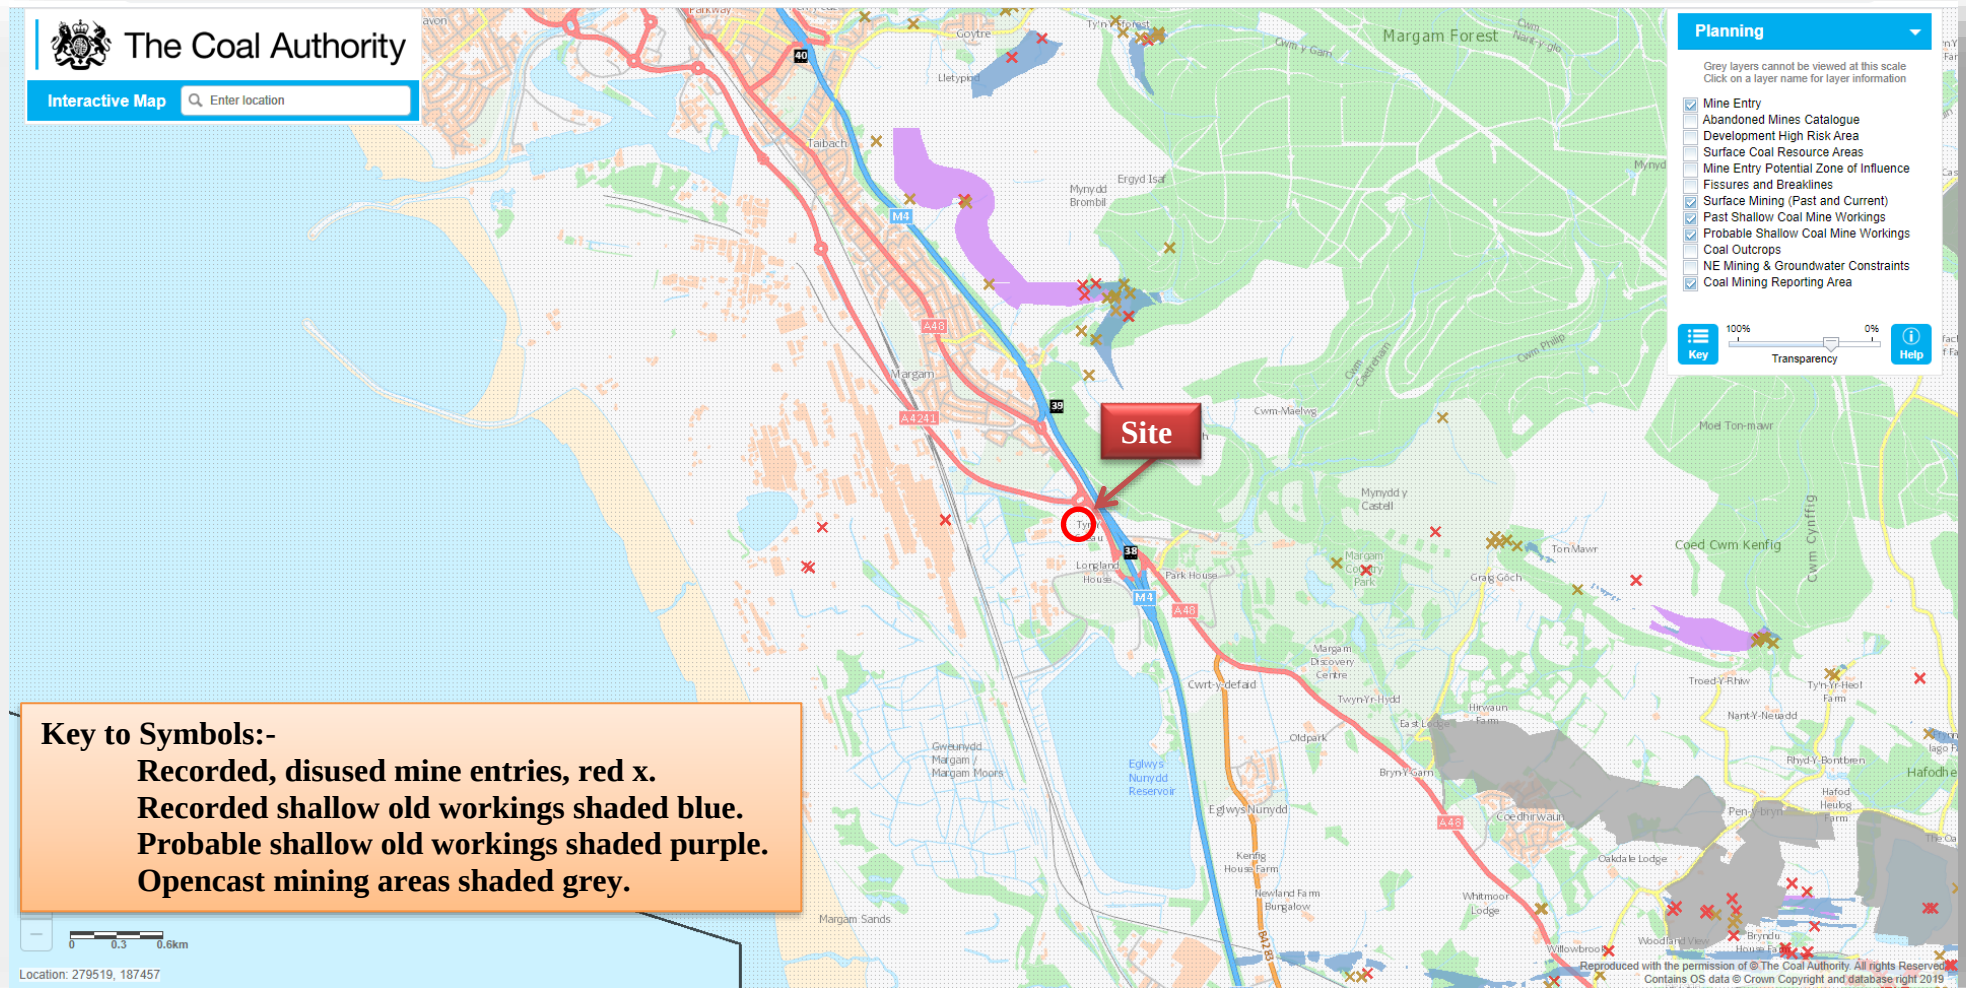
**Figure 3**  
**Print-out of The Coal Authority's Interactive Map**  
 (Accessed 20<sup>th</sup> May 2020)

The area has been subject to fairly extensive coal mining operations dating back to the nineteenth century. Coal seams were accessed by adits driven into the mining horizons near their outcrops supplemented by air shafts; larger shafts gave access to deeper lying coal seams. Mining in the immediate area around the Site was prosecuted from deep mines. The Coal Authority's interactive map also shows that there are no recorded workings underlying the Site, shallow or otherwise, and no 'probable' shallow mine workings in the vicinity of the Site (see Figure 3).

There are no recorded workings underlying the Site, shallow or otherwise, and The Coal Authority's interactive map shows that there are no 'probable' workings present, *i.e.* suspected shallow mine workings for which there is no record. The records of two boreholes drilled close to the Site and held by BGS found that there are no coal seams at shallow depths that are thick enough to have supported underground mining operations. There are no active coal mines in the area that could affect the structural integrity of the proposed development and the Site has not been part of an opencast coal site. In so far as the mining heritage of the area is concerned, there is no risk to the proposed development.
