**CRYNALLT FARM HOUSE, CRYNALLT ROAD, CIMLA, NEATH,  
SA11 3RL**

**BAT SURVEY  
ISSUE 1, VERSION A**

**JULY 2020**

**CRYNALLT FARM HOUSE, CRYNALLY ROAD, CIMLA, NEATH****Bat Survey Report**

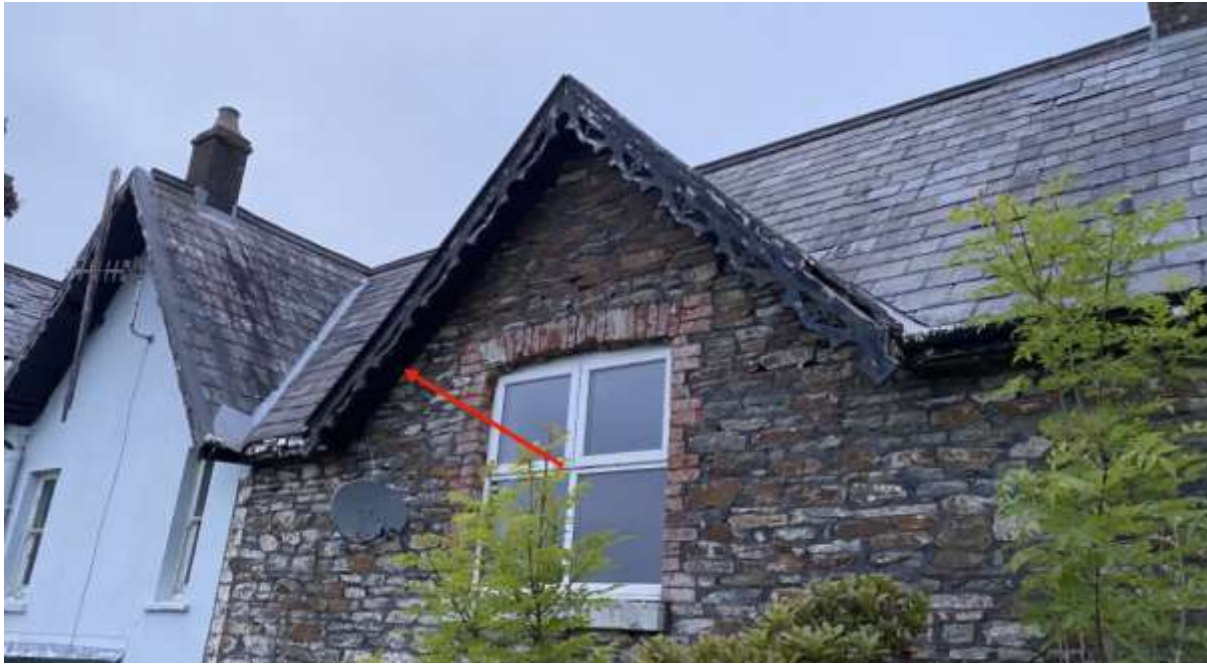
The first bat call heard was a common pipistrelle at 21:09. The bat was seen emerging from beneath the barge board of gable (figure 6). The infra red camera revealed three bats that may have emerged from the ridge of the property, however, it could not be concluded with any confidence at all that the bats had emerged from this location, due to the fact that bat calls were heard and bats seen at the front of the property immediately prior to the bats “emerging” from the ridge.

Figure 6: common pipistrelle emergence point (arrowed red)

A bat box on a pole will be mounted on a pole within the south eastern boundary of the site. The bat box will be a Schwegler 1FF or similar.

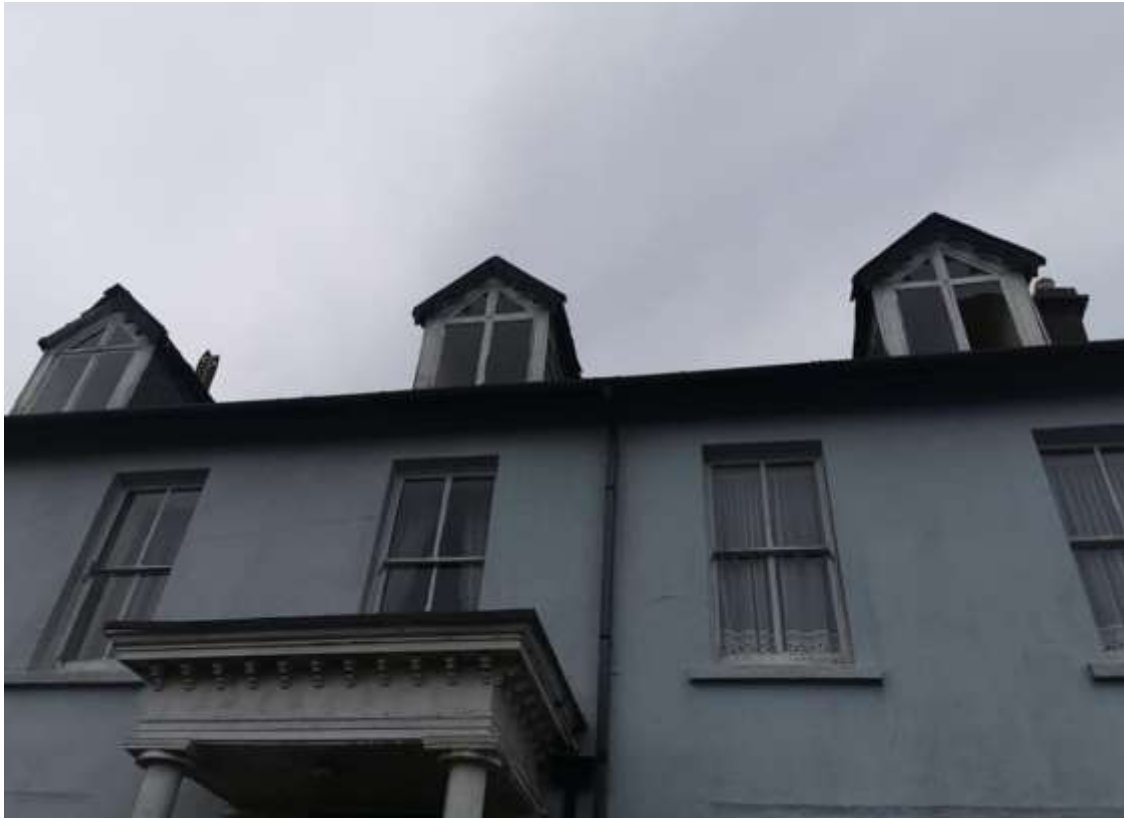
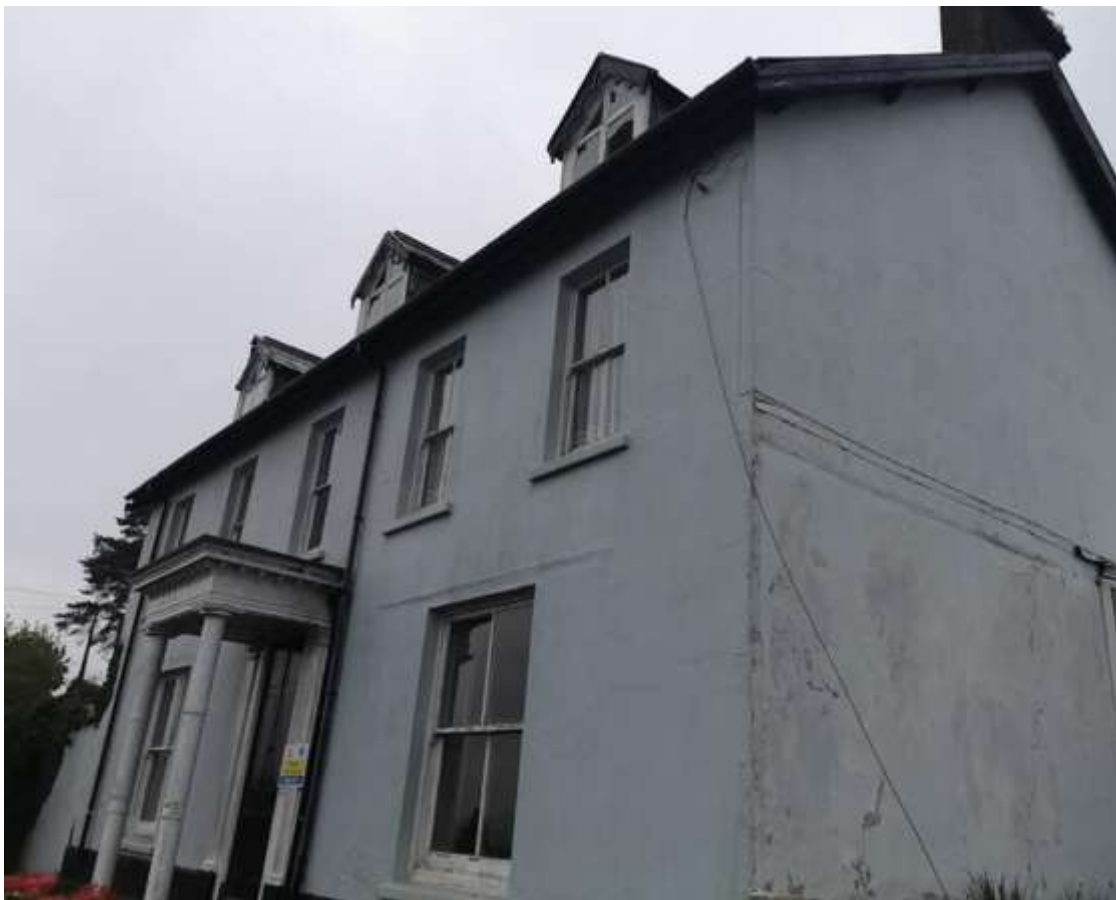
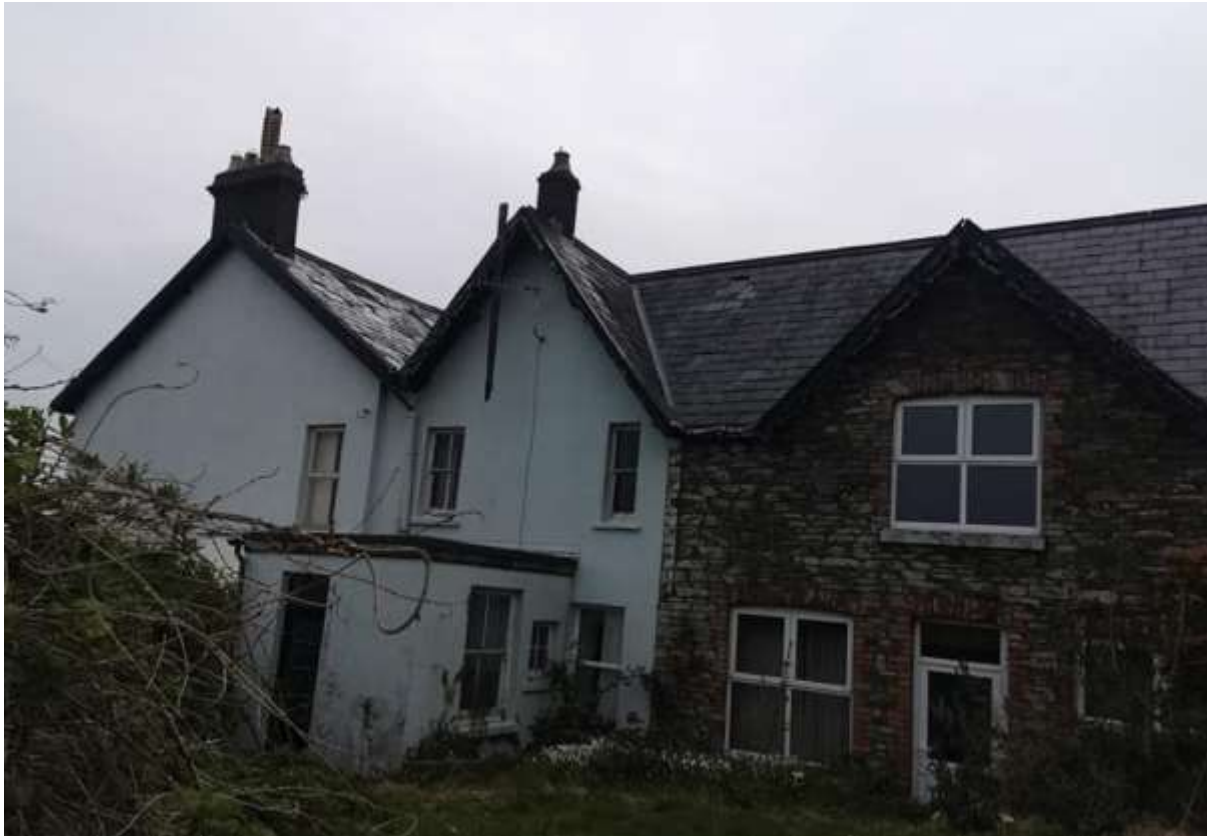
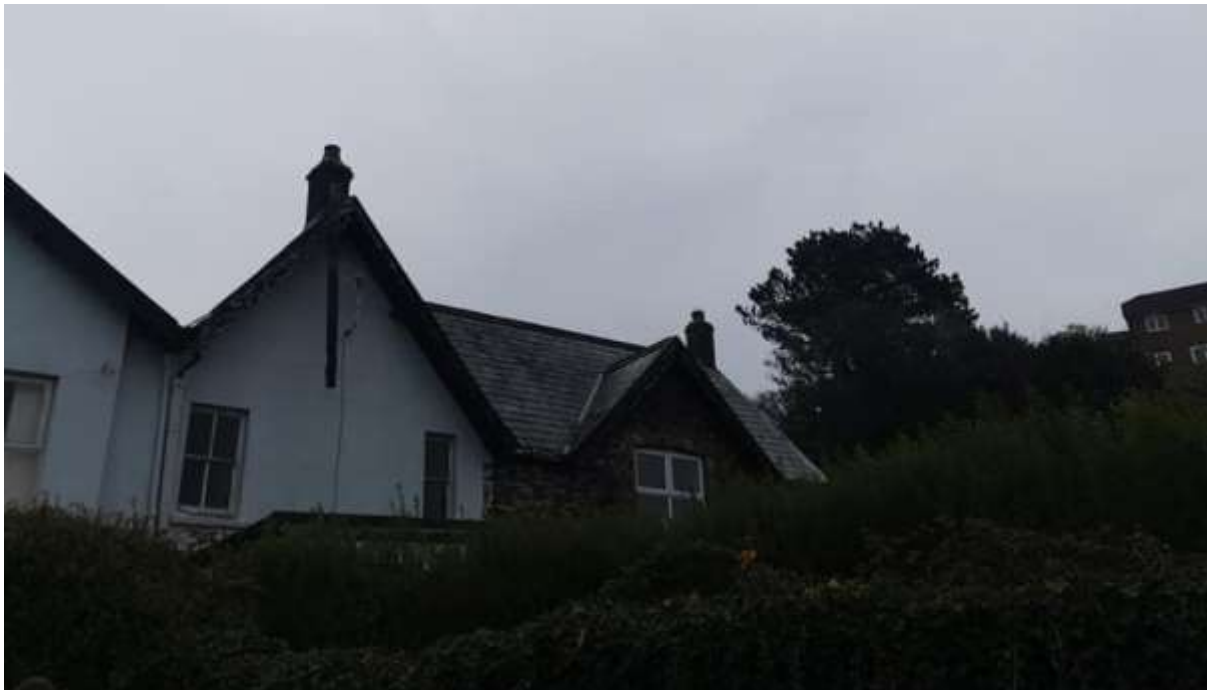
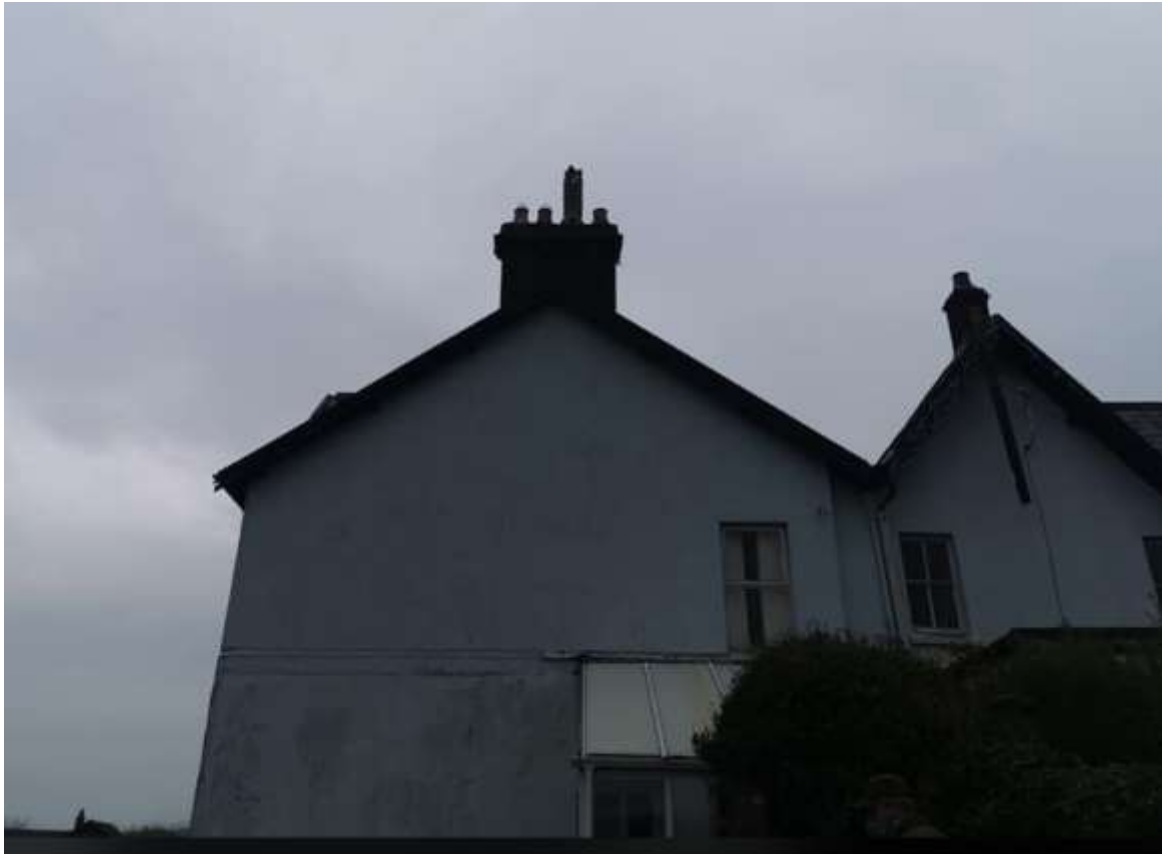
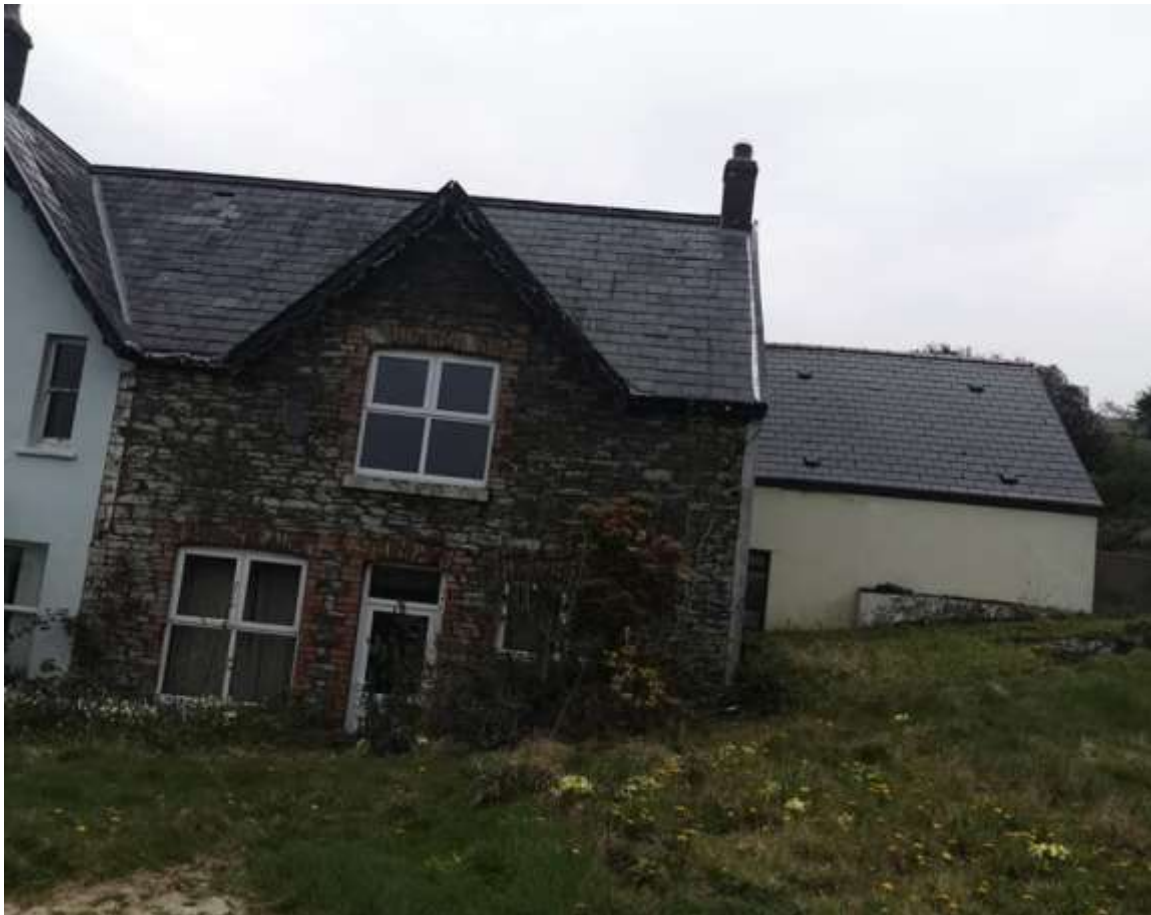
The survey carried out by BE Ecological Ltd revealed no droppings or evidence of bats on the exterior of the building, however, access and roosting potential for bats was identified on all buildings in the form of:

- Slipped slates
- Gaps beneath timber work at some locations
- Gaps beneath ridges

Please see appended plates for photographs of the property exterior.
