# Arboricultural Report

Date – 16<sup>th</sup> September 2020

Site – Leiros Park, Neath

Project Reference – ArbTS\_295.5\_LeirosPark

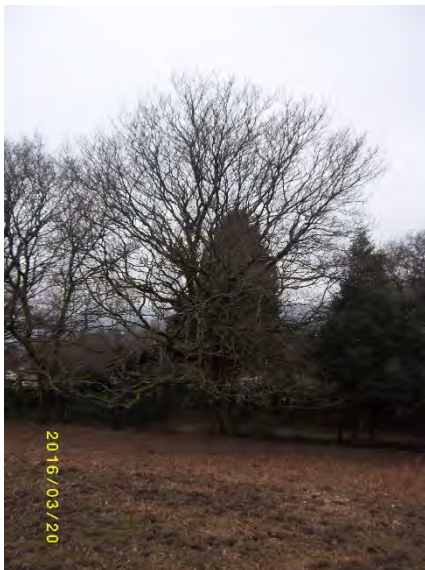
Tree ID#T276

| Tree ID # | Tree Species | Age | Stems | Stem Diam (mm) | Cat | Height + (Lower Branch Height) | Nrth | Est | Sth | Wst | Phys Cond | Struc Cond | Est. Remain Contrib | Comments | Preliminary Management Recommendations | Work Prior | RPR (m) | RPA (m2) |
|---|---|---|---|---|---|---|---|---|---|---|---|---|---|---|---|---|---|---|
| T276 | Quercus petraea (Sessile Oak) | M | 1 | 730 | A1 | 16(1) | 9 | 13 | 7 | 9 | G/F | G/F | 40+ | low A category. a broad tree of fair to good form and of some age, long low lateral branches noted, deadwood noted in southern crown | | | 8.76 | 241.1 |

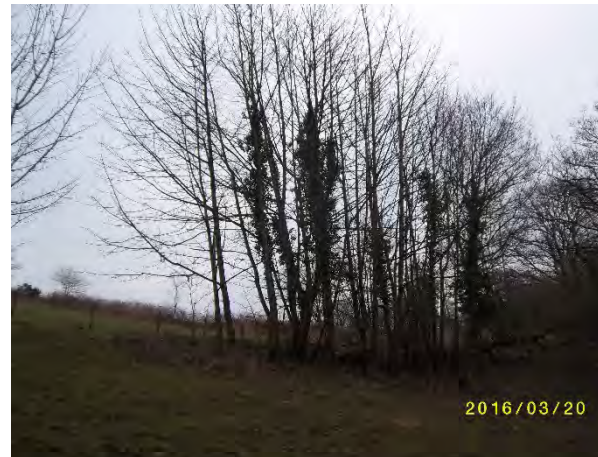
Tree ID#G1

| Tree ID # | Tree Species | Age | Stems | Stem Diam (mm) | Cat | Height + (Lower Branch Height) | Nrth | Est | Sth | Wst | Phys Cond | Struc Cond | Est. Remain Contrib | Comments | | Preliminary Management Recommendations | | Work Prior | RPR (m) | RPA (m2) |
|---|---|---|---|---|---|---|---|---|---|---|---|---|---|---|---|---|---|---|---|---|
| G1 | Betula pendula (Silver Birch),Salix caprea (Goat Willow),Ilex aquifolium (Holly) | EM | 1 | 150 | B2 | 6(0) | 3 | 3 | 3 | 3 | F | F | 20+ | low B Category | a group of boundary trees on edge of stream and site, possible animal damaged noted to trunk, trees have received little maintenance | | | | 1.8 | 10.18 |

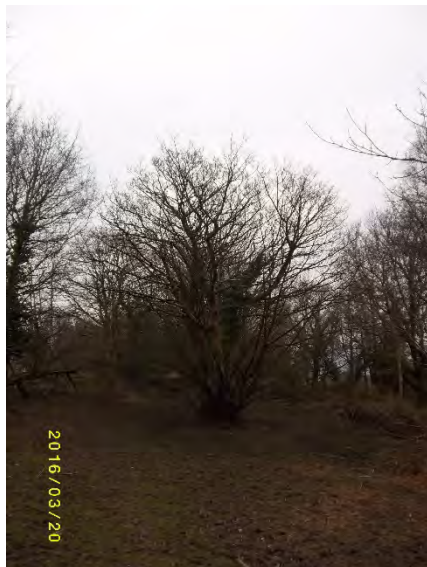
Tree ID#T285

| Tree ID # | Tree Species | Age | Stems | Stem Diam (mm) | Cat | Height + (Lower Branch Height) | Nrth | Est | Sth | Wst | Phys Cond | Struc Cond | Est. Remain Contrib | Comments | Preliminary Management Recommendations | Work Prior | RPR (m) | RPA (m2) |
|---|---|---|---|---|---|---|---|---|---|---|---|---|---|---|---|---|---|---|
| T285 | Acer pseudoplatanus (Sycamore) | OM | 3 | 844 | U | 10(0) | 8 | 5 | 4 | 6 | P | P | <10 | tree of some age for species, appear to be growing on old bank, large wound noted on southern main trunk with surrounding reactive growth noted, bark flake and surrounding callus growth noted on northern stem, various occluding branch collars from old failed lower branch, long lower small diameter growth from base, poor health | | | 10.1 | 322.4 |

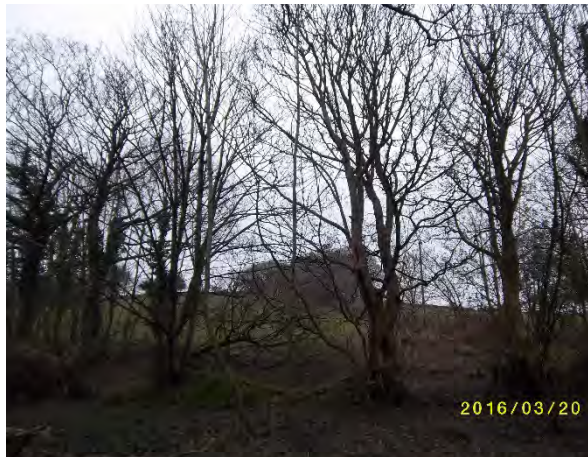
Tree ID#T286-288

| Tree ID # | Tree Species | Age | Stems | Stem Diam (mm) | Cat | Height + (Lower Branch Height) | Nrth | Est | Sth | Wst | Phys Cond | Struc Cond | Est. Remain Contrib | Comments | Preliminary Management Recommendations | Work Prior | RPR (m) | RPA (m2) |
|---|---|---|---|---|---|---|---|---|---|---|---|---|---|---|---|---|---|---|
| T287 | Acer pseudoplatanus (Sycamore) | M | 1 | 570 | C2 | 10(2) | 1 | 4 | 3 | 6 | F | F | 20+ | grafted twin stem to form one, small area of buttress root damage with surrounding callus growth, large vertical cavity noted on western stem with good surrounding callus rams horn growth, slightly suppressed in southern crown formation, growing from possible old bank | | | 6.84 | 147 |

| Tree ID # | Tree Species | Age | Stems | Stem Diam (mm) | Cat | Height + (Lower Branch Height) | Nrth | Est | Sth | Wst | Phys Cond | Struc Cond | Est. Remain Contrib | Comments | Preliminary Management Recommendations | Work Prior | RPR (m) | RPA (m2) |
|---|---|---|---|---|---|---|---|---|---|---|---|---|---|---|---|---|---|---|
| T288 | Acer pseudoplatanus (Sycamore) | M | 1 | 400 | U | 10(2) | 1 | 4 | 3 | 5 | F | P | <10 | large vertical cavity noted on southern stem with generally poor surrounding callus rams horn growth and poor adaptive buttress root growth, advanced decay noted within this cavity and some buttress roots , growing from possible old bank | Remove tree and retain root. | H/M | 4.8 | 72.39 |

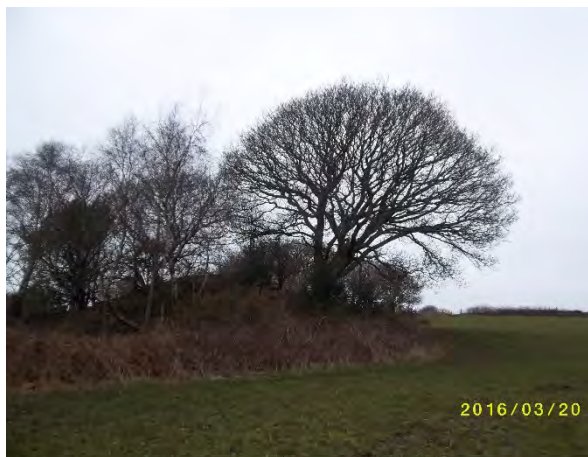
Tree ID#T305 + G5

| Tree ID # | Tree Species | Age | Stems | Stem Diam (mm) | Cat | Height + (Lower Branch Height) | Nrth | Est | Sth | Wst | Phys Cond | Struc Cond | Est. Remain Contrib | Comments | | Preliminary Management Recommendations | | Work Prior | RPR (m) | RPA (m2) |
|---|---|---|---|---|---|---|---|---|---|---|---|---|---|---|---|---|---|---|---|---|
| G5 | Quercus petraea (Sessile Oak),Betula pendula (Silver Birch),Ilex aquifolium (Holly),Crataegus monogyna (Hawthorn),Sorbus aucuparia (Rowan) | EM | 1 | 200 | B2 | 8(1) | 3 | 3 | 3 | 3 | G/F | G/F | 20+ | | a group that consists of mainly similar aged and sized semi mature trees, 3 oak and one birch noted along boundary with one slightly larger oak tree at northern end of row, to the east of this approx. 8 smaller younger diameter trees, group growing on boundary bank and what appears to be old soil heap | | | | 2.4 | 18.1 |

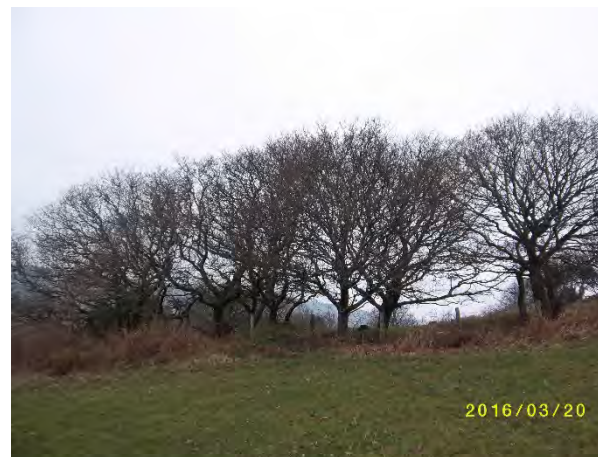
Tree ID#G6

| Tree ID # | Tree Species | Age | Stems | Stem Diam (mm) | Cat | Height + (Lower Branch Height) | Nrth | Est | Sth | Wst | Phys Cond | Struc Cond | Est. Remain Contrib | Comments | | Preliminary Management Recommendations | | Work Prior | RPR (m) | RPA (m2) |
|---|---|---|---|---|---|---|---|---|---|---|---|---|---|---|---|---|---|---|---|---|
| G6 | Quercus petraea (Sessile Oak) | M | 1 | 400 | A1 | 8(1) | 4 | 4 | 4 | 4 | G/F | G/F | 40+ | | a group of short oak trees many early mature in age and size of moderate to high value. older larger trees noted further west away from boundary, located outside of the site | | | | 4.8 | 72.39 |

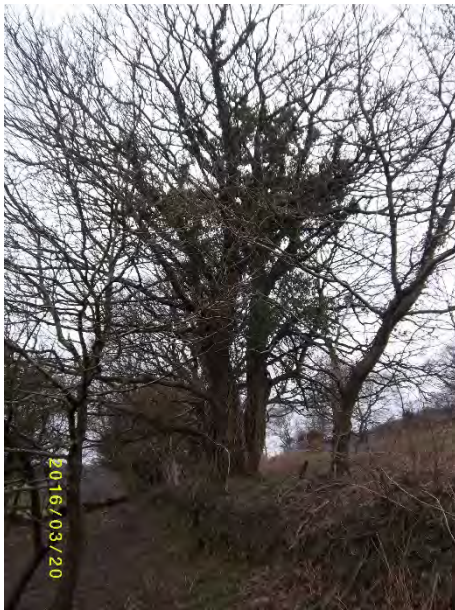
Tree ID#T309

| Tree ID # | Tree Species | Age | Stems | Stem Diam (mm) | Cat | Height + (Lower Branch Height) | Nrth | Est | Sth | Wst | Phys Cond | Struc Cond | Est. Remain Contrib | Comments | Preliminary Management Recommendations | Work Prior | RPR (m) | RPA (m2) |
|---|---|---|---|---|---|---|---|---|---|---|---|---|---|---|---|---|---|---|
| T309 | Acer pseudoplatanus (Sycamore) | M | 3 | 730 | B2 | 10(0) | 7 | 6 | 7 | 7 | F | F | 20+ | growing on old dry stone wall, bark flake and surrounding callus growth noted on predominant northern stem, very slightly sparse in leaf bud cover, ivy cover, a broad tree | | | 8.76 | 241.1 |

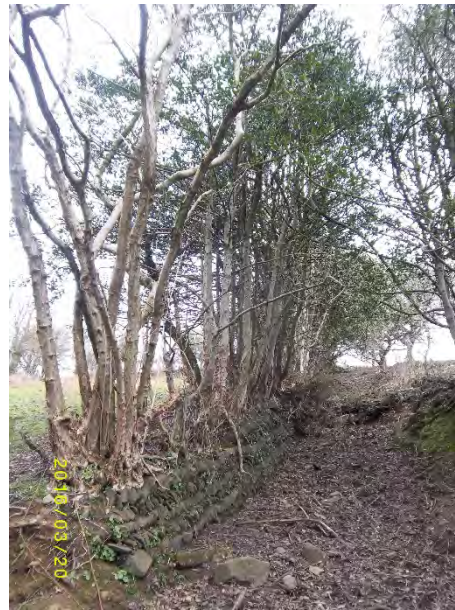
Tree ID#H2

| Tree ID # | Tree Species | Age | Stems | Stem Diam (mm) | Cat | Height + (Lower Branch Height) | Nrth | Est | Sth | Wst | Phys Cond | Struc Cond | Est. Remain Contrib | Comments | Preliminary Management Recommendations | Work Prior | RPR (m) | RPA (m2) |
|---|---|---|---|---|---|---|---|---|---|---|---|---|---|---|---|---|---|---|
| H2 | Ilex aquifolium (Holly) | M | 1 | 150 | C2 | 3(0) | 2 | 2 | 2 | 2 | F | F | 10+ | numerous areas of animal damage to trunk, growing on top of old dry stone wall\bank | consider recoppice lay stems to manage as hedgerow | L | 1.8 | 10.18 |

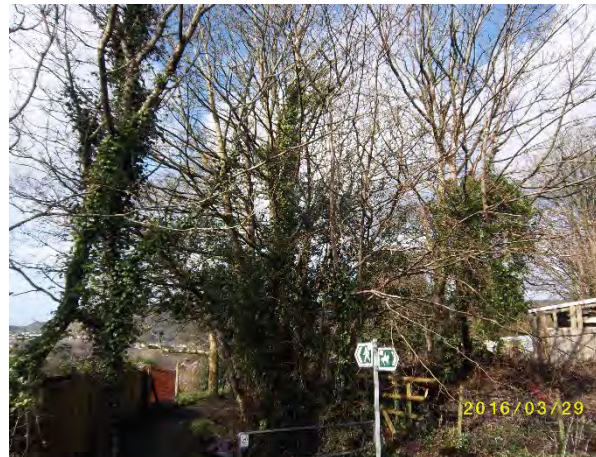
Tree ID#G9

| Tree ID # | Tree Species | Age | Stems | Stem Diam (mm) | Cat | Height + (Lower Branch Height) | Nrth | Est | Sth | Wst | Phys Cond | Struc Cond | Est. Remain Contrib | Comments | Preliminary Management Recommendations | Work Prior | RPR (m) | RPA (m2) |
|---|---|---|---|---|---|---|---|---|---|---|---|---|---|---|---|---|---|---|
| G9 | Acer pseudoplatanus (Sycamore) | EM | 1 | 350 | C2 | 10(2) | 4 | 4 | 4 | 4 | F | F/P | 10+ | A group of 4 multi stem trees slightly untidy in form , some structural issues noted on boundary stems of concern is central tree in group on boundary, a group likely to offer a limited future but currently provides moderate landscape value to the users of the foot path, high c quality | Reduce central boundary tree 1 metre due to decay and lean over path | H/M | 4.2 | 55.42 |

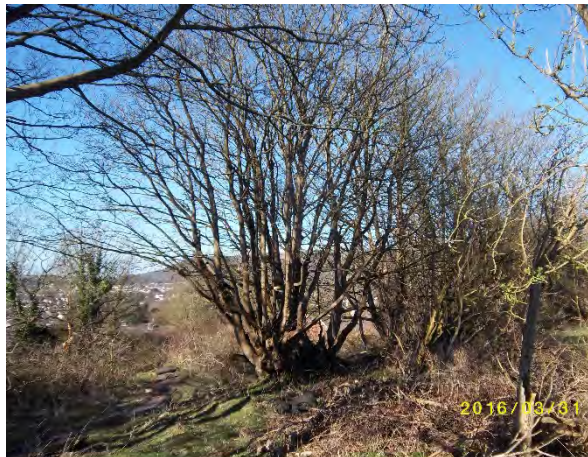
Tree ID#G8

| Tree ID # | Tree Species | Age | Stems | Stem Diam (mm) | Cat | Height + (Lower Branch Height) | Nrth | Est | Sth | Wst | Phys Cond | Struc Cond | Est. Remain Contrib | Comments | Preliminary Management Recommendations | Work Prior | RPR (m) | RPA (m2) |
|---|---|---|---|---|---|---|---|---|---|---|---|---|---|---|---|---|---|---|
| G8 | Acer pseudoplatanus (Sycamore) | M | 1 | 450 | C2 | 15(2) | 6 | 6 | 6 | 6 | F | F/P | 10+ | a group of sycamore trees growing on top of an old dry stone wall, likely to be a group of old hedgerow trees that have been left unmanaged for some time, many multistemmed and slender in form, some stems and trees in poor structural condition, trees have grown together as a group, provide moderate short term landscape value to the area, as a group offer a limited safe future | remove dead dying dangerous stem/branches or consider pollard to one metre stump | M/L | 5.4 | 91.62 |

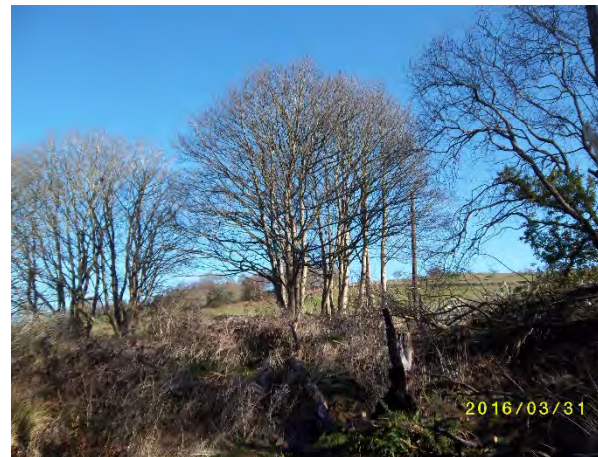
Tree ID#G10

| Tree ID # | Tree Species | Age | Stems | Stem Diam (mm) | Cat | Height + (Lower Branch Height) | Nrth | Est | Sth | Wst | Phys Cond | Struc Cond | Est. Remain Contrib | Comments | Preliminary Management Recommendations | Work Prior | RPR (m) | RPA (m2) |
|---|---|---|---|---|---|---|---|---|---|---|---|---|---|---|---|---|---|---|
| G10 | Acer pseudoplatanus (Sycamore) | M | 1 | 450 | C2 | 15(2) | 6 | 6 | 6 | 6 | F | F/P | 10+ | a group of sycamore trees growing on top of a old dry stone wall, likely to be a group of old hedgerow trees that have been left unmanaged for some time, multistemmed and slender in form, some stems and trees in poor structural condition, trees have grown together as a group and provide moderate short term landscape value, as a group offer a limited safe future with predicted future failures | remove dead dying dangerous stem branches or consider pollard to one metre stump | M/L | 5.4 | 91.62 |

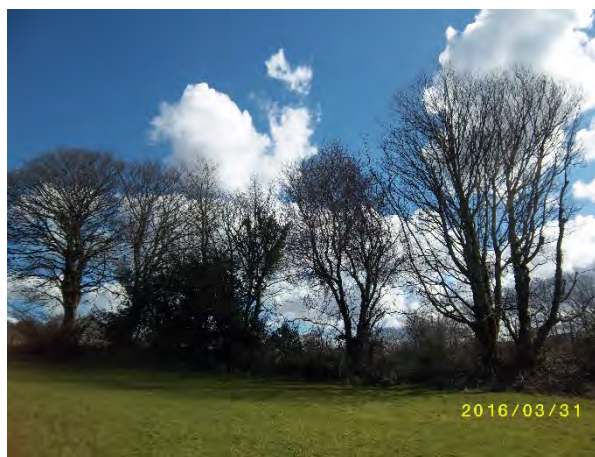
Tree ID#T11-T358

| Tree ID # | Tree Species | Age | Stems | Stem Diam (mm) | Cat | Height + (Lower Branch Height) | Nrth | Est | Sth | Wst | Phys Cond | Struc Cond | Est. Remain Contrib | Comments | | Preliminary Management Recommendations | | Work Prior | RPR (m) | RPA (m2) |
|---|---|---|---|---|---|---|---|---|---|---|---|---|---|---|---|---|---|---|---|---|
| T11 | Acer pseudoplatanus (Sycamore) | M | 1 | 700 | B2 | 17(3) | 7 | 7 | 4 | 8 | G/F | N/A | 20+ | Suckers around stem base. Surrounding vegetation prevented close inspection of the tree therefore all observations and measurements are estimated. | a tall broad tree of good form growing from what appears to be a old bank, large cavity noted on northern side of trunk with some surrounding reactive growth, unable to fully inspected due to thick surrounding epicormic growth | remove surrounding epicormic growth and inspect cavity | H/M | 8.4 | 221.7 | |

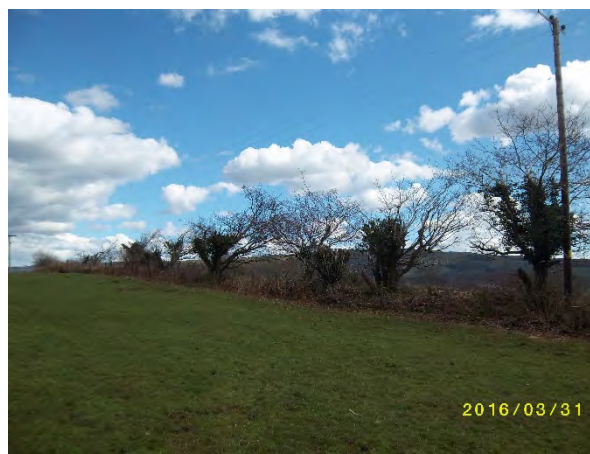
Tree ID#H5

| Tree ID # | Tree Species | Age | Stems | Stem Diam (mm) | Cat | Height + (Lower Branch Height) | Nrth | Est | Sth | Wst | Phys Cond | Struc Cond | Est. Remain Contrib | Comments | Preliminary Management Recommendations | Work Prior | RPR (m) | RPA (m2) |
|---|---|---|---|---|---|---|---|---|---|---|---|---|---|---|---|---|---|---|
| H5 | Ilex aquifolium (Holly),Betula pendula (Silver Birch) | EM | 1 | 300 | C2 | 4(0) | 2 | 2 | 2 | 2 | F | F | 20+ | row of trees topped to allow clearance from over head electrical lines, gaps noted in hedgerow between topped trees | | | 3.6 | 40.72 |

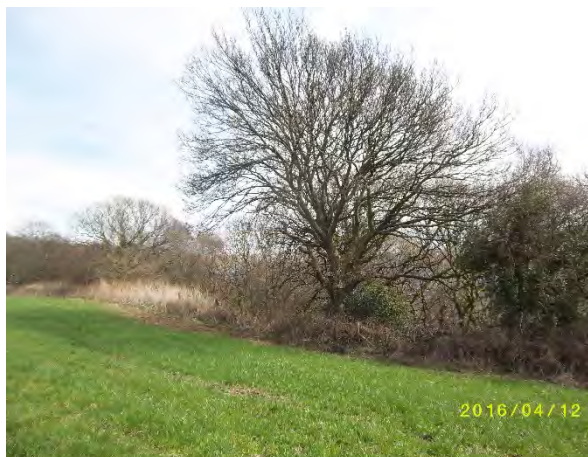
Tree ID#T36

| Tree ID # | Tree Species | Age | Stems | Stem Diam (mm) | Cat | Height + (Lower Branch Height) | Nrth | Est | Sth | Wst | Phys Cond | Struc Cond | Est. Remain Contrib | Comments | Preliminary Management Recommendations | Work Prior | RPR (m) | RPA (m2) |
|---|---|---|---|---|---|---|---|---|---|---|---|---|---|---|---|---|---|---|
| T36 | Quercus cerris (Turkey Oak) | M | 1 | 700 | B2 | 15(1) | 8 | 8 | 8 | 8.5 | G/F | N/A | 20+ | Surrounding vegetation prevented close inspection of the tree therefore all observations and measurements are estimated. Located on private land preventing a close inspection of the tree therefore all observations and measurements are estimated. | a broad tree, northern branch damage noted, crown slightly out of balance as a whole | | 8.4 | 221.7 |
