# Preliminary Bat Roost Assessment and Ground- level Tree Assessment

Ynysarwed Mine Water Treatment Scheme

The Coal Authority

April 2021

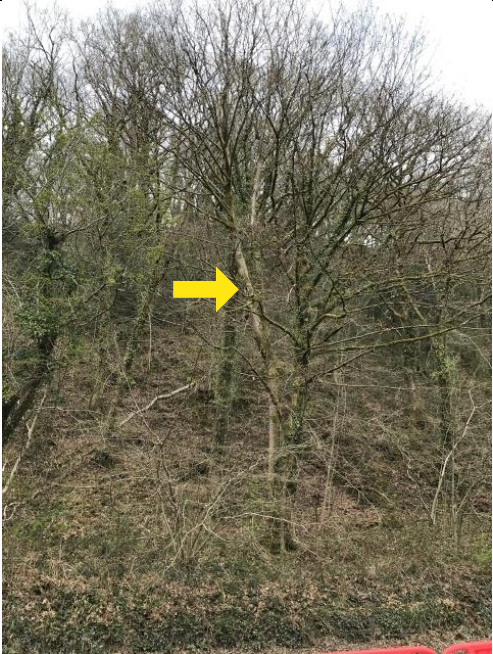
| Feature ID | Photograph(s) | Description | Bat Roost Suitability Category |
|---|---|---|---|
| T01 | 1-2 | A sycamore ( <i>Acer pseudoplatanus</i> ) on the opposite side of the B4242 (Neath Road) to the western most corner of the Site, just within the woodland boundary. There is one knothole on the southwest face at approximately 10 m from the ground. | Low |

| <p>Photograph 1: The south face of T01 as viewed from the pavement across the B4242; approximate location of knothole indicated with arrow.</p> | <p>Photograph 2: The south west face of T01 with a knothole.</p> |

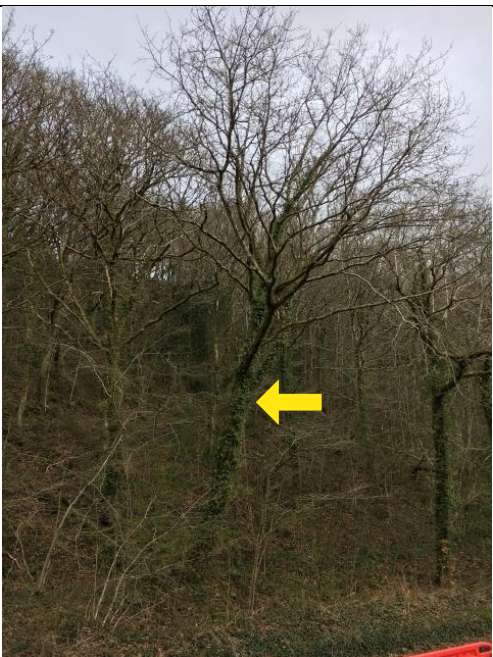
| Feature ID | Photograph(s) | Description | Bat Roost Suitability Category |
|---|---|---|---|
| T02 | 3-4 | An oak ( <i>Quercus</i> sp.) on the opposite side of the B4242 (Neath Road) to the Site, just within the woodland boundary. There is a small woodpecker hole on the southeast face approximately 3 m from the ground. | Low |

| <p>Photograph 3: The south face of T02 as viewed from the pavement across the B4242; approximate location of woodpecker hole indicated with arrow.</p> | <p>Photograph 4: The location of the woodpecker hole in T02 on the south east face.</p> |

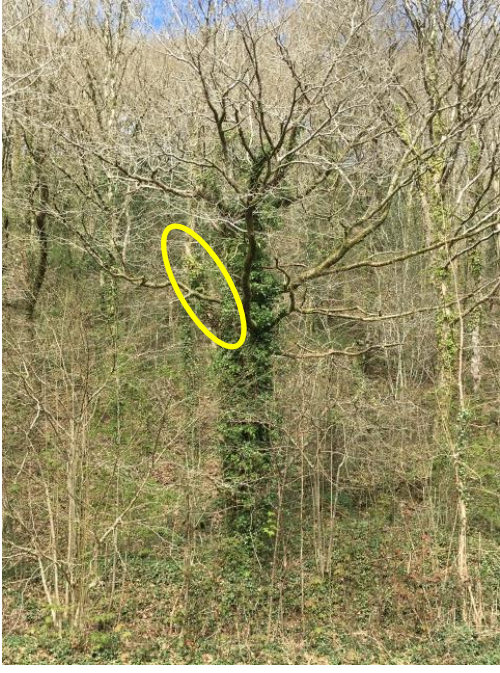
| Feature ID | Photograph(s) | Description | Bat Roost Suitability Category |
|---|---|---|---|
| T03 | 5 | A dead silver birch ( <i>Betula pendula</i> ) on the opposite side of the B4242 (Neath Road) to the Site, just within the woodland boundary. T03 is adjacent to T04. There is a broken branch on the west face, with the potential for a cavity, at approximately 7 m from the ground. There is a dense covering of ivy, especially as the base, which may be obscuring additional cavities or form a suitable a feature itself. | Moderate |
| T04 | 5 | An oak tree on the opposite side of the B4242 (Neath Road) to the Site, just within the woodland boundary. T04 is adjacent to T03. There is a dense covering of ivy at the base that may be hiding cavities or be a feature itself. | Low |

| <p>Photograph 5: Trees T03 (left) and T04 (right) south west faces, present immediately adjacent to each other. The trunks do not appear separate due to the dense ivy growing on them. The broken branch of T03 is circled.</p> | <p>Photograph 6: T05 south face and the locations of the small broken branch (above) and rocks at its base (below).</p> |

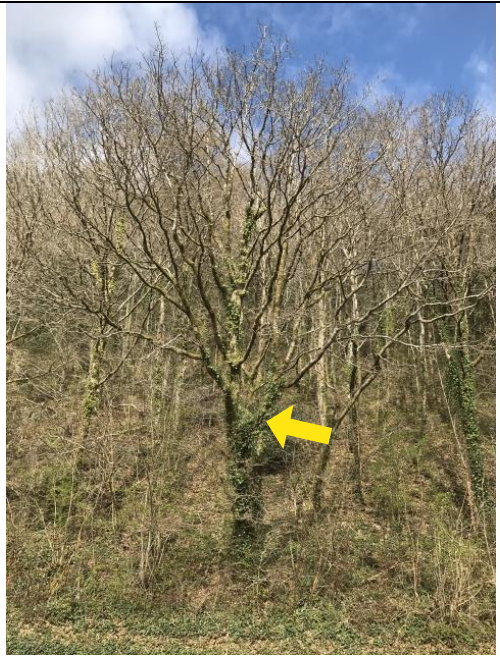
| Feature ID | Photograph(s) | Description | Bat Roost Suitability Category |
|---|---|---|---|
| T06 | 7-8 | An oak tree on the opposite side of the B4242 (Neath Road) to the Site, just within the woodland boundary. There is a missing branch and a small hole possibly leading to a cavity or crevice on the east face approximately 2 m from the ground. | Low |

| <p>Photograph 7: T06 south east face; approximate location of the missing branch indicated by arrow.</p> | <p>Photograph 8: The missing branch with a potential small hole on T06.</p> |

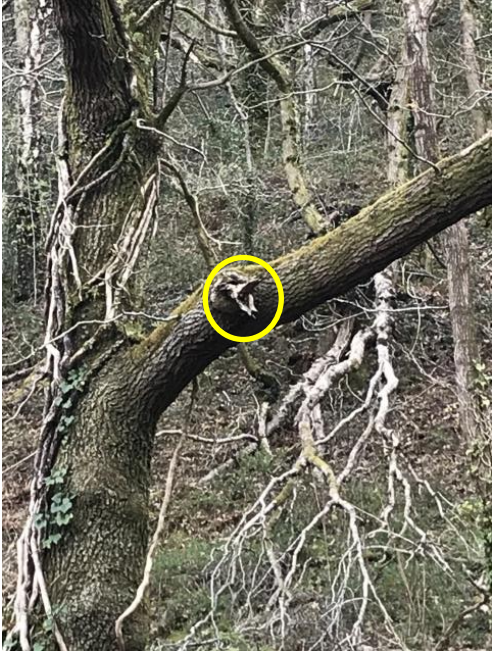
| Feature ID | Photograph(s) | Description | Bat Roost Suitability Category |
|---|---|---|---|
| T07 | 9-10 | An oak tree on the opposite side of the B4242 (Neath Road) to the Site, just within the woodland boundary. There is a missing branch with hole on the south face that is creating a void/crevice. A pair of blue tits ( <i>Cyanistes caeruleus</i> ) were observed using the hole for nesting, as such, it is not likely to be in current use by roosting bats. | Low |

| <p>Photograph 9: T07 south east face; approximate location of the missing branch indicated by arrow.</p> | <p>Photograph 10: The location of the missing branch with a hole on T07.</p> |

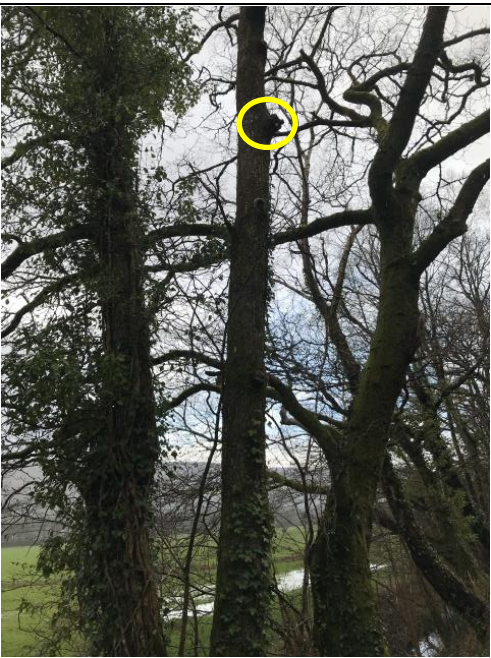
| Feature ID | Photograph(s) | Description | Bat Roost Suitability Category |
|---|---|---|---|
| T08 | 11 | An oak tree across the Neath Canal from the eastern most corner of the Site. There is one hole where a branch has been removed on the north side of the trunk 5 m from the ground. This hole may extend into a crevice and as such has been classified as Low precautionarily. | Low |

| <p>Photograph 11: Potential hole on T08 on north face.</p> | <p>Photograph 12: Small stem of T09 with downward facing hole.</p> |

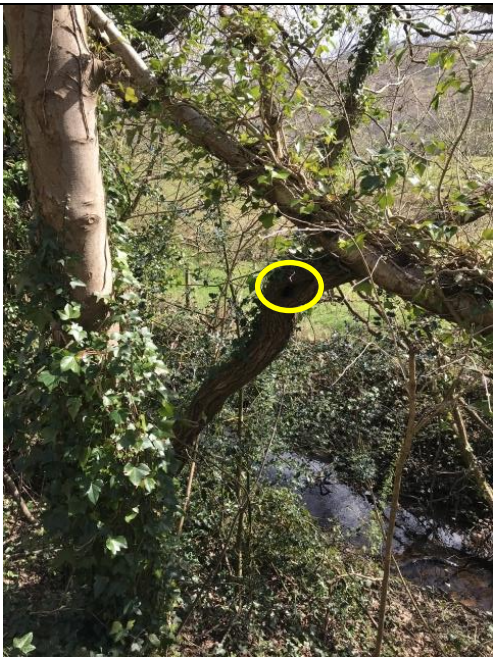
| Feature ID | Photograph(s) | Description | Bat Roost Suitability Category |
|---|---|---|---|
| T09 | 12 | A willow tree ( <i>Salix</i> sp.) across the Neath Canal from the eastern most corner of the Site. There is a small stem with a downward facing hole approximately 3 m off the ground facing northwest. The hole is sheltered and may not accumulate water so it is possibly suitable for bats. | Low |

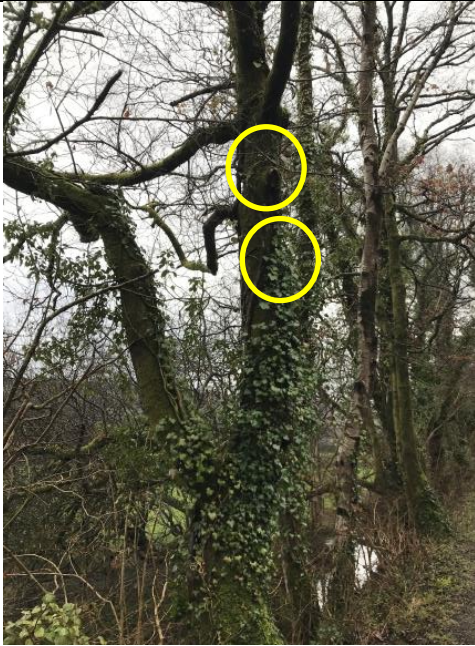
| Feature ID | Photograph(s) | Description | Bat Roost Suitability Category |
|---|---|---|---|
| T10 | 13-14 | An oak tree on south facing bank of Neath Canal. It has a large split on the north side of the trunk which likely leads into a cavity in the tree. This extends upwards from 1 m from the ground. There is also a knot hole 3 m from the ground on the north side with a gap under which may provide another entrance for bats. | Moderate |

Photograph 13: Two highlighted potential features on the north face of T10, a hole (top) and a split in the trunk (below).

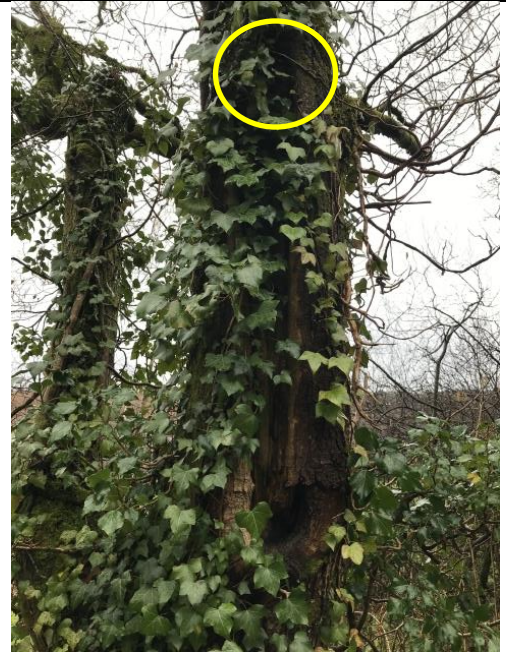
Photograph 14: A close up photograph of the split in the north side of the trunk on T10.

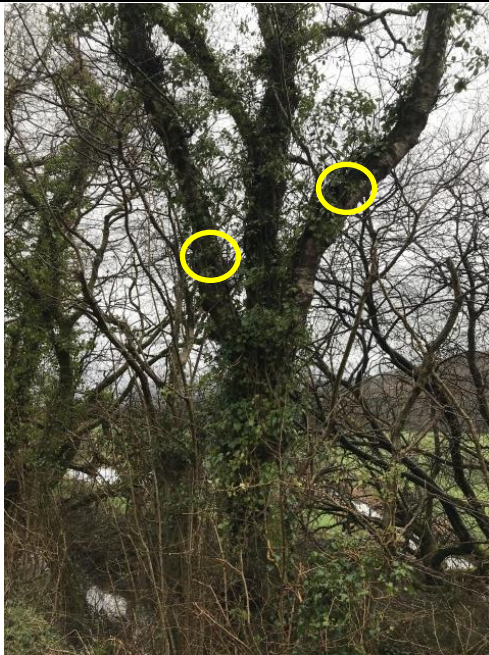
Photograph 15: Two holes on the north face of T11.

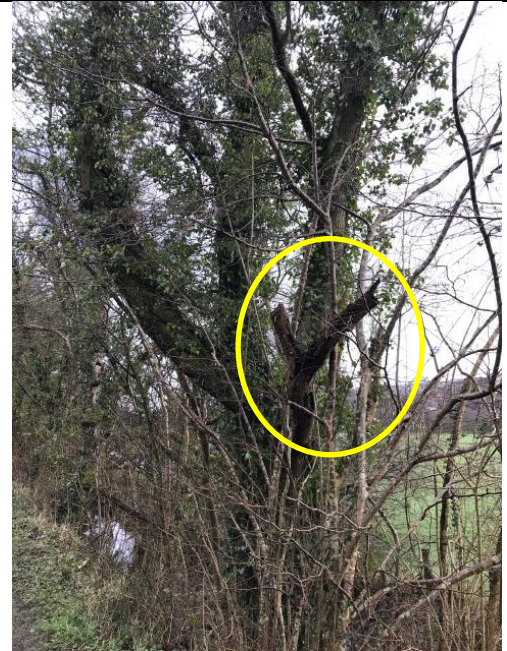
Photograph 16: The rotten branch on the north west face of T12.

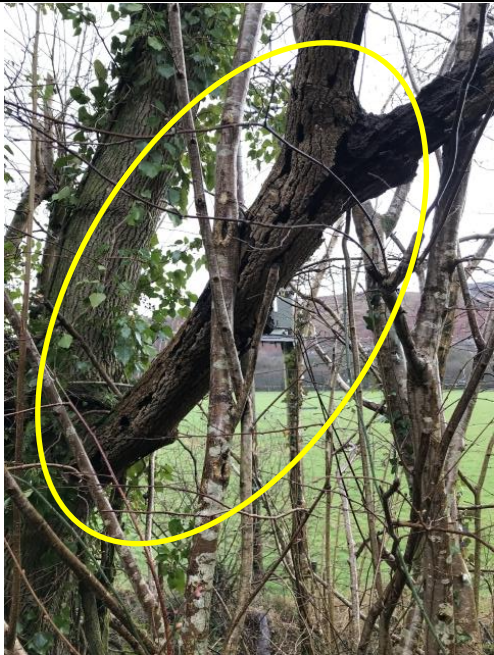
| <p>Photograph 17: A close up photograph of the rotten branch on T12.</p> | <p>Photograph 18: The north-east face of T13, with a split in the trunk.</p> |

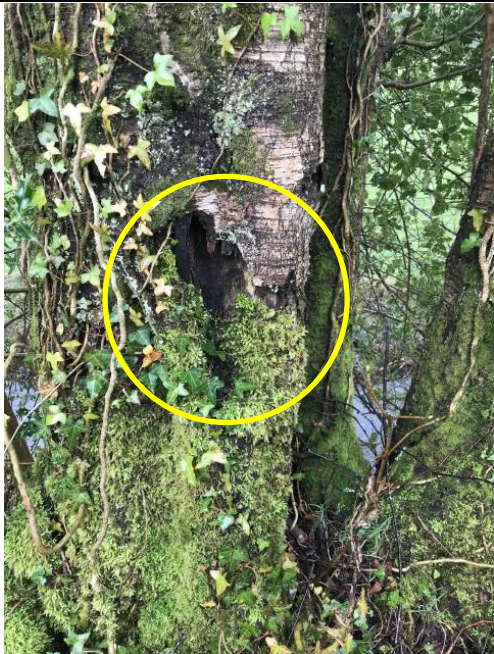
| <p>Photograph 19: A close up photograph of the split bark on T13.</p> | <p>Photograph 20: The splits in the trunk on the northern side of T14.</p> |

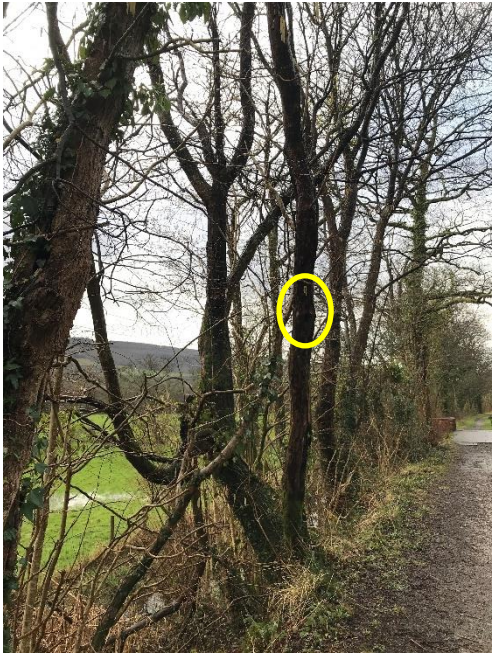
| <p>Photograph 22: Knot hole on the east face of T15.</p> | <p>Photograph 23: A close up photograph of the knot hole recorded on T15.</p> |

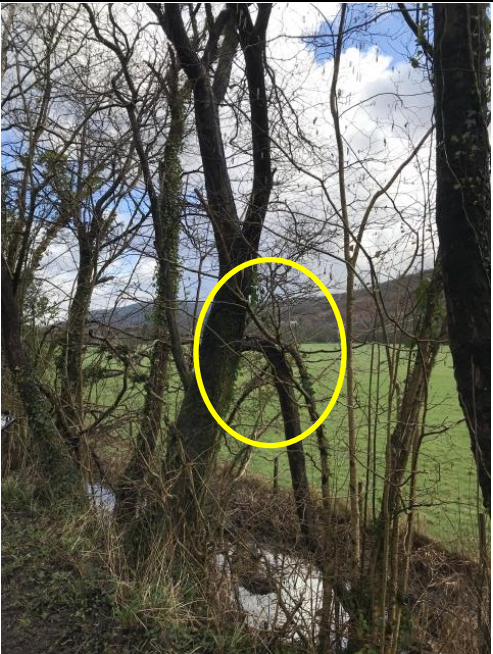
| <p>Photograph 24: Fallen branch on the south side of T16.</p> | <p>Photograph 25: The location of the knot hole on T17.</p> |

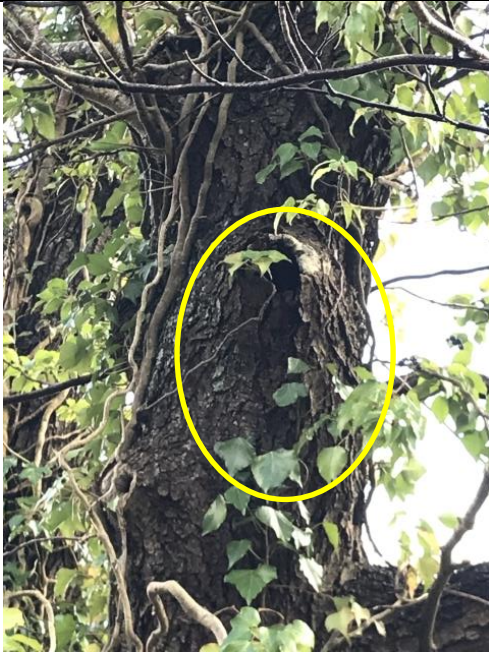
Photograph 26: A close up photograph of the knot hole 4 m from the ground on T17.

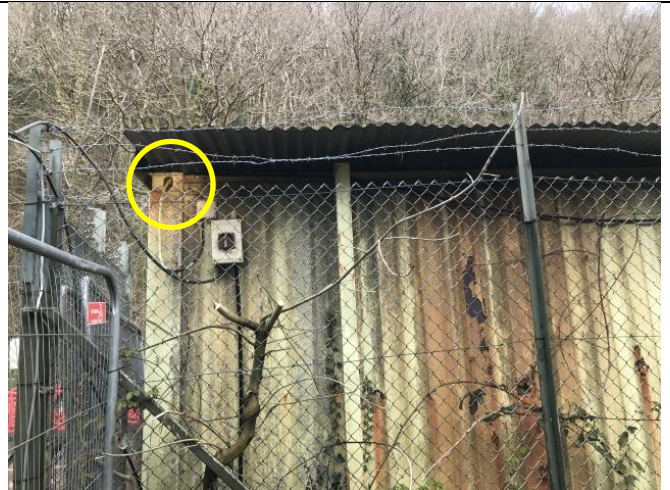
| Building ID | Photograph(s) | Description | Bat Roost Suitability Category |
|---|---|---|---|
| Building 1 | 27-30 | A temporary, metal container in good condition with no potential bat entrance points or roosting opportunities. There is evidence of old bird nests in the south east facing corners which do not appear adequate for bats. There are several rusted holes through the south east face of the container leading into a cavity between the metal exterior and the boarding making up the interior walls; this cavity includes some foam insulation. The holes are less than a metre from the ground, with jagged edges and has no direct flight access due to the presence of a chain link fence around the south east fence. There is no other access to the cavity between the inner and outer wall (no gaps between roof and building fasciae). There are some gaps where the metal fascia boards are lifting away which leads to a gap under the corrugated metal roof; however, this feature is considered unlikely to be suitable for supporting bats due to the extreme temperature changes that would occur during the day. | Negligible |

Photograph 29: The south east face of Building one with location of one of the old bird nest circled. The second is similarly positioned on the other south east facing corner.

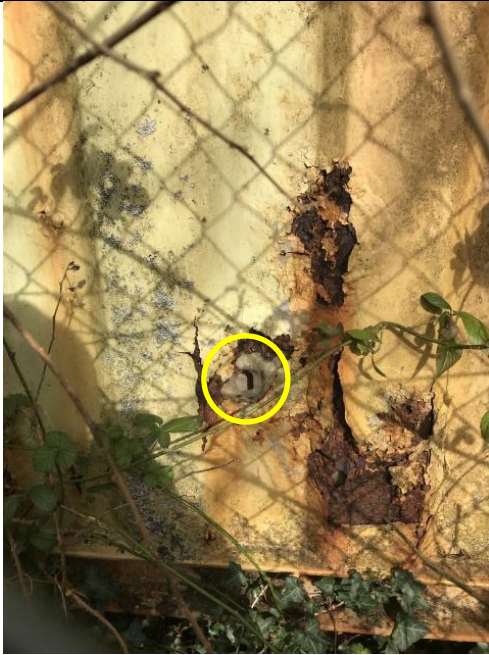
Photograph 30: Example of rusted holes on the south east face of Building 1.

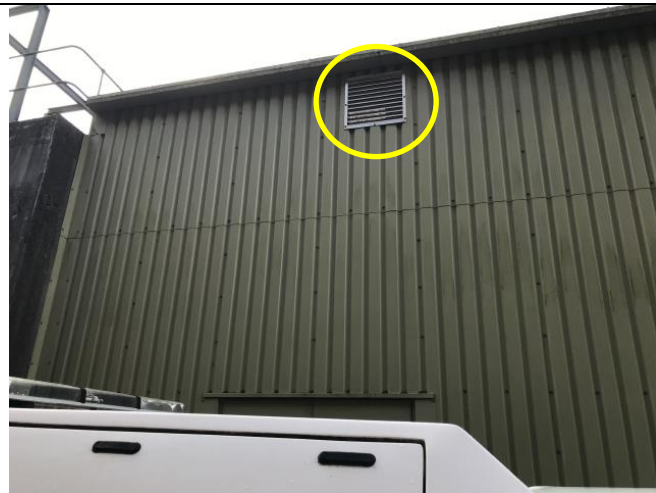
| Building ID | Photograph(s) | Description | Bat Roost Suitability Category |
|---|---|---|---|
| Building 3 | 31-34 | A large, metal building with a pitched, corrugated metal roof. The interior of the building is also metal, in good condition, subject to high light levels and housing mine water treatment equipment. The building is subject to high levels of disturbance – the site manager stated that when operation the equipment is | Negligible |

Photograph 32: The location of the vent on the north west face of Building 3.

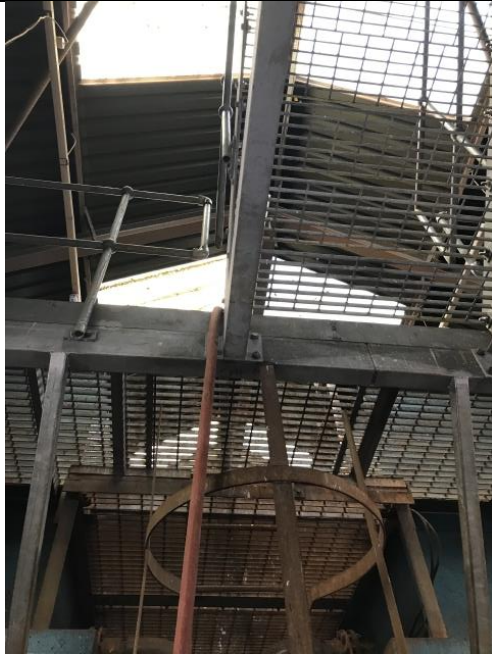
Photograph 34: The interior of Building 3 showing the lack of insulation on the roof.
