**Cwm Planning & Design**  
(civil, structural and architectural services)

## **Soakaway Test Report**

**For a Proposed Residential Development  
at 18 Leyshon Road  
Gwaun Cae Gurwen**

**Date:** September 2015

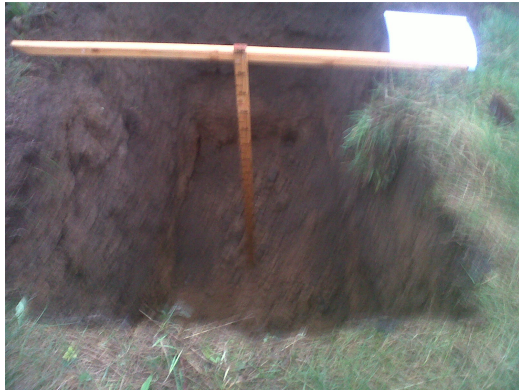
Photograph shows excavated **Trial Pit 1** with 1600mm long timber measuring tool resting on base and top edges.

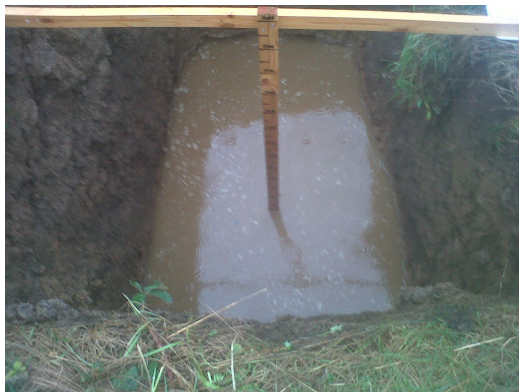
Photograph shows **Trial Pit 1** filled with 400mm of water.

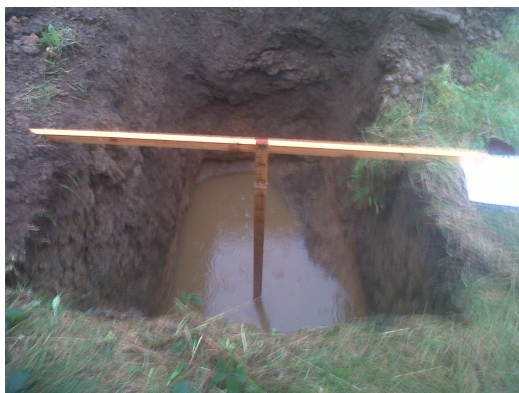
Photograph shows **Trial Pit 1** after 60mins with approximately 200mm of water remaining.

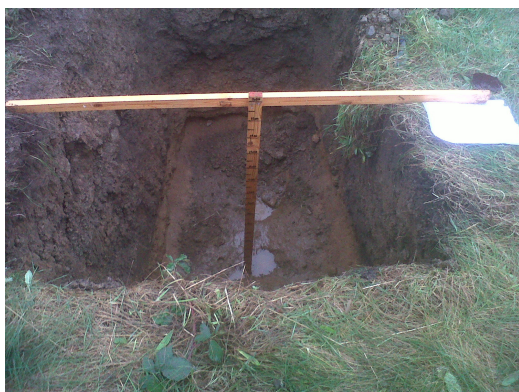
Trail Pit 1:      Test 1: 110mins  
                      Test 2: 120mins  
                      Test 3: 120mins (*value used*)

Photograph shows **Trial Pit 1** after 120mins with water fully drained away.

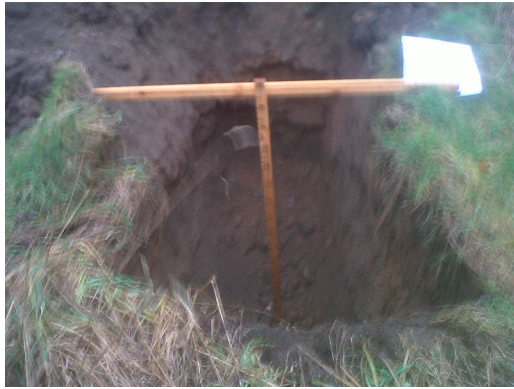
Photograph shows excavated **Trial Pit 2** with 1600mm long timber measuring tool resting on base and top edges.

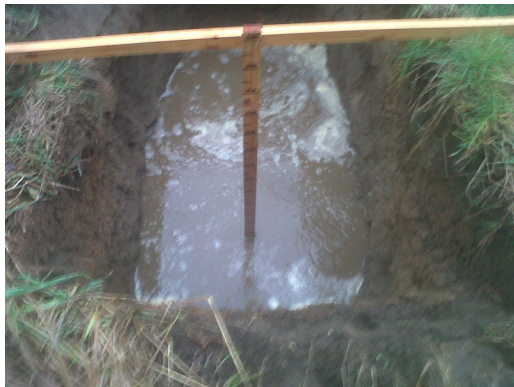
Photograph shows **Trial Pit 2** filled with approximately 400mm of water.

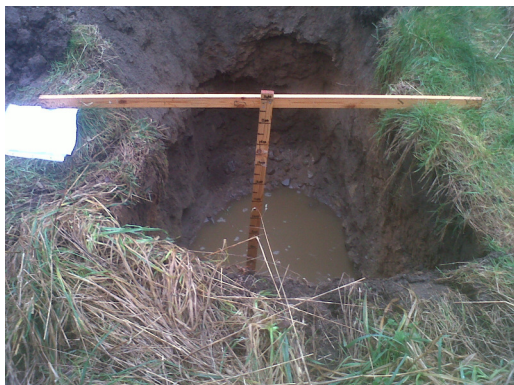
Photograph show **Trial Pit 2** after 60mins with approximately 200mm of water remaining.

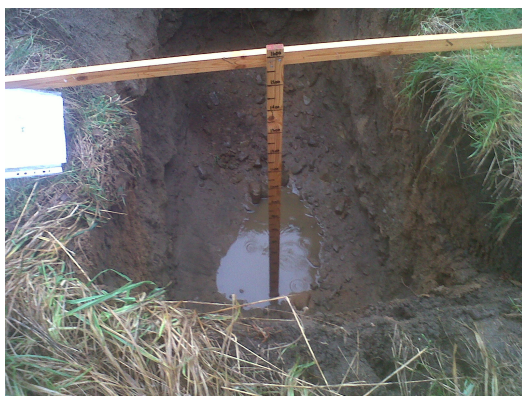
Trial Pit 2        Test 1: 115mins  
                      Test 2: 115mins  
                      Test 3: 120mins (*value used*)

Photograph shows **Trial Pit 2** after 120mins with only a small amount of water remaining < 25mm.
