COAL MINING RISK ASSESSMENT  
NEATH PORT TALBOT C.B.C.

PROPOSED COMMERCIAL DEVELOPMENT  
MARDON PARK  
BAGLAN ENERGY PARK  
PORT TALBOT  
N.P.T.  
SA12 7AX  
15/04/2021

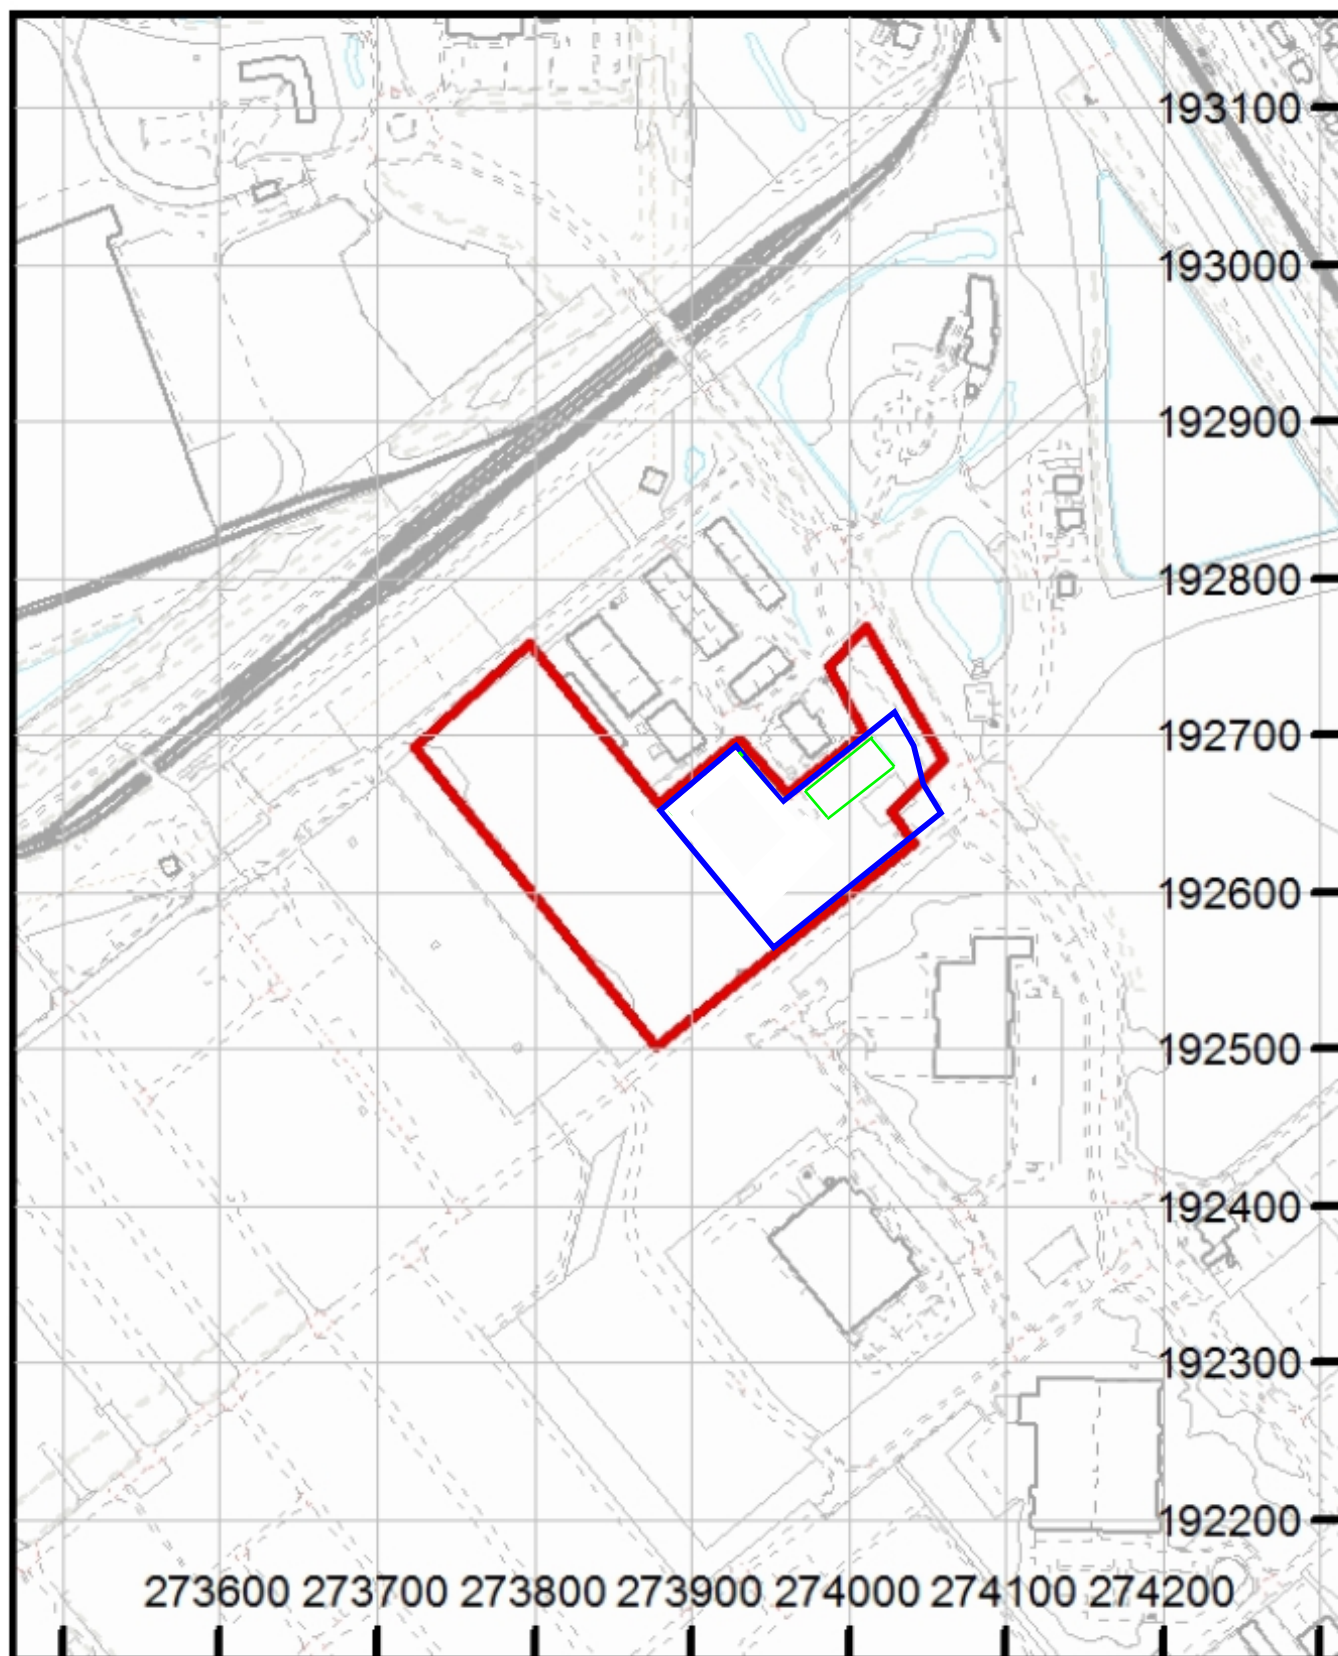
FIGURE 2

SITE BOUNDARY FROM COAL AUTHORITY CON29 REPORT.  
THE SITE BOUNDARY COVERED BY THE C.M.R.A. IS IN BLUE, THE  
CURRENT PLANNING APPLICATION BOUNDARY IS IN GREEN.

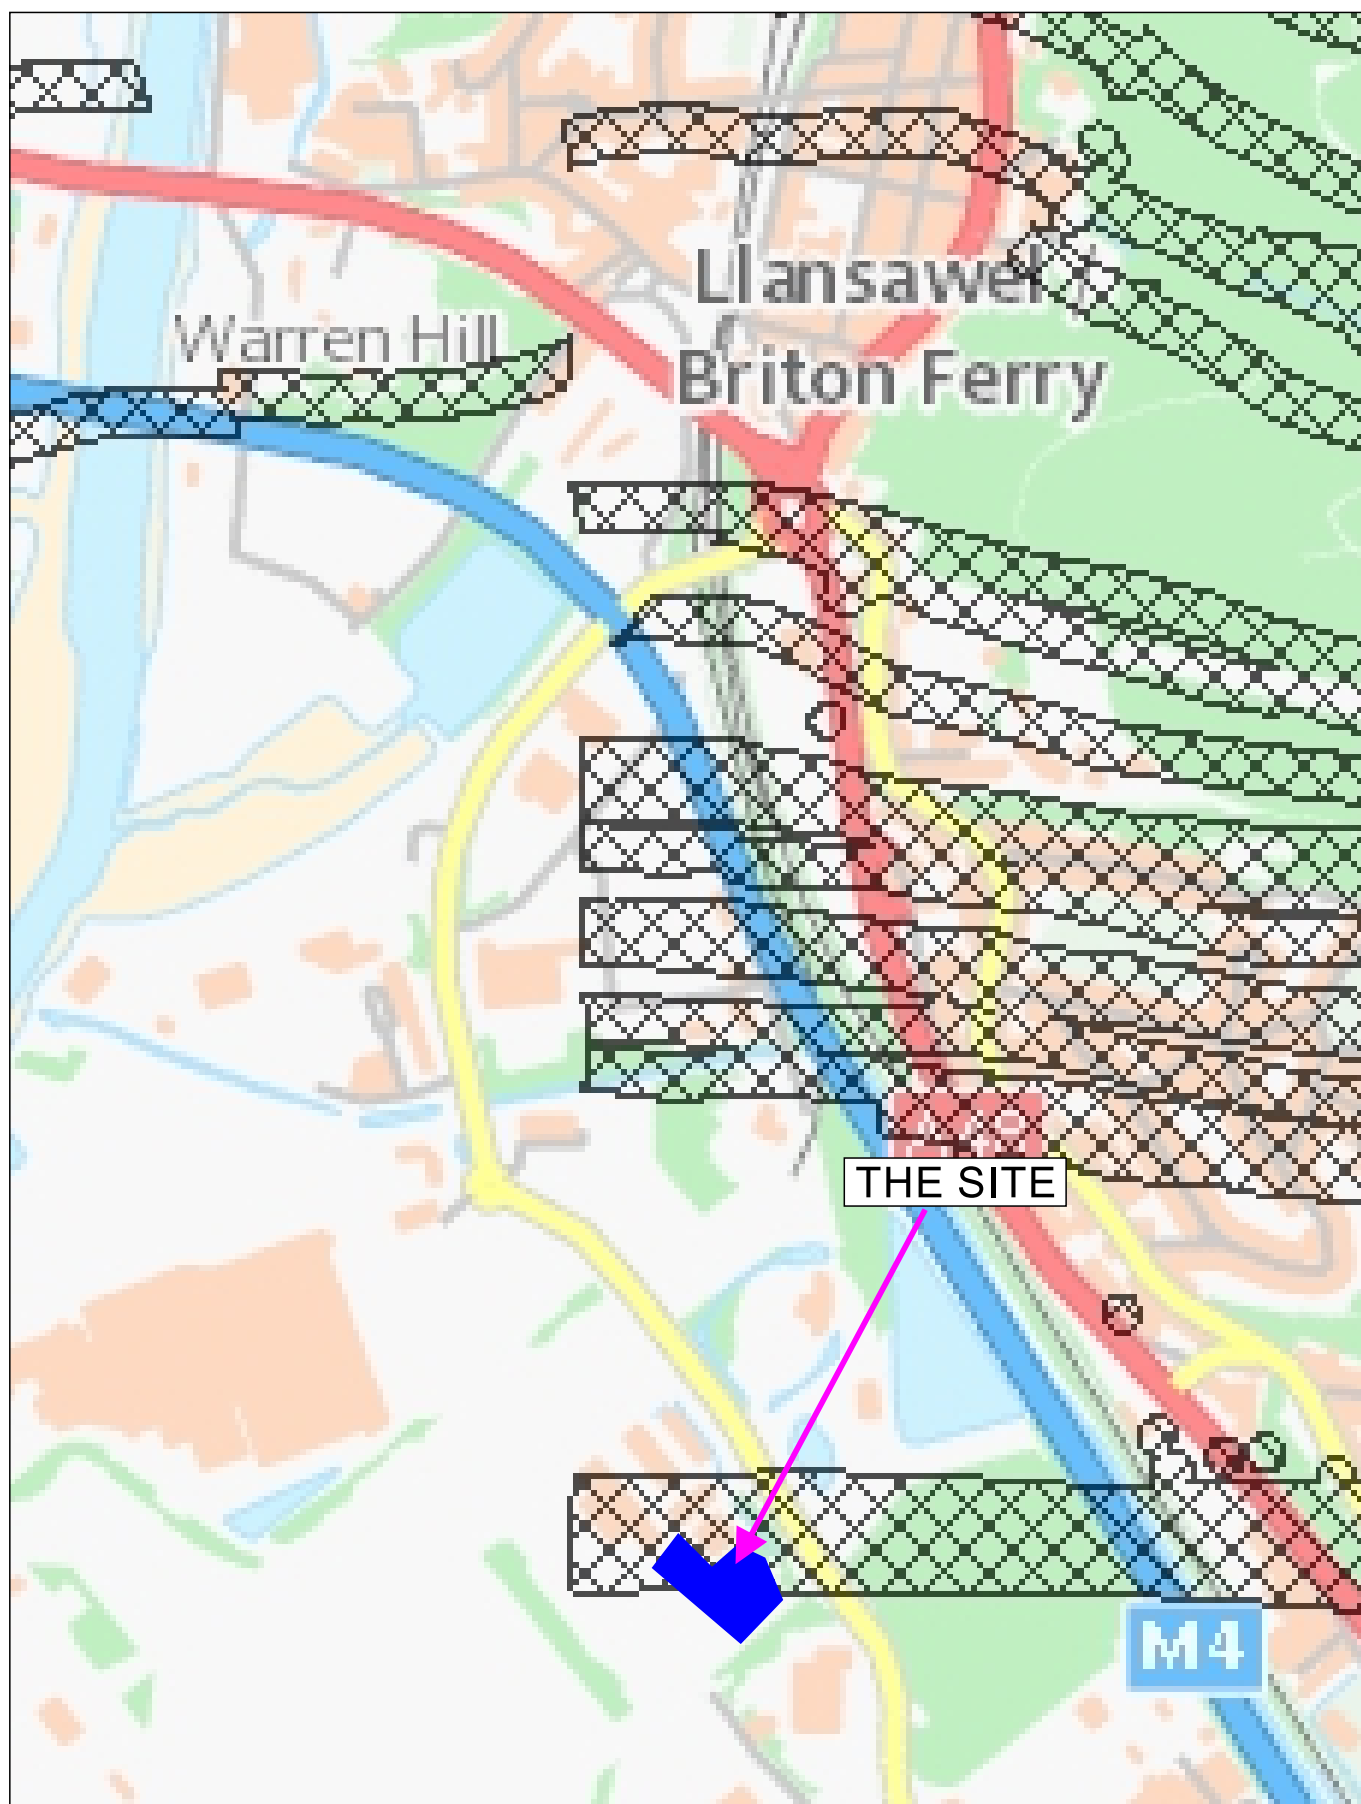
FIGURE 3

2b) The C.A. interactive viewer contains a vast amount of information from various sources, particularly on the mining data window. An extract from the planning window can be seen in Figure 3. The site partially lies on a linear belt of Development High Risk. From its appearance this would appear to be a buffer zone covering a shallow coal seam(s). There are multiple other linear areas of Development High Risk north of the site. These would appear to be buffer zones above other seam outcrops. The isolated small circular areas northeast of the site are 20m exclusion zones around mine entrances. In order to fully understand why a site has a high-risk status it is informative to study the Coal Mining Data window. This window is far superior to the planning window as it is at a larger scale. There are multiple datasets which can be turned on and off. Information that can be obtained on the viewer includes the exact orientation of adits, and any further information held on any mine entries, including names and depths. This additional information can be extremely useful to a risk assessment.

EXTRACT FROM THE COAL AUTHORITY INTERACTIVE VIEWER PLANNING WINDOW. BLACK HATCHED AREAS ARE CLASSSED AS DEVELOPMENT HIGH RISK. THE SITE POSITION IS HIGHLIGHTED

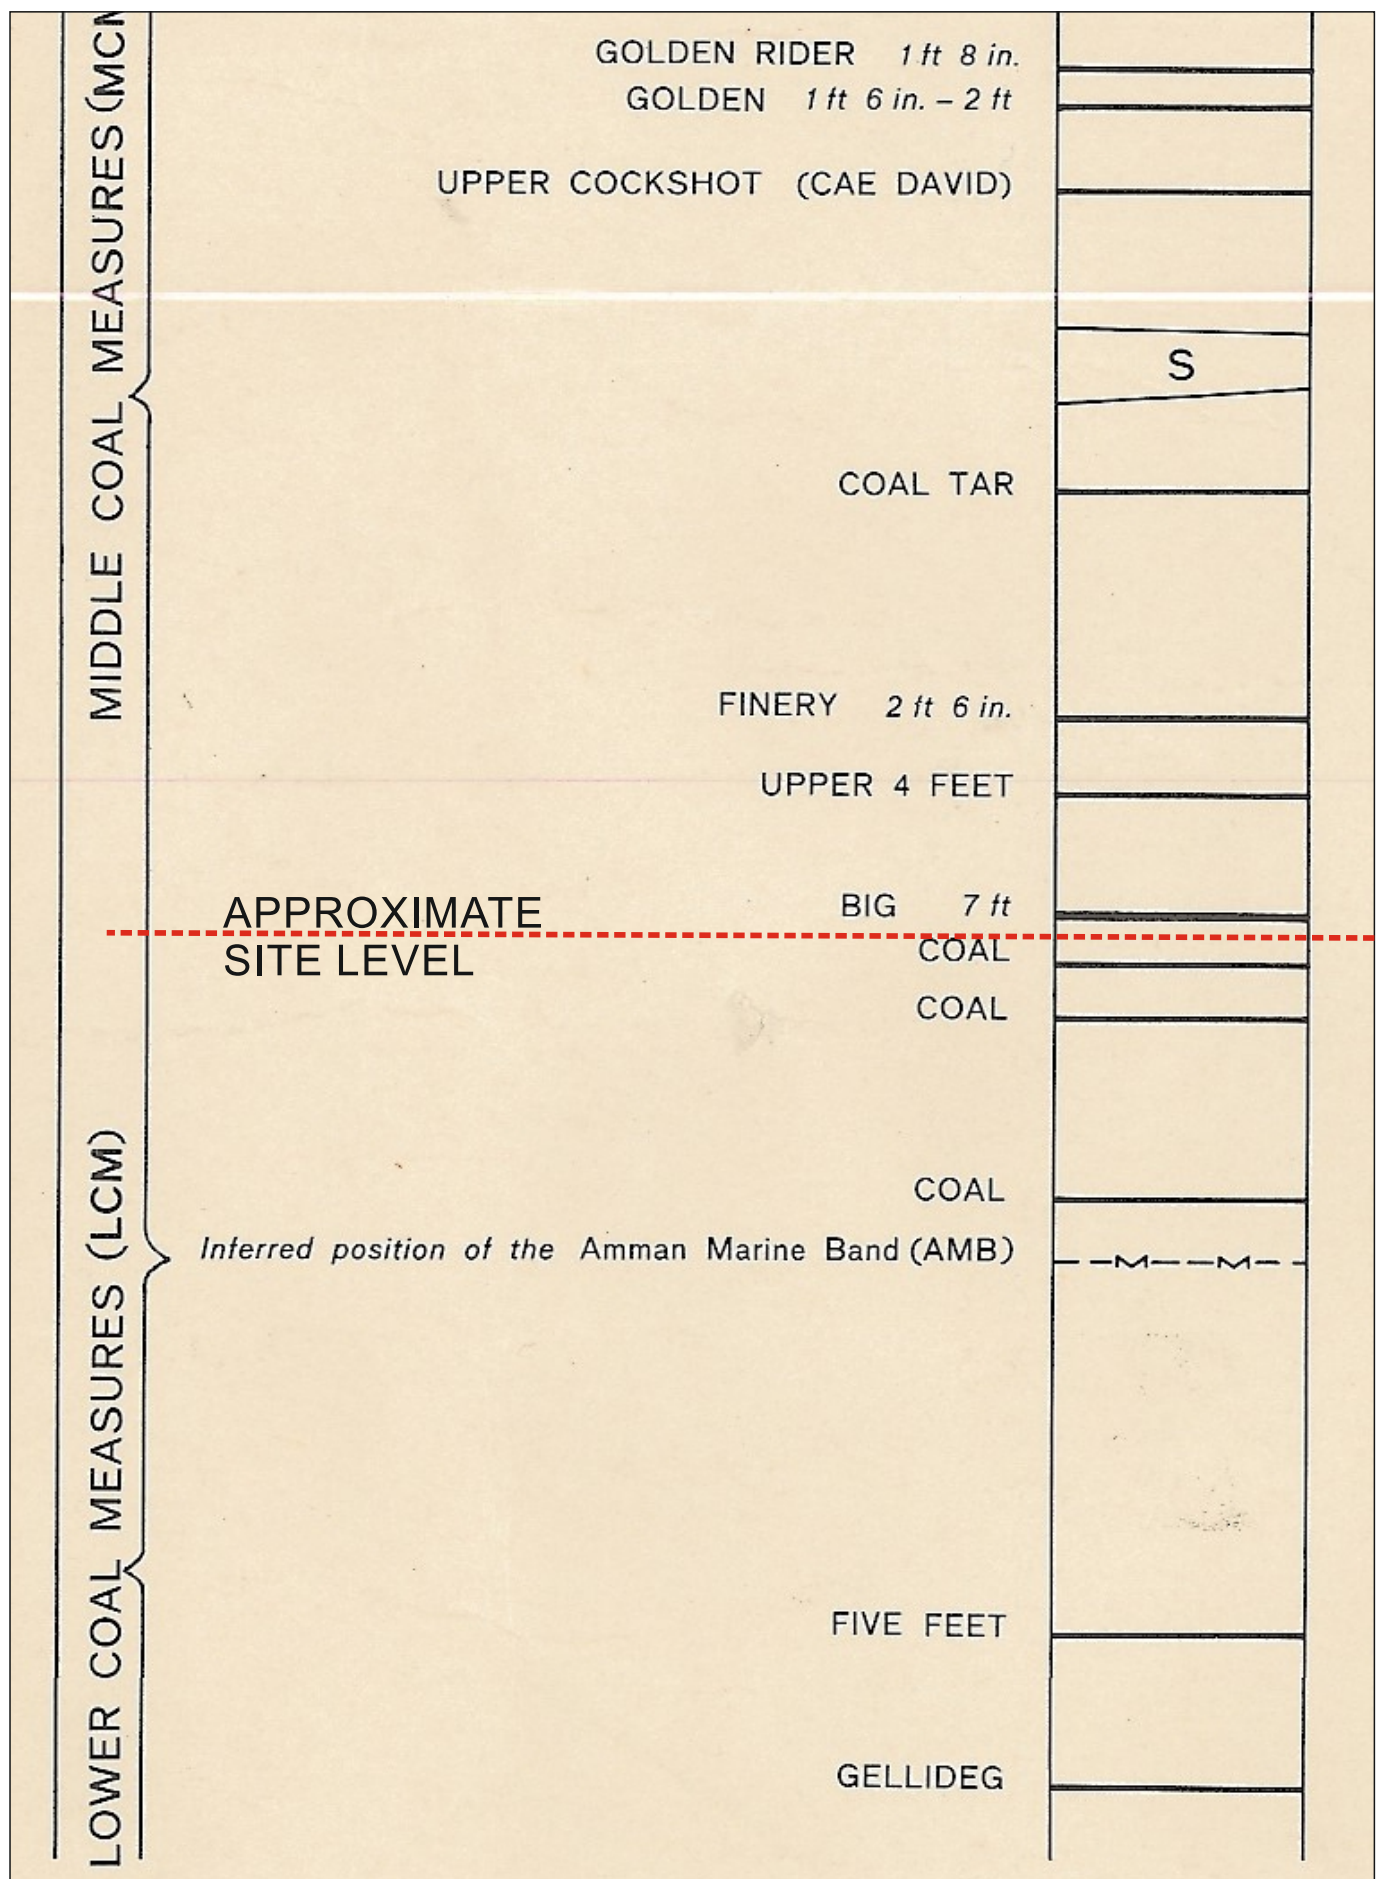
The Survey Sheet shows that the site is underlain by bedrock of the Middle Coal Measures, which are undifferentiated in South Wales. The Amman Marine Band marks the boundary with the Lower Coal Measures and the conjectural position of this is shown just south of the site. In South Wales the Middle and Lower Coal Measures are predominantly argillaceous with closely spaced coal seams, many of which were economically important in the past. The absence of these seams south of the site all the way to the outcrop of the Gellideg Seam is significant. The map shows the strata dips at between 26° and 40° to the north. The dips are all north of the shafts of Baglan Hall Colliery and would have been measured underground because of the lack of bedrock outcrops. Four seam outcrops are shown in Figure 5 in a similar arrangement to Figure 4. The reason for their truncation can be seen to be the Giants Grave Fault. The outcrops are marked further north than in Figure 4. The site footprint has been accurately positioned using georeferencing, as will be seen in the following section. Two of the seams are labelled as the Upper Four Feet and the Big, neither of which underlie the site. In Figure 6 it can be seen that the Big Seam is given a thickness of 7' (2.15m). This is very thick for South Wales, hence the name. This can be contrasted with the thicknesses of the Finery, Golden and Golden Rider, all of which were worked to the north of the site. The Upper Four feet and the two unnamed seams below the Big, which do cross the site, are unlabelled and are not assigned a thickness. This would imply they are less than 12" (300mm) thick and thus unworkable.

FIGURE 6  
SECTION OF THE STRATIGRAPHIC COLUMN FROM SS 79SW.  
THE APPROXIMATE SITE LEVEL IS SHOWN

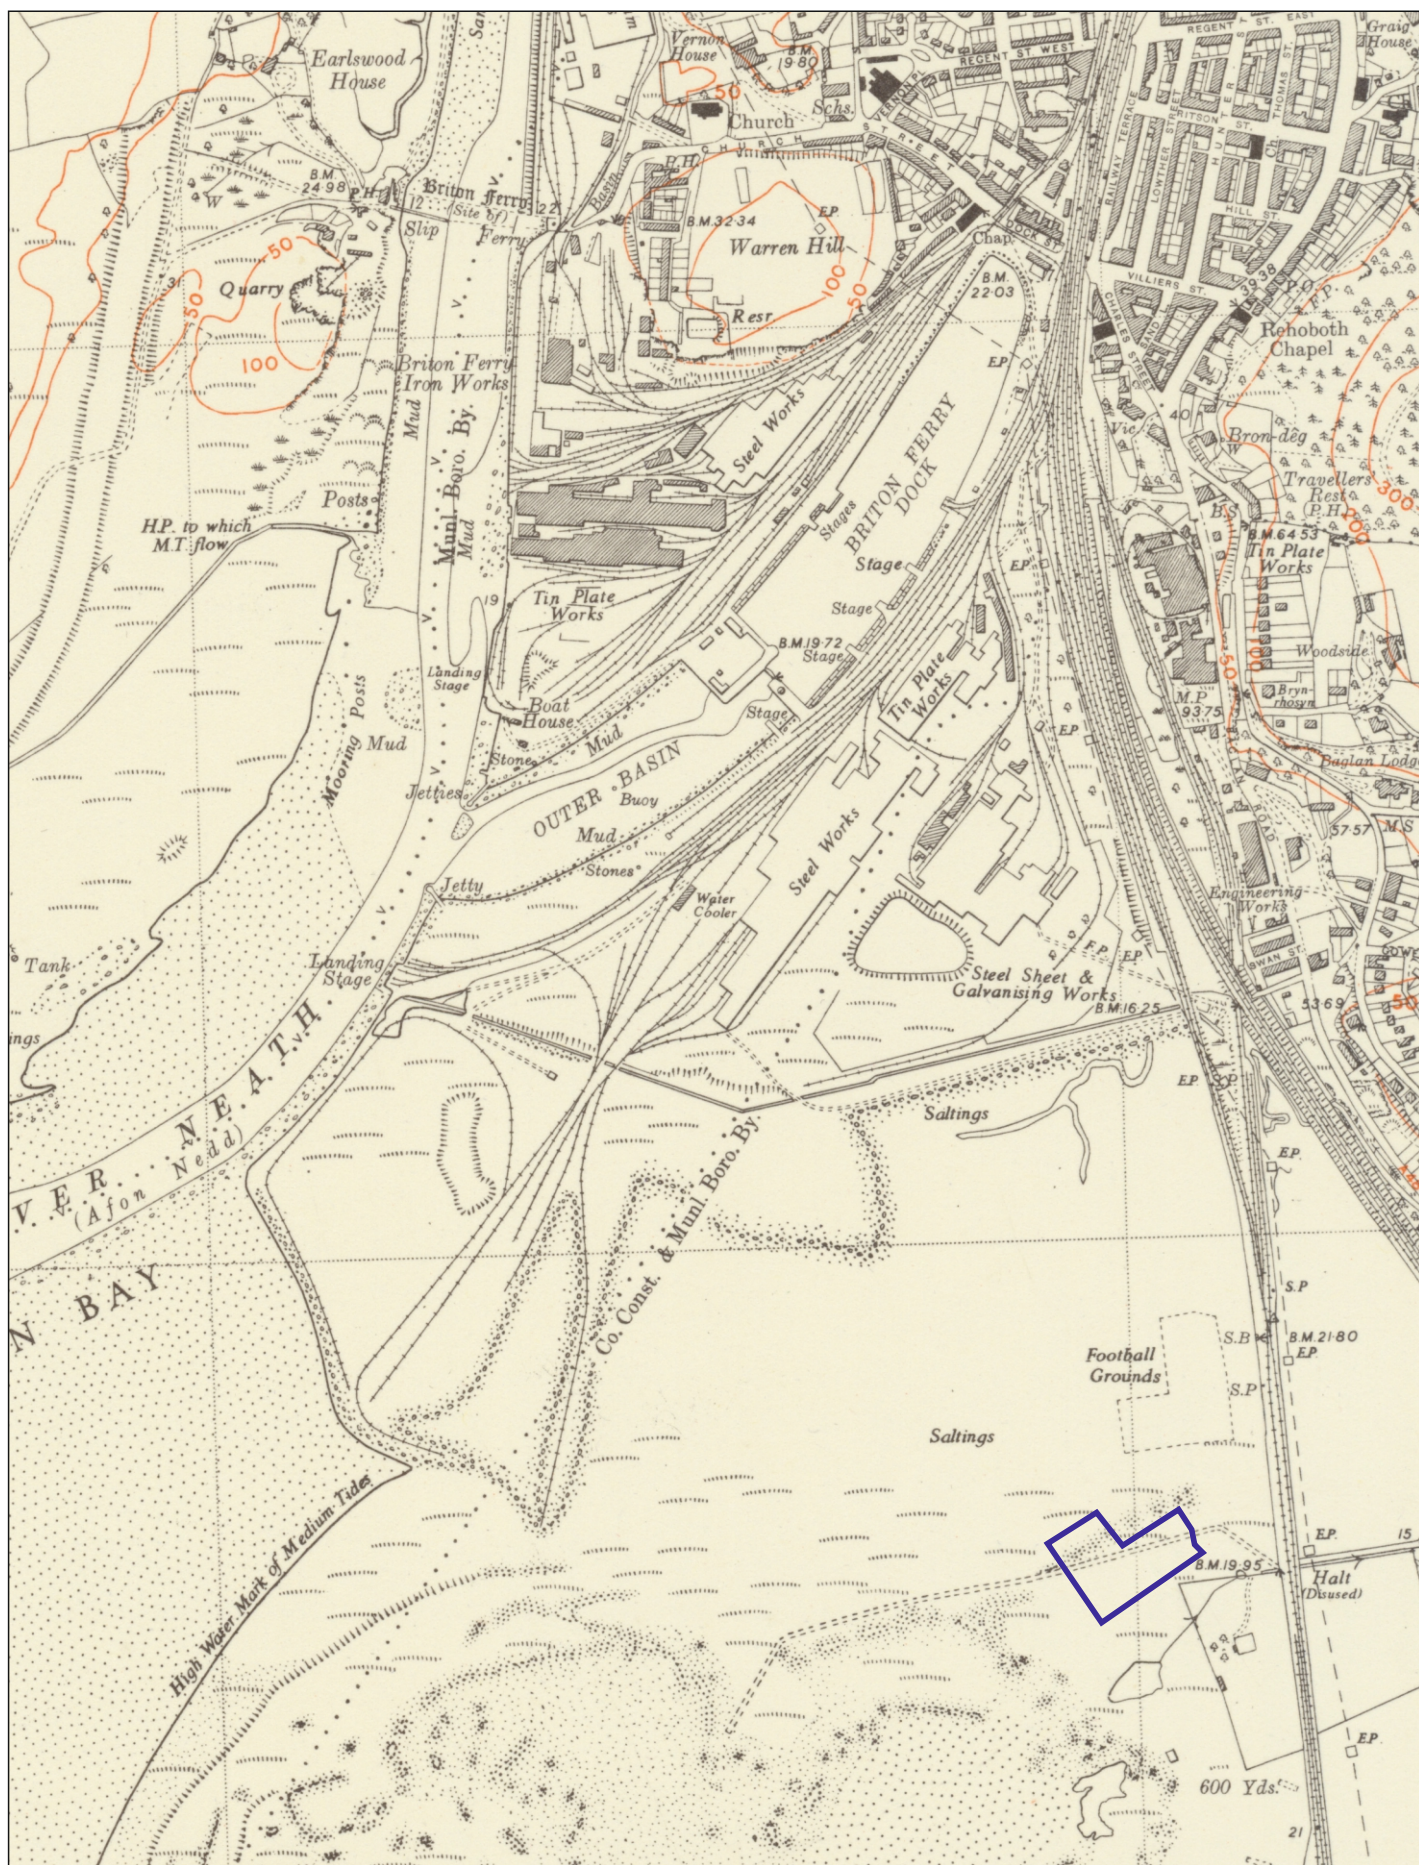
FIGURE 8  
THE SITE ON THE 1948 1:10,560 O.S.
