# Coal Mining Risk Assessment

**For development at:** Carters MOT & Auto Repair Centre, 40 Cilmaengwyn, Pontardawe, SA8 4QL

**For proposal:** Detached 4 bay repair outbuilding to rear of existing MOT and Auto Repair Centre

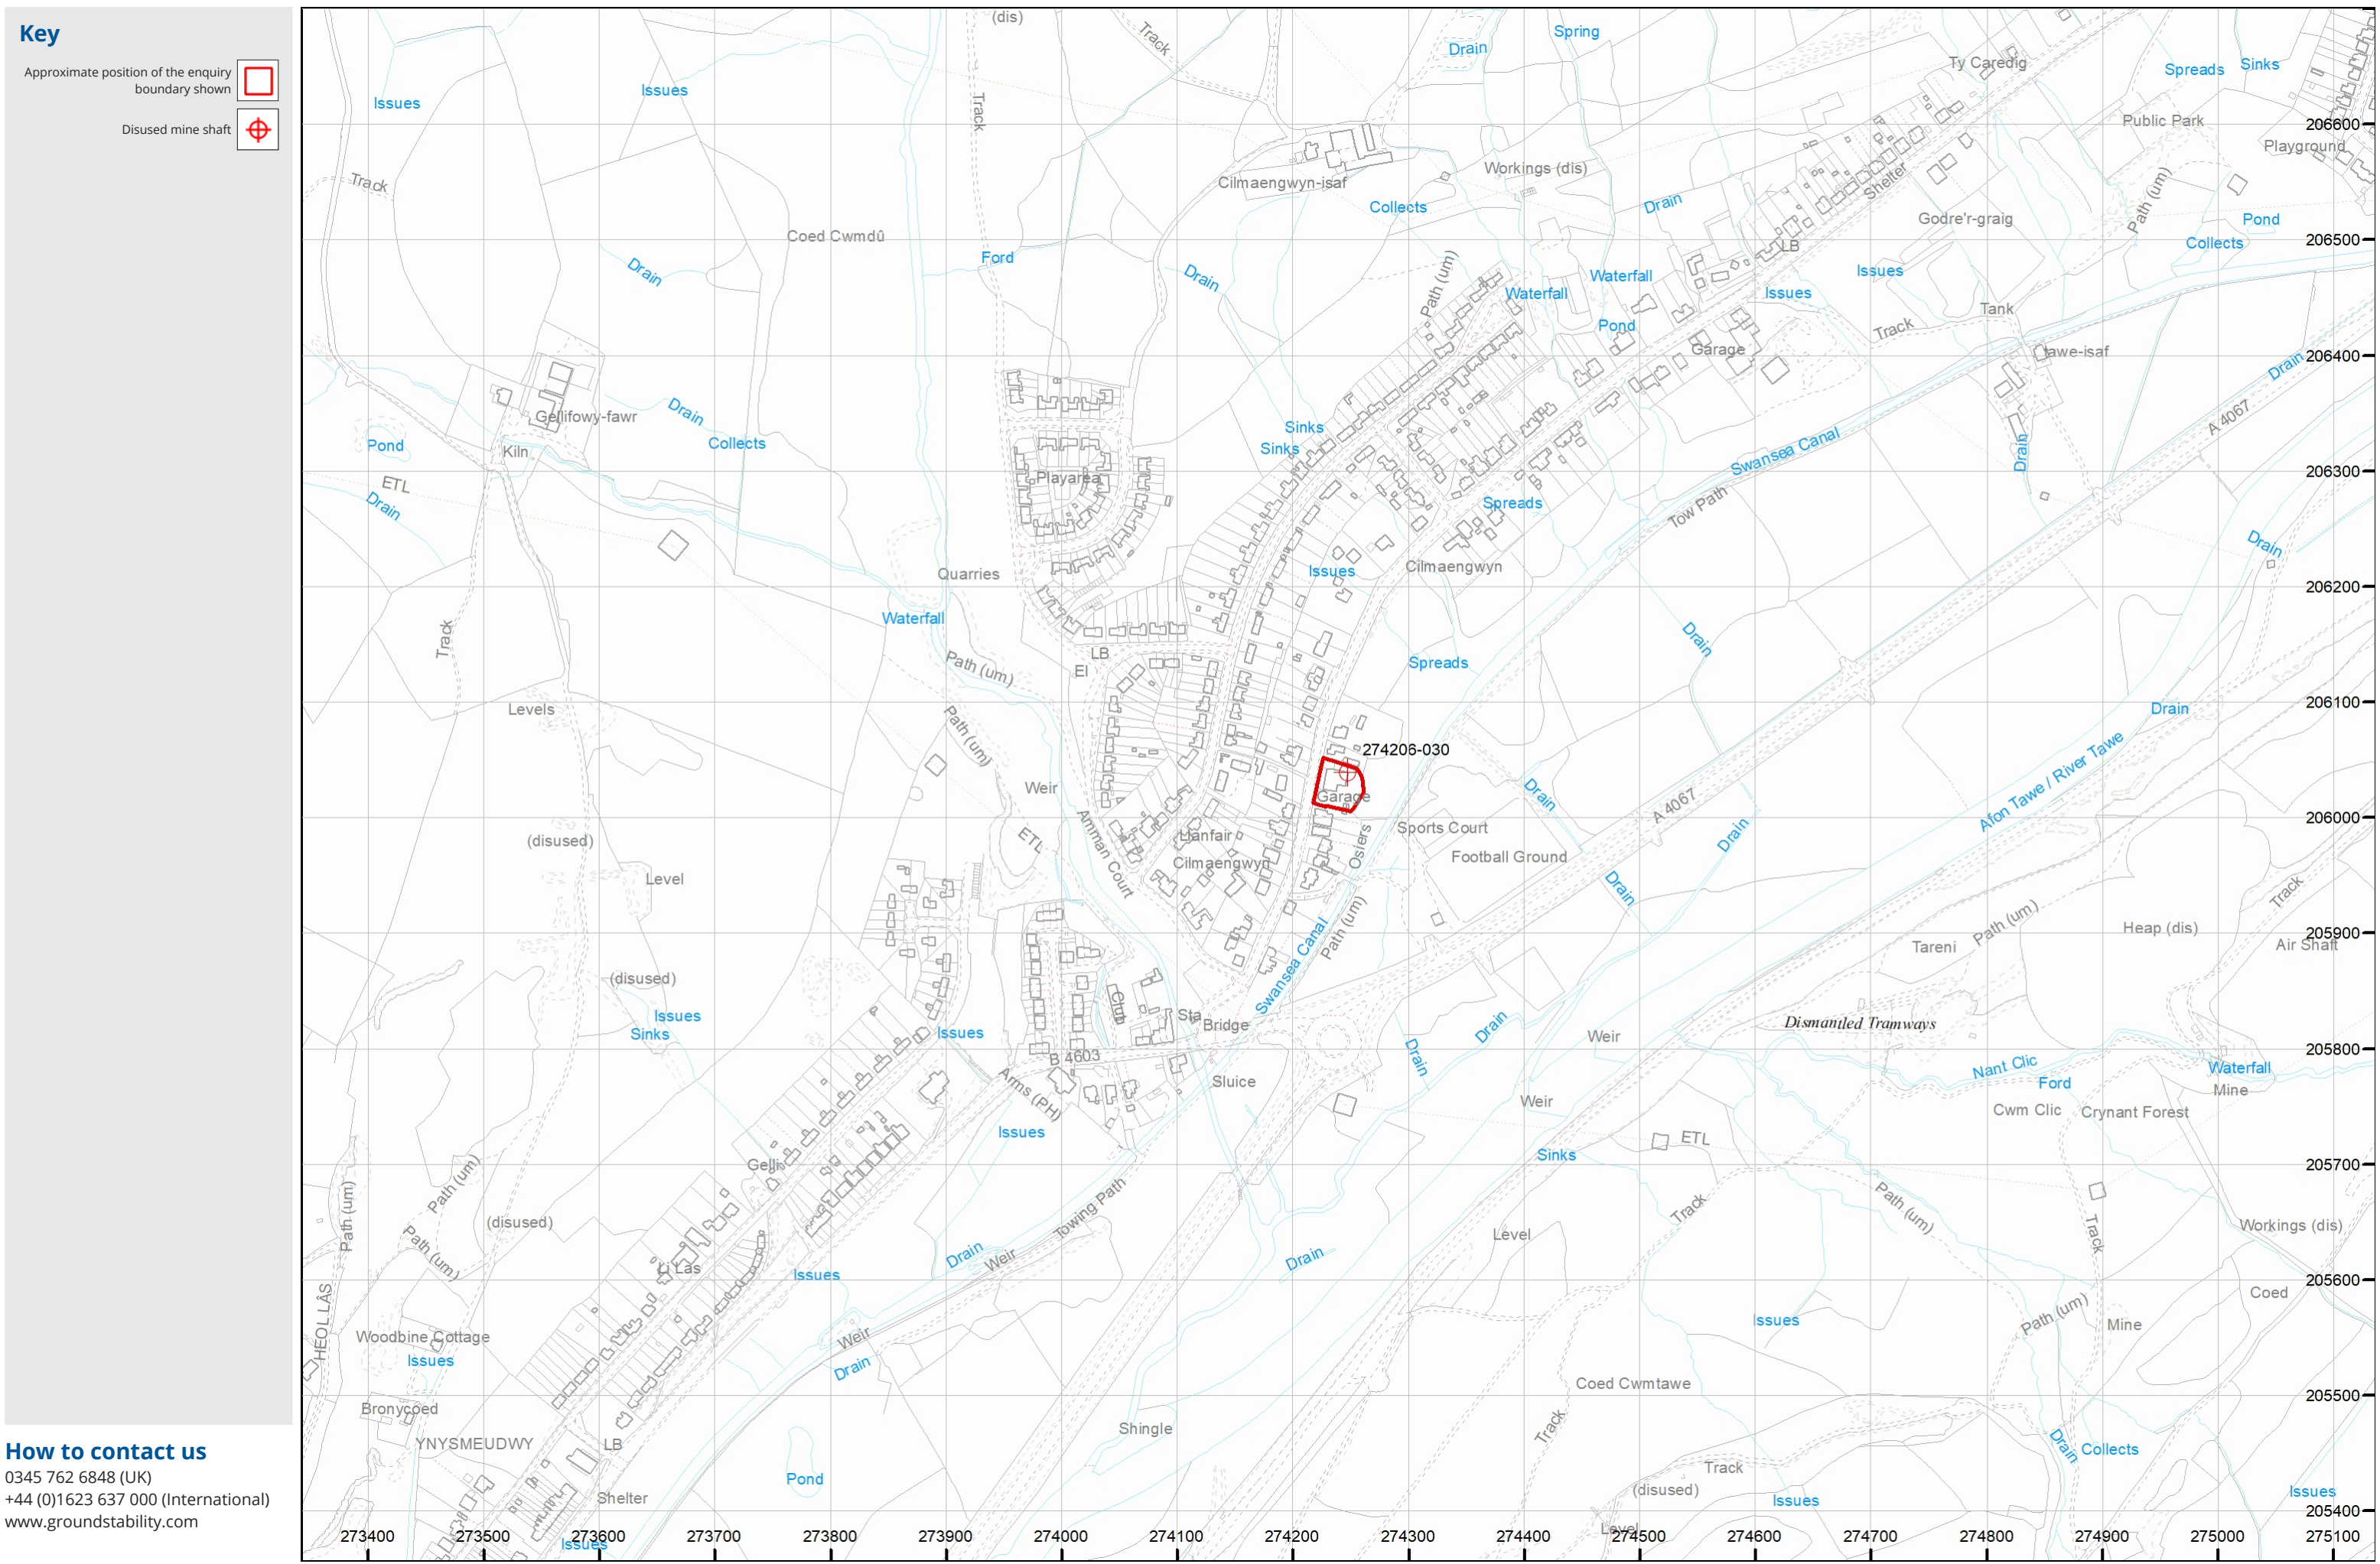
| Entry type | Reference | Grid reference | Treatment description | Mineral | Conveyancing details |
|---|---|---|---|---|---|
| Shaft | 274206-030 | 274248 206039 | | Coal | |

The map highlights any specific surface or subsurface features within or near to the boundary of the site.
