RHONDDA  
GEOTECHNICAL  
SERVICES

COAL MINING RISK ASSESSMENT  
NEATH PORT TALBOT  
PLANNING APP. P2021/0412  
TWO HOLIDAY LODGES AT  
OAKFIELD HOUSE  
HEOL Y GLO  
PEN Y BRYN  
PYLE  
CF32 9EB  
21/07/2021

## **COAL MINING RISK ASSESSMENT**

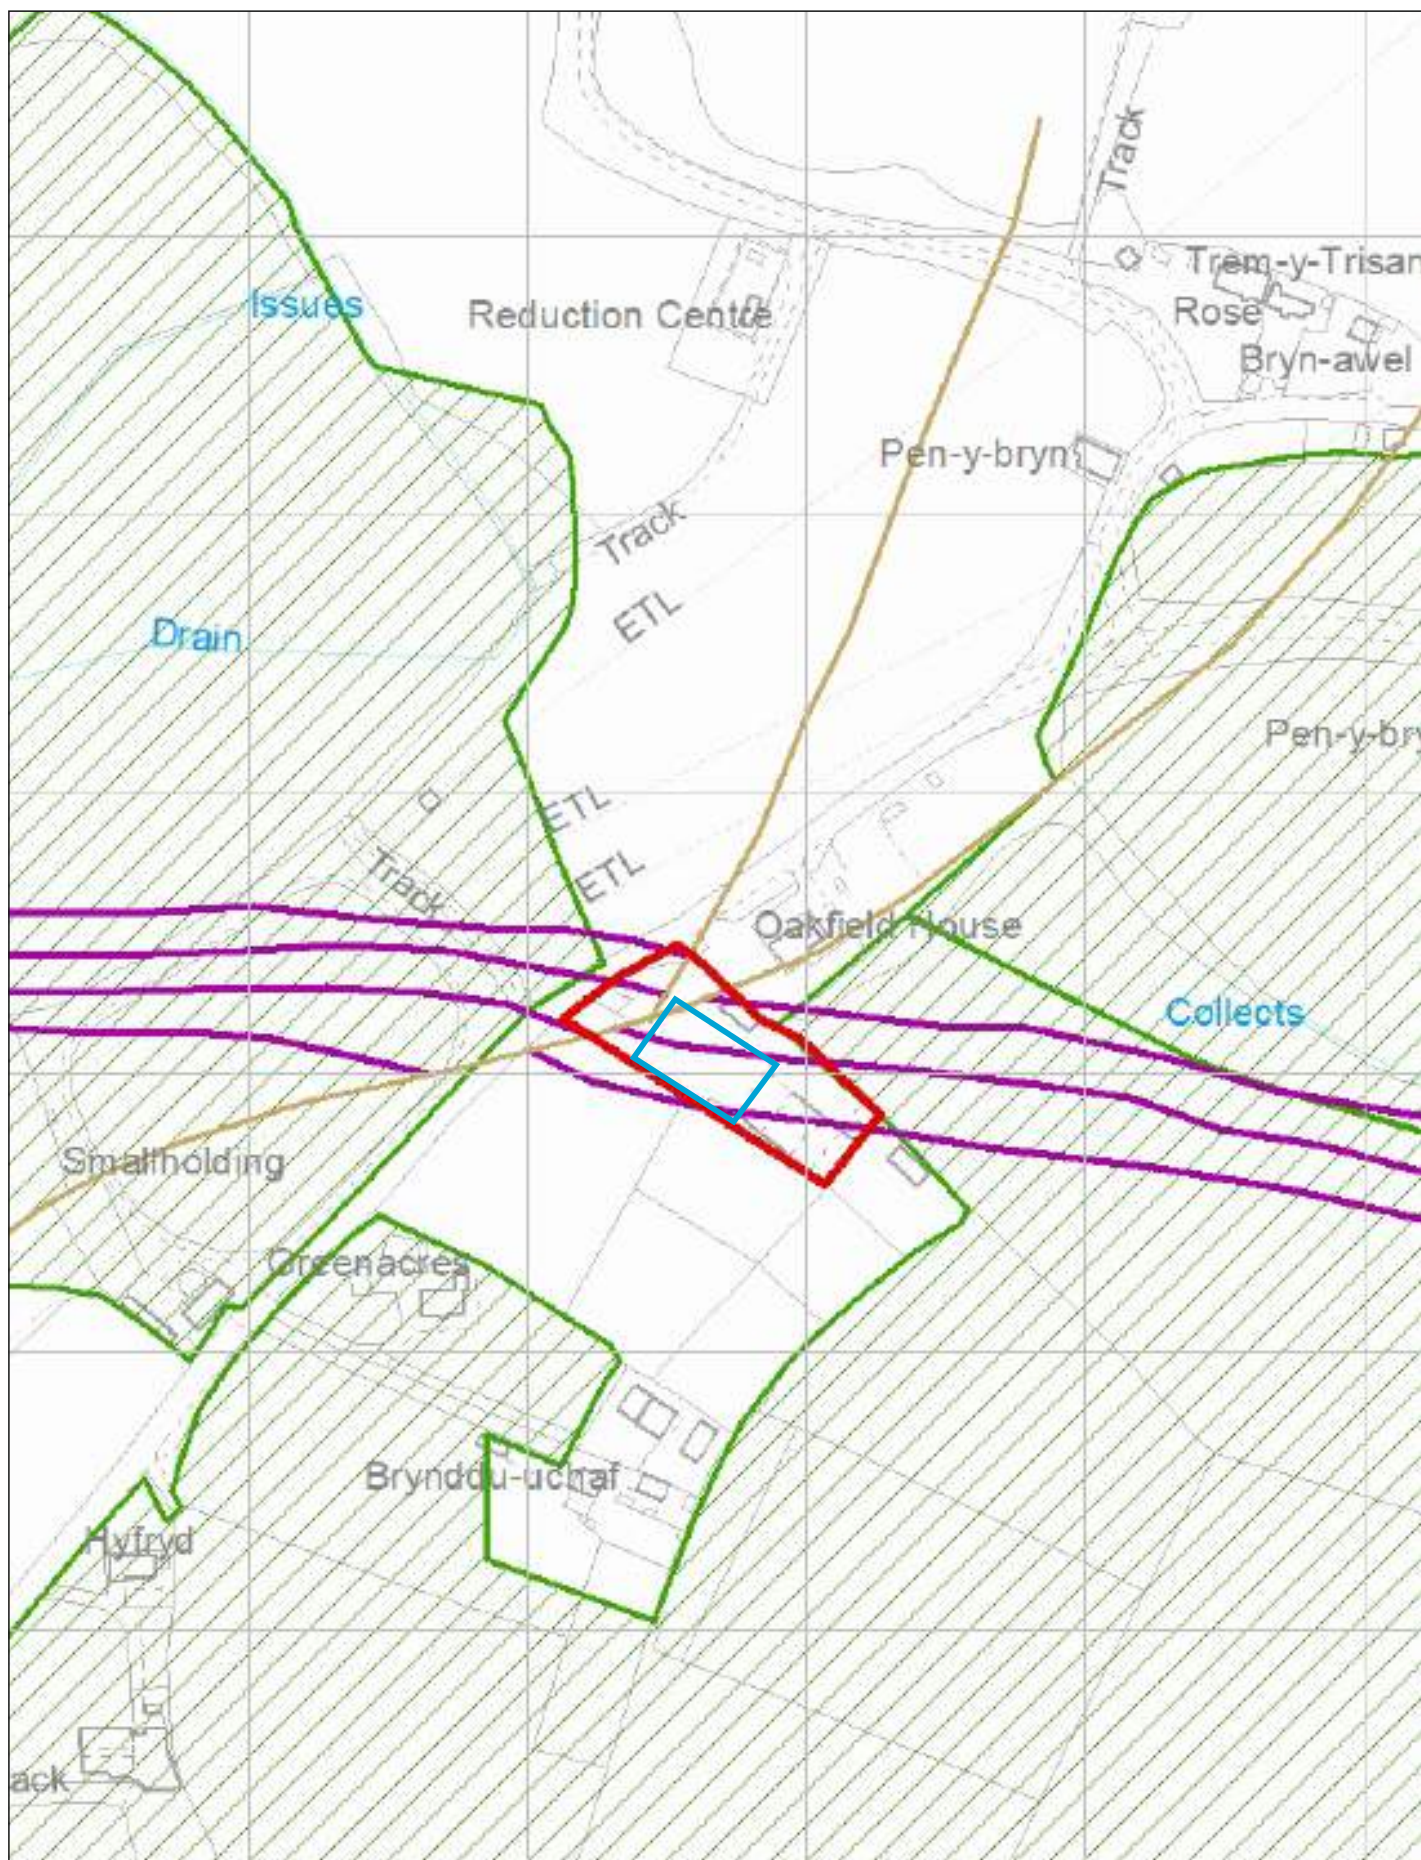
FIGURE 3  
SUMMARY OF FINDINGS MAP.  
THE PLANNING APPLICATION AREA IS OUTLINED IN BLUE

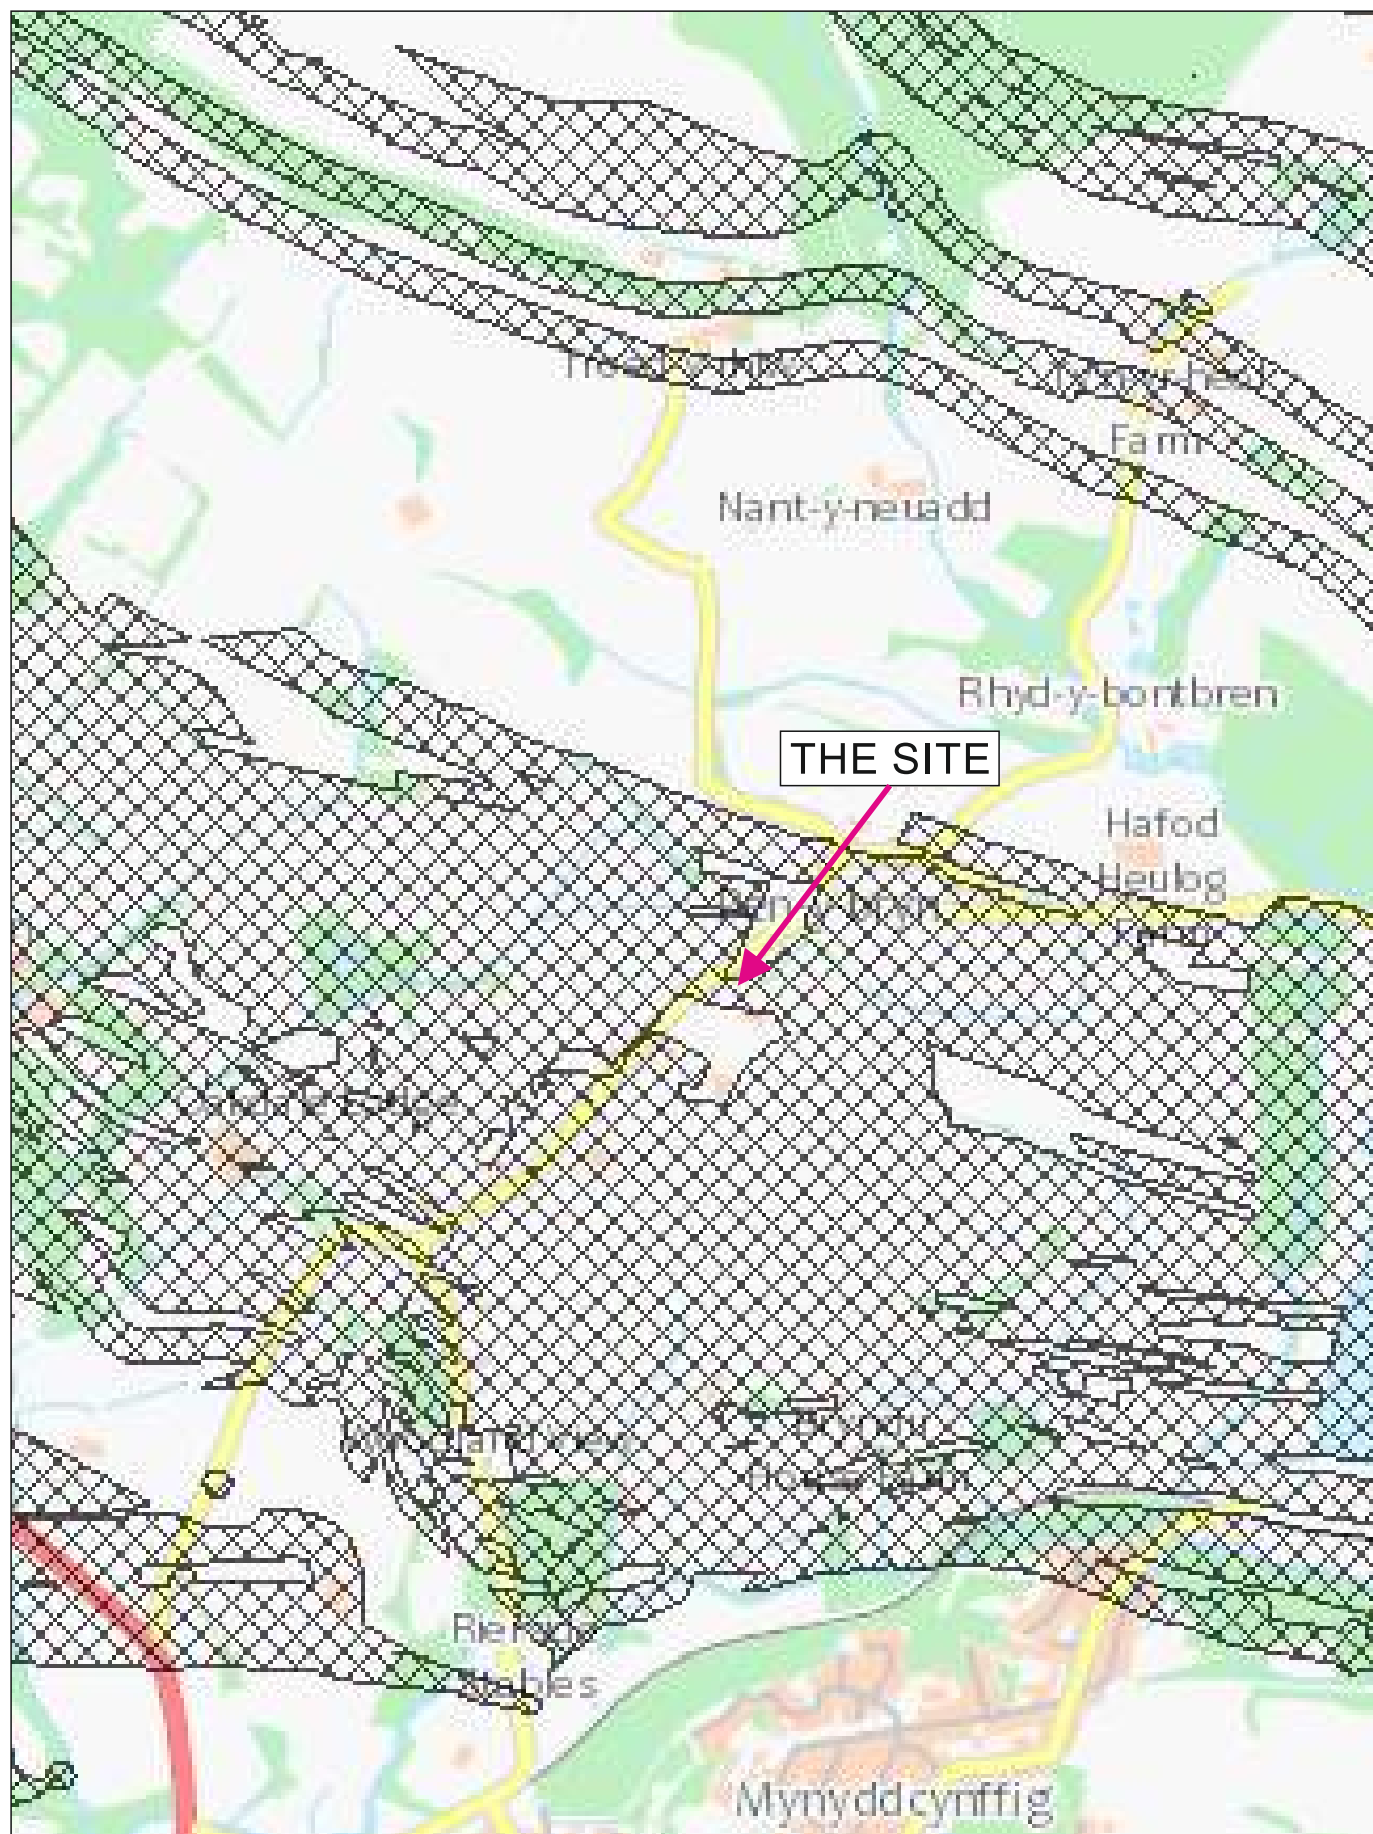
FIGURE 4  
 COAL AUTHORITY INTERACTIVE VIEWER, PLANNING WINDOW.  
 BLACK HATCHED AREAS ARE DEVELOPMENT HIGH RISK.

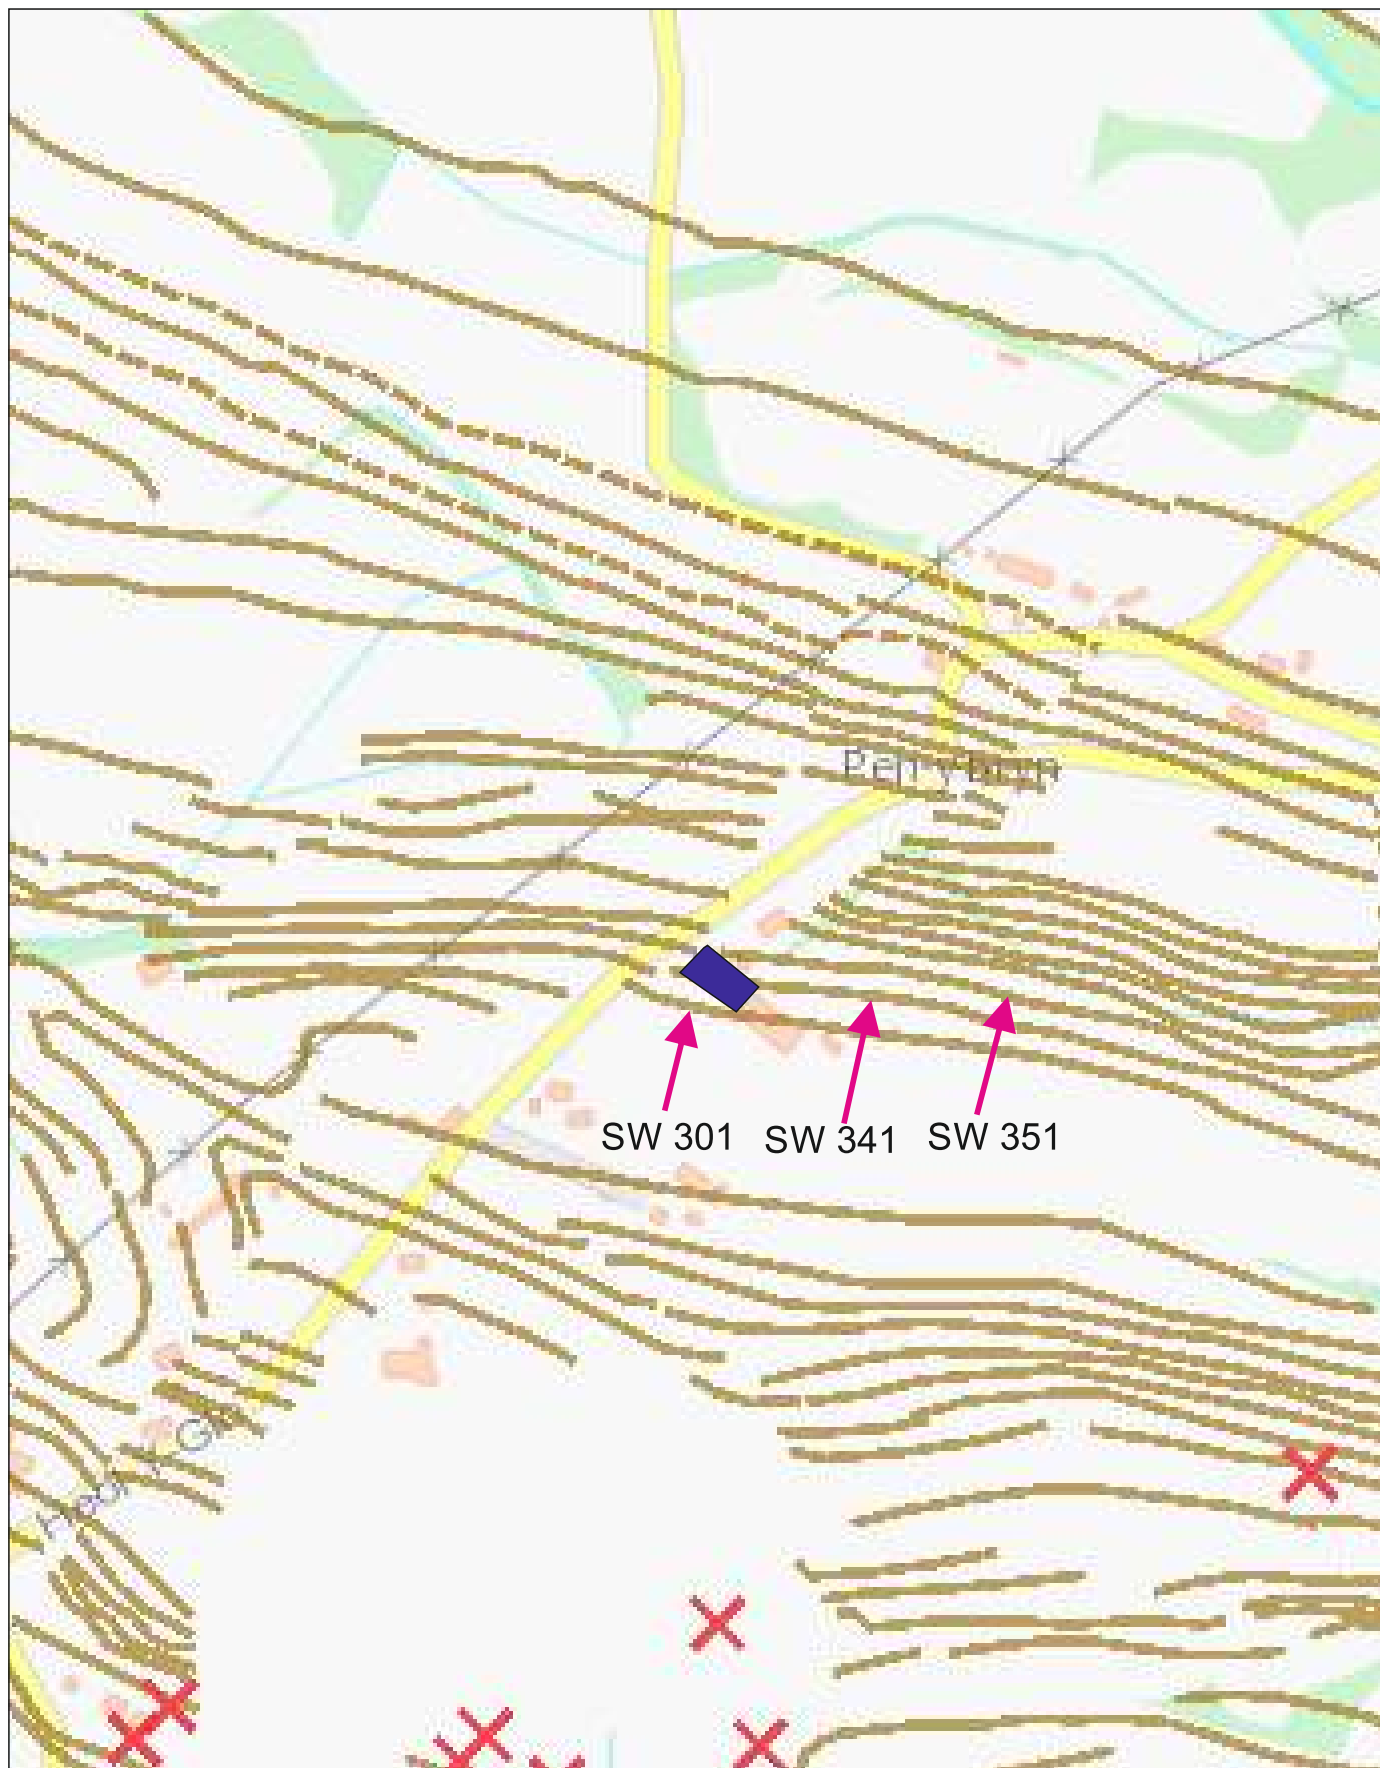
FIGURE 5

An extract from the Mining Data Window is reproduced as Figure 5 overleaf. For clarity only two sets of data are turned on in Figure 5- seam outcrops and mine entries. The brown lines are coal seam outcrops. Multiple outcrops run through the site as in the SoF map. A series of other seam outcrops run parallel to this both north and south of the site. The C.A. seam codes are shown marking the nearest seams to the site. The seam north of the site is SW0351 (Red Vein Seam in the C.A. Seam Directory). SW0341 runs through the site. This is the Upper Nine Foot Seam according to the C.A. Seam Directory. Immediately south of the site is SW0301 (Lower Nine Foot in the C.A. Seam Directory). Dip directions are not shown on the data window. However, as the seam codes are

in ascending order going north, it is safe to assume that the dip direction is to the north.

The red crosses are mine entries. The first thing noticeable is the complete lack of mine entrances in the area of the site. Given the proliferation of seam outcrops this is unusual for the South Wales Coalfield. There could be several reasons for this. The seams shown are good quality and thick enough to be workable. Extreme structural deformation and thick superficial cover are possibilities for the lack of exploitation. It seems that the reserves lay undisturbed until being removed by opencasting. There are multiple mine entrances south of the site. These are linked to several collieries which operated in the Nineteenth century. All would be considered much too far away to influence ground stability at the site.

C.A.VIEWER, MINING DATA WINDOW. BROWN LINES ARE SEAM OUTCROPS, RED CROSSES ARE MINE ENTRIES. THE SITE IS HIGHLIGHTED IN BLUE. C.A. SEAM CODES HAVE BEEN ADDED.

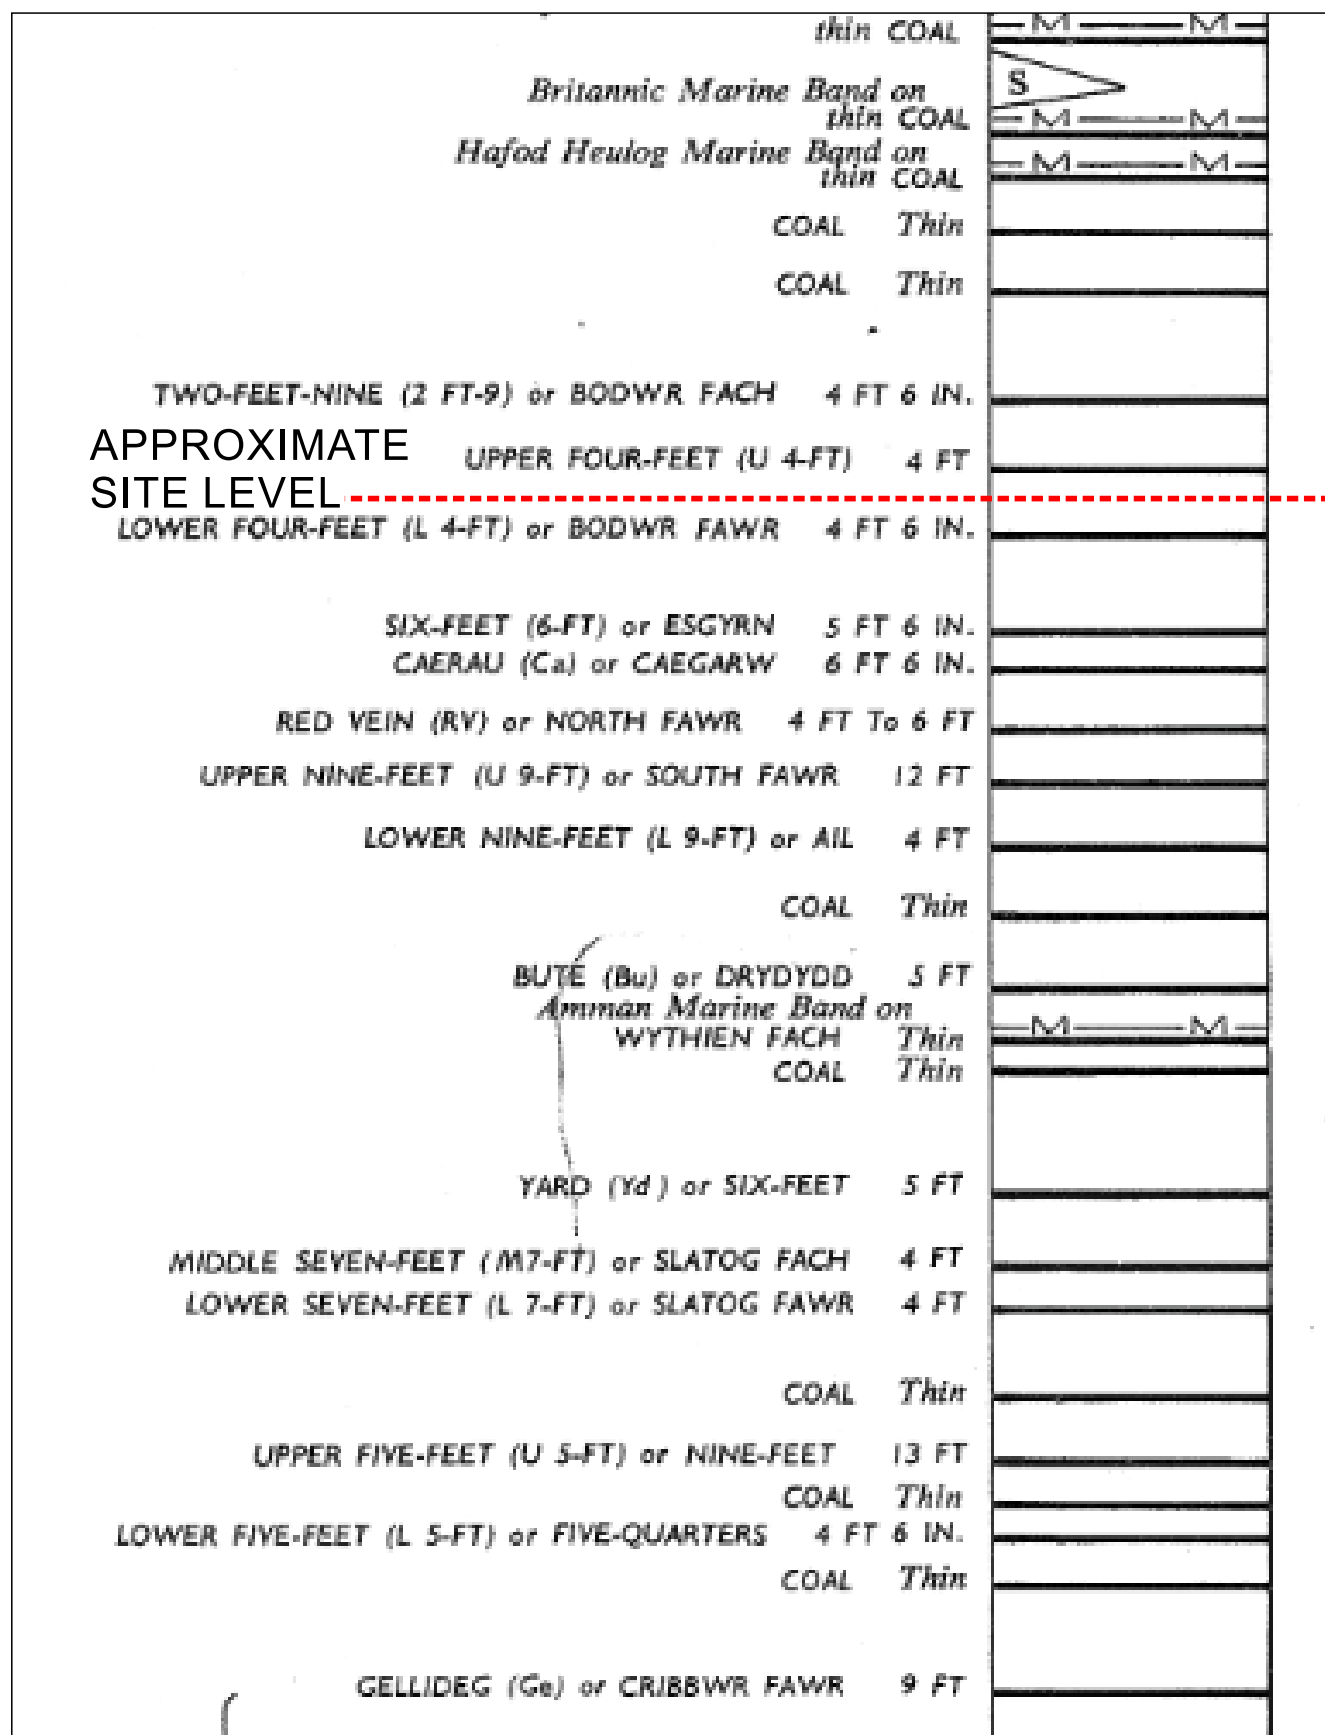
The Survey Sheet shows that the site is underlain by bedrock of the Middle Coal Measures which are undifferentiated in the South Wales Coalfield. The Measures consist of predominantly argillaceous strata with multiple rich coal seams, many of which have been economically important in the past. There are several measured strata dips ranging from  $18^{\circ}$ - $32^{\circ}$  and uniformly to the north. Just south of the site the east-west dashed line is the conjectural position of a thrust plane. This is responsible for a repetition of seam outcrops. The Lower Four Foot outcrop is marked running through the site, with the Upper Four Foot outcrop just to the north. The same seams also outcrop south of the site near Bryndu Uchaf Farm. The two outcrops near the site run from a small opencast west of the site to another small opencast east of the site on the adjacent sheet GLAM34SW. These seam names do not tally with the seam outcrops shown in the C.A. data on the site. The reason for these differences will be discussed further in the following section. There is an annotation on the Survey Sheet stating "in the area between Bryndu Uchaf, Bryndu House and the road to the west the seam outcrops are marked by lines of numerous old bell pits". There is also a disused slant marked at Bryndu Slip which is outside the boundary of Figure 6. In addition there are shafts, spoil heaps and other mining features just north of Kenfig Hill on the boundary of the two adjacent Survey Sheets. There are no mining features marked in the vicinity of the site.

FIGURE 7  
SECTION OF THE STRATIGRAPHIC COLUMN FROM GLAM 33SE  
THE APPROXIMATE LEVEL OF THE SITE IS MARKED.

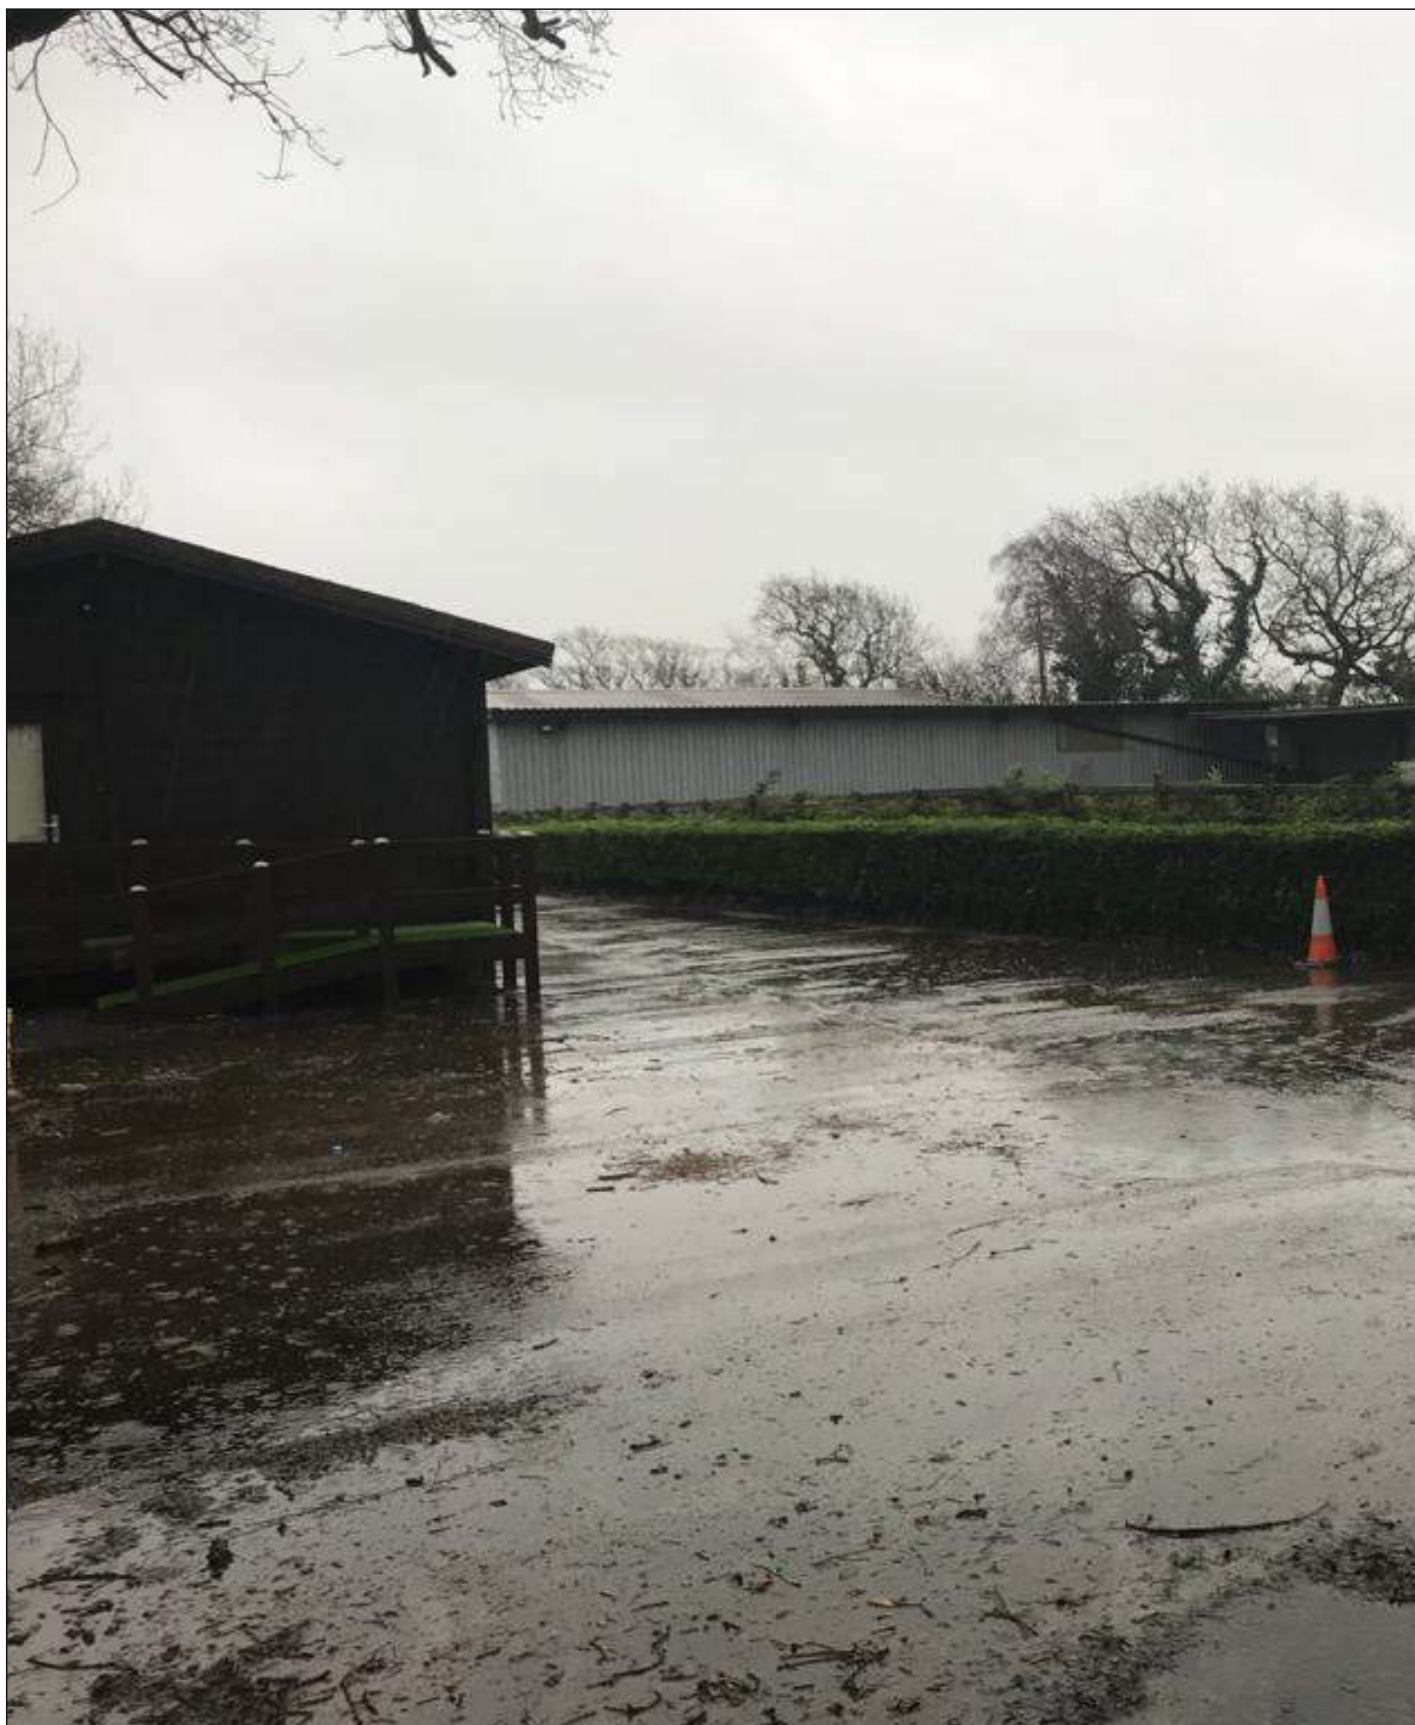
FIGURE 10

A PHOTOGRAPH OF THE SITE. IN THE LEFT FOREGROUND IS A CABIN IDENTICAL TO THE TWO PROPOSED. THE PROPOSED LOCATION IS OVER THE HEDGE IN THE RIGHT FOREGROUND. IN THE BACKGROUND IS ONE OF THREE LARGE AGRICULTURAL BUILDINGS CONSTRUCTED DIRECTLY OVER SEAM OUTCROPS.
