# THE BARN, TRENACHE FARM, NEATH PRELIMINARY ROOST ASSESSMENT FOR BATS

| <b>TITLE:</b> | Preliminary Roost Assessment for Bats |

| <b>PROJECT REF:</b> | 319-01-01-21 |
| <b>REPORT No.:</b> | 319-01-01.R1 |

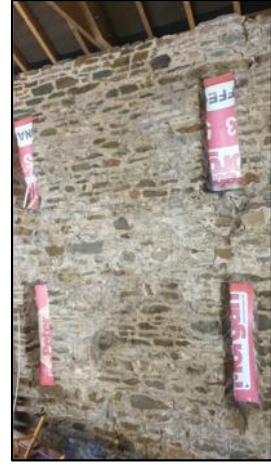
A number of slit windows can be found across all floors. These are open in nature from the building exterior, but have been well-sealed from the building interior using plastic sheeting which has been cut to size for each window. These areas were inspected thoroughly from the building exterior for potential access points or features which may be suitable for crevice-dwelling bats. The slit windows were found to be well-sealed with no potential access/egress points to the building interior for bats being noted, and no features such as damaged masonry or gaps being recorded which may be suitable for crevice-dwelling bats.

**Figure 12 – Well-sealed Window Detail**

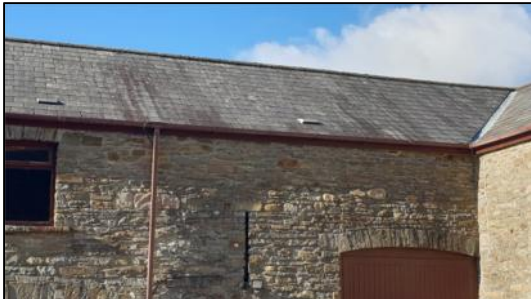
**Figure 15 – Slates in Excellent Condition**

the building interior. It should be noted that the external roof slates were observed to be in excellent condition, with no areas of damage, lifting or slipping being recorded during the survey.

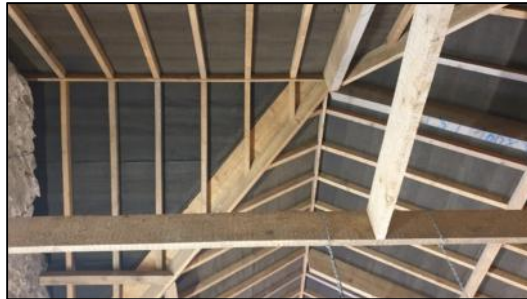
**Figure 16 – Underside of Roof Detail**

The roof felt on the underside of the roof was found to be in generally excellent condition, although a few small tears were recorded which may allow access to a void between the external roof slates and the roof felt from

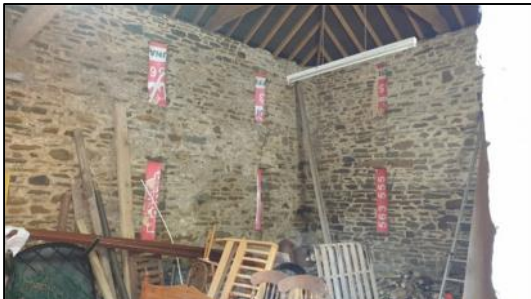
**Figure 17 – Well-sealed Windows (NW)**

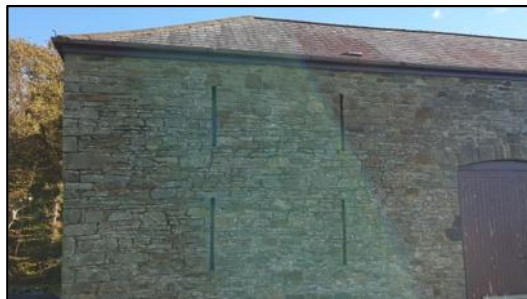
**Figure 18 – External view of Sealed Windows (NW)**

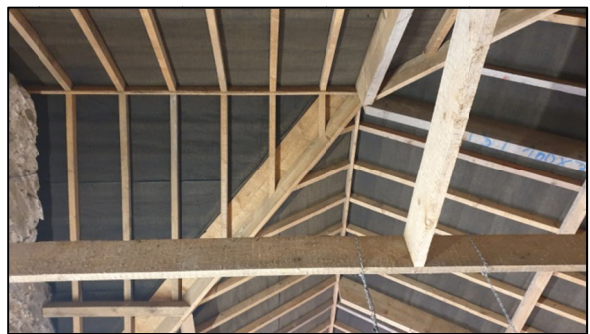
A number of roosting features were noted, including; horizontal rafters, purlins and ridge beams used to support the roof – suitable for free-hanging and void-dwelling bats, small gaps where beams adjoin the masonry of the building which may be suitable for crevice-dwelling bats, connections between ceiling joists, rafters and areas below the rafters, and small holes and gaps above the extent of the masonry of the walls of the building interior. All cracks and gaps were inspected thoroughly for any evidence of bat use. No evidence was recorded in or around these areas, and similarly no evidence of bat use was recorded throughout the entirety of the building.

**Photo 4** – Roof Detail with Roosting Features

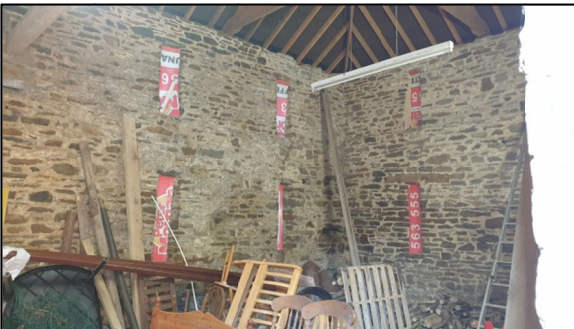
**Photo 7** – (NW) Corner of Room when Strip Lighting Turned on. Plastic Sheeting used to Block the Slit Windows is Visible, Tightly Sealing the Windows

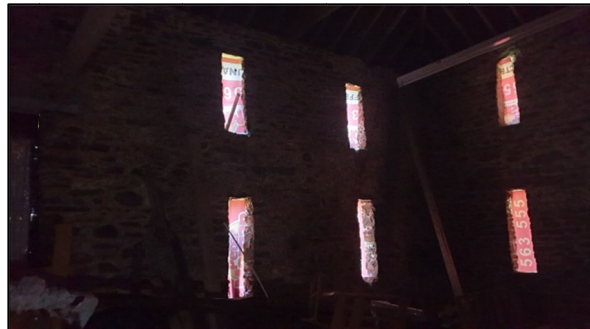
**Photo 8** – (NW) Corner of Room when Strip Lighting is Turned off. Some Natural Light can be Seen Entering via the Translucent Plastic Sheets

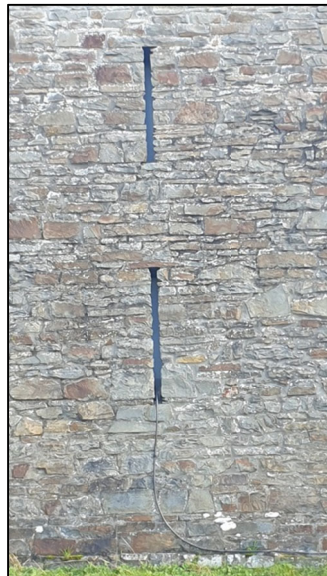
**Photo 10** – Slit Window Detail with Internal Plastic Sheeting used to Block Windows Visible

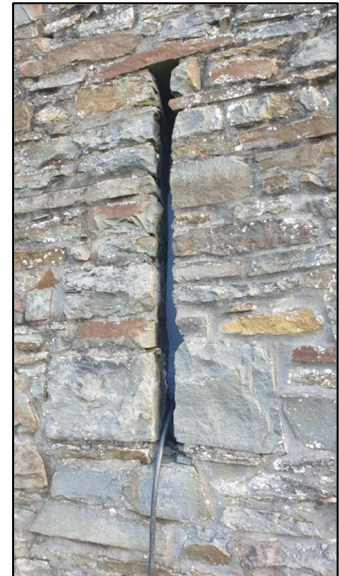
**Photo 11** – Closer view of Slit Window Internally Blocked by Plastic Sheeting

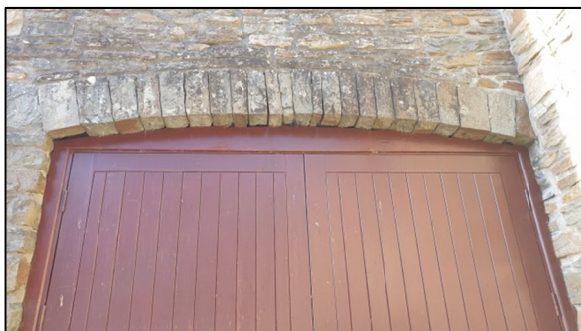
**Photo 12** – Small gaps between stones of Semi Circular Arch above (E) Barn Door Visible

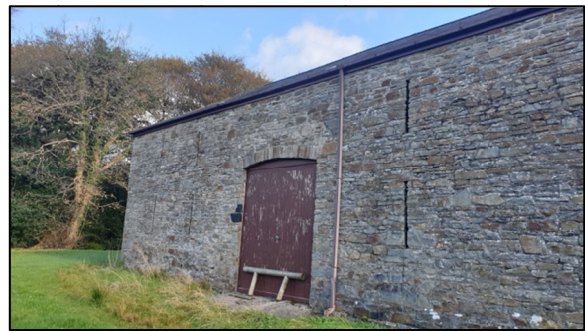
**Photo 13** – (W) Aspect of the Building with Typical Example of Excellent Condition of Masonry

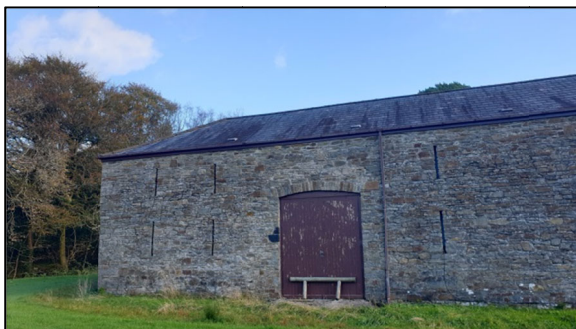
**Photo 14** – (W) Aspect of the Building Showing Excellent Condition of Roof Slates and Masonry

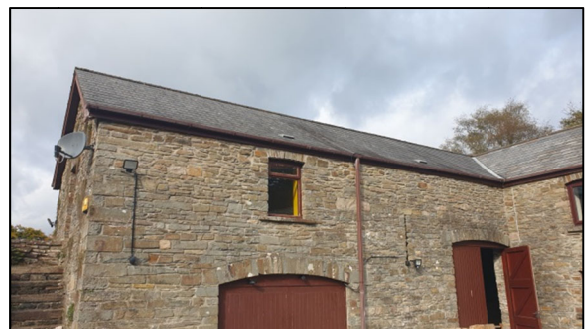
**Photo 15** – (S) Section of Barn with Dedicated Window and Double Door – Not Surveyed
