## Plaza, Port Talbot

### HERITAGE IMPACT STATEMENT

Prepared for: Neath Port Talbot County Borough Council

(385)1902-GWP-Rev 01

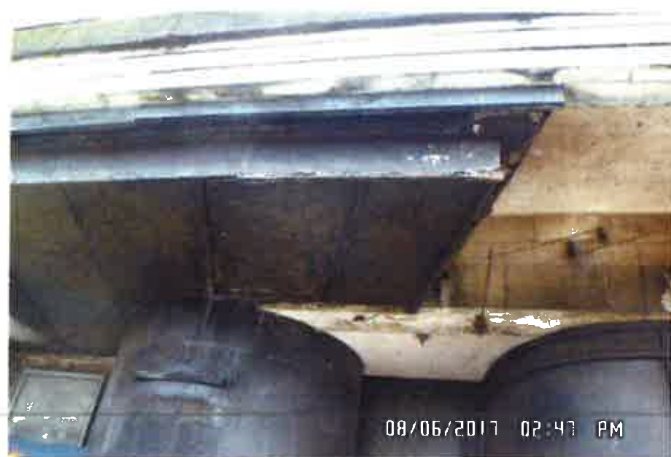
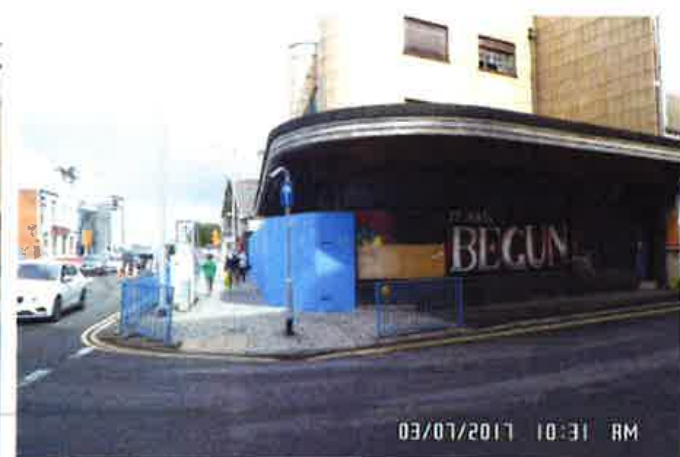
**Concrete Canopy (front elevation):** There were badly corroded steel soffit panels, support trims and metal work hanging loose which posed a risk to the public walking below. The area has now been fenced off with 8ft solid timber hoarding to prevent access under the canopy. See photographs below:

Loose/corroded metal soffit panels (June 2017) Pavement hoarded off below (July 2017)

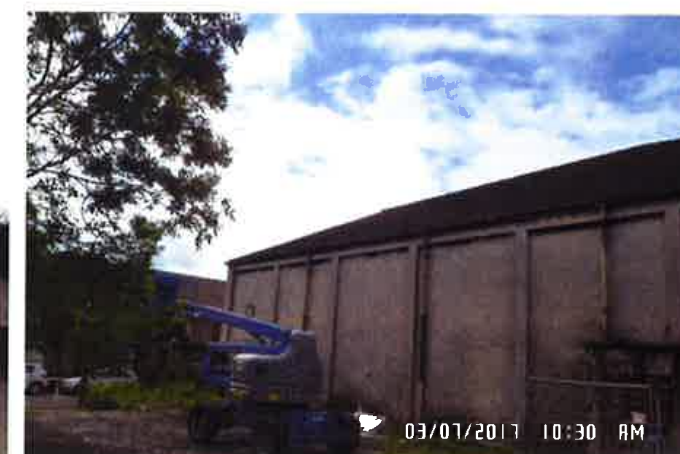
**High level asbestos cement guttering:** The guttering along Eagle Street was clearly overgrown with moss and vegetation. In one area it looked as though the guttering was sagging under the weight and if this were to fall onto a member of the public below it could cause serious injury. As a result the gutter has now been cleaned out and checked for damage including its support brackets via MEWP. The contractor has given assurances the gutter is secure. The rear and opposite side gutters were also cleaned and checked for damage. Whilst not immediately adjacent to a public highway they still pose a risk and a small length of guttering to the rear and side elevation had to be removed. See photographs below:

Overgrowth in high level gutters (June 2017) Overgrowth removed via MEWP (July 2017)

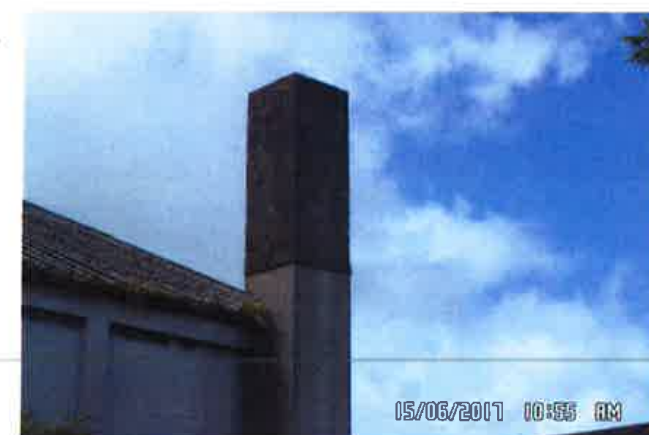
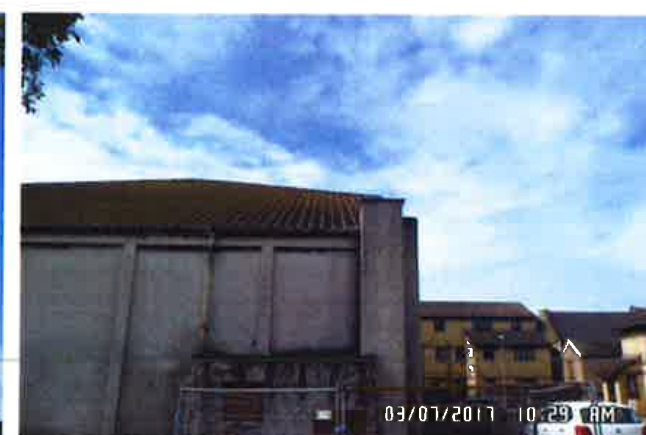
**Rear Chimney:** The chimney was clearly in a state of disrepair in 2012 and it was recommended to be reduced in height to a safe level in the J&N report. The chimney had deteriorated and looked extremely unstable and could potentially fall into the parking area outside the side boundary. There was a clear danger so the decision was made to remove the chimney down to a safe level. This work has been carried out and approximately 1.5m of the top section of chimney has been taken down. Refer to photographs below:

Rear Chimney cracked and leaning (June 2017) Top portion of chimney removed (July 2017)

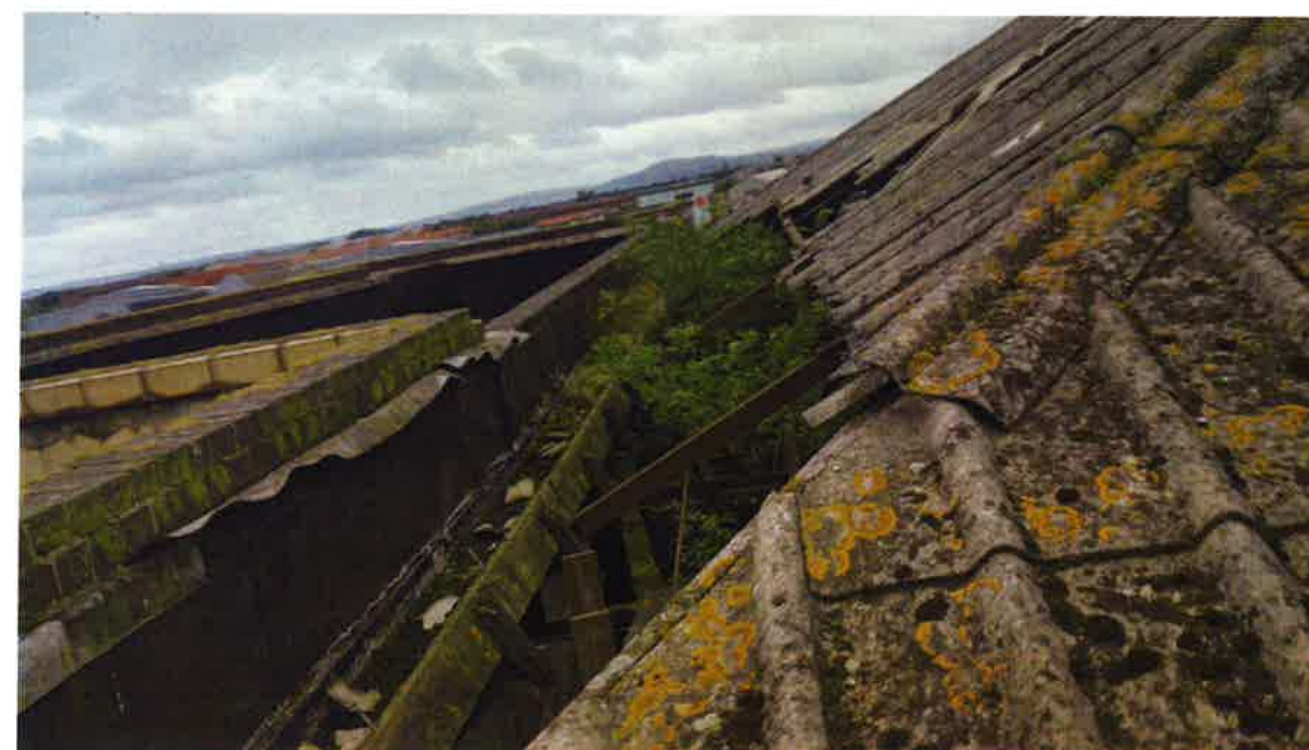
Broken section of asbestos cement roof sheeting, exposed steel trusses (rusted) to the elements (Photograph taken from MEWP July 2017)

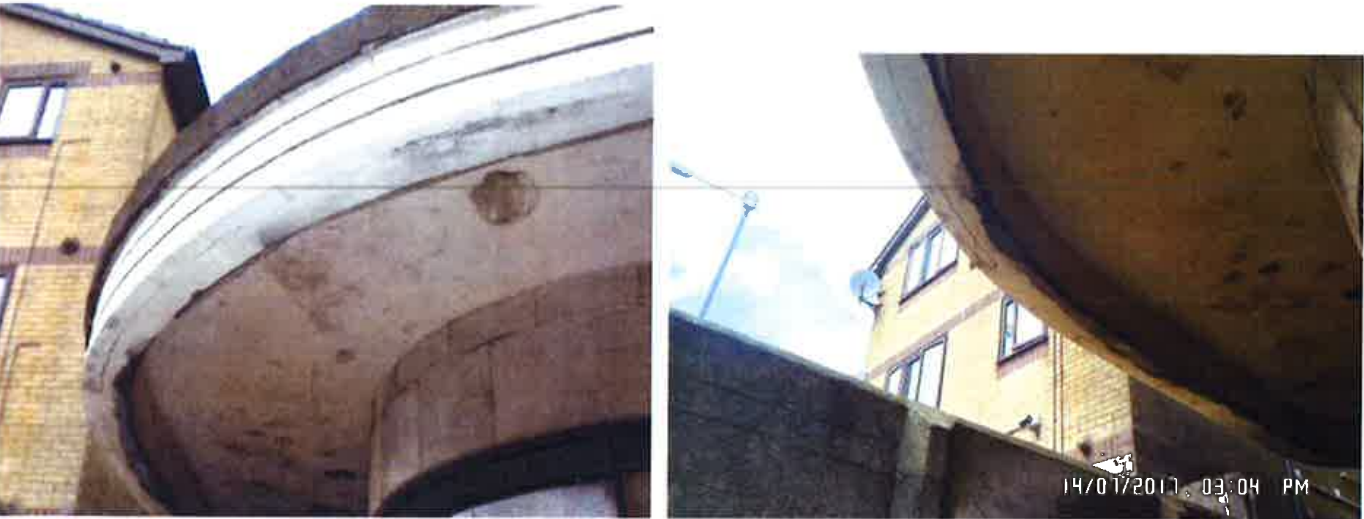
Front Canopy, town end (2012)

The exposed concrete soffit does not appear to have any additional areas of localised spalling compared to the 2012 report. There was approximately 1m of spalling along the curved down stand edge (town end) identified in 2012. Having looked at this area it appears that the edge fillet of concrete has been pushed out further by the corroded reinforcing bars within. Refer to photographs below:

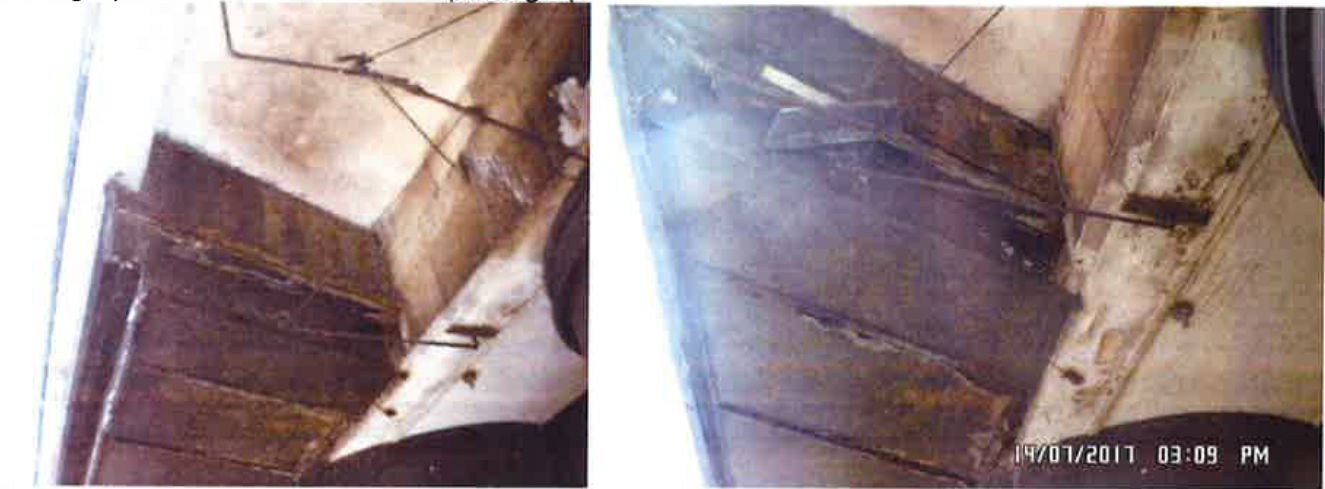
There is significant deterioration of the metal panels hung from the soffit which are badly corroded and delaminated around the edges including their support members. There is a corroded steel fascia section approximately 0.2 x 0.4m hanging dangerously loose that is not present on the 2012 report photograph for this area. Refer to photographs below:

Corroded metal soffit panels (2012)

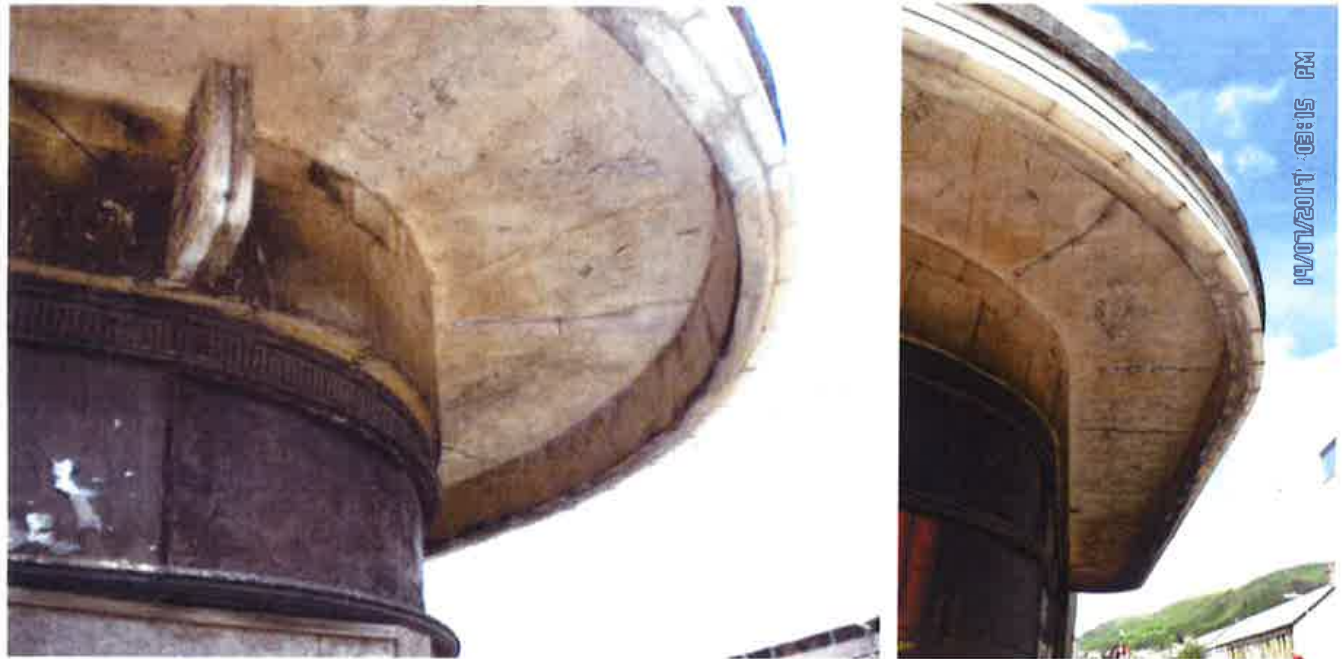
There does appear to be a few additional hairline cracks radiating around the soffit on Eagle Street and what appears to be additional calcium carbonate stalactites hanging from the cracks in comparison with 2012 photographs for this area. Refer to photographs below:

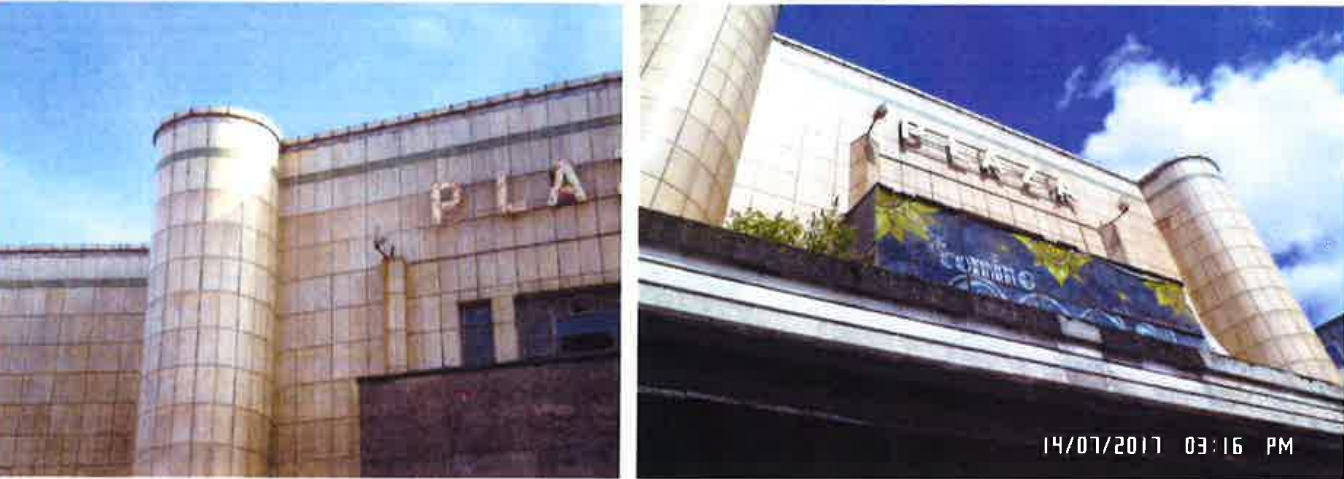
The 2012 report made no mention of any defects to the tiles, however, it did suggest a detailed inspection would be required to assess if they still had adequate bond to the wall. During our inspection it was noted that a section of tile has fallen from the RHS curved portion of the elevation. This has shown that the bond has failed locally and water ingress behind could affect the tiles immediately local to this in future. Refer to photographs below:

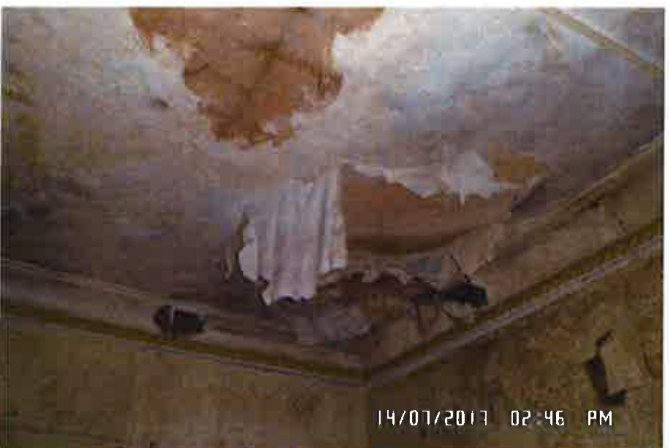
Cracked ceiling slab/damp, July 2017

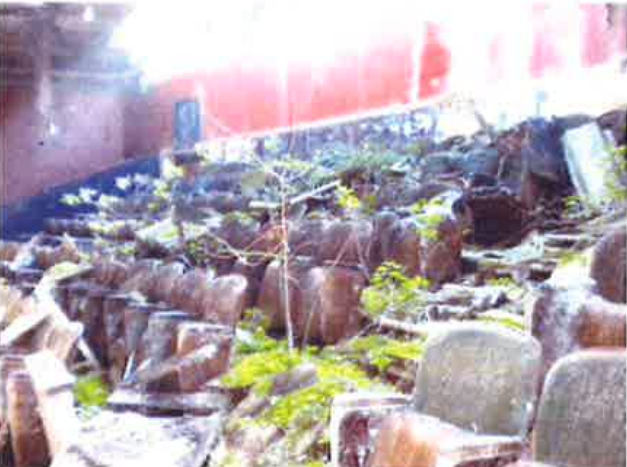
The projection room and balcony were not inspected as it was deemed to be dangerous to enter these areas due to the extent of dilapidation and excessive build-up of pigeon droppings over the years. We managed to gain access through to the main auditorium at ground level and the vegetation that was noted as growing from the balcony seats in 2012 are now fully grown trees that extend up towards the broken roof sheeting and beyond. The trees also appear to be directly adjacent to the front wall to the auditorium structure. Whilst this wall has not been inspected the tree/vegetation roots may have caused damage to the wall. See photographs below:

2012 vegetation over seating

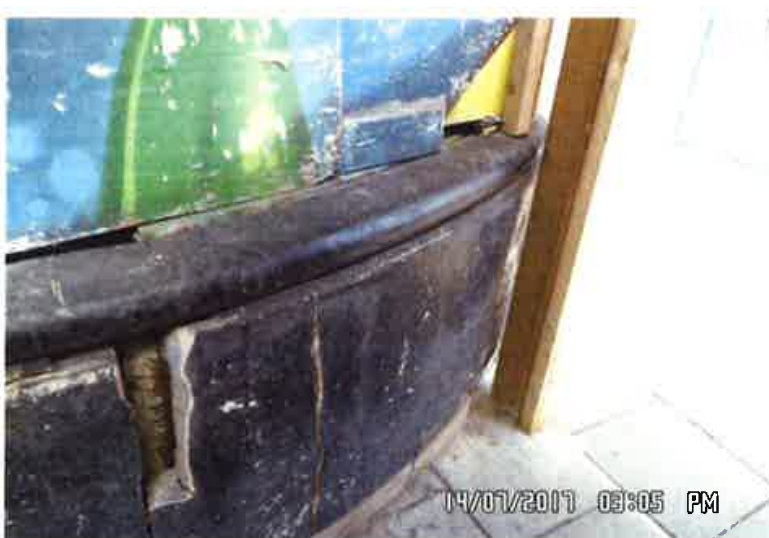
Additional cracking July 2017

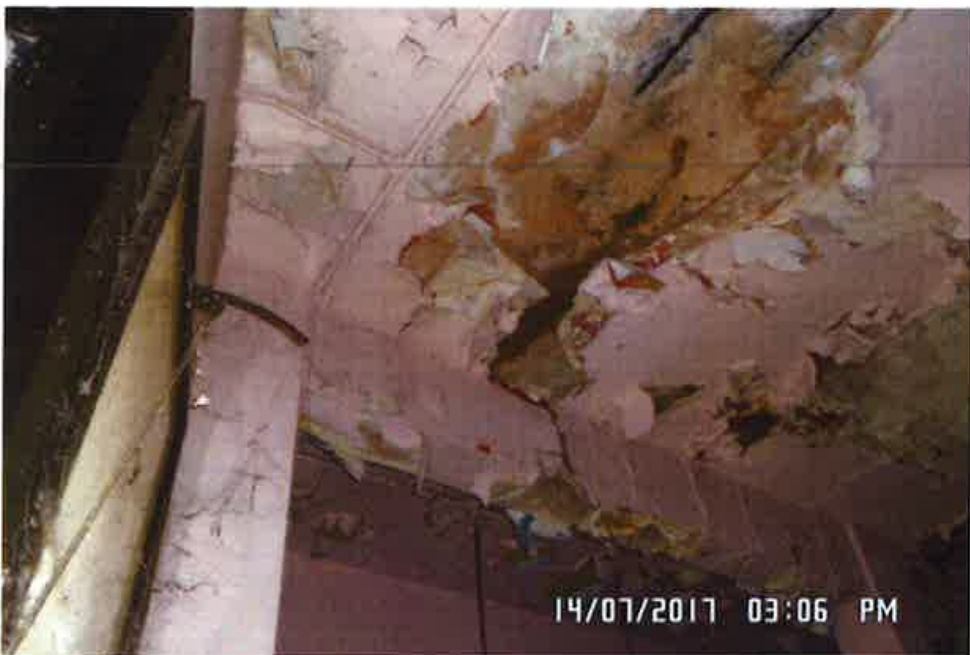
Likewise with unit 1 there are hairline cracks with water penetration to the soffit of the slab in two areas with algae staining and exposed corroded reinforcement. The paintwork is also looking in a much poorer state than the photographs on the 2012 report. Refer to photographs below:

July 2017 indicates clear evidence of water penetration through hairline cracks

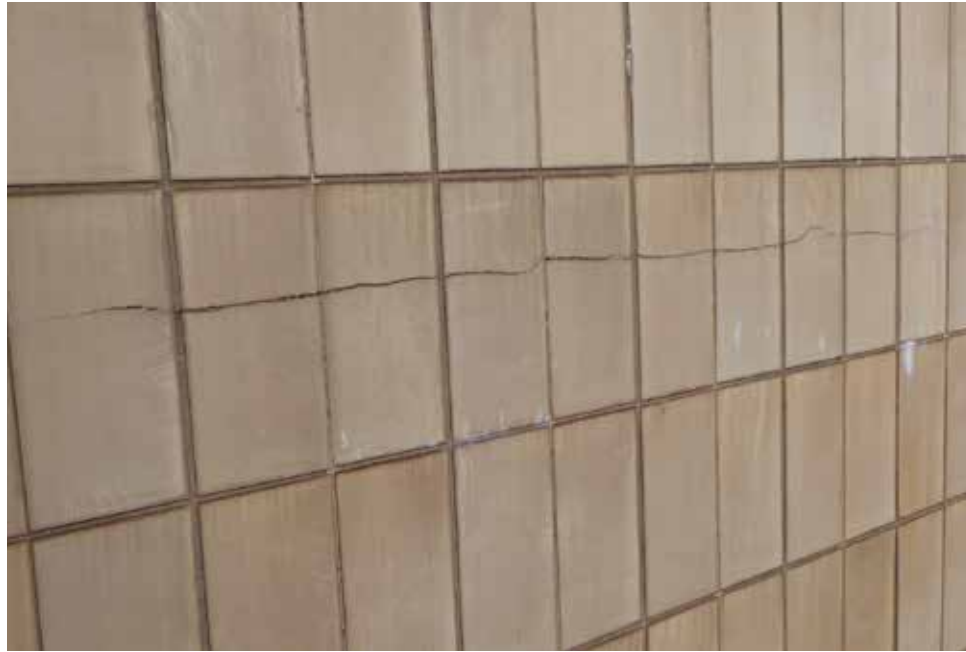
**A Cracks in Faience Tiling**

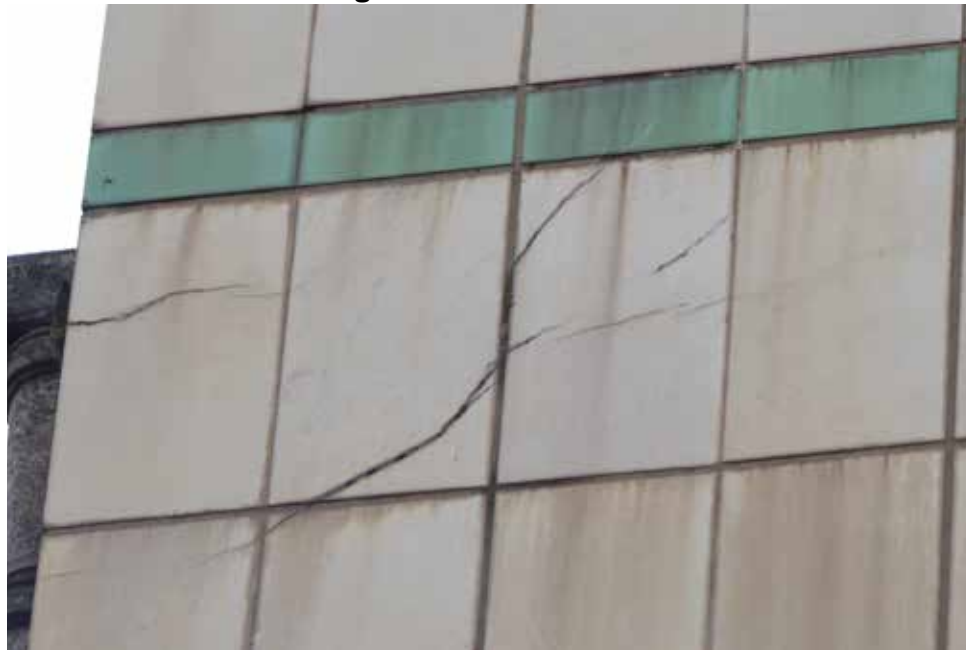
**A Cracks in Faience Tiling**

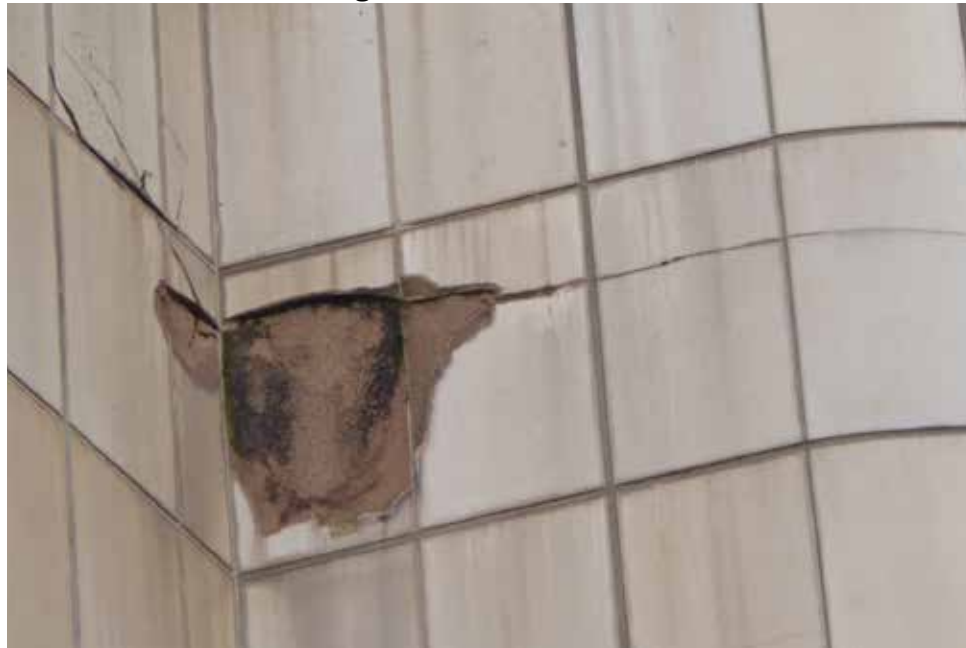
**B Faience Tiling probably needing replacement**

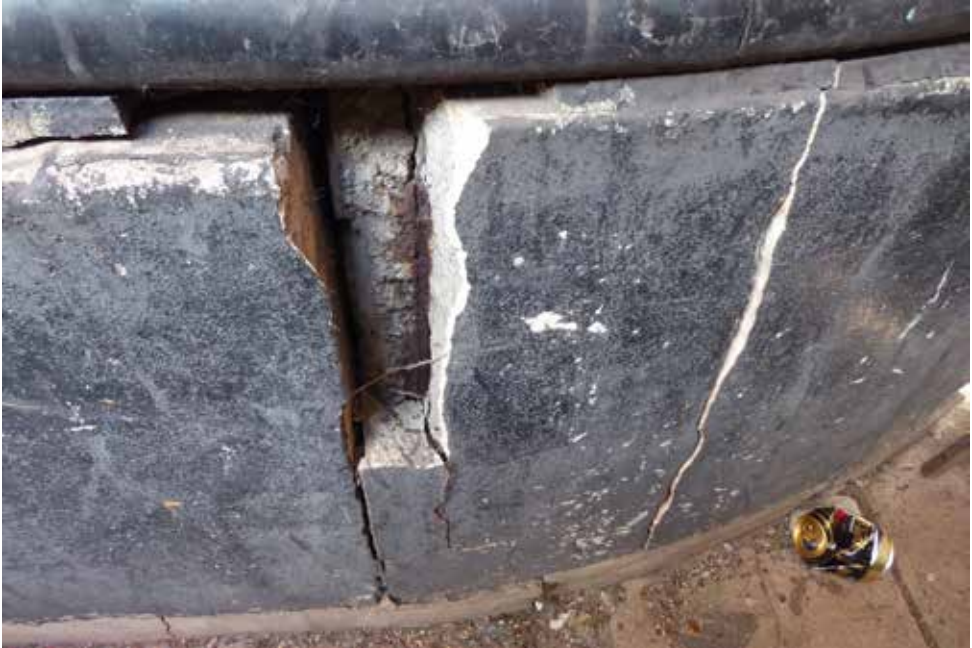
N Example of Damage to Masonry

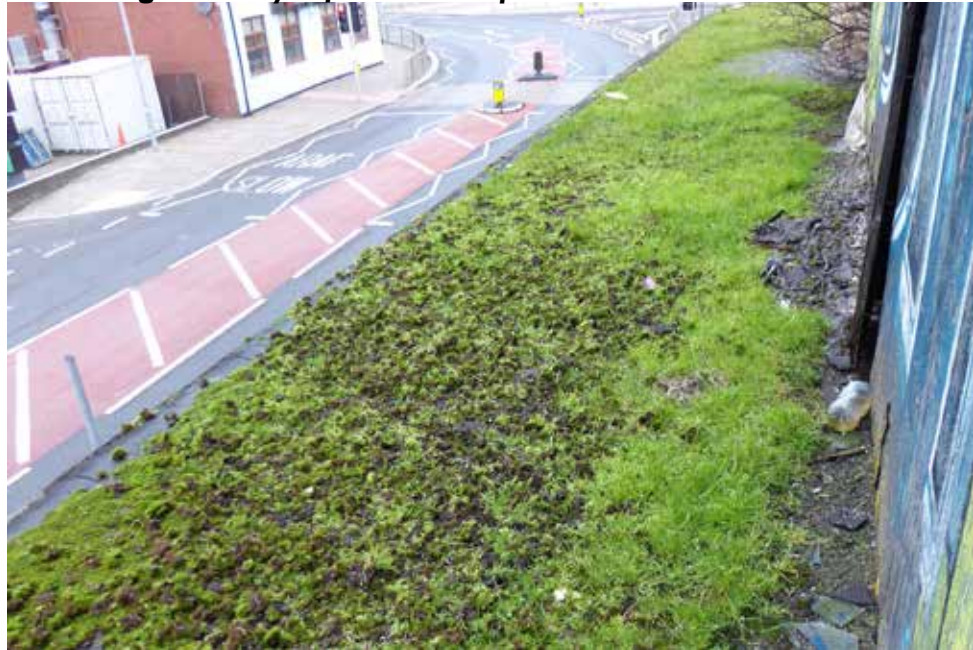
Canopy Bitumen Felt Roof. In very poor condition. Proposal: to be taken up & Re-applied. Dress new felt covering down front of fascia, as existing. At top / edge, form 50mm timber chamfer to drain water away from edge & back to roof. Area in centre to be made internal & carpetted.

**S** Canopy Bitumen Roof to be Replaced

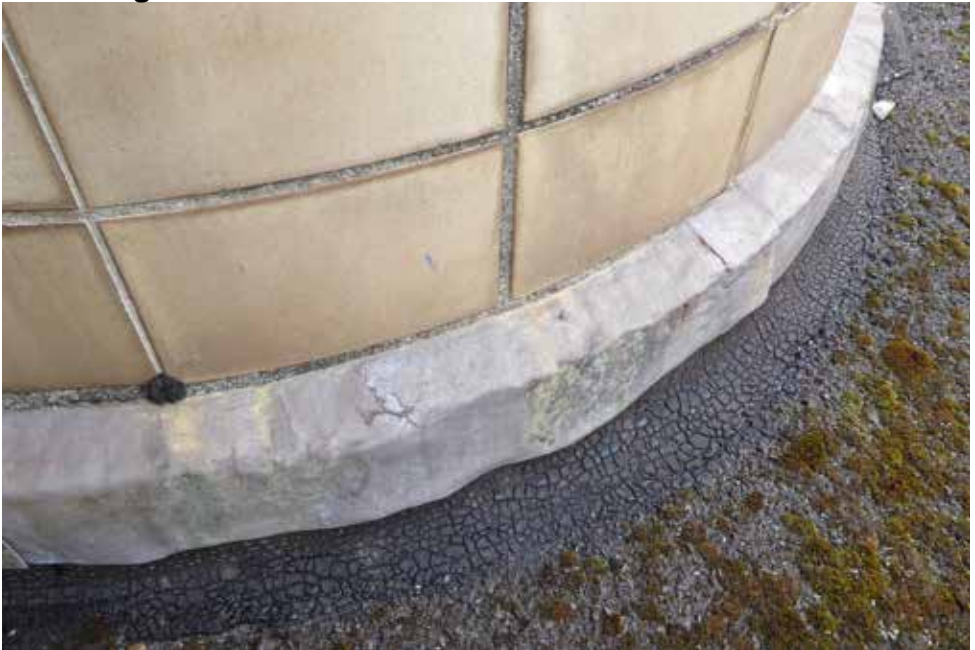
**Y** Lead Flashing at base of faience tiling

- Y Lead flashing at base of faience tiling, dressed over flat bitumen roof, damaged in areas. Removal of lead could damage faience tiling, so proposal is to dress new roof finish under lead, chased into bottom joint, & patch repair all damaged areas to lead flashing in situ. [YX = damaged to lead flsahing]
