## Understanding the Heritage

## Explanation of Proposed Interventions

**STRUCTURAL OBSERVATIONS** *(Taken directly from Ateb Consult's structural survey dated July 2021)*

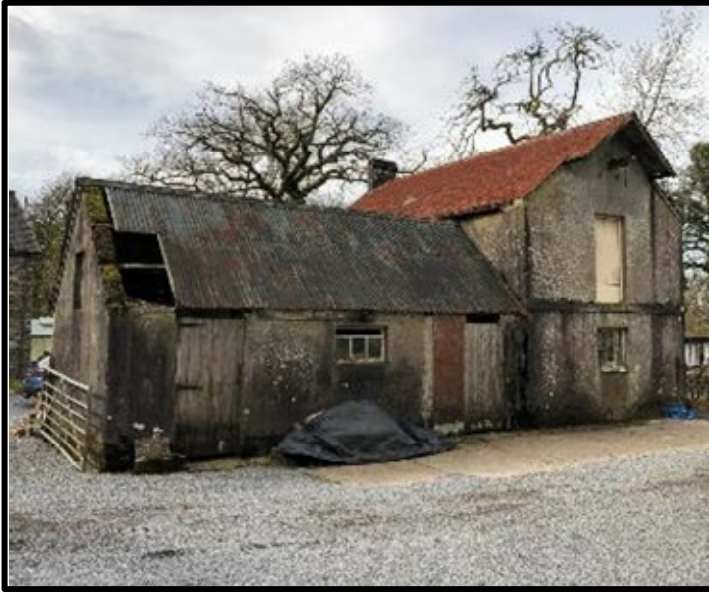
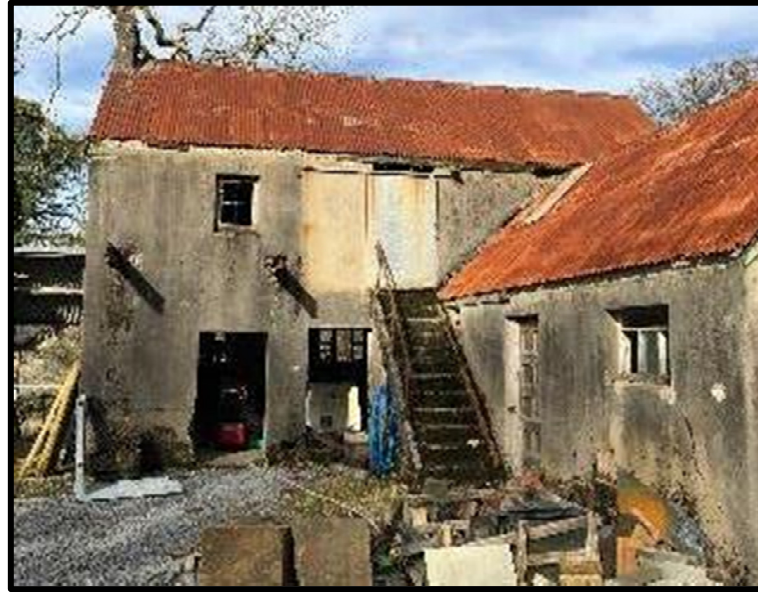
**Top Left & Top Centre :** North Elevation & East Elevation (respectfully) demonstrating the structure's dilapidated condition, including missing roofing sheets & timber weather boards & damage to concrete walls

- The corrugated roof finish is in a very poor condition and will need to be completely replaced.
- The timber roof structure will be retained where possible, even if this is serving an aesthetic purpose only.
- A number of doors and windows are completely missing leaving just the openings. The remaining timber windows and doors still in position are in very poor condition and will need to be replaced.
- The balustrading to the external stairs is rusted, and its design does not meet current building regulations, and will therefore need to be replaced.
- Some later steel additions will need to be removed.
- The concrete ground floor is in very poor condition and will need to be replaced. Some areas of the existing slab have interesting channel markings, and it is intended that some areas of the slab are carefully removed but retained to create an external patio area.

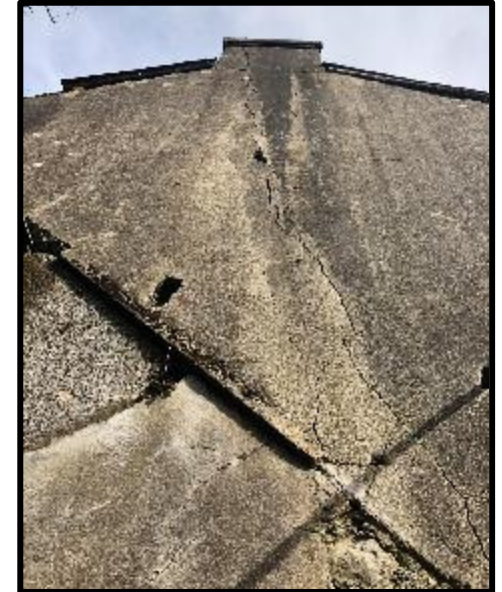
structurally stable and considering their age and lack of maintenance, Whilst the cracking is limited in places, there is a large vertical crack in one elevation that also needs local rebuild and recasting of a section of wall to tie all together. At other crack locations it is recommended that specialist stitching is introduced with stainless ties used to tie the original walls together and a compatible concrete mix used to seal the cracks. A detailed drawing / survey and specification should be drawn up for implementation.

**Top Right:** Large crack in gable end wall

- Specialist concrete repairs to the existing walls to tie across the main cracks in the building so as to maintain integrity. Localised concrete repairs to any other areas of 'non-structural' damage.
- Underpinning of the external corner where there is evidence of past subsidence
- Timber survey to establish which timbers can remain and treated and which timbers need to be taken out
- Provision of a new ground floor slab / raft tied into the walls at floor level to form a sub-floor and lateral tie / plate holding all together at this level
- New internal timber frame with ply sheathing and insulation introduced off the new ground slab and ties into the existing concrete walls so as to afford support, with new timber first floor and repaired roof structure taken back to the timber frame to take loads off the original concrete walls.

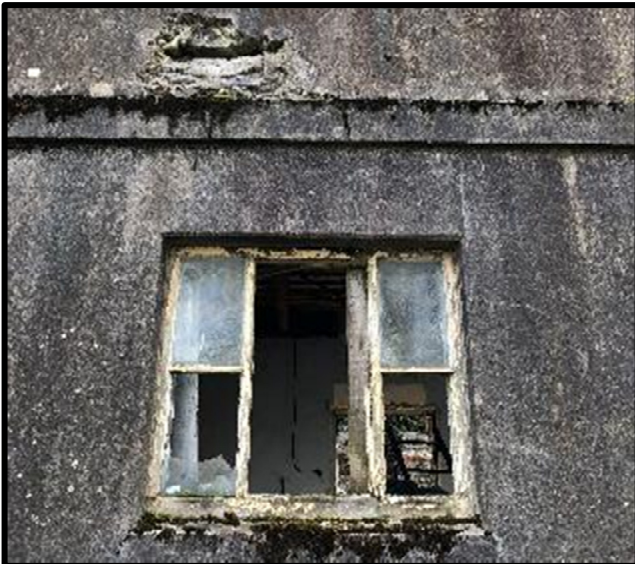
The walls to the barn building are in mass concrete, with window and door openings formed. The windows and doors where present are in timber and show signs of rot and decay and woodworm. These would need replacement with similar style timber windows. The external walls whilst having cracks present in them do however appear

**Bottom Left.** Decayed ground floor timber window, typical of the condition of most of the outbuilding's windows

Existing doors and windows will be replaced with new treated timber frame designed to reflect the original designs.

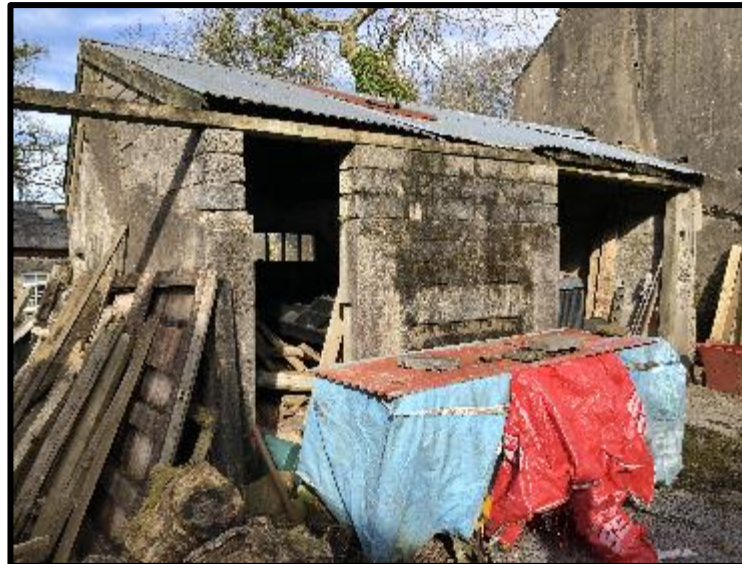
**Bottom Centre:** South Annexe – originally constructed as pigsty and crudely altered to create additional storage

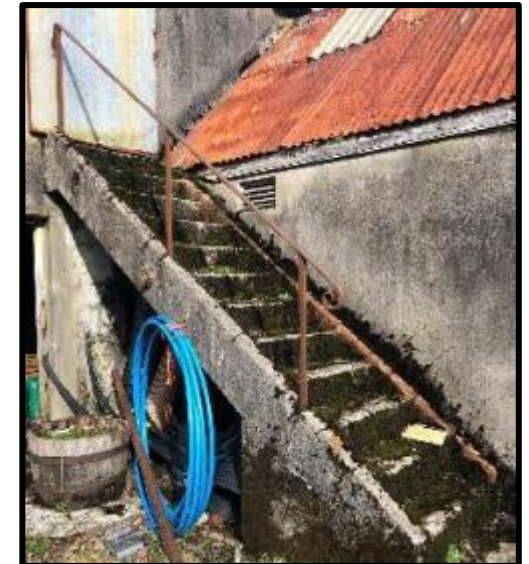
The external concrete staircase appeared in reasonable condition and suitable for reuse, subject to local concrete repair and introduction of handrailing and balustrading.

**Bottom Right.** Existing external staircase

The existing external concrete stair will provide access to the first floor holiday flat. Due to its current condition, the existing balustrade will be replaced with a new PPC steel design.

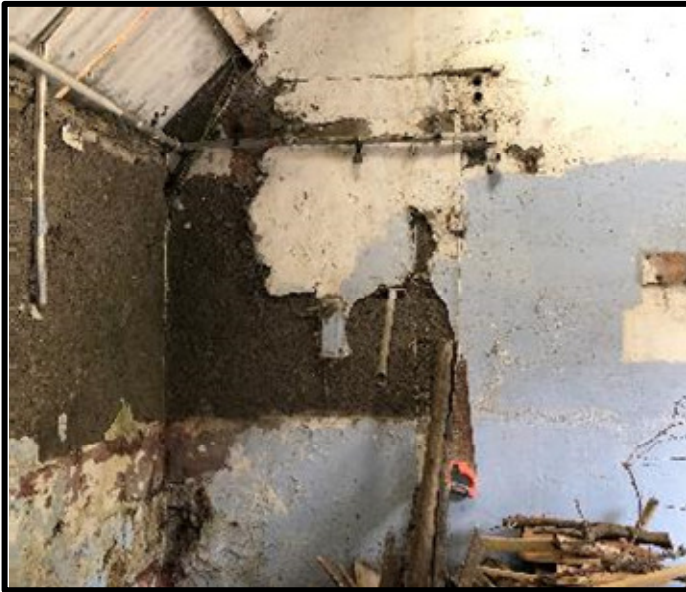
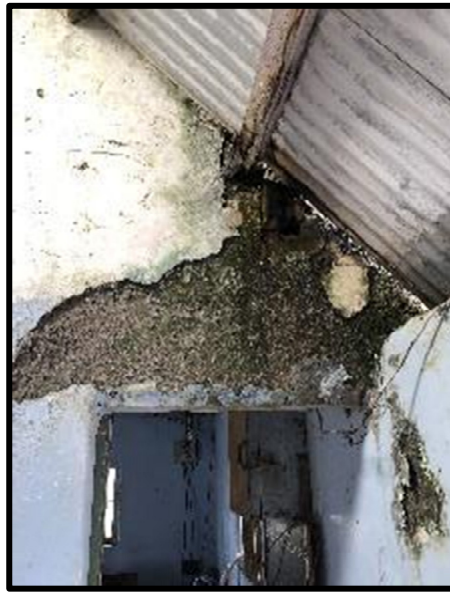
**Top Left:** current condition of internal plaster  
**Bottom Left:** Existing mid-late 20th timber floor

**Top Centre:** current condition of internal plaster  
**Bottom Centre:** water damage to existing floor boards

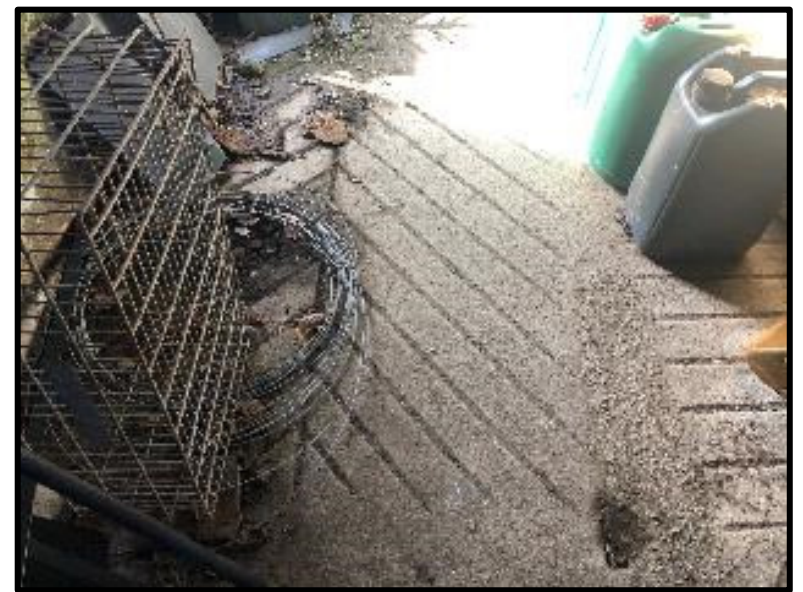
**Top Right:** Drainage channel markings within concrete floor slab  
**Bottom Right:** Timber roof structure (to be retained where possible)

The existing concrete ground floor will be broken up and removed. Areas of existing floor with interesting channel markings will be retained for future use externally. A new insulated concrete ground floor will be constructed to finish level with existing door thresholds.

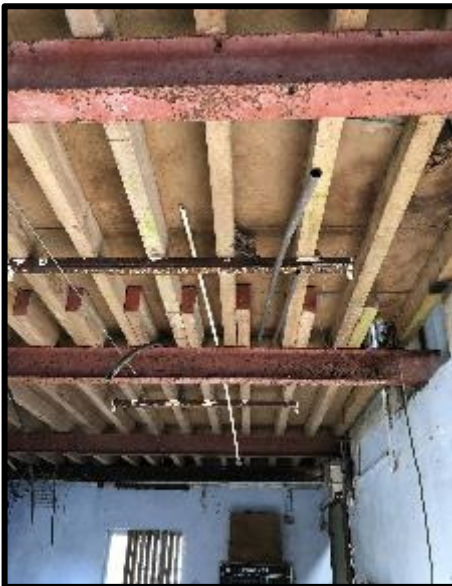
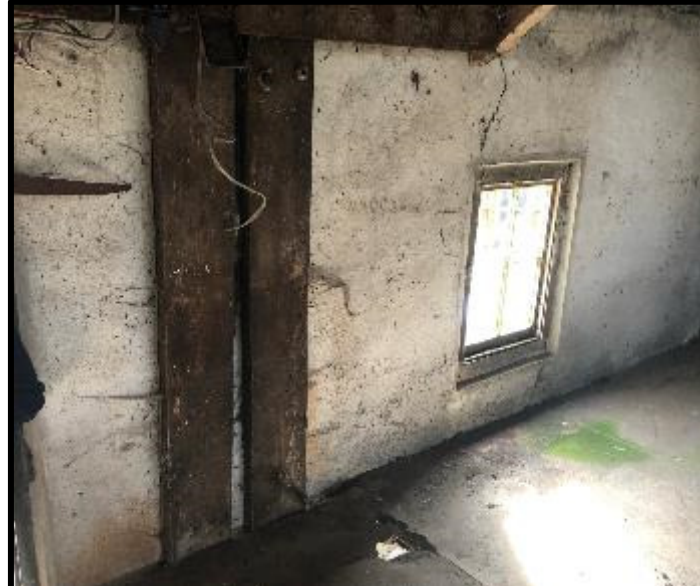
The first floor area is of timber construction, carried off timber and in places steel beams. The floor areas where access was possible were not in good condition and areas of rot and distress observed. New floors would be needed in a rebuild as the existing floors are not structurally sound and would not support the proposed imposed loads

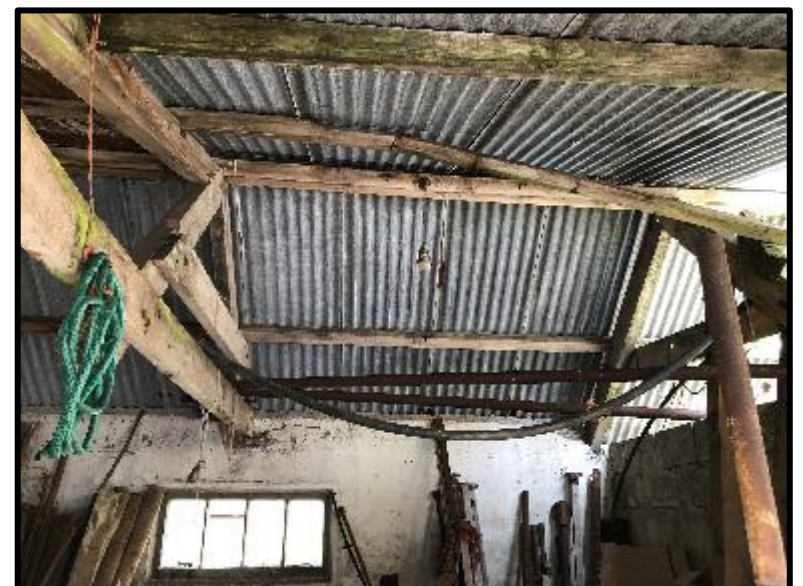
The roof structure to the barn consists of timber A frame trusses that carry timber purlins that also span onto the gable walls. The trusses and purlins carry metal corrugated sheeting. The roof sheeting is in relatively poor condition and would not be suitable for incorporation into a conversion scheme. The roof's timber trusses appeared in reasonable condition considering their age [they do not however appear as being original] and subject to timber rot and specialist survey could possibly be made good where necessary to carry a new roof.

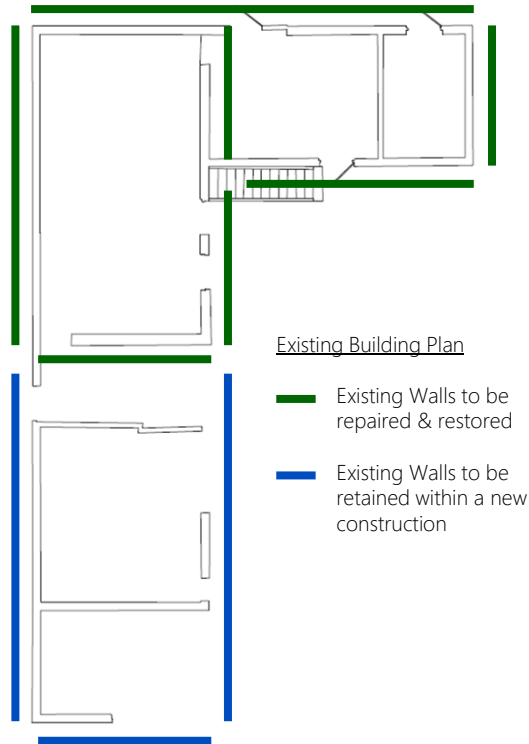
The existing concrete walls will require an element of repair works including infilling of holes, gaps and cracks which have developed over time. The internal and external surfaces will be cleaned of any organic growth and loose objects removed.

*Photograph of existing typical façade to be restored highlighting necessary repair, cleaning and recoating*

The primary elevations where the existing walls are largely intact (as highlighted on the plan shown here) are intended to be restored to their original appearance externally, and will be subject to specialist sub-contractors proposals for water proofing and final re-coating. Internally new timber walls will be constructed to support the new upper floor and roof construction and lined with plasterboard.

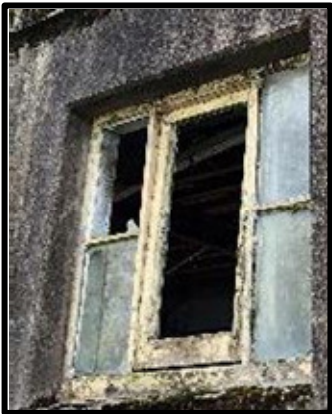
The existing windows are to be removed as in their current condition they are considered to be beyond reasonable repair.

Photographs of existing typical timber windows which have deteriorated considerably and are deemed beyond reasonable repair

The replacement windows will also be timber frame and the new design will replicate the existing configuration as close as possible.

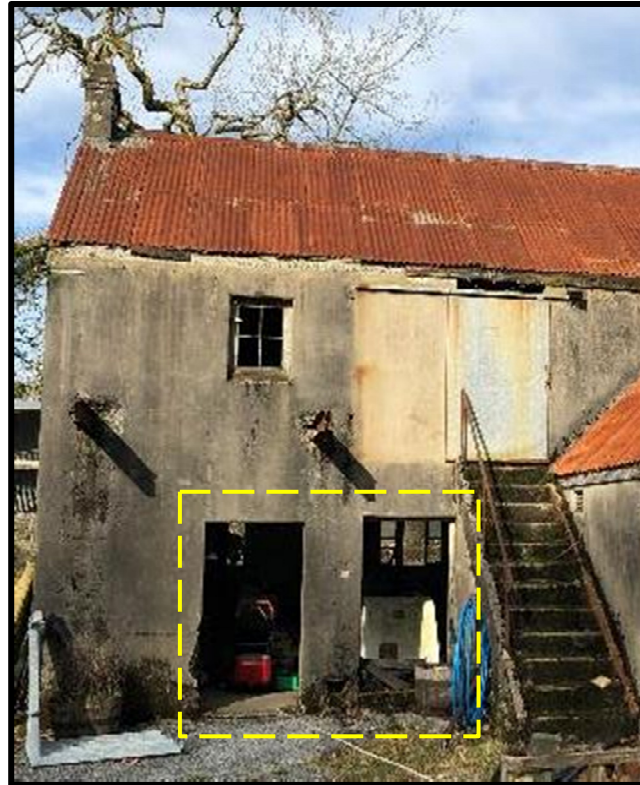
Photo of existing openings which do not currently have doors or windows within them

New windows which are to be positioned into existing openings that do not currently have a window or door within them (note below) are to be simple fixed aluminium frame windows. The frame will be partly concealed behind the check reveal and therefore appear as frameless glass within the existing opening.

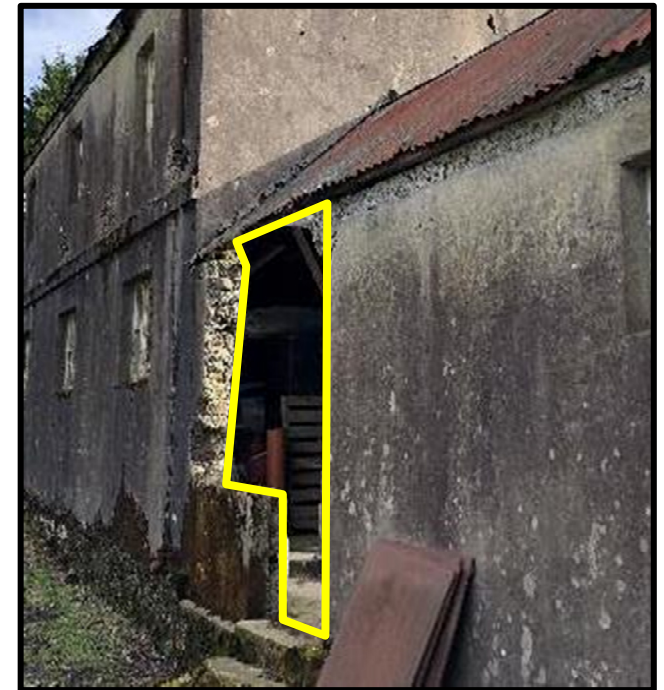
A large opening (above) has developed on the rear elevation following some partial collapse. A new glazed wall will be constructed behind the opening. The original partially collapsed structure will be retained in its current condition and appearance.

Photo of existing opening. New aluminium frame fixed window to be fixed behind and independently of the existing opening
