ARBORICULTURAL  
REPORT:

BS 5837 – 2012

LAND OFF MAESTY  
CANOL, BAGLAN

| Project: LAND OFF MAES TY CANOL, BAGLAN | | |
|---|---|---|
| <b>Document Number</b> | K069- Arb Report-V1.3 | |

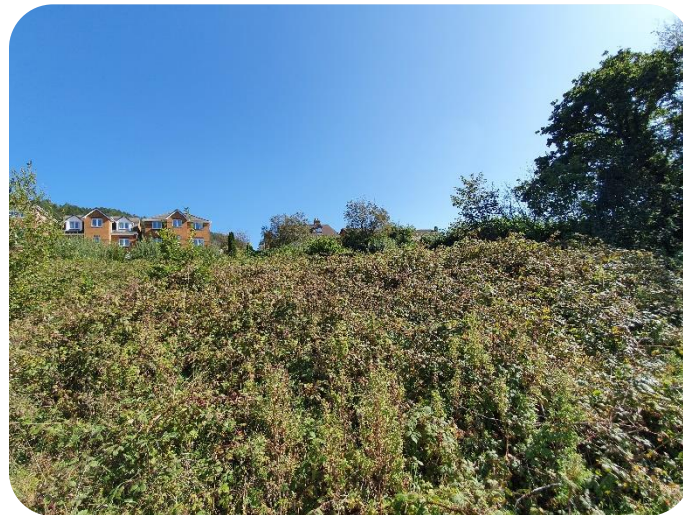
- 2.7 The site is dominated by vast areas of dense continues scrub and many parts of the site were inaccessible so most measurements, species identification and feature inspections were done at a distance with high powered binoculars.

*Picture 1: An example of the continues scrub on site which limited access for inspections.*

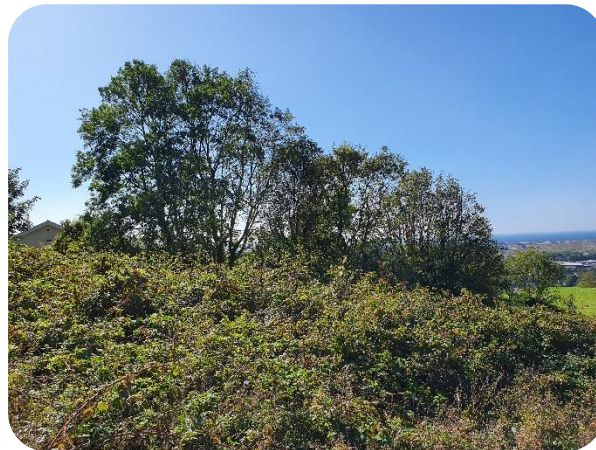
| Tree No | Tree Tag ID | Spp | Diameter mm | Crown Spread (m) | | | | Height (m) | Life stage | Remaining cont' | Category | Observations |
|---|---|---|---|---|---|---|---|---|---|---|---|---|
| Group 2 | | Category B2 | Small area of mature woodland. The woodland is limited in extent with most mature standards following the linear path of a previous hedge. The woodland is dominated by mature and semi mature ash, there are occasional immature oak, hazel, holly, sycamore and field | | | | | | | | | |

| | | maple. The understorey is dominated by continuous bramble scrub and. The mature trees have some suitability for bats and there is evidence of nesting birds within the wood, and the woods have the potential to be used by badgers. |

*Picture 2: G2 woodland, with linear structure.*

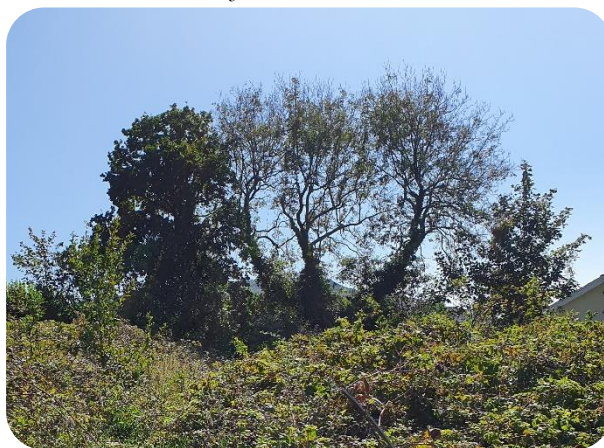
| Tree No | Tree Tag ID | Spp | Diameter mm | Crown Spread (m) | | | | Height (m) | Life stage | Remaining cont' | Category | Observations |
|---|---|---|---|---|---|---|---|---|---|---|---|---|
| 1 | 1276 | Ash | #300; 150; 300 | | | | | 16 | M | | U | The tree has ash dieback disease. Recommend removal. |
| 2 | 1274 | Oak | #500 | 7 | 6 | 2 | 6 | 16 | M | | U | The tree has sign of disease, with fungal growth on the trunk. Heavily impacted by neighbouring trees, has heavy lean. |
| 11 | 1264 | Sycamore | #110 | 3 | 3 | 3 | 3 | 9 | Y | 20-40 | C1 | Bowed trunk |

*Picture 3: Picture of T1, T2 and T11..*

- 3.6 As there is currently no design plan it is unsure at this stage which trees need to be lost to accommodate the development; however it is likely trees T1 and T2 will be lost to accommodate access, and G2 will be impacted by works.

- 4.16 A landscape plan will be drawn up. This will incorporate new planting sympathetic to the environment and to the benefit of the new development and the surrounding landscape. This will compensate for the loss of T1, T2 and likely G2.
