# ELBA CRESCENT, SWANSEA

## Tree Survey Report and Arboricultural Impact Assessment

JSL4233\_770  
Tree Survey and  
Arboricultural Impact  
Assessment  
-  
11 March 2022

## TREE SURVEY AND ARBORICULTURAL IMPACT ASSESSMENT

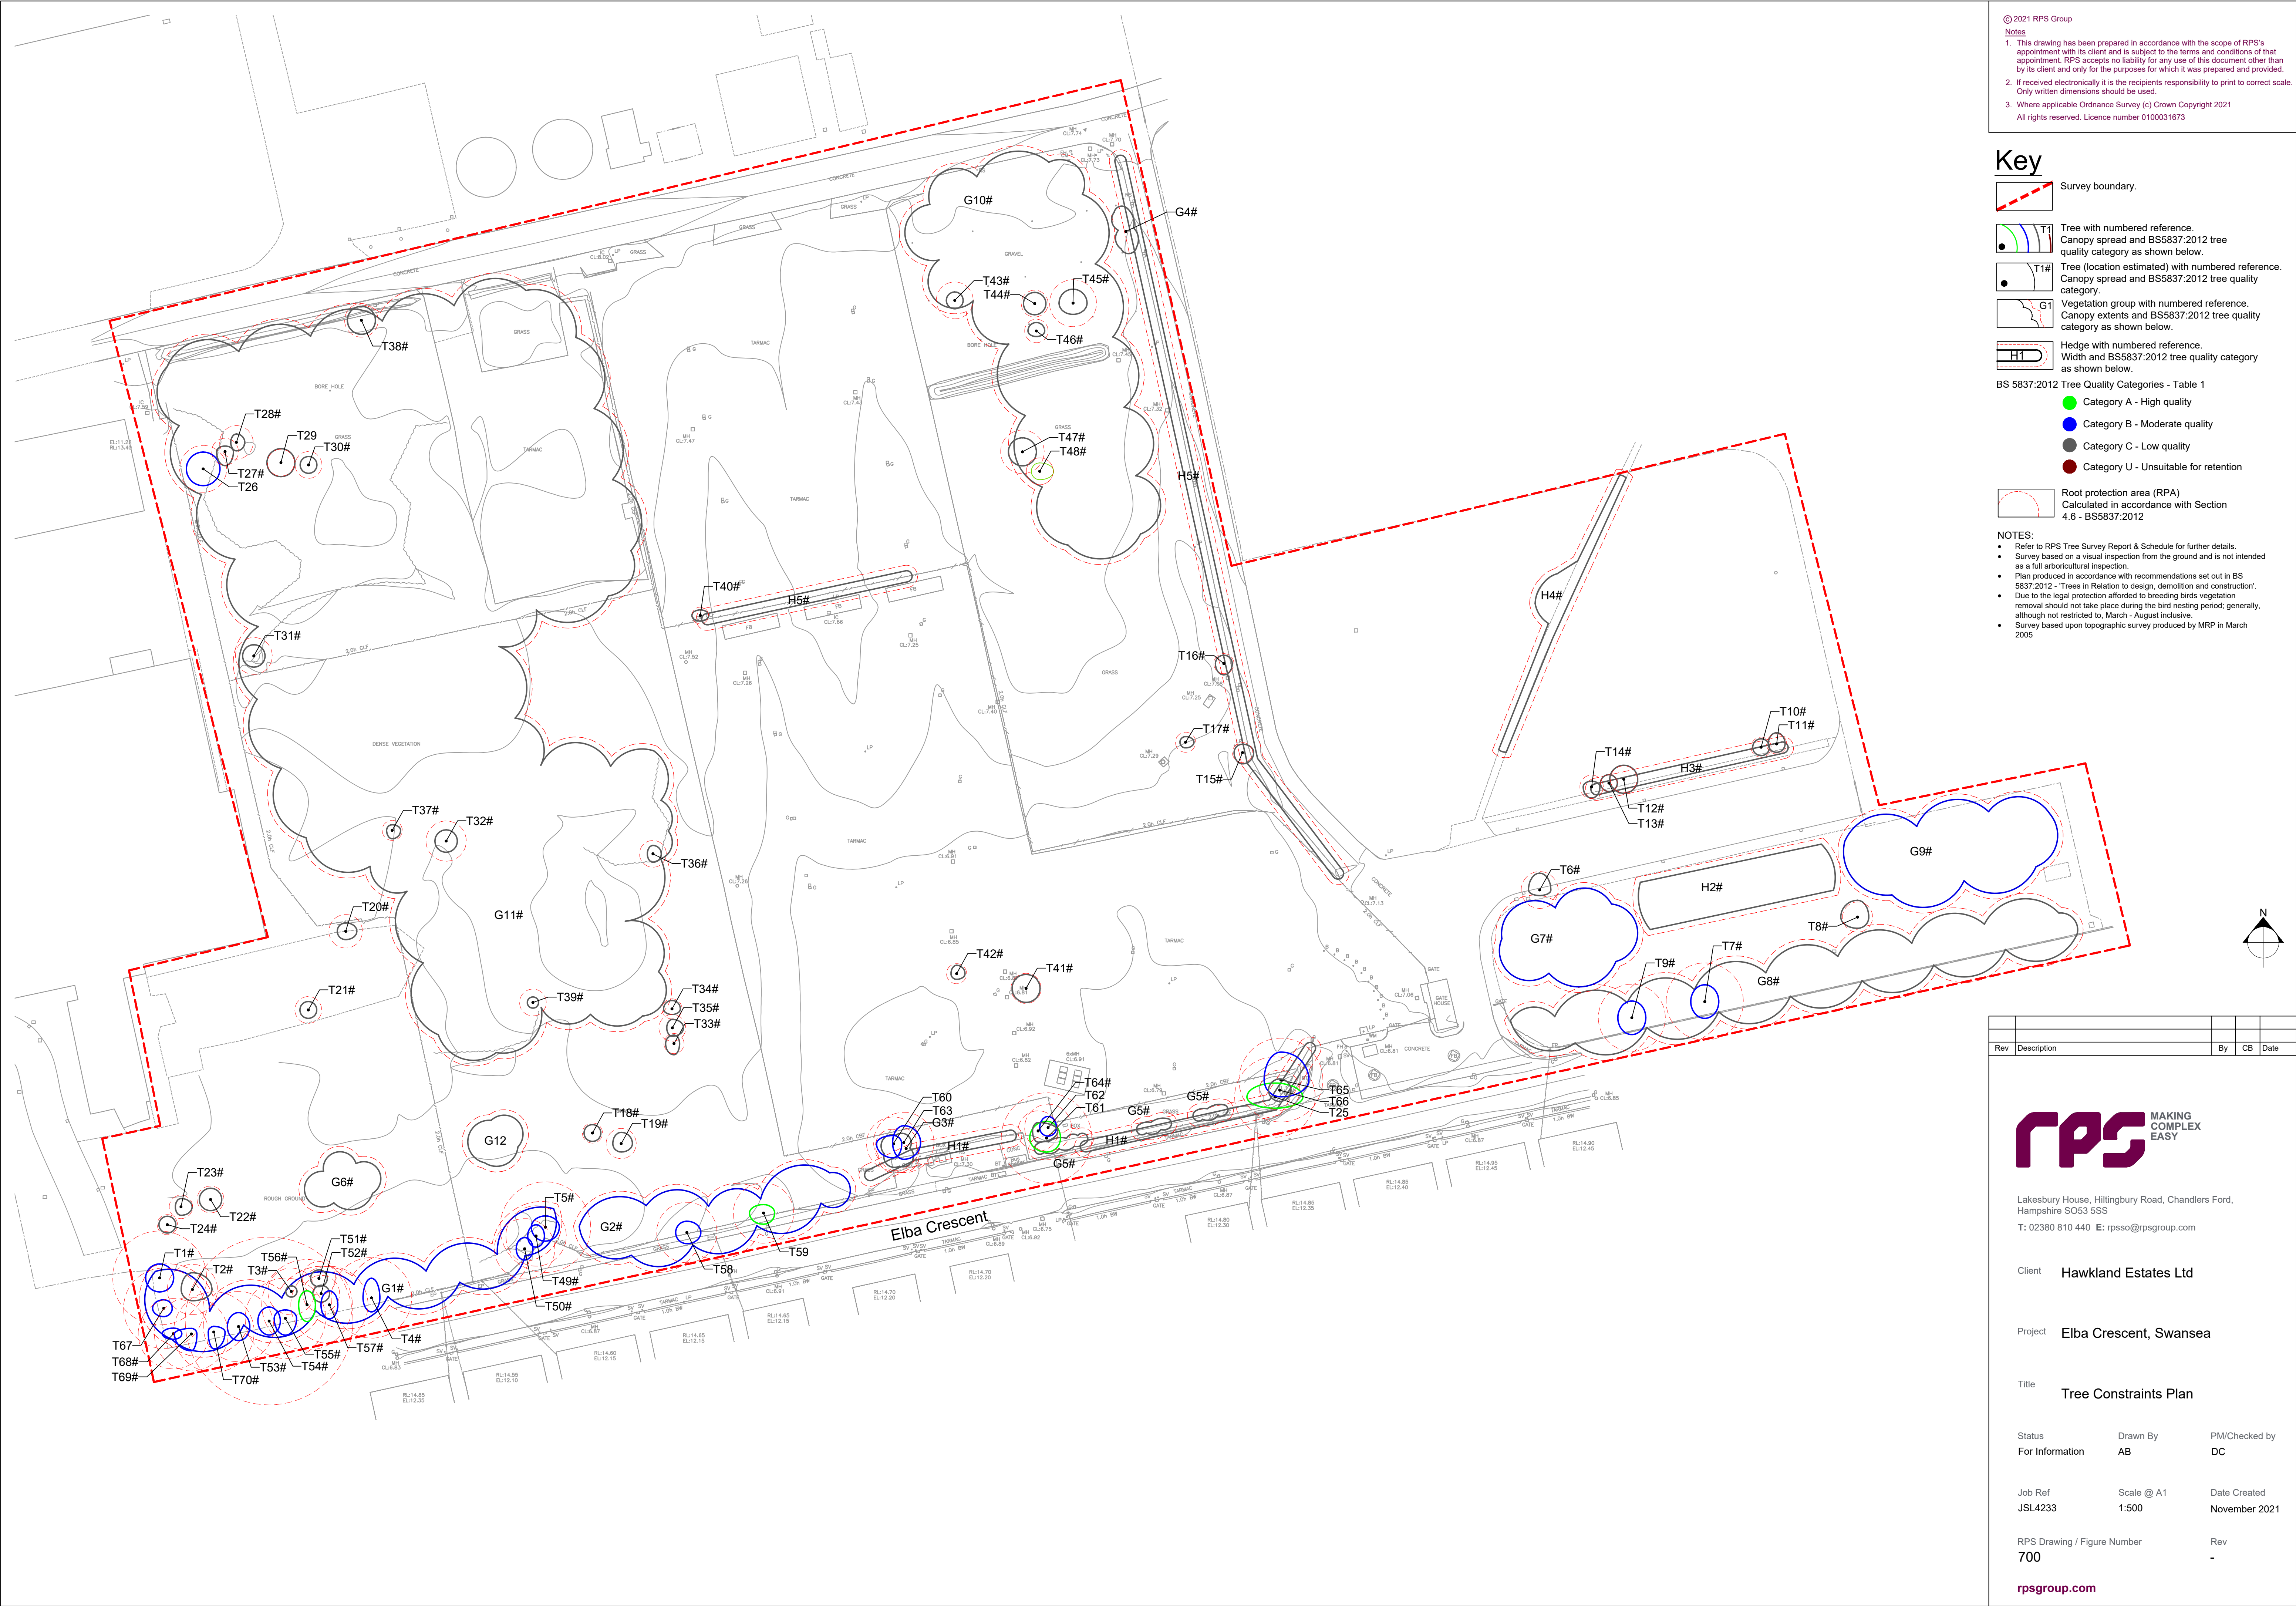
### Tree Constraints Plan JSL4233\_700

- 1.2 A tree survey of the application area was carried out by RPS on the 20<sup>th</sup> October 2021 and 21<sup>st</sup> October 2021, in accordance with the requirements of BS5837:2012. Refer to Tree Constraints Plan JSL4233\_700 (Appendix A). The weather was clear and dry.
