# BS5837 2012 Arboricultural Implications Assessment

R&J Metals  
The Docks Estate  
Briton Ferry  
Neath  
SA11 2HZ

Report by James Pinder Tech Cert (Arbor A)

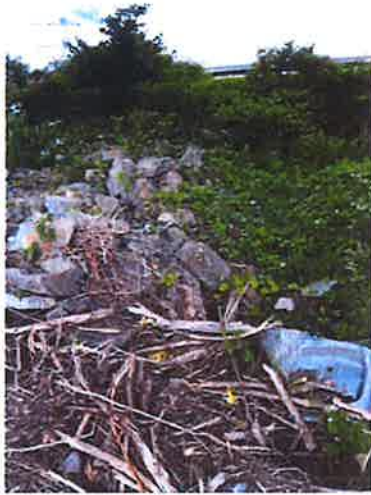
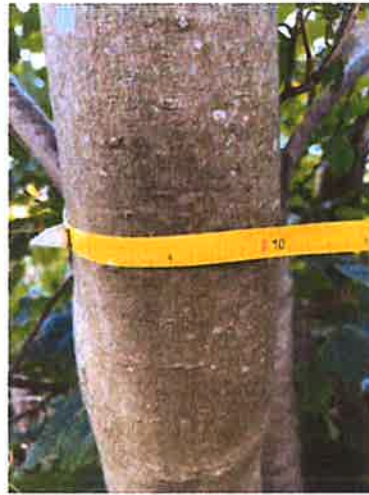
The above sycamore tree is located under the A48 in a rubble pile. Whilst its stem diameter is worthy of classification of 75mm or greater (BS5837 2012), the overall tree is very low value and will be lost in management of the site.

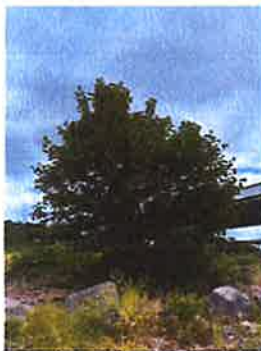
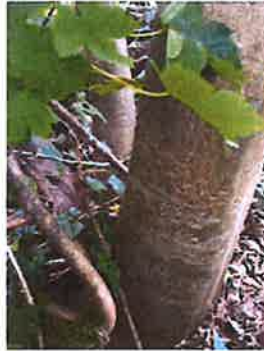
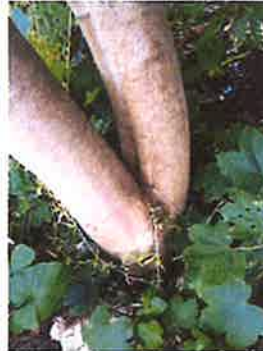
The images above show the second sycamore tree on site near the existing entrance. It is multi-stem suggesting previous control but it has no regrown within the rubble mound. This mound will need to be removed and with it the tree. The tree will not survive the rooting area changes around its location.

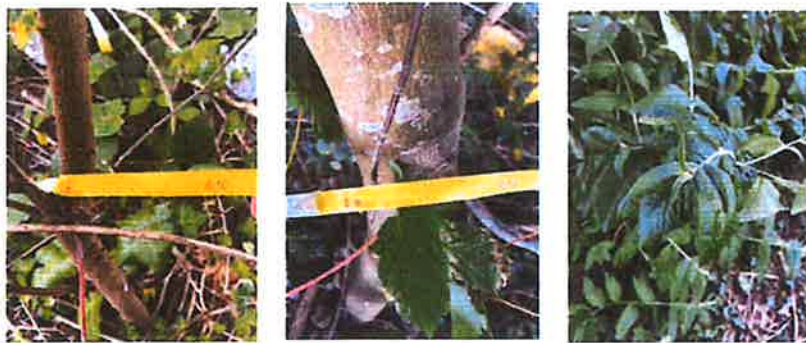
The above images show further small diameter sycamore stems and budleah plants.

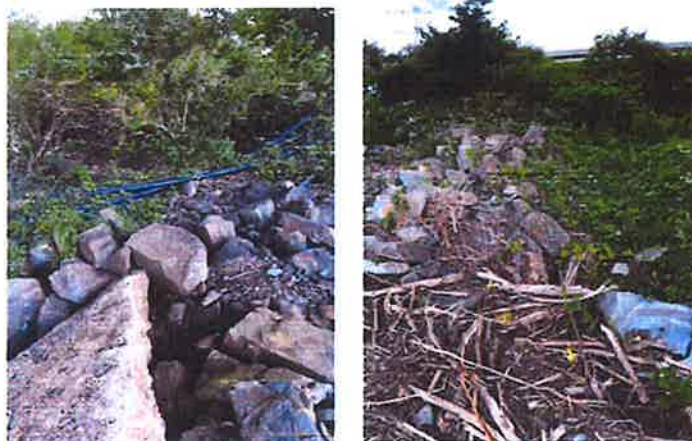
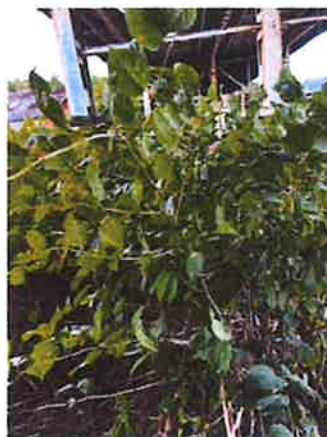
The images below show the general site rubble and Japanese knot weed presence.

Given no trees worthy of recording within a BS583 2012 survey exist on site or the proposed site boundaries, my suggestion is that the landowner carry out control of Japanese knotweed through chemical control whilst in full leaf summer 2022. Icade herbicide would be a suitable product to use via stem injection of moisture droplet applied. I would also advise that control of remaining weed species is advisable within the proposed site area using Round Up Pro Vantage 480 mixed at suitable rates to control the species present. The initial recommended vegetation controls will enable far easier marking out and site clearance in relation to the proposed project.
