## Land between Cwmavon and Dan y Bont

## BS5837:2012 Tree Survey and Arboricultural Impact Assessment

October 2021

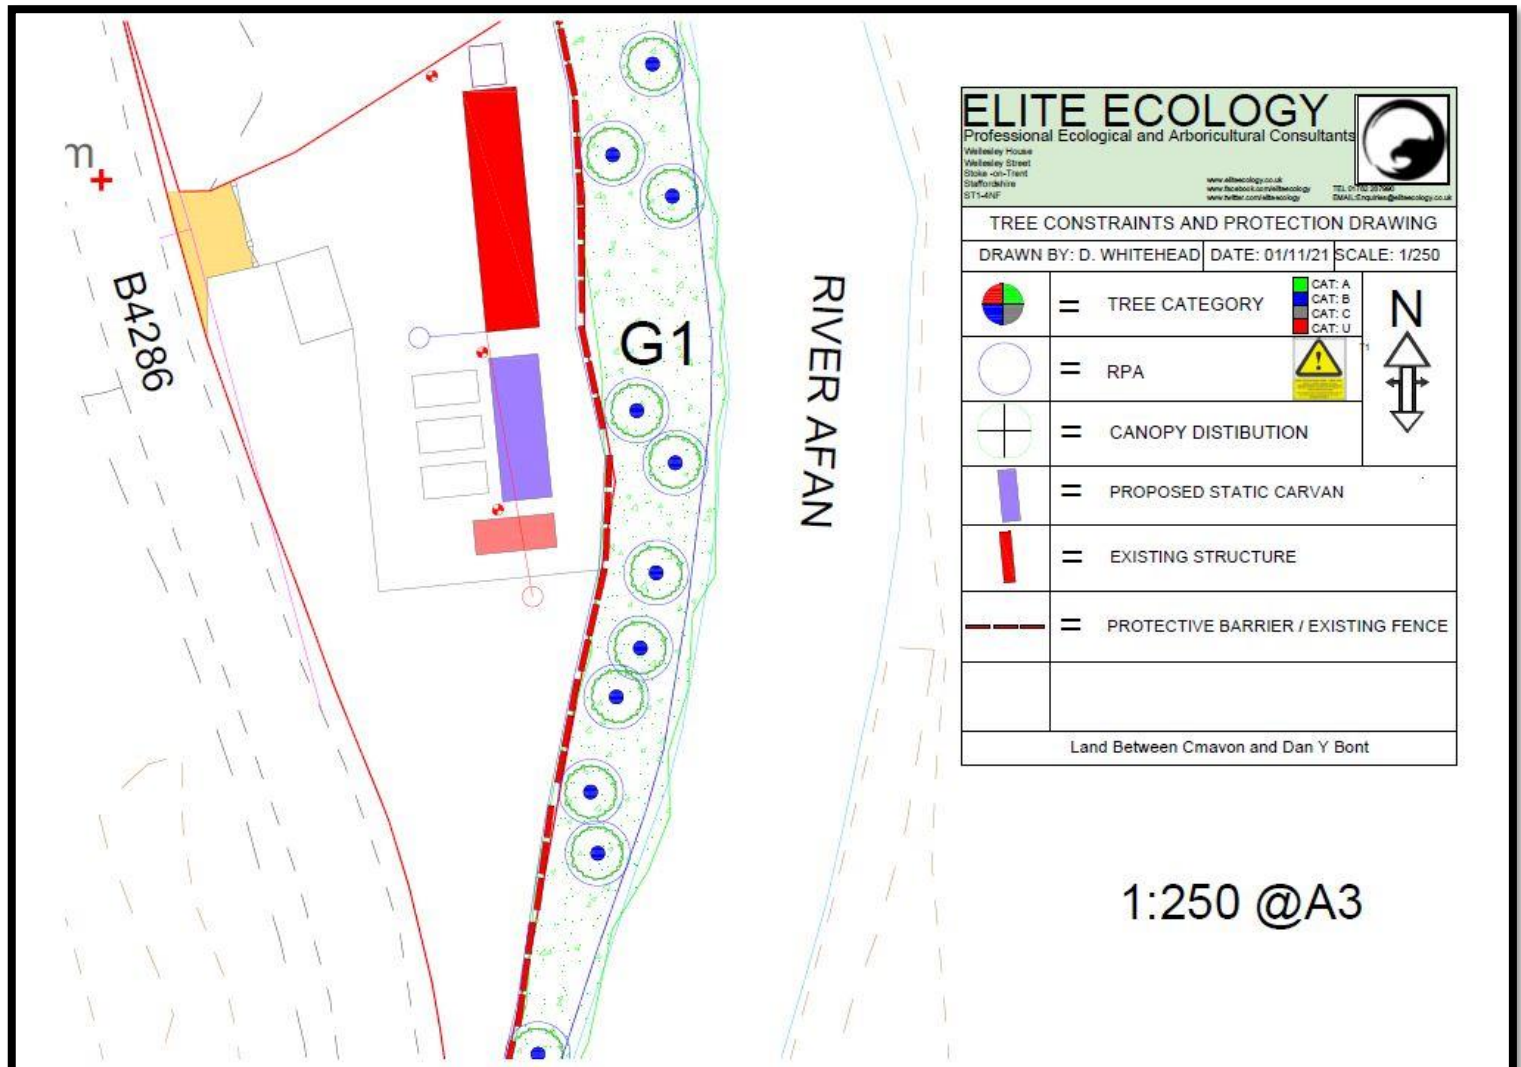
**Appendix A: Tree Constraints and Protection Drawings**

A suitably robust “Heras” type fencing is recommended for the protection of the main stems. The recommended location for fencing is shown as a red dashed line on the tree constraints drawing.

Prior to any demolition, or construction activities commencing, the recommended and suitable protection barriers should be erected and set out around the root protection areas as shown in the tree protection plan. Checks should be made to ensure that these have been suitably erected and are of sufficient construction to provide the necessary protection from the demolition and construction activities. These protective fences should not be removed until construction is fully complete.

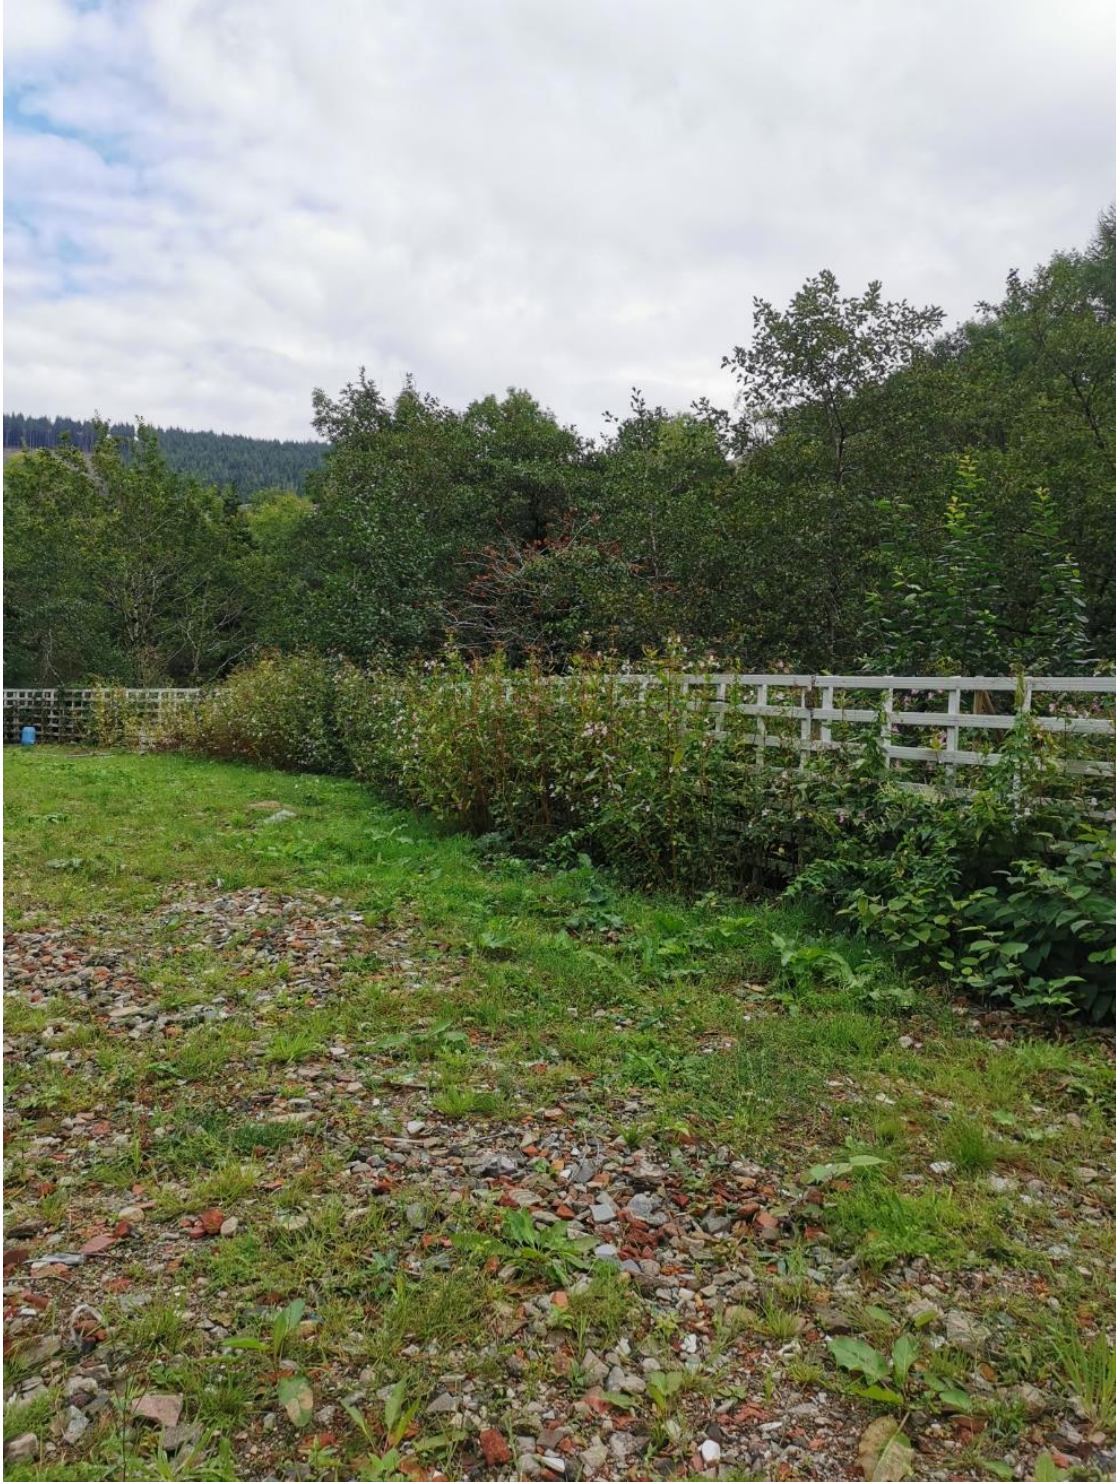
**Plate 1:** Existing fence line with G1 behind.

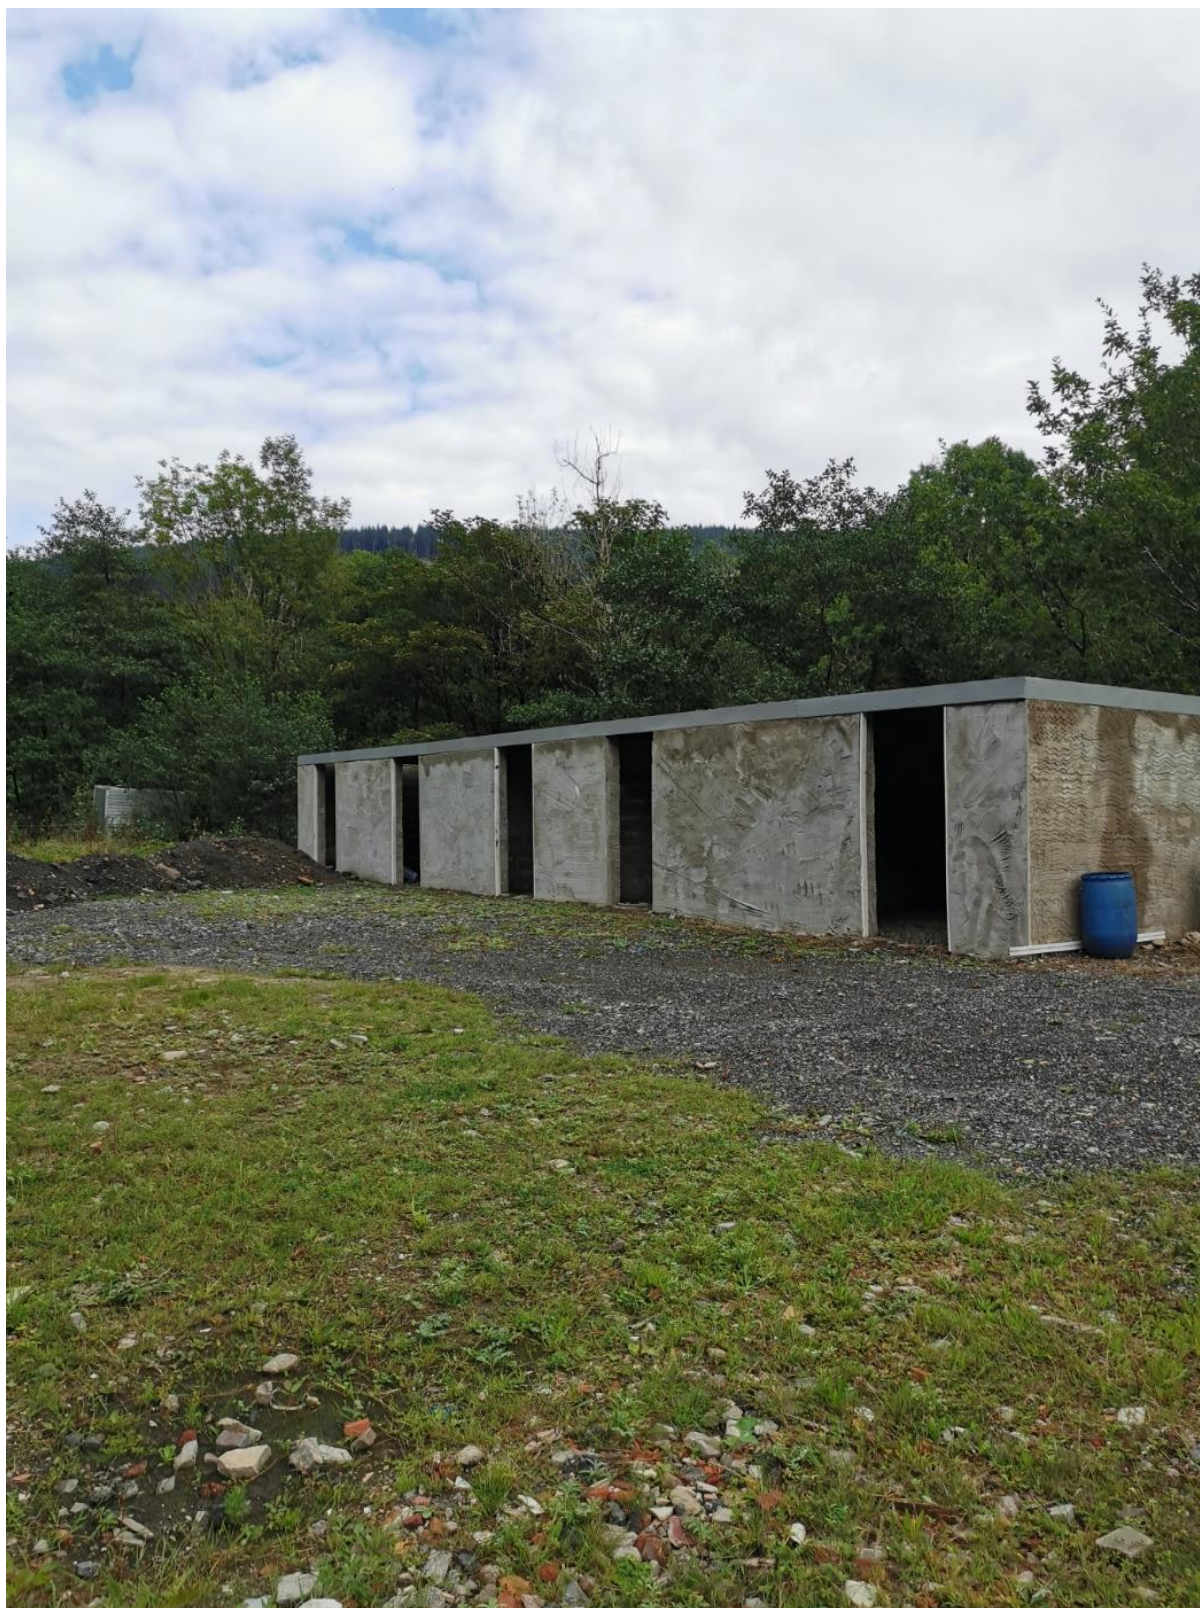
**Plate 2:** Existing stable block.
