| Location | Neath Leisure Centre, Neath. |
| Title | Preliminary Bat Roost Assessment and Bat Activity Surveys and Assessment |
| Report Date | October 2022 |

## Neath Leisure Centre Bat Survey Report

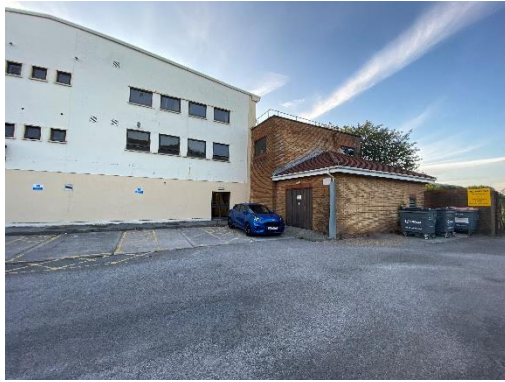
***Figure 1: East side looking North***

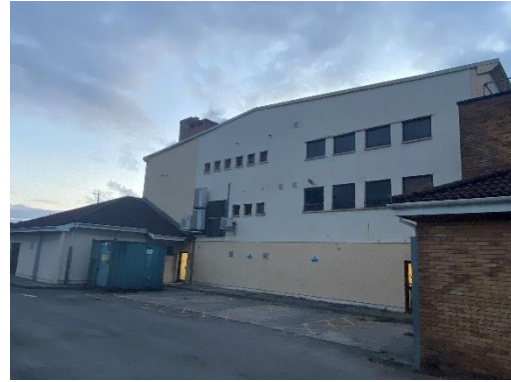
***Figure 2: East side looking South***

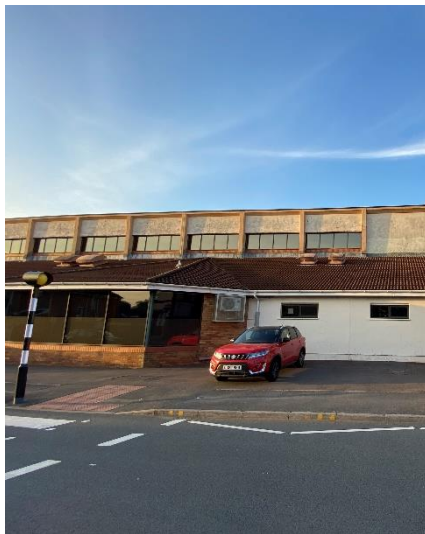
***Figure 3: South side of leisure centre from Dyfed Road (SE)***

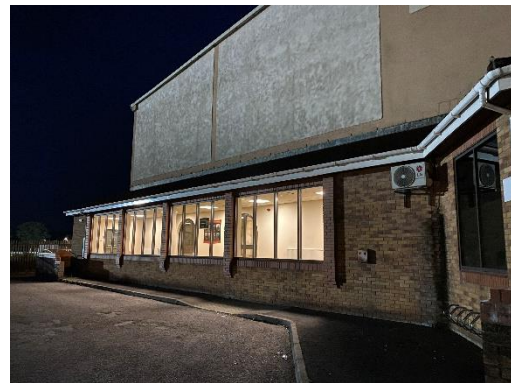
***Figure 4: South side (western end)***

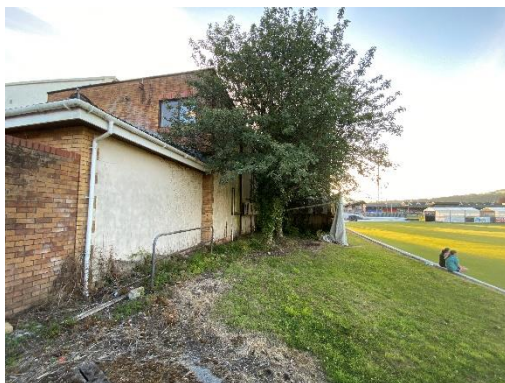
It was not possible to access the north side of the building directly during the PRA to identify any potential roosting features. The north side of the building was mostly covered with white cladding and netting for cricket purposes. A medium sized / semi-mature tree was located to the NE corner further obscuring the view of the north side. (Figure 5). This limited access to the north side was seen as a constraint to the survey. The tree was assessed from the entrance to the cricket ground and was not noted as having potential for roosting bats, although this could not be confirmed at this distance.

***Figure 5: North side (NE) inaccessible***

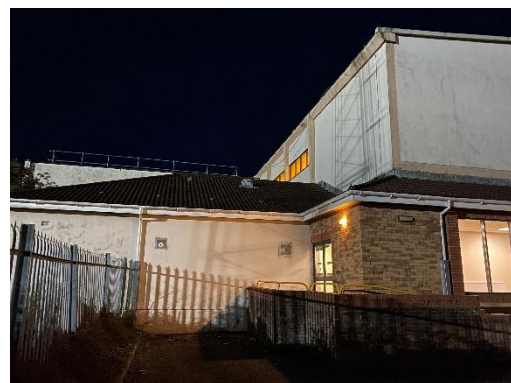
***Figure 6: West side (NW corner)***

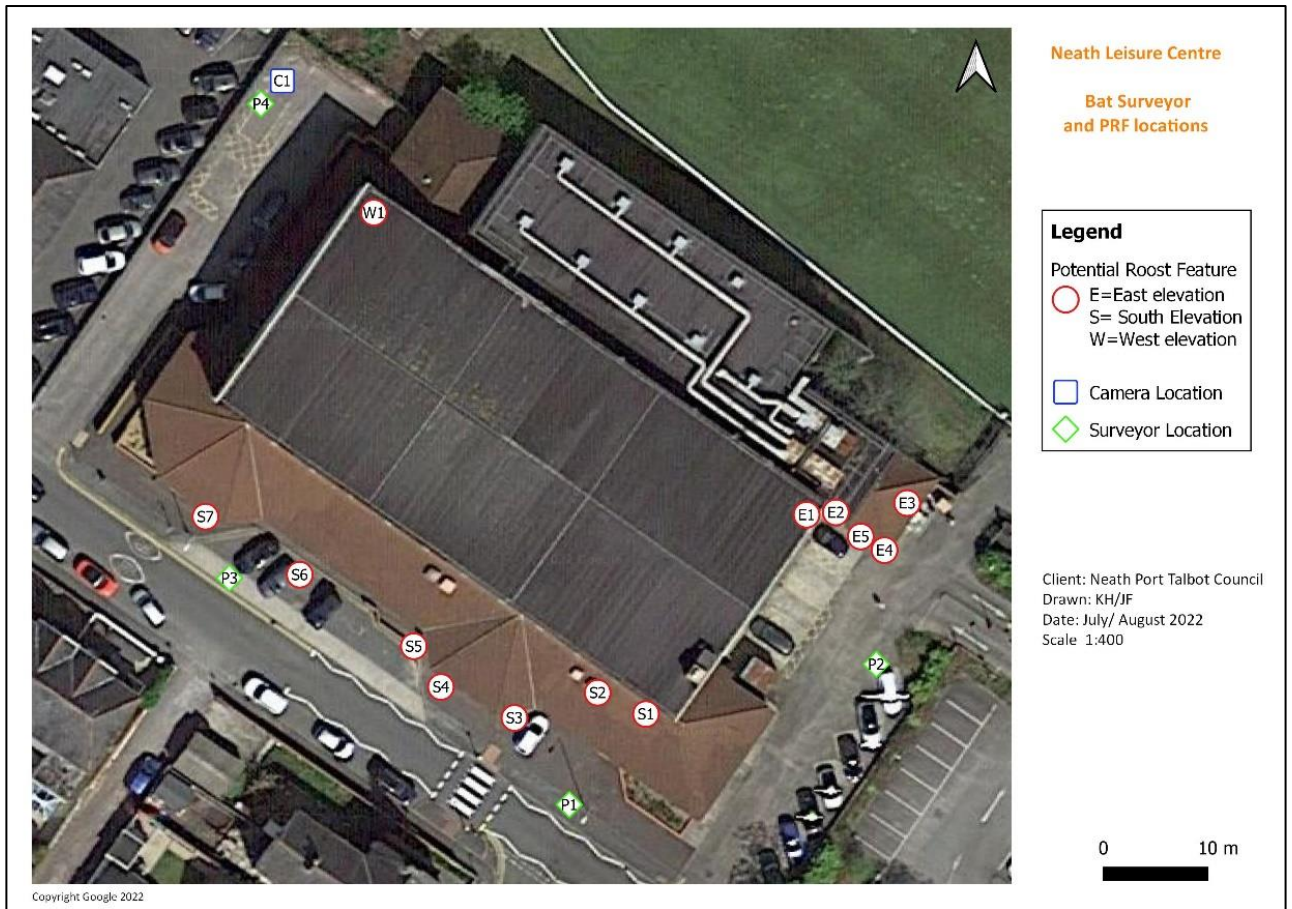
**Figure 8: Surveyor and PRF Locations**

| FEATURE REFERENCE<br>(by building elevation) | DESCRIPTION | IMAGE |
|---|---|---|
| EAST 1 (E1) | Small gap by soffit NE corner of main building, small crack to fascia. | |

| EAST 2 (E2) | 2 small holes in brick wall, below flat roof and above the window to south elevation of brick extension/garage/ storage building to east of main building. | |
| EAST 3 (E3) | 2 adjacent features -<br><br>Missing small circular vent cover to soffit, east elevation of garage building.<br><br>External vent to garage wall. | <br> |
| EAST 4 (E4) | Small opening at tip of sloping ridge tile. | |
| EAST 5 (E5) | Short section of narrow metal vent missing on underside, south elevation. | |
| WEST 1 (W1) | Rendered brick, small gap to NW base of soffit. | |

| SOUTH (S1) | SE uppermost corner of main concrete rendered building. Small slit to base of soffit, slit midway (peeling paint?) and small crack in wall below soffit. | |
| SOUTH 2 (S2) | Base of wooden soffit, close to air conditioning unit, part of the rusty metal vent missing leaving approx a 1-1.5" gap. | |
| SOUTH 3 (S3) | Small gap above window | |
| SOUTH 4 (S4) | Dropped wooden soffit approx. leaving approx 1-1.5" gap. | |
| SOUTH 5 (S6) | Missing vent and gap to soffit | |
| SOUTH 6 & 7<br>S6 & S7 | Dropped soffit as S4 | |
