# 0346- Main Road Dyffryn Cellwen, Neath

Tree Survey Summary - REV A

Tree Survey by Tree Scene, summary by Hickman & Smith Architects

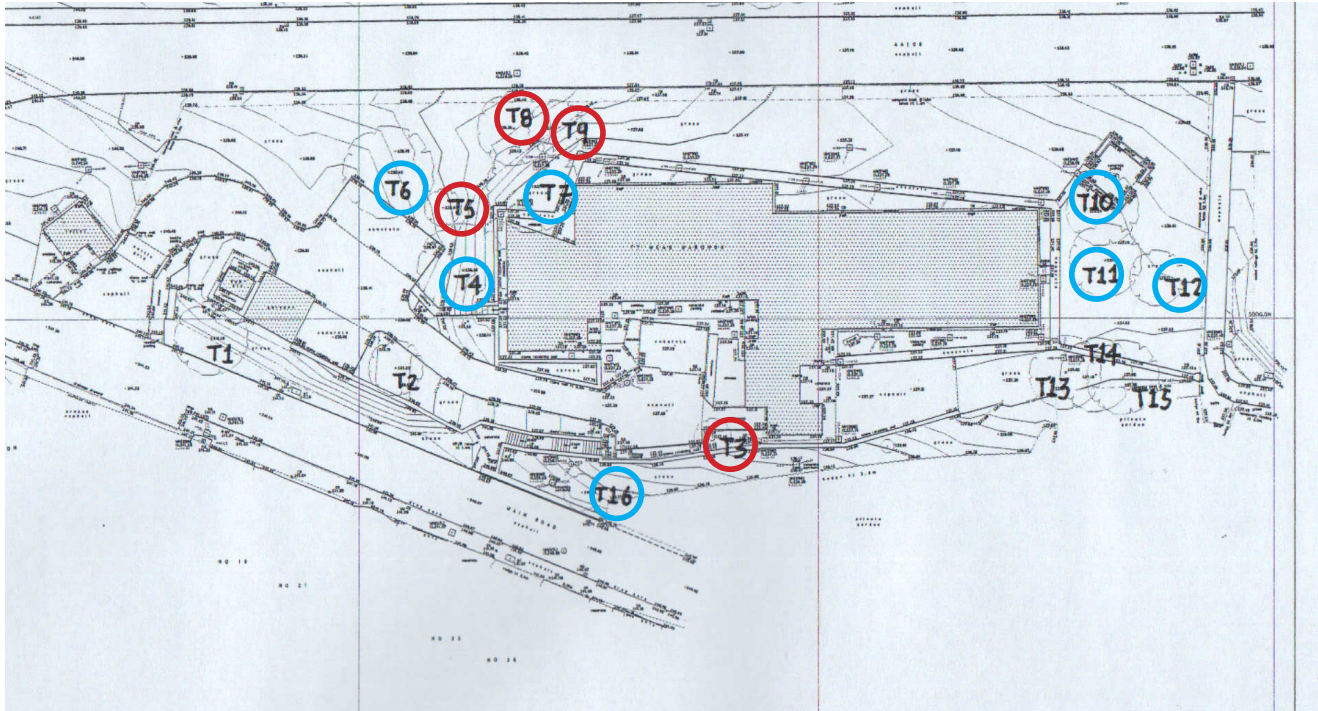
In support of the outline planning application P2017/0025 for the Land at Main Road Dyffryn Cellwen, Neath, which was approved 15/08/2017 a tree survey report was submitted by Treescene which identified 15 trees on the site as shown below. (Tree report in Appendix A)

Of those trees the trees highlighted in red were proposed for removal within the tree report due to poor condition (T3, T5, T8, T9) and a further 7 were noted on the approved site plan for removal to facilitate the development (T4, T6, T7, T10, T11, T12, T16) leaving 5 trees remaining on the site (T1, T2, T13, T14, T15).

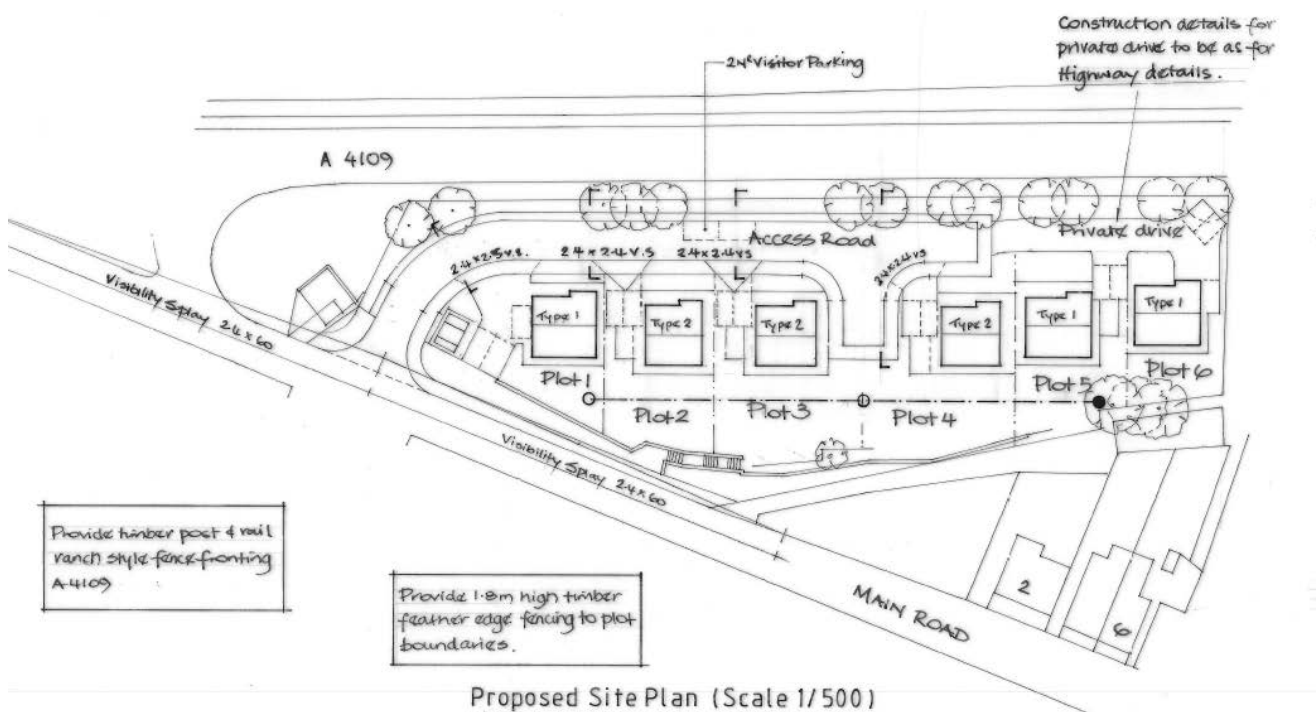
The approved reserved matters application P2020/0703 then showed the same trees being removed with the addition of T1 as this clashed with the pavement and vision splays required by the council. However, at present this tree still remains on the site.

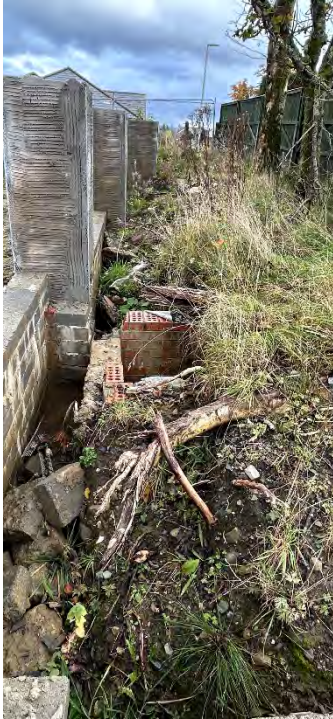
Suggested actions – Same as the previous 2 trees, as they are located in the same ditch it has been damaged in the same capacity. This tree's roots took on severe damage and has caused the tree to die, which can be identified by the brittle branches through the tree and a lack of leaves. This tree needs to be removed and again be replaced at a later date if required. Once again this is a potential hazard in adverse weather.

The image below is the tree line of T13, T14 & T15. And this image shows the severe root damage that the trees have taken with what appears to be due to an excavator.

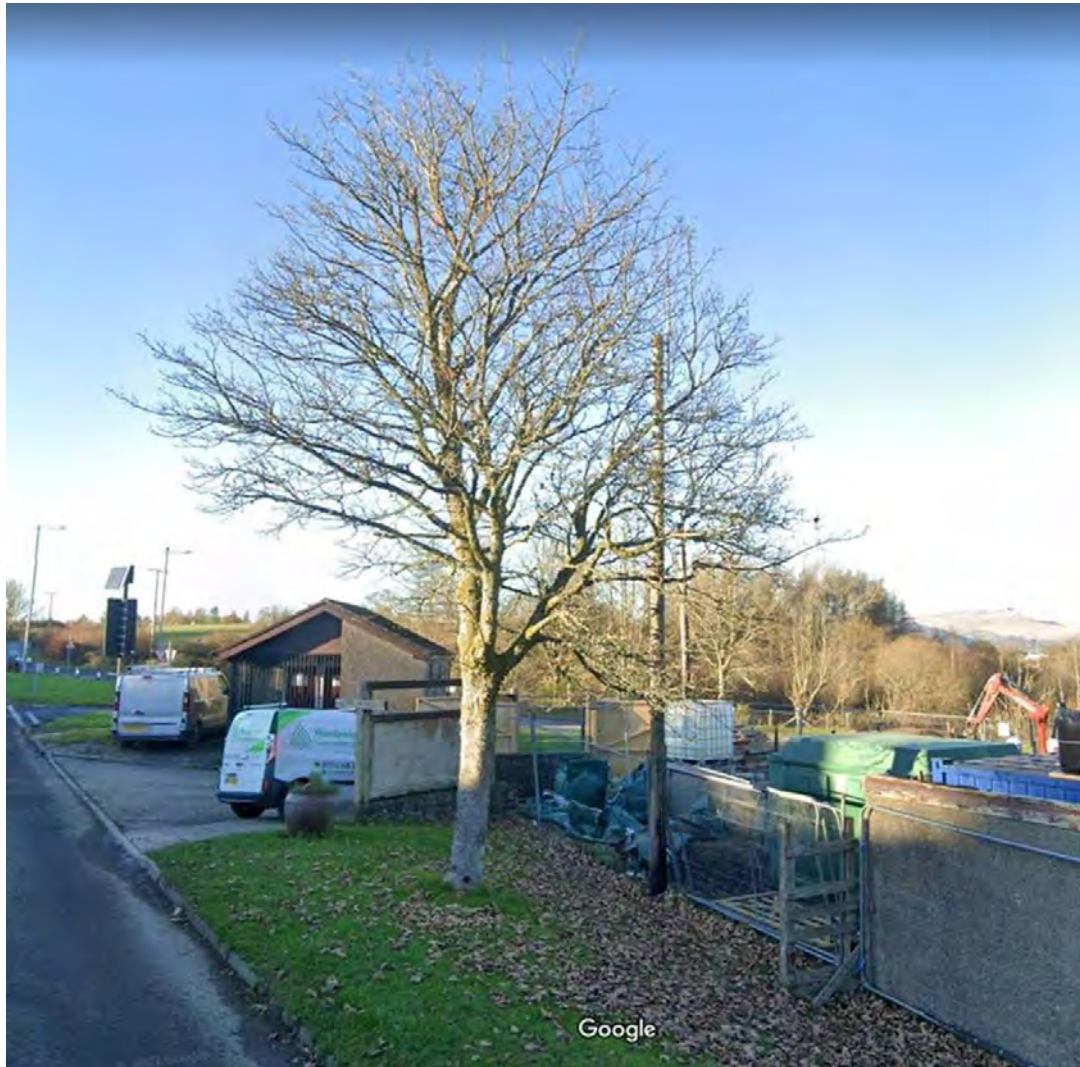
We are currently working on the Main Road Dyffryn Cellwen, Neath site. Rhodri Griffiths has asked me to make contact with you regarding a tree that remains on site. Please see below a google street view image of the tree in question, I have also attached a summary of our tree reports which explain the situation with the trees on site now and the fact that this is now the only healthy tree left on the site due to works carried out by the previous contractor (our new client has taken on the site from the previous contractors and are looking to rectify the works wherever possible).

We have an issue where we would like to retain this tree but it is in contradiction with the planning condition shown below to ensure there is a footpath and appropriate vision splays for the tree. Putting in this footpath would clash with the tree and its root protection area.

Would you be able to offer your comment on whether you would find it acceptable to remove this tree (planting new trees elsewhere on the site) in order to make the footpath achievable? Or would you feel strongly that the tree should be retained- in which case, would you be willing to see the footpath stop before the tree?
