## Site Photographs

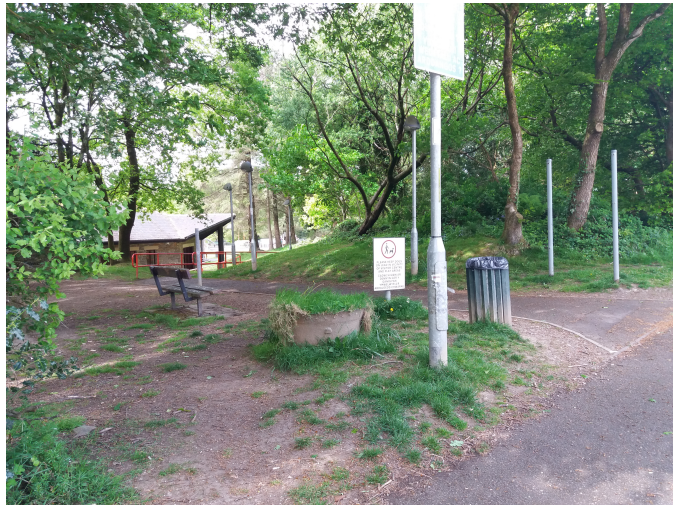
*Sloped access path leading from the carpark to the main, northern entrance. Location and poor quality of materials acts to the detriment of the legibility of the building and access routes*

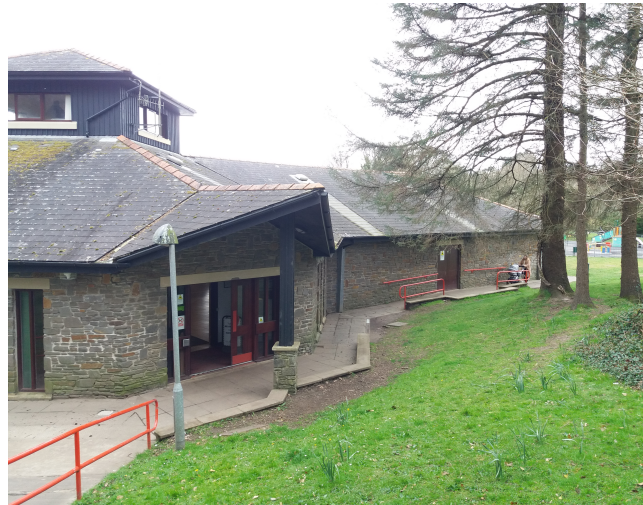
*(Top) The main entrance to the north sits away from the principal car park exit and lacks a sense of arrival  
(Bottom) Main exit point from carpark. Visitor centre does not present itself as a main welcome building*

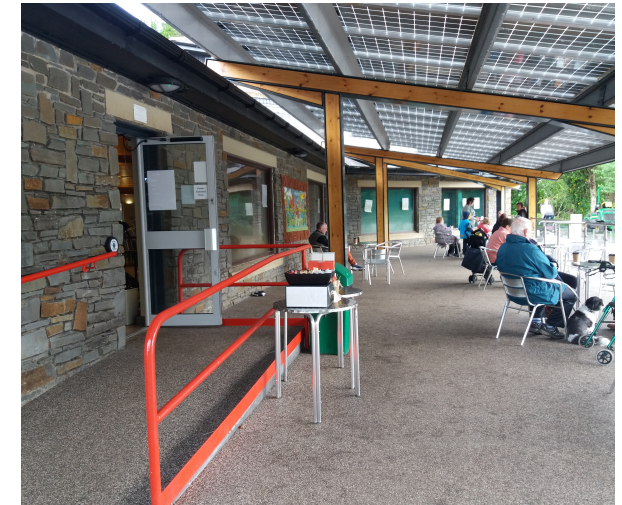
*(Top) Canopy with secondary access to the café area, which has become a principal access.  
(Bottom) The tramper store acts as a barrier to the building and views of the reservoir beyond.*
