Project Dragon SAF  
Production Facility

Waterbody Location Plan

## Appendix A PRA Results

Appendix B Building Descriptions and Photos.

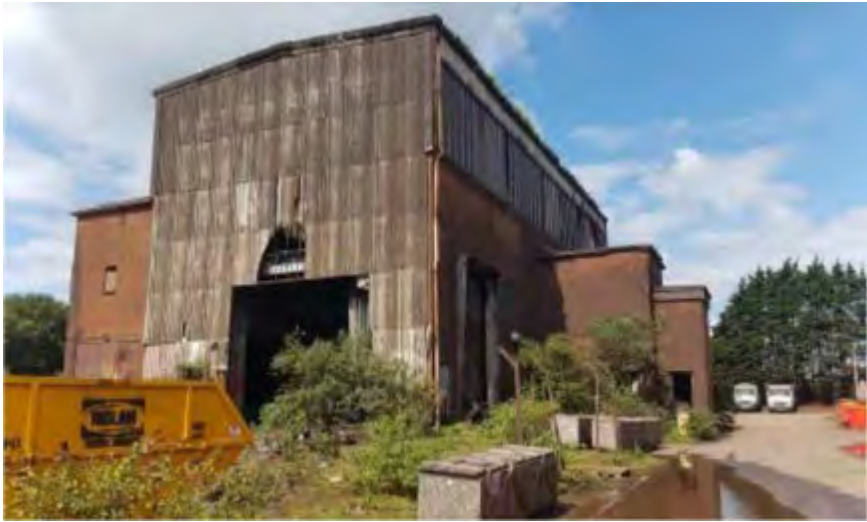
| Table 1 – Preliminary Roost Assessment (PRA) conducted on 25/07/2023 | |
|---|--|
| <p><b>Low</b></p> <p>Tall abandoned industrial building constructed from brick with a shallow pitched roof of corrugated sheet mineral. Glass in upper portion but some panes broken. Main building has multiple access points.</p> <p>NW side single storey brick addition with glass in upper portion of walls, door propped open. Small crevices on external brick corner where roof joins wall. Internally shallow tunnel under the floor with metal covers. Crevice in internal wall at 3-4m.</p> <p>SW side corrugated extension has a small gap along roof edge. Brick area with concrete roof has gaps along edge of the roof. Internally dark room with no features or signs of bats.</p> <p>NE brick extension has a gap along wall above roof join to wall. Crack in the brickwork. Street lighting between building 1 &amp; 2 and NW side.</p> | |

| Building Number | Building Description and Potential Roost Features | Overall Suitability | Recommended further surveys | Number of surveyors required for emergence/re-entry surveys |
|---|---|---|---|---|
| B1 | Tall abandoned industrial building constructed from brick with a shallow pitched roof of corrugated sheet mineral. Glass in upper portion but some panes broken. Main building has multiple access points. | <b>Low</b> | <b>One emergence / re-entry survey</b> | <b>4 surveyors</b> |

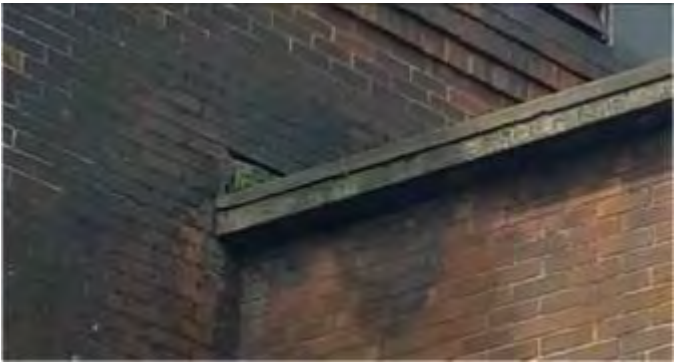
| Table 1 – Preliminary Roost Assessment (PRA) conducted on 25/07/2023 | |
|---|---|
| Potential feature above flat roof | |

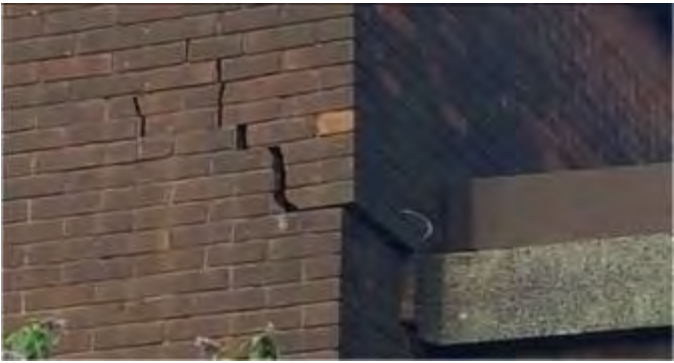
| Table 1 – Preliminary Roost Assessment (PRA) conducted on 25/07/2023 | |
|---|---|
| Potential feature in brick side building | |

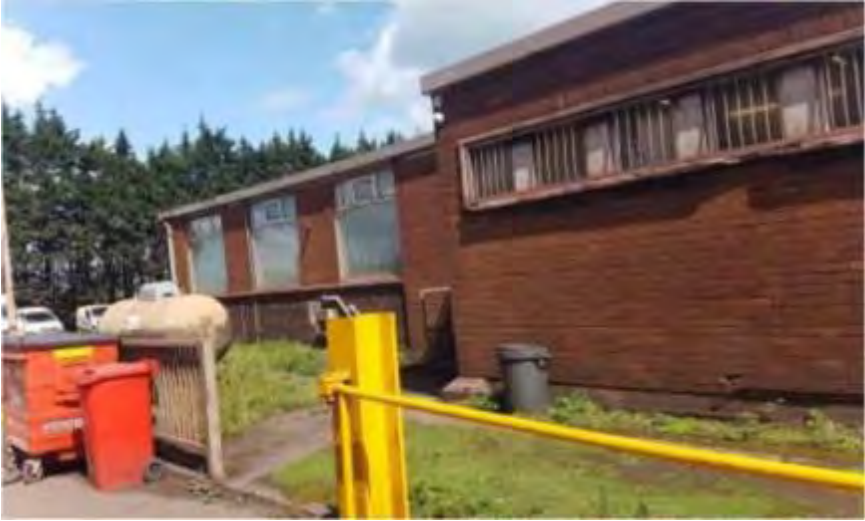
| Table 1 – Preliminary Roost Assessment (PRA) conducted on 25/07/2023 | |
|---|---|
| Building 2 | |

| Table 1 – Preliminary Roost Assessment (PRA) conducted on 25/07/2023 | |
|---|---|
| <p><b>Negligible</b></p> <p>Single storey, flat roof, brick office building in use. Gaps in the brickwork of the southwest side were examined with an endoscope and ruled out for bat potential.</p> | |

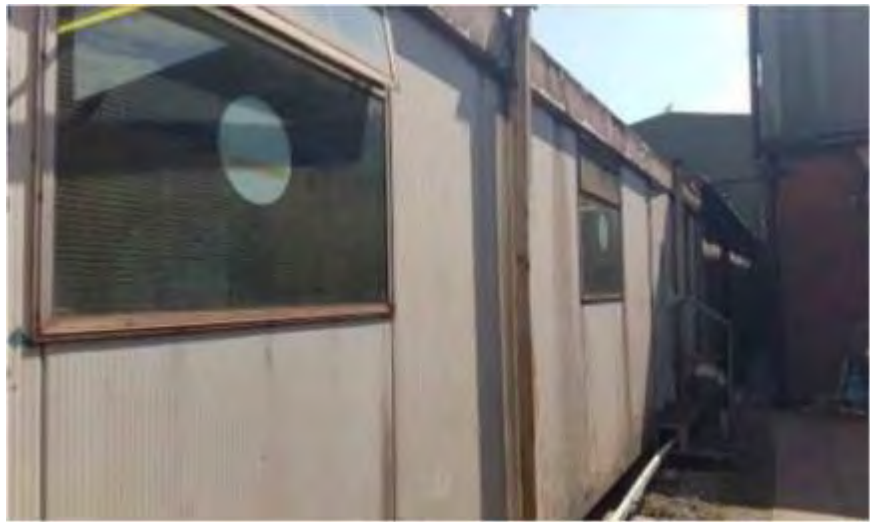
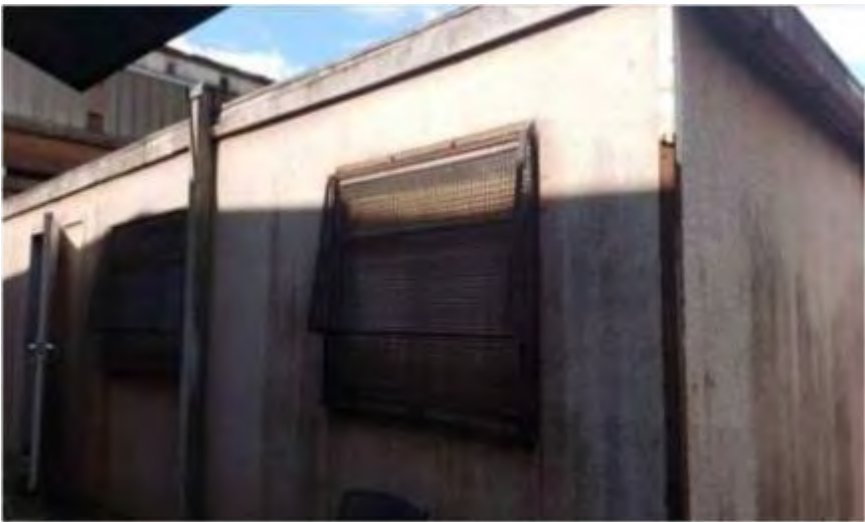
| Table 1 – Preliminary Roost Assessment (PRA) conducted on 25/07/2023 | |
|---|---|
| Building 3A-D | |

| Table 1 – Preliminary Roost Assessment (PRA) conducted on 25/07/2023 | |
|---|---|
| <p><b>Negligible</b></p> <p>Series of portacabins, in use. No features apart from a round hole into roof but thick with cobwebs. 3D has a flap of roofing felt at the edge but unlikely to be suitable.</p> | |

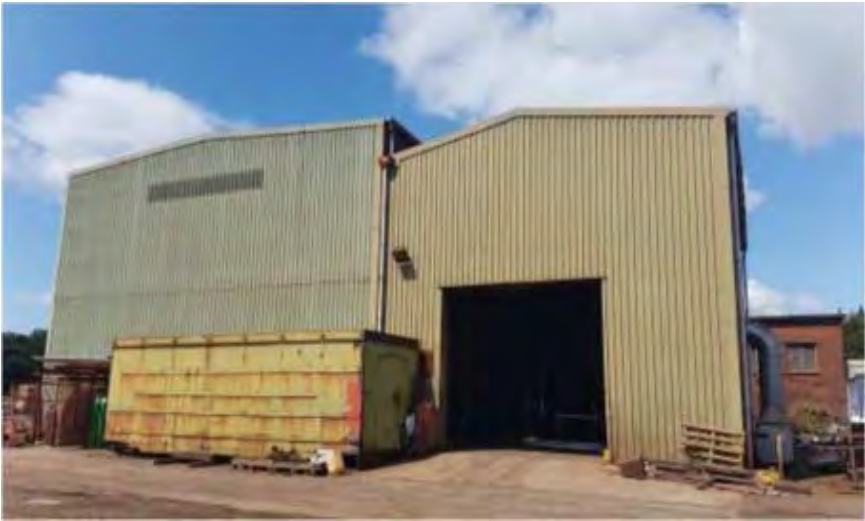
| Table 1 – Preliminary Roost Assessment (PRA) conducted on 25/07/2023 | |
|---|---|
| Building 4 | |

| Table 1 – Preliminary Roost Assessment (PRA) conducted on 25/07/2023 | |
|---|---|
| <p><b>Negligible</b><br/>Large green corrugated metal shed, in use. Bright lighting on SW side.</p> | |

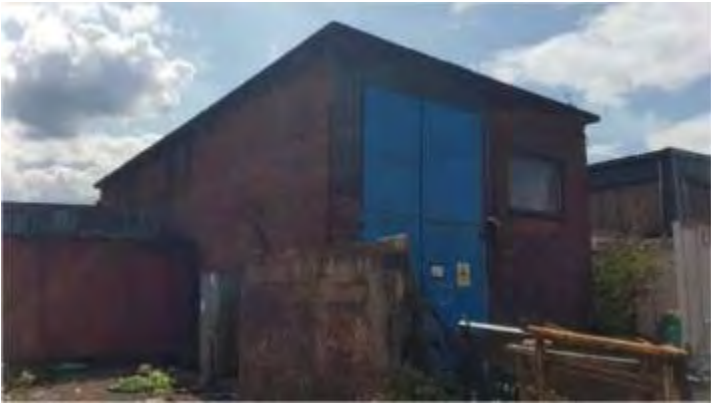
| Table 1 – Preliminary Roost Assessment (PRA) conducted on 25/07/2023 | |
|---|---|
| Building 5 | |

| Table 1 – Preliminary Roost Assessment (PRA) conducted on 25/07/2023 | |
|---|---|
| <b>Low</b><br>Brick single storey industrial building with a blue door, possibly in use. Gap behind sheet cladding near to door and apparently deep missing mortar crevices in brickwork of the NE side. | |

| Building Number | Building Description and Potential Roost Features | Overall Suitability | Recommended further surveys | Number of surveyors required for emergence/re-entry surveys |
|---|---|---|---|---|
| B5 | Brick single storey industrial building with a blue door, possibly in use. Gap behind sheet cladding near to door and apparently deep missing mortar crevices in brickwork of the NE side. | <b>Low</b> | <b>One emergence / re-entry survey</b> | <b>1 surveyor</b> |

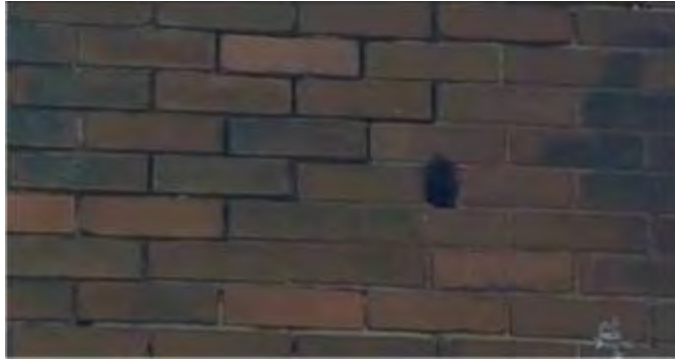
| Table 1 – Preliminary Roost Assessment (PRA) conducted on 25/07/2023 | |
|---|---|
| Low bat roost potential in cladding and missing brick mortar and hole in brickwork | |

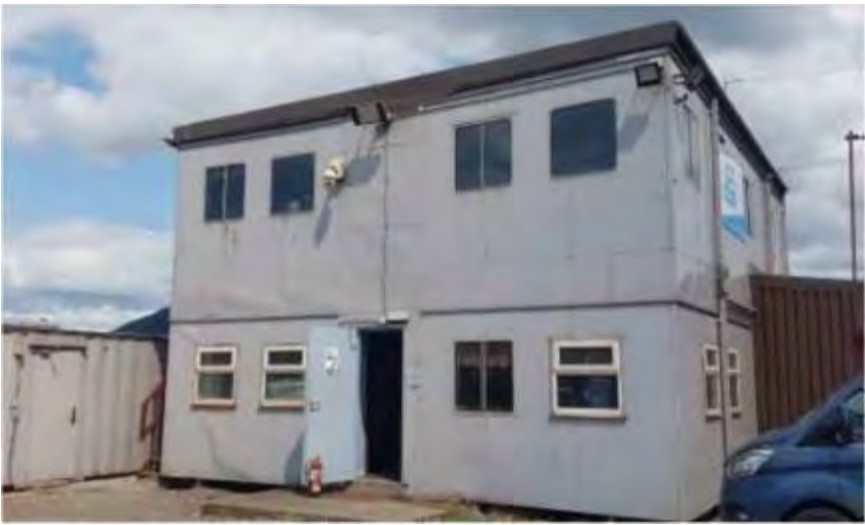
| Table 1 – Preliminary Roost Assessment (PRA) conducted on 25/07/2023 | |
|---|---|
| Building 6 | |

| Table 1 – Preliminary Roost Assessment (PRA) conducted on 25/07/2023 | |
|---|---|
| <p><b>Negligible</b></p> <p>Portacabin modular structure in use. Small potential gap at the barge board of the SW side but all elevations are extremely well lit with several lamps. Surrounded by hardstanding, no vegetation.</p> | |

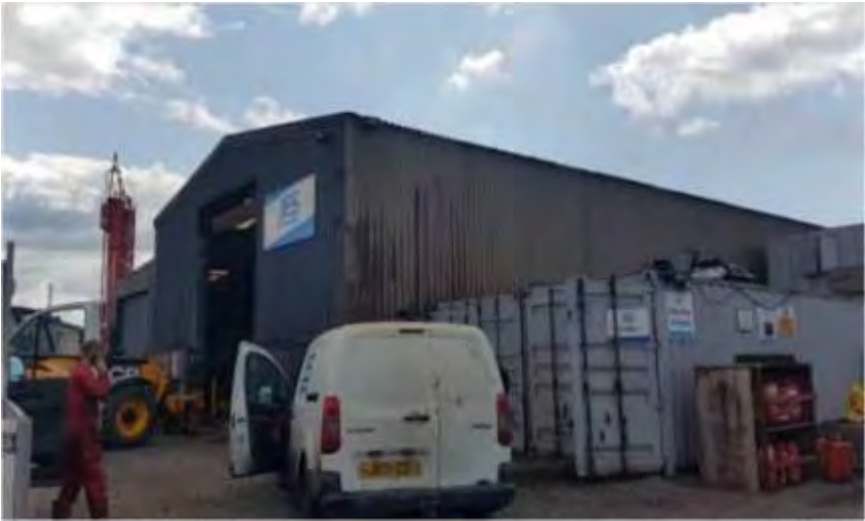
| Table 1 – Preliminary Roost Assessment (PRA) conducted on 25/07/2023 | |
|---|---|
| Building 7 | |

| Table 1 – Preliminary Roost Assessment (PRA) conducted on 25/07/2023 | |
|---|---|
| <b>Negligible</b><br>Stacked container buildings sheet metal walls and roof, in use | |

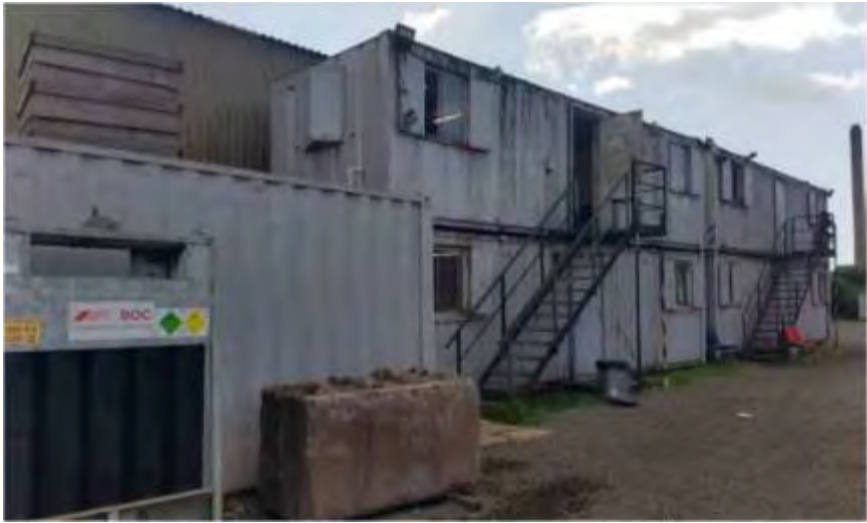
| Table 1 – Preliminary Roost Assessment (PRA) conducted on 25/07/2023 | |
|---|---|
| Building 8 | |

| Table 1 – Preliminary Roost Assessment (PRA) conducted on 25/07/2023 | |
|---|---|
| <p><b>Negligible</b></p> <p>In use by JES Group Ltd. Large corrugated metal shed with side extension. Further stacked container buildings along its side. Very well lit with bright lamps at SW end, no vegetation or cover.</p> | |

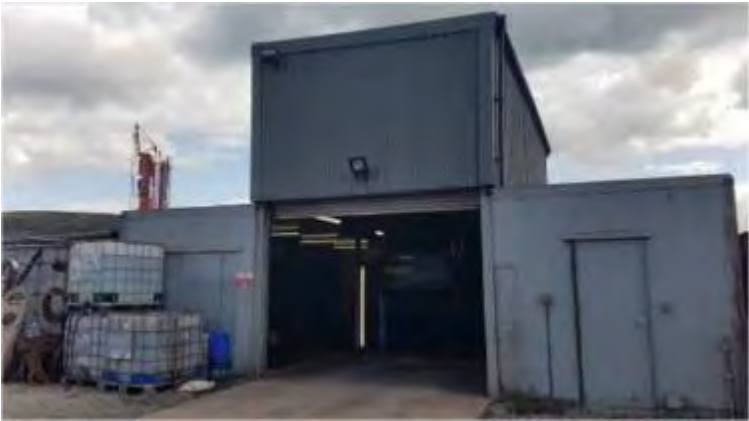
| Table 1 – Preliminary Roost Assessment (PRA) conducted on 25/07/2023 | |
|---|---|
| Building 8A | |

| Table 1 – Preliminary Roost Assessment (PRA) conducted on 25/07/2023 | |
|---|---|
| <b>Negligible</b><br>Building not showing on aerial photography. Small, corrugated metal garage in use. | |

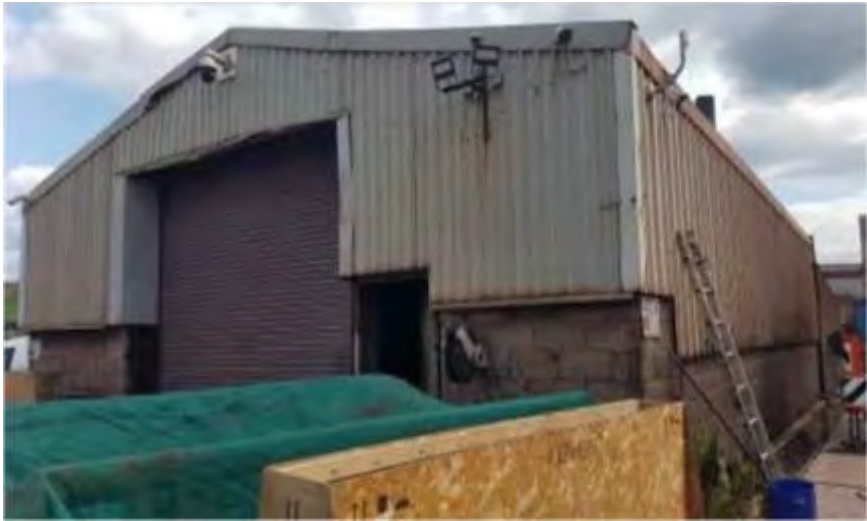
| Table 1 – Preliminary Roost Assessment (PRA) conducted on 25/07/2023 | |
|---|---|
| Building 9 | |

| Table 1 – Preliminary Roost Assessment (PRA) conducted on 25/07/2023 | |
|---|---|
| <p><b>Negligible</b></p> <p>In use by Davies Crane Hire, corrugated metal shed structure with bright lighting</p> | |

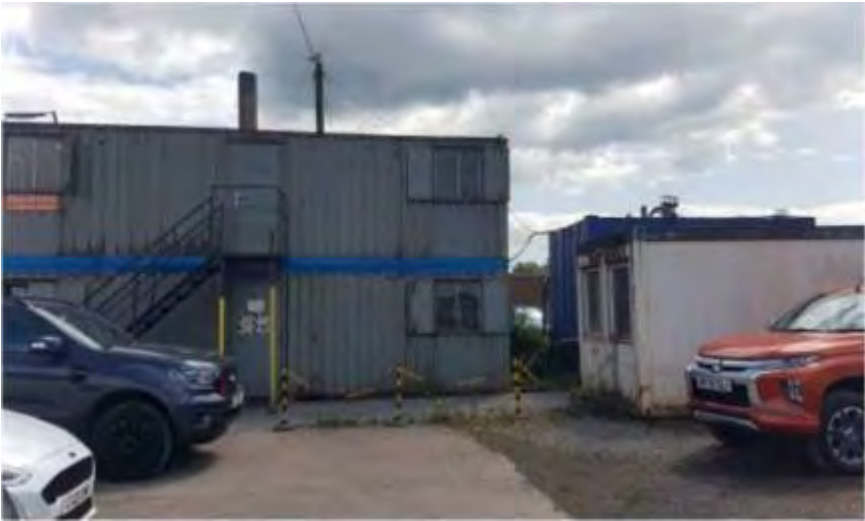
| Table 1 – Preliminary Roost Assessment (PRA) conducted on 25/07/2023 | |
|---|---|
| Building 10 | |

| Table 1 – Preliminary Roost Assessment (PRA) conducted on 25/07/2023 | |
|---|---|
| <b>Negligible</b><br>Stacked container buildings in use. Lighting from 9 spills onto this area. | |

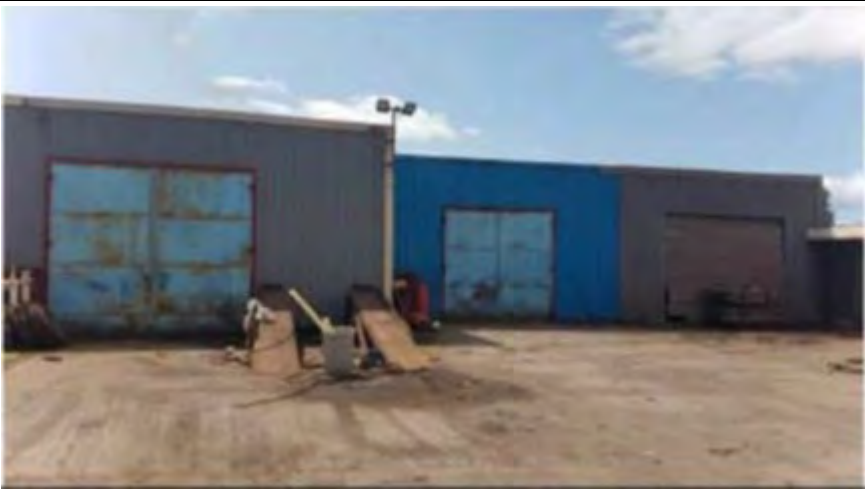
| Table 1 – Preliminary Roost Assessment (PRA) conducted on 25/07/2023 | |
|---|---|
| Building 11 | |

| Table 1 – Preliminary Roost Assessment (PRA) conducted on 25/07/2023 | |
|---|---|
| <b>Negligible</b><br>In use by MII Total Access. Single storey corrugated metal shed (grey/green). Bright lighting at corner, front and NE side. No vegetation or cover | |

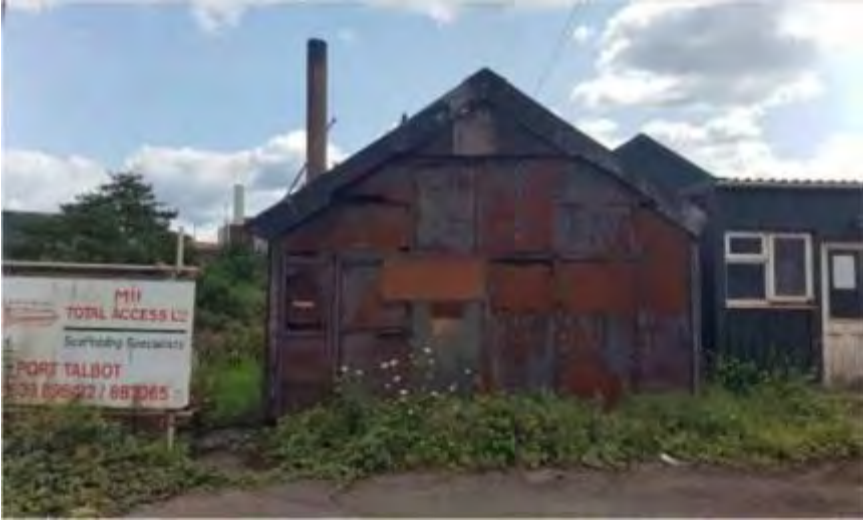
| Table 1 – Preliminary Roost Assessment (PRA) conducted on 25/07/2023 | |
|---|---|
| Building 12 | |

| Table 1 – Preliminary Roost Assessment (PRA) conducted on 25/07/2023 | |
|---|---|
| <b>Negligible</b><br>Old metal shed, no longer in use, very corroded, holes in walls, but cobwebs across them. | |

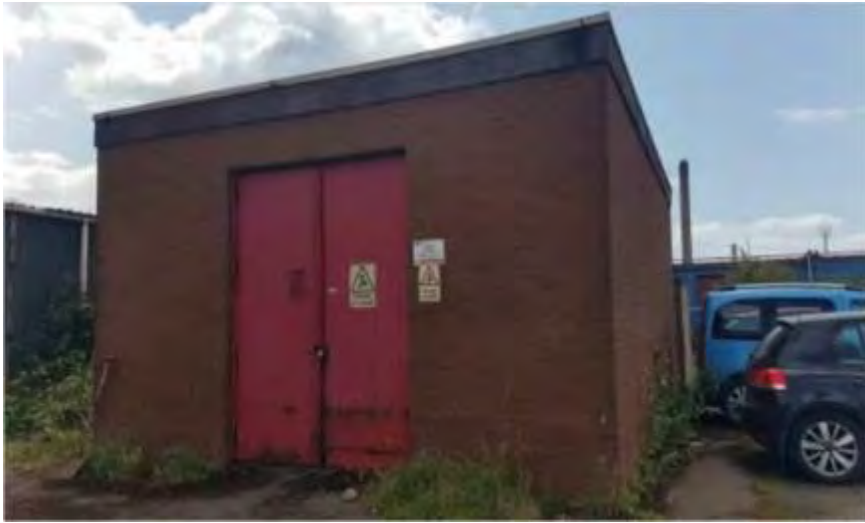
| Table 1 – Preliminary Roost Assessment (PRA) conducted on 25/07/2023 | |
|---|---|
| <p><b>Low</b></p> <p>Small brick sub-station (Margam Sub-station building). Presumably in irregular use. Some damaged wood to the rear with no bat access, but a crevice behind the barge board along the side and front.</p> | |

| Building Number | Building Description and Potential Roost Features | Overall Suitability | Recommended further surveys | Number of surveyors required for emergence/re-entry surveys |
|---|---|---|---|---|
| B13 | Small brick sub-station (Margam Sub-station building). Presumably in irregular use. Some damaged wood to the rear with no bat access, but a crevice behind the barge board along the side and front. | <b>Low</b> | <b>One emergence / re-entry survey</b> | <b>2 surveyors</b> |

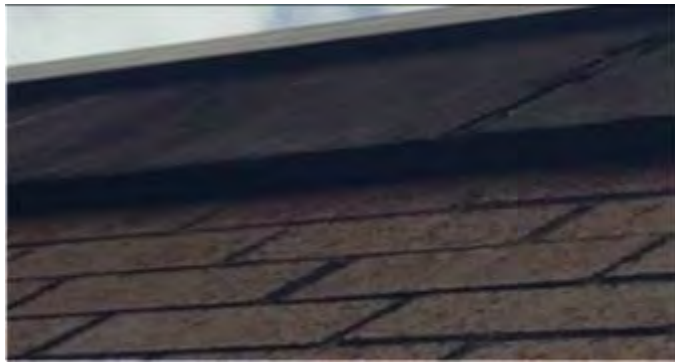
| Table 1 – Preliminary Roost Assessment (PRA) conducted on 25/07/2023 | |
|---|---|
| Potential gap in roof | |

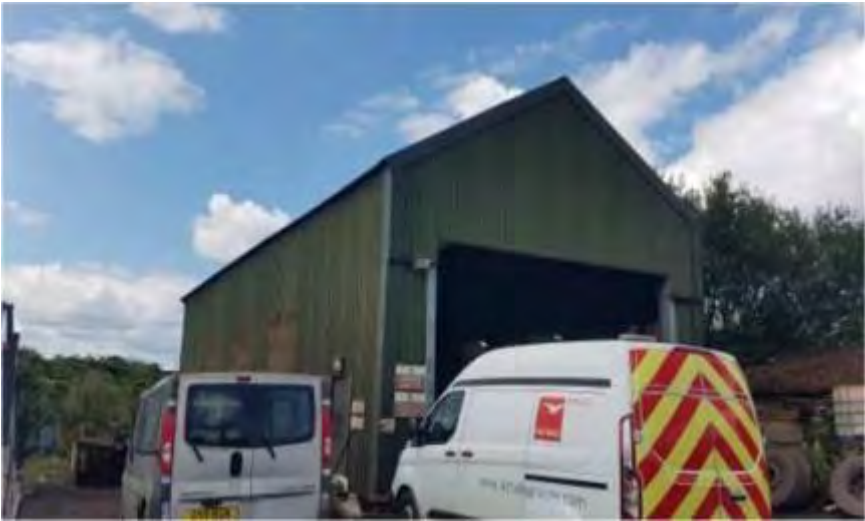
| Table 1 – Preliminary Roost Assessment (PRA) conducted on 25/07/2023 | |
|---|---|
| Building 16 | |

| Table 1 – Preliminary Roost Assessment (PRA) conducted on 25/07/2023 | |
|---|---|
| <p><b>Negligible</b><br/>Green corrugated shed in use with external lighting to the SE end.</p> | |

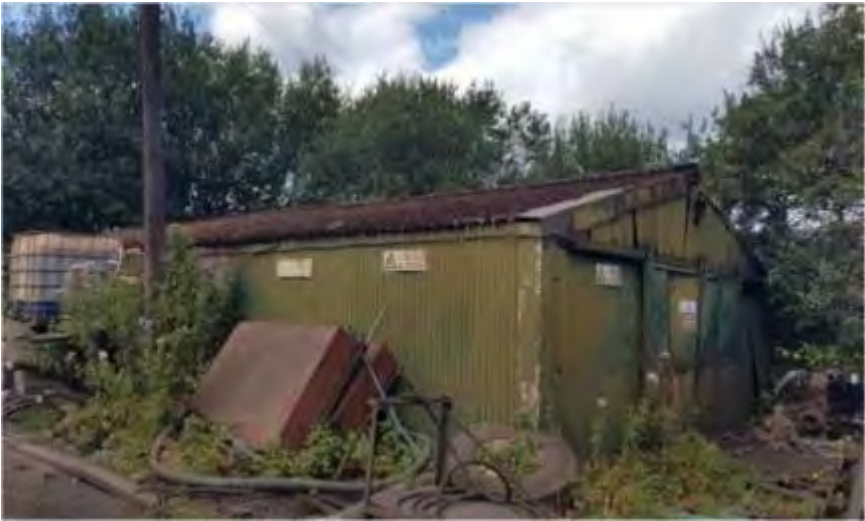
| Table 1 – Preliminary Roost Assessment (PRA) conducted on 25/07/2023 | |
|---|---|
| Building 17 | |

| Table 1 – Preliminary Roost Assessment (PRA) conducted on 25/07/2023 | |
|---|---|
| Low<br>Disused green corrugated metal shed with corrugated mineral roof. Plenty of access points around gable end. No lighting on this building and vegetation present. | |

| Building Number | Building Description and Potential Roost Features | Overall Suitability | Recommended further surveys | Number of surveyors required for emergence/re-entry surveys |
|---|---|---|---|---|
| B17 | Disused green corrugated metal shed with corrugated mineral roof. Plenty of access points around gable end. No lighting on this building and vegetation present. | <b>Low</b> | <b>One emergence / re-entry survey</b> | <b>2 surveyors</b> |

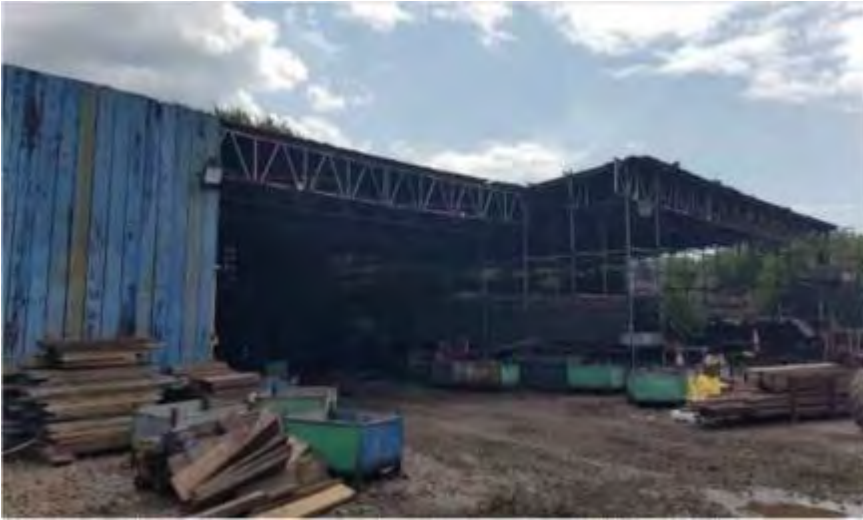
| Table 1 – Preliminary Roost Assessment (PRA) conducted on 25/07/2023 | |
|---|---|
| Building 18 | |

| Table 1 – Preliminary Roost Assessment (PRA) conducted on 25/07/2023 | |
|---|---|
| <b>Negligible</b><br>Open structure made of scaffold for storing scaffold. Yard very well lit. | |

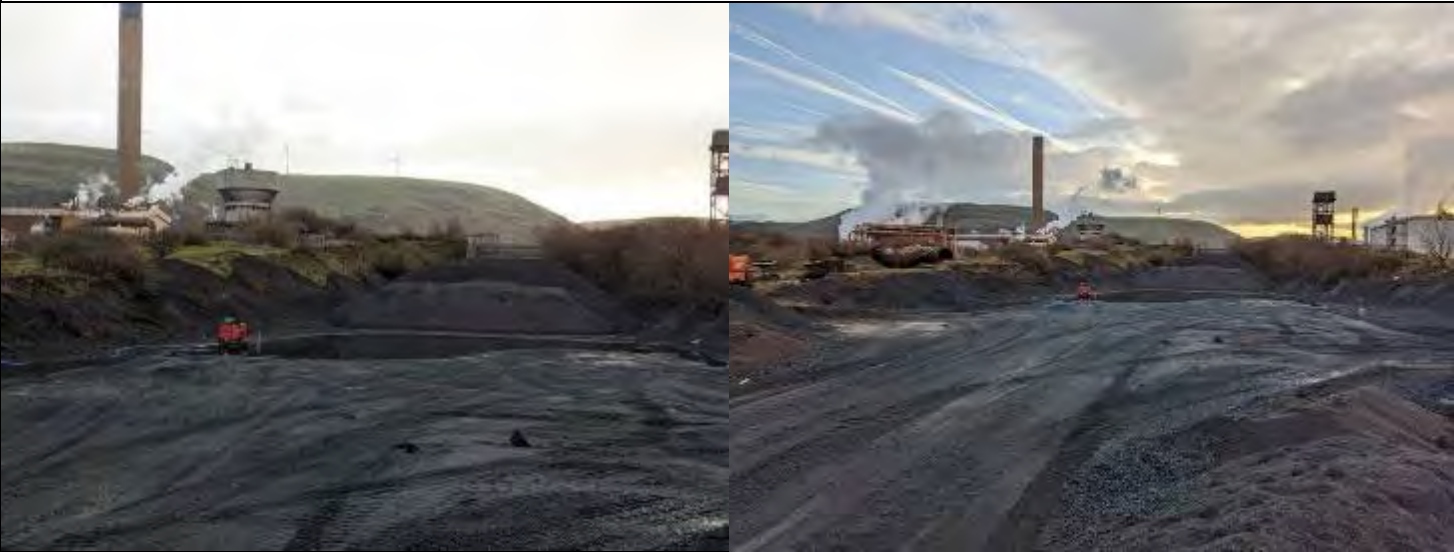
| Pond ID | Photo | Description |
|---|---|---|
| W1 | | <p>Standing surface water in raw materials storage area.</p> <p>Permanence: Temporary pooling during heavy rainfall.</p> <p>Water quality: Low and it is highly trafficked area.</p> <p>Depth in winter: 2-5cm maximum depth</p> |

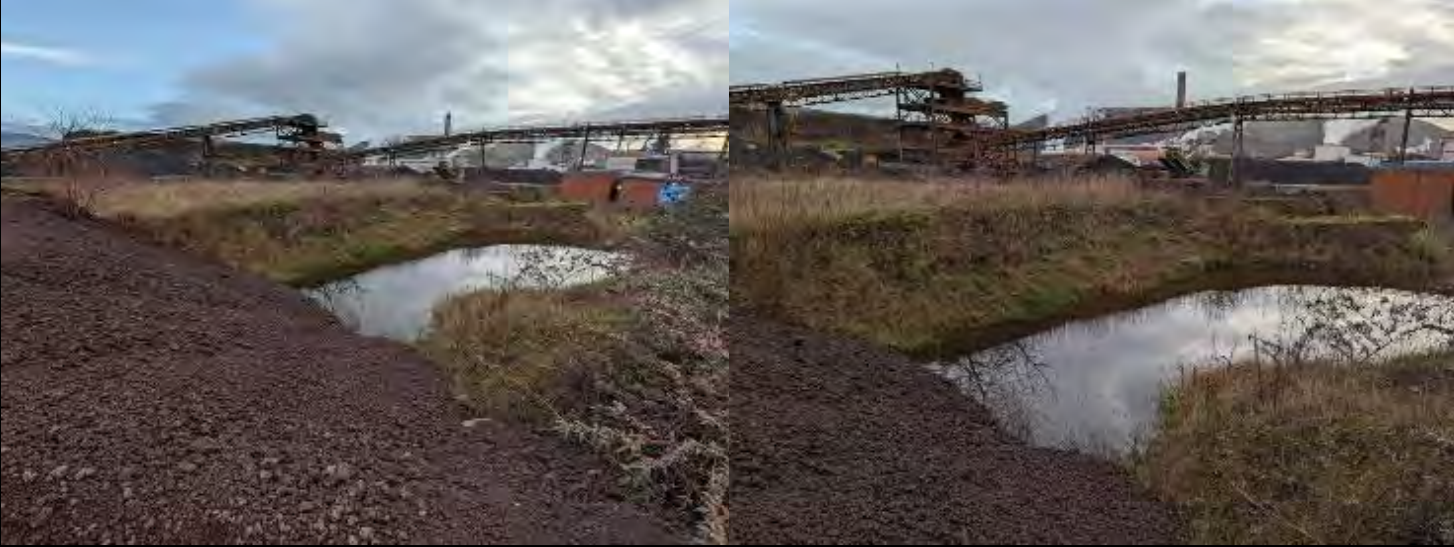
| Pond ID | Photo | Description |
|---|---|---|
| W2 | | <p>As above, standing surface water in raw materials storage area.</p> <p>Permanence: Less transient than W1 but is not present all year round</p> <p>Water quality: contaminated with iron ore stocks .</p> <p>Depth in winter: 2-5cm maximum</p> |

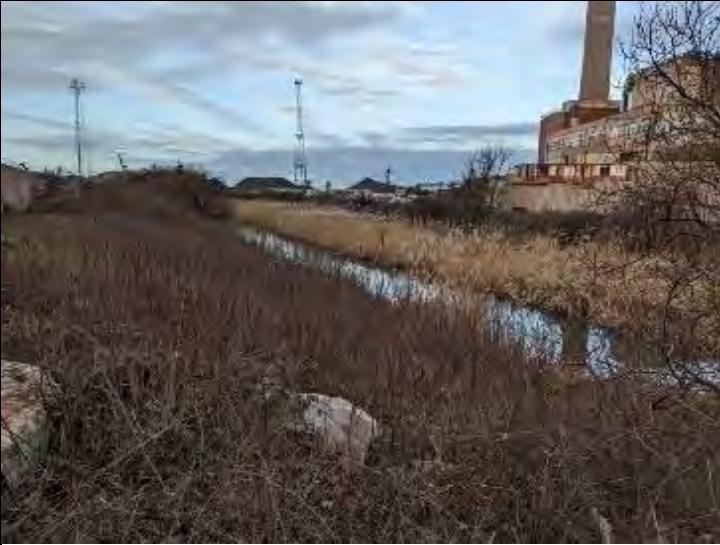
| Pond ID | Photo | Description |
|---|---|---|
| W4 | | <p>Forms part of the site drainage and is pumped into sump 1 near the sinter plant, predominantly formed from rainwater and run-off from the blast-furnace slurry stocking area.</p> <p>There is a significant barrier to the migration of any species from the target site. The sinter plant blocks access along with very steep embankments to the north of the plant.</p> <p>Permanence: Will hold water throughout the year.</p> <p>Water quality: likely to be poor</p> <p>Depth: 1m maximum</p> |
