## **DETAILED UXO RISK ASSESSMENT**

## STAGE 2 DETAILED UXO RISK ASSESSMENT

**Client:** TEC Ltd  
**Project Ref:** TWEE89R  
**Site:** Project Dragon, Port Talbot  
**Report Ref:** DRA-23-1532-TWEE89R-ProjectDragon,PortTalbot  
**Revision:** 2  
**Status:** Final  
**Release Date:** 6<sup>th</sup> September 2023

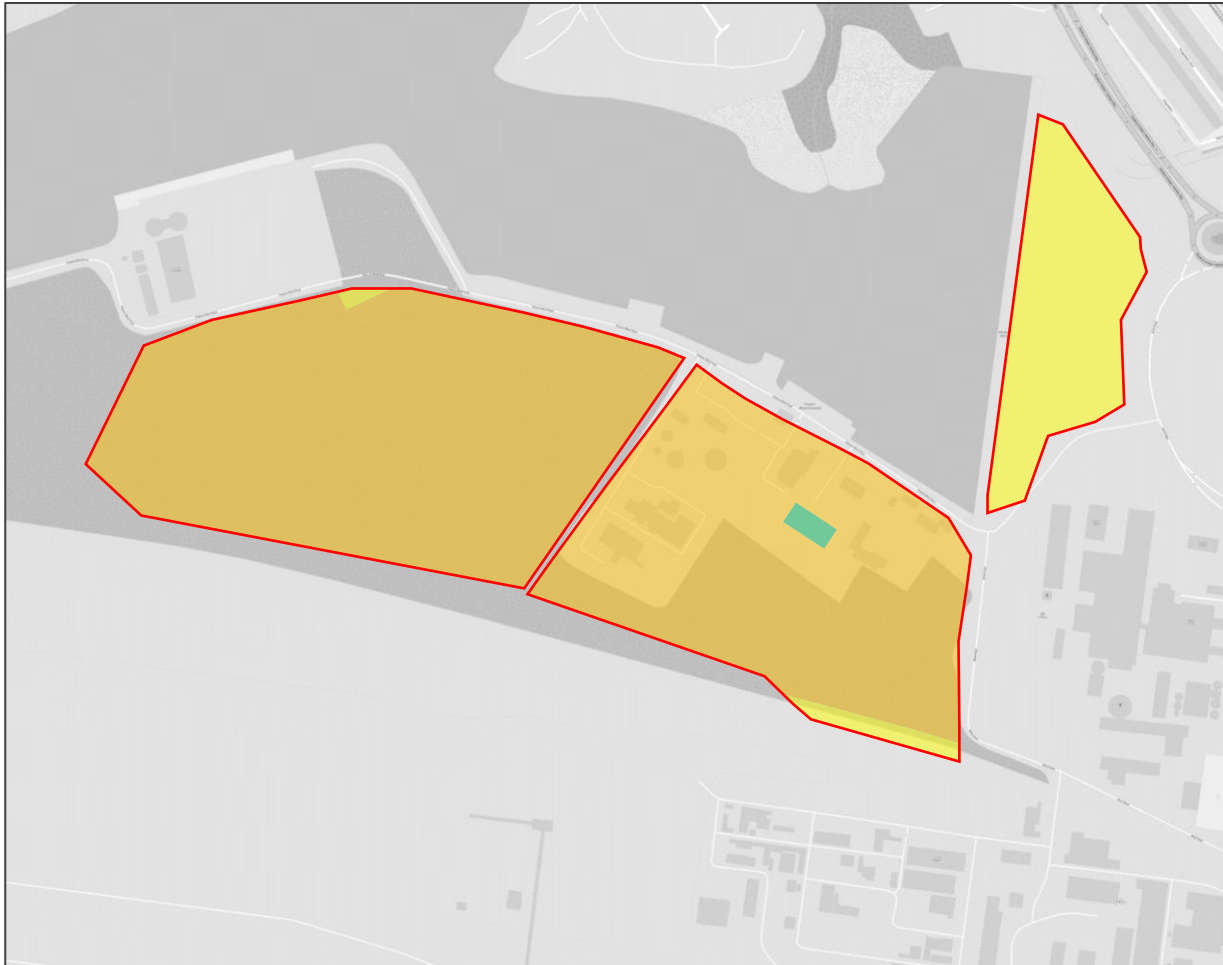
**Risk Map:**

**RESULT:** Brimstone concludes that German UXBs and unexploded HAA shells poses a **LOW, LOW-MODERATE** and **MODERATE RISK** to the proposed works. See **FIGURE 7** for risk mapping.

- No evidence of damage to the copper works in Site A, railway infrastructure in both Site A and B, nor the structures in Site C, has been identified. The presence of significant and important infrastructure in these locations indicate that a UXB strike will have been observed and dealt with at the time. However, given recorded bombing to the copper works, south side of the docks and the steelworks, the risk from German UXBs is slightly elevated and has been assessed as **Low-Moderate**.

- Similar to the copper works and railway infrastructure within Site A, as well as structures in Site C, no confirmed visual evidence of damage has been observed to the briquetting works in Site B. A UXB strike is likely to have been observed at this location during WWII. Given this, a **Low Risk** has been assessed at the footprint of this structure, with the zone accounting for the possibility of J-Curve causing a UXB to come to rest beneath. As a result, this zone is smaller than the structure itself.

**RECOMMENDED RISK MITIGATION MEASURES:** The measures detailed below are recommended to mitigate the risk to ALARP level.

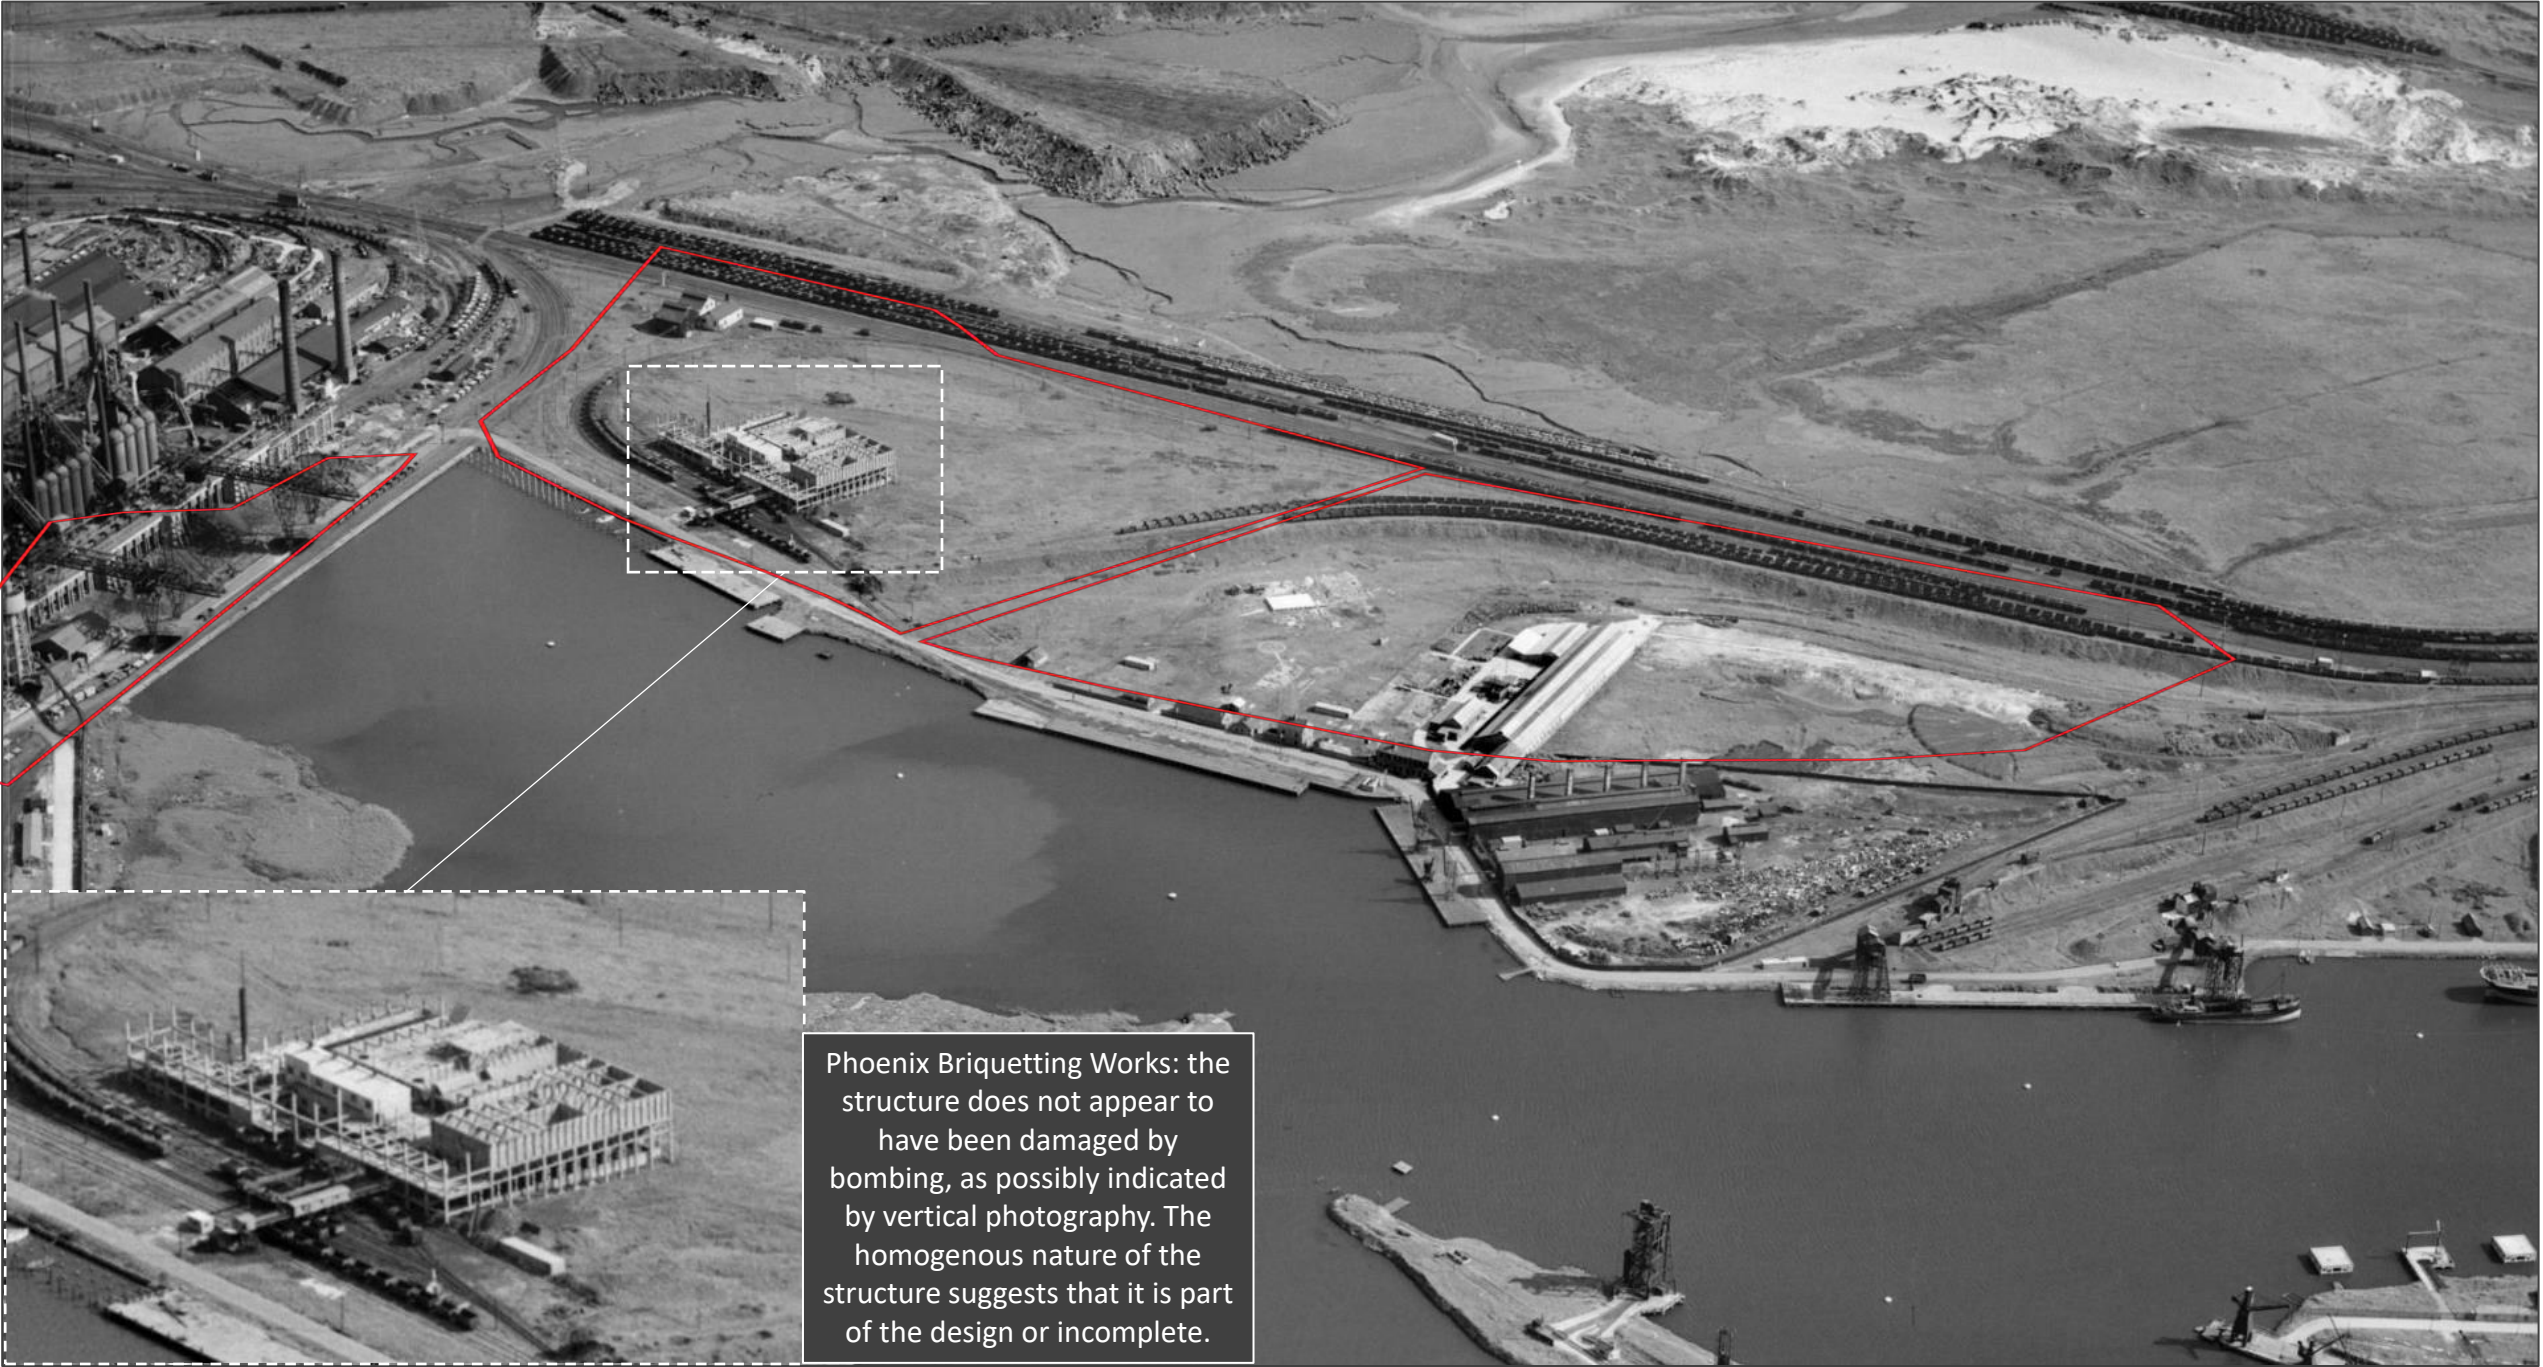
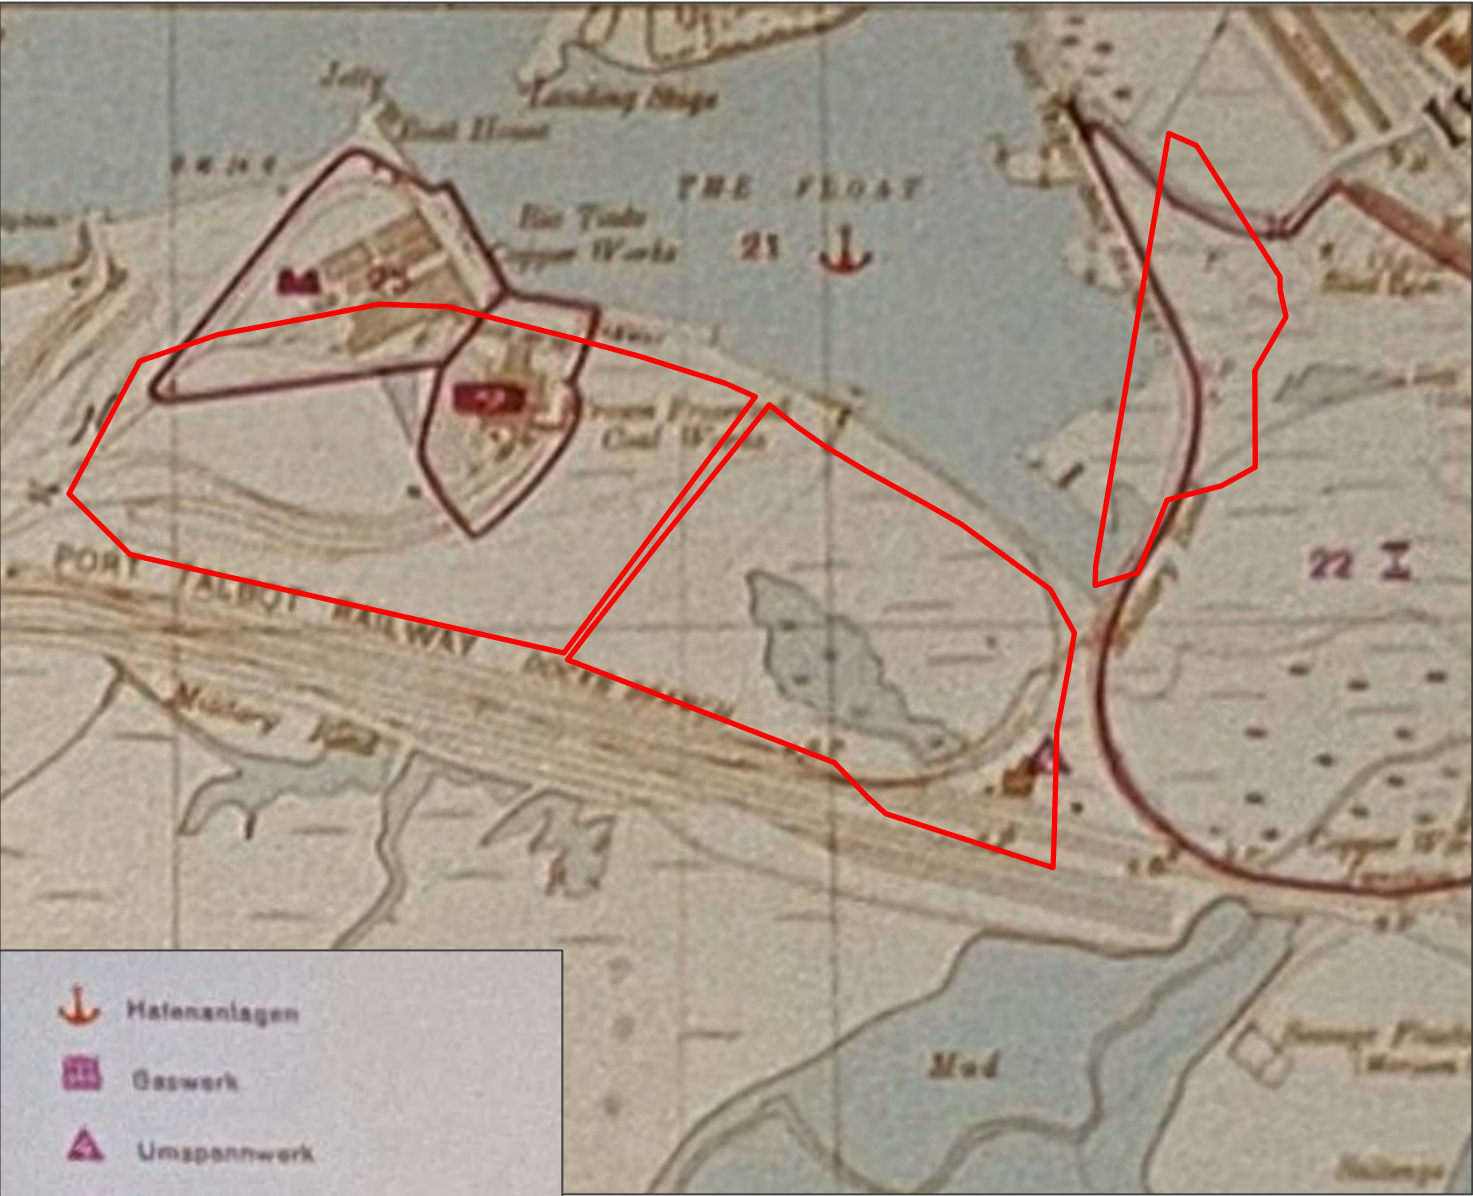
Site C. This is further recorded within Luftwaffe target mapping (**FIGURE 6**), which highlights the copper works (Kupferwerke) and hard coal briquettes (Steinkohlenbrikettebrik) within Site A as bombing targets, as well as the iron foundry (Eisengießerei) within which Site C was located.

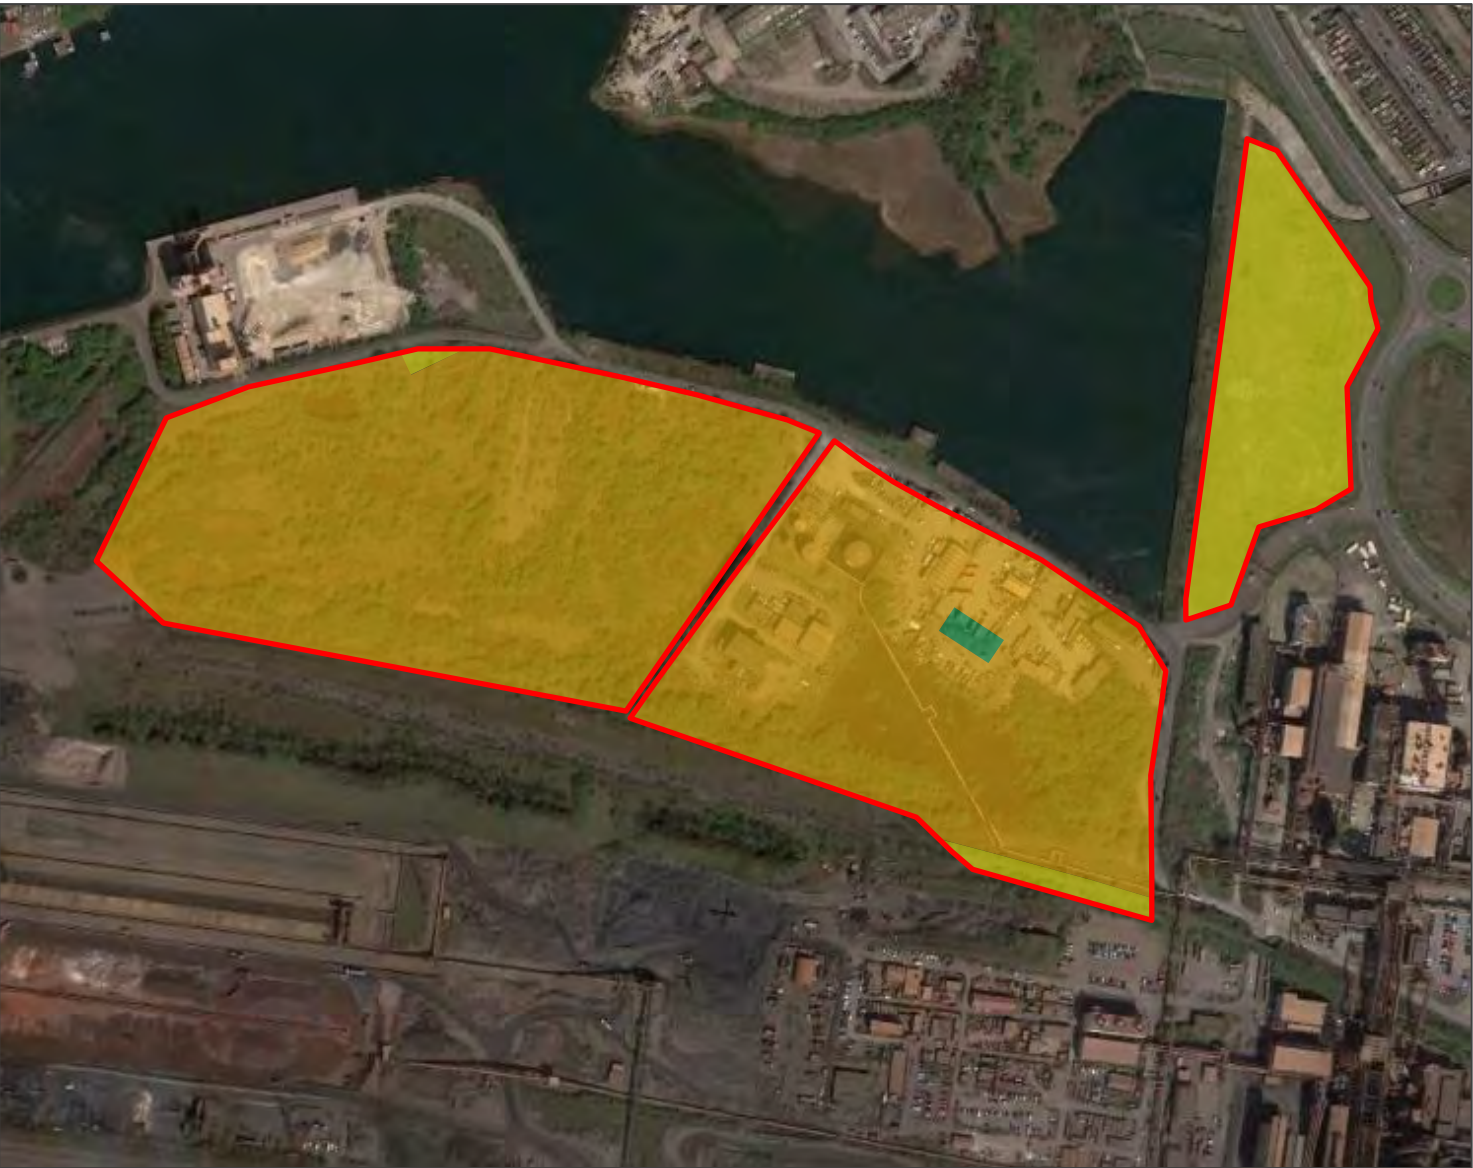
| Low Risk from German UXBs & HAA Shells |
| Low-Moderate Risk from German UXBs & HAA Shells |
