**Y Bryn Wind Farm, Neath Port Talbot**

**Updated Preliminary Coal Mining  
Risk Assessment**

**Report No 14923  
December 2023  
Version 5**

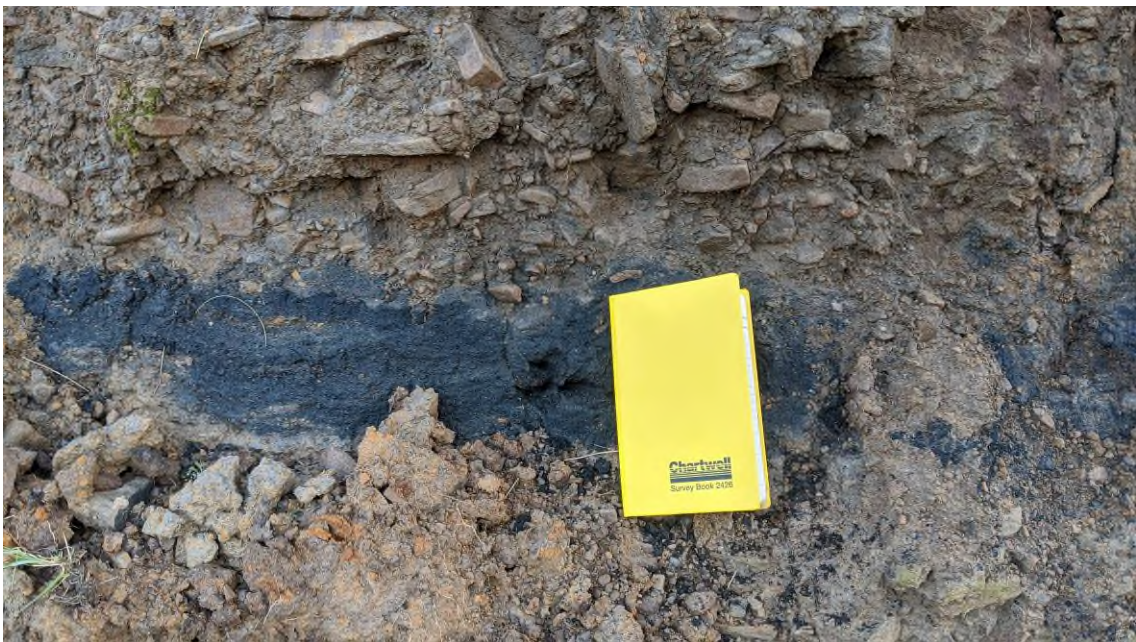
An outcrop of the Wernddu coal seam (Plate 2) was identified within a cutting to the north of T02. Historical mapping shows a trial level (Plate 5) to be present at this location and broken ground (Plate 3), considered to potentially be representative of historical workings (adits/ drifts/ crop workings), was identified in this area.

Plate 2: Outcrop of Wernddu (Wd) within cutting to north of T02.

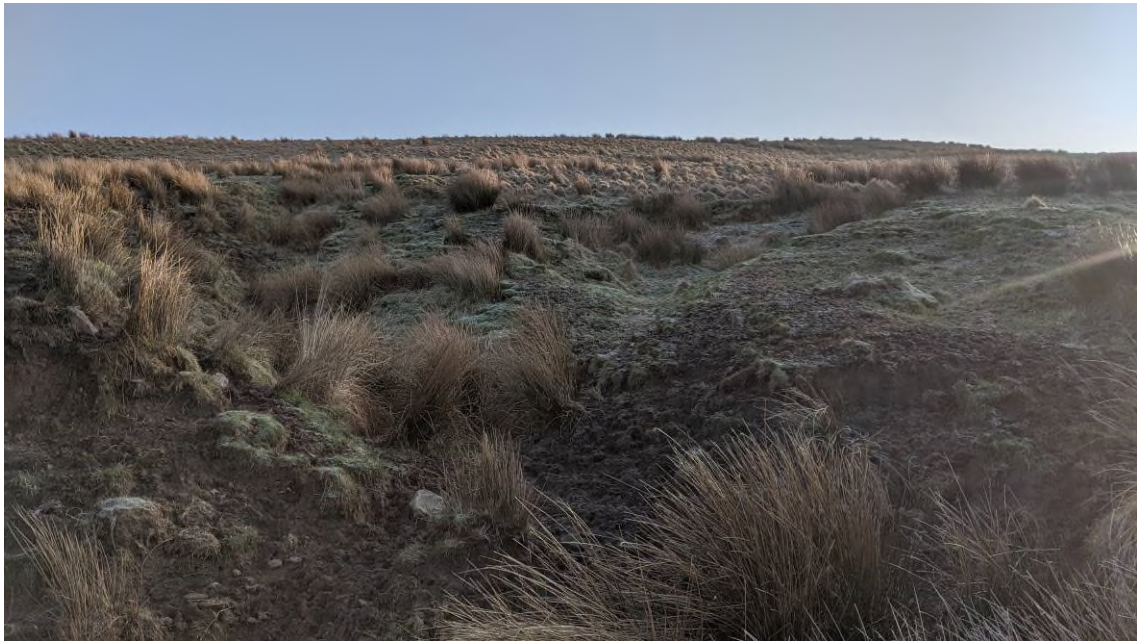
Plate 3: Possible crop workings to east of Wd outcrop (Plate 2), viewed from the south.

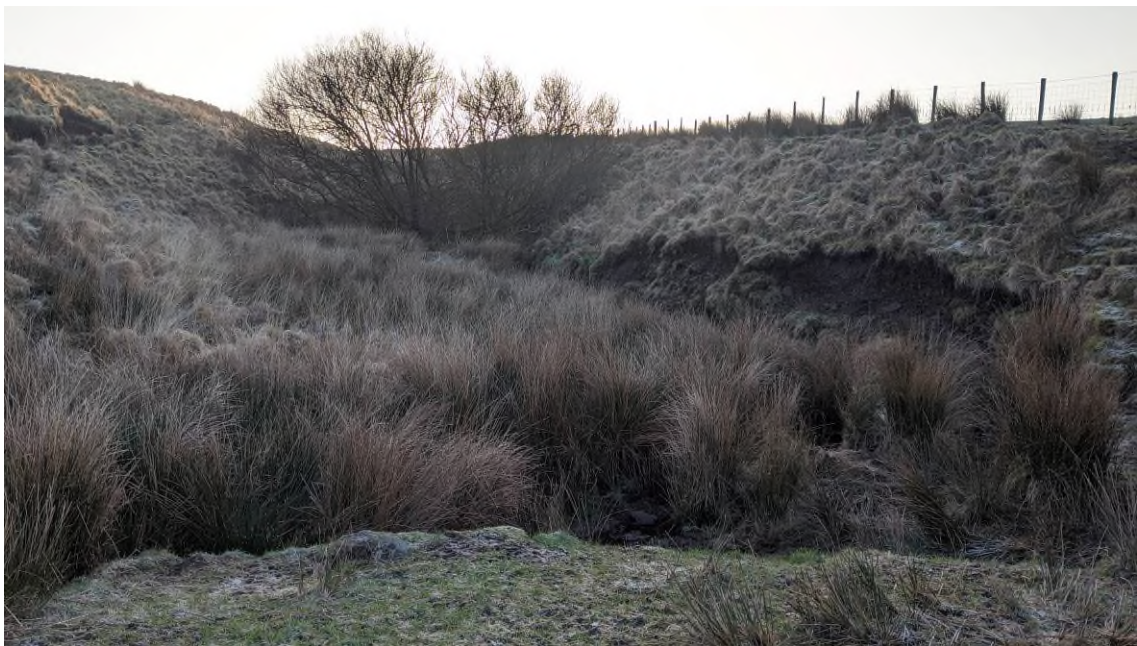
Plate 4: Fault valley to north of T02, viewed from the west.

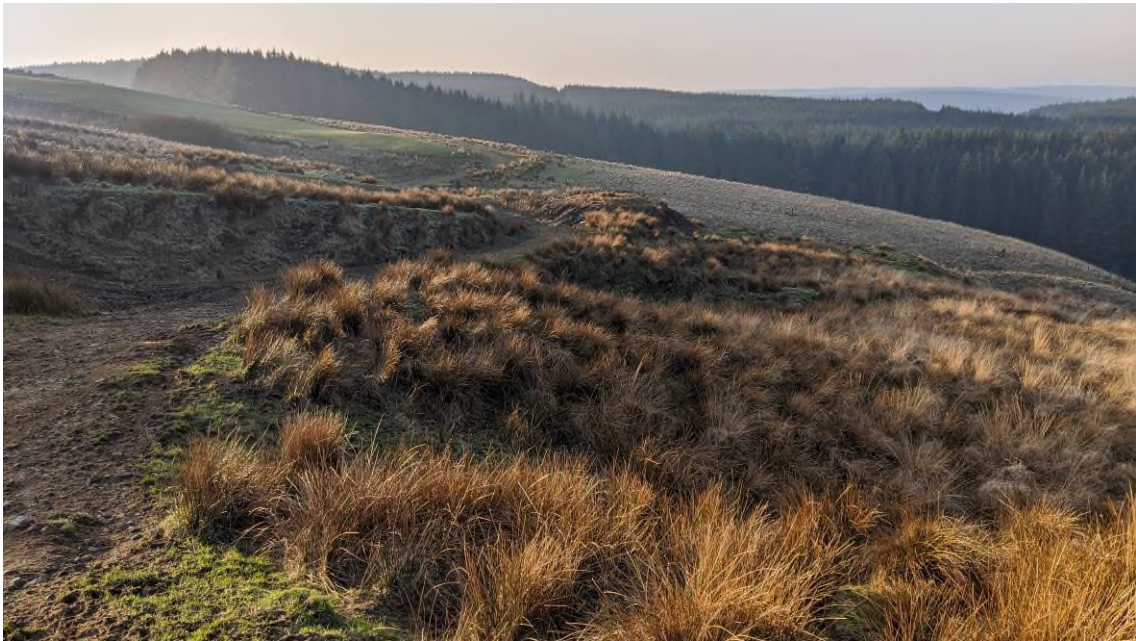
Plate 5: Area of historical coal level, to the north of T02, viewed from the northwest.

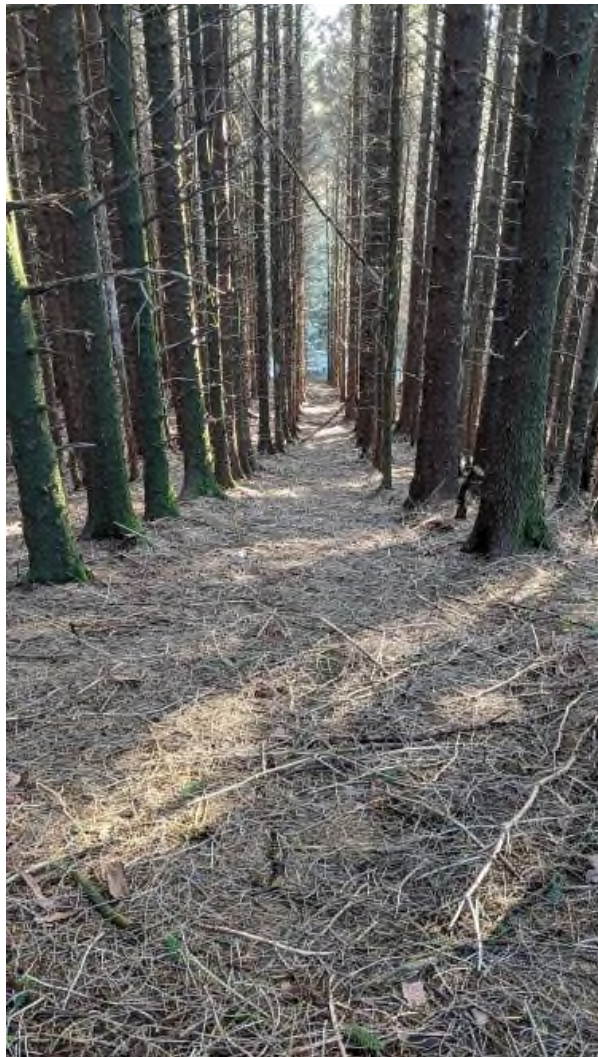
Depressions in the ground surface (Plate 8), potentially indicative of historical crop workings associated with the abovementioned Field Vein were observed to the southwest of T01. In addition, a large break in slope (Plate 6), trending roughly east-west, parallel to the Field Vein outcrop, was noted to be present south west of T01. Although no significant evidence of recent movement was observed, this break in slope may be indicative of historical collapse of shallow mining associated with the Field Vein, or collapse of deeper workings associated with a number of veins which underlie the Field Vein.

Plate 6: Change in topography to southwest of T01, possible collapse feature, viewed from the north.

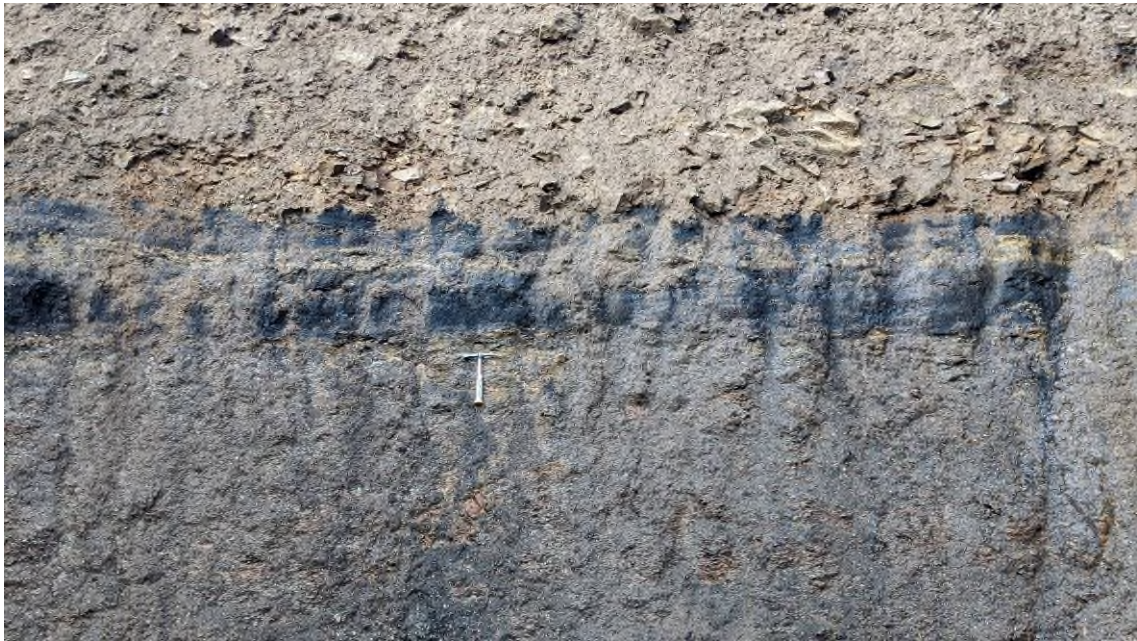
An outcrop of the Field Vein coal seam (Plate 7) was observed within a cutting to the west south of T01. The seam was approximately 0.90m in thickness at outcrop and comprised two major coal beds separated by seatearth. The apparent dip of the outcrop was recorded as 18° down to 198° (approximately south).

Plate 7: Outcrop of Field Vein, to south west of T01, viewed from the south.

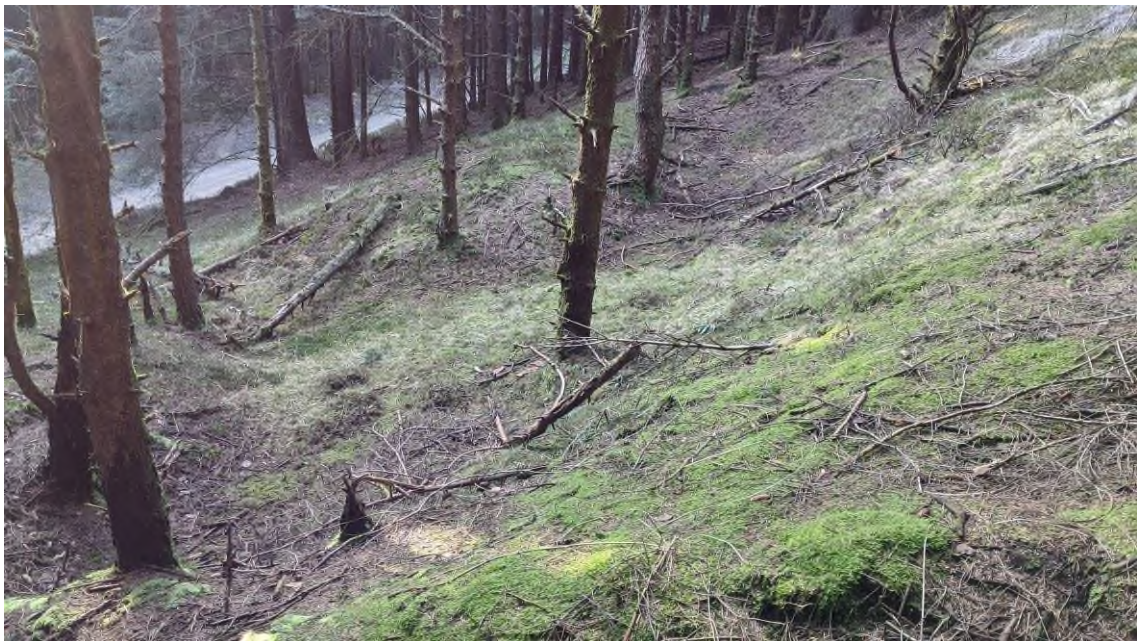
Plate 8: Example of possible crop working, to south west of T01, viewed from the northeast.

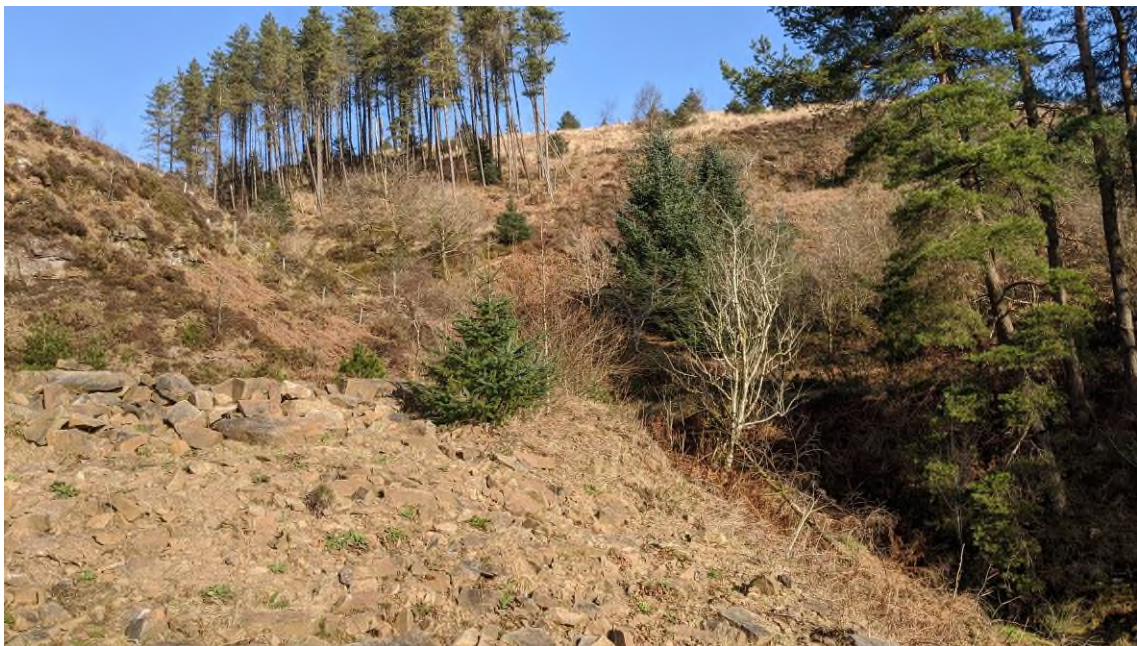
Plate 10: Area of old coal level, to east of T03, viewed from southwest.

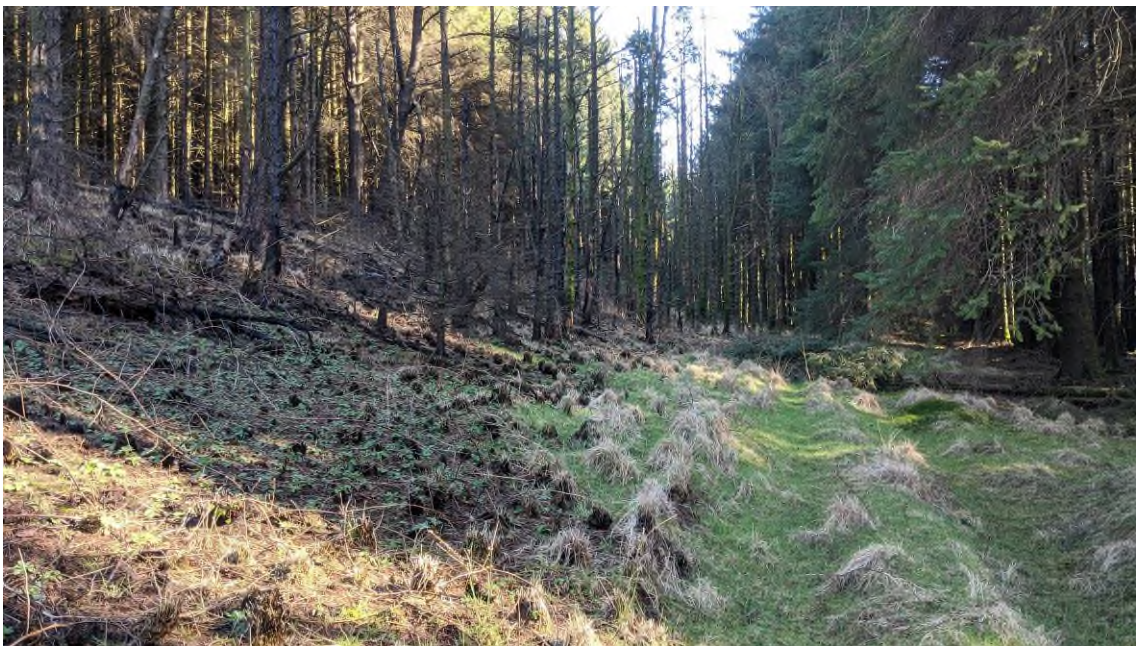
A break in slope (Plate 12) was observed to be present trending approximately east-west across the location of the Penhydd Main construction compound. This break in slope is considered to potentially be a surface expression of an outcrop of 'Thin Coal' mapped to be present at this location. Although not observed, small scale, localised crop workings associated with the abovementioned outcrop may be present at the location of the compound.

Plate 12: Change in elevation associated with Thin Coal outcrop to east of Penhydd Main construction compound, viewed from west.

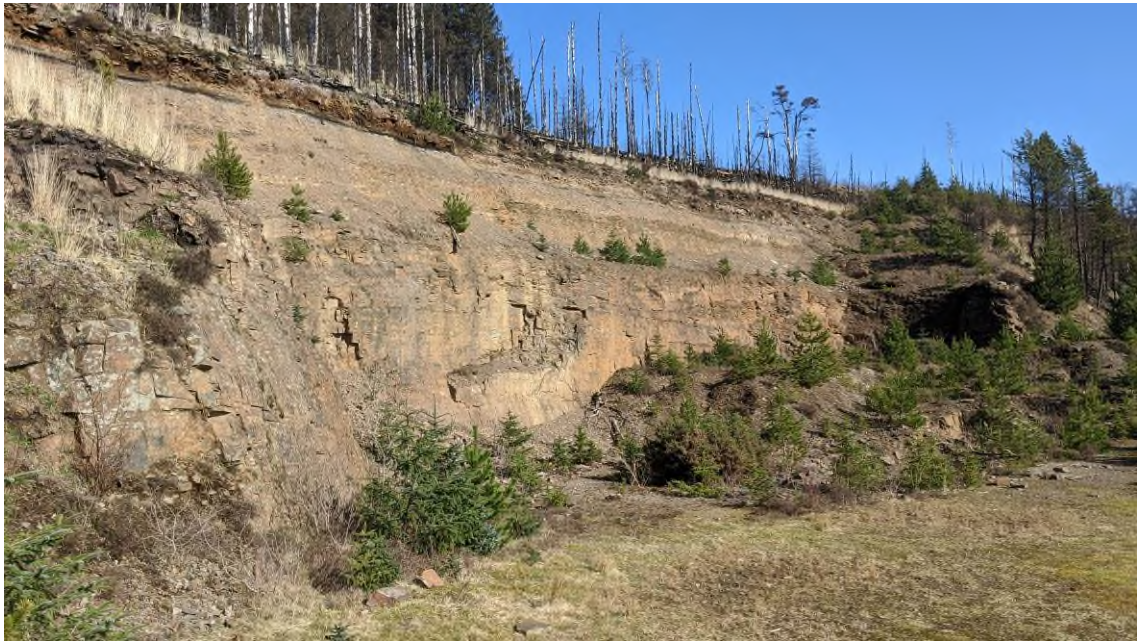
An outcrop of the Tormynydd coal seam was also observed within a quarry (Plate 13) to the east of T05. Access was not possible to the seam.

The dip direction of the exposed bedding in each quarry location is presented on Figures G and H and an example photograph of the quarry features is shown on Plates 13. The exposed bedrock typically comprised sandstone, which ranged from medium strong to strong and was typically thinly to thickly bedded and closely to widely fractured.

Plate 13: Bedrock exposure within historical quarry to east of T5, with outcrop of Tormynydd seam (To) visible towards crest, viewed from southwest.

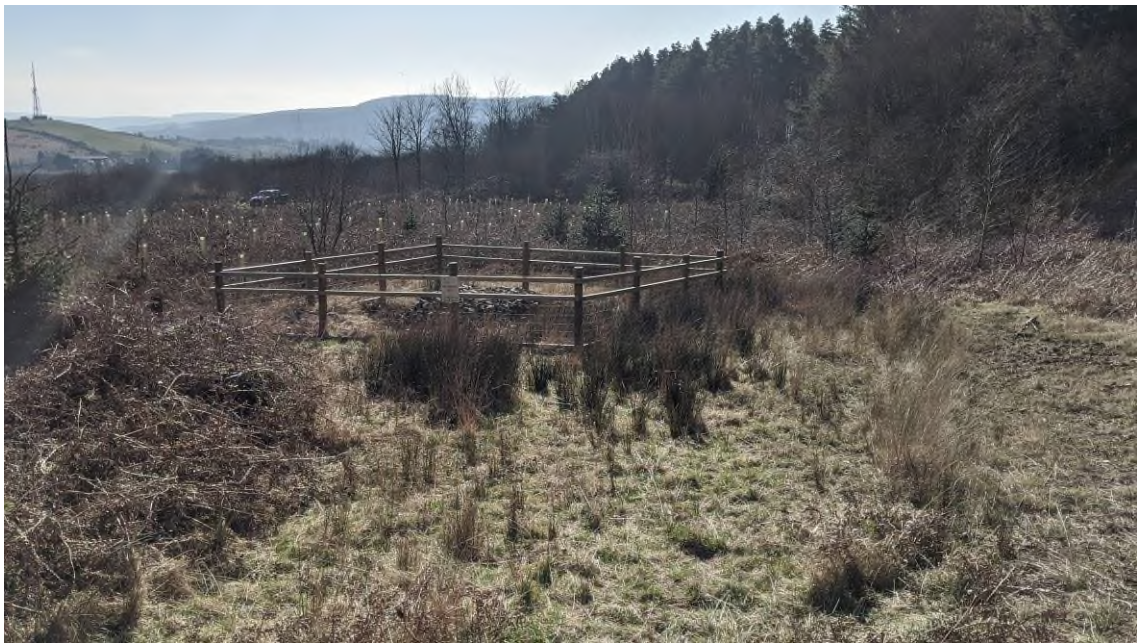
The shaft was noted to have been secured by a wooden post and rail fence with stone boulders present across the entrance.

Plate 15: Shaft in north of proposed Penhydd Entrance construction compound location, showing fencing and stone covering, viewed from north.

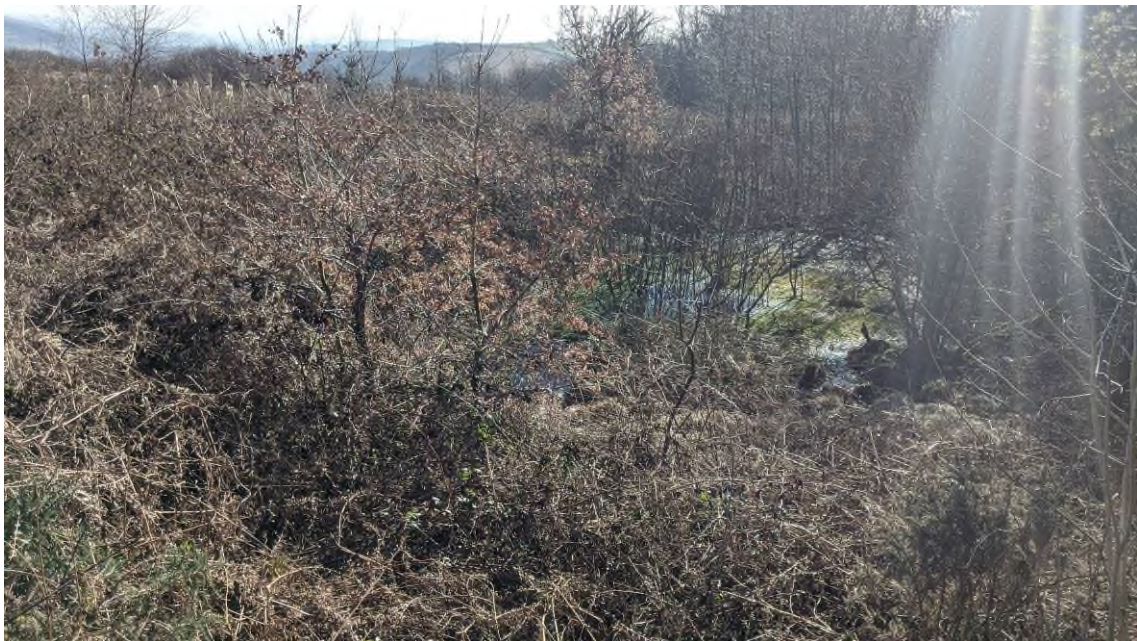
Plate 16: Overgrown slant in location proposed Penhydd Entrance construction compound, water logged ground in right of frame showing base of cutting with sapling sleeves in left of frame showing surrounding ground level, viewed from north.

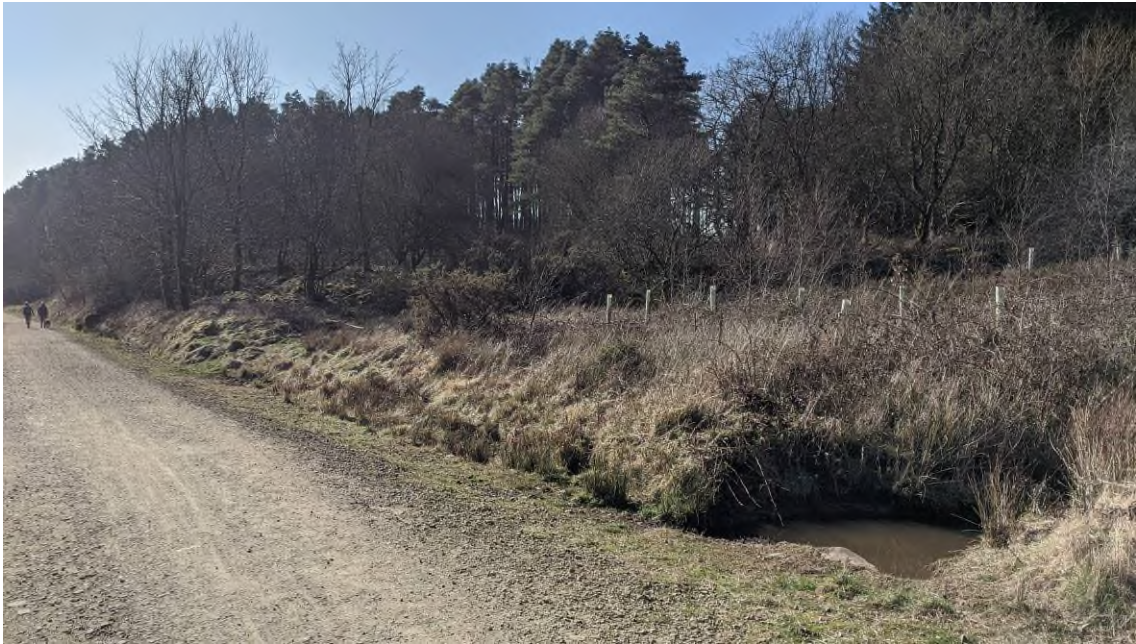
Plate 17: Overgrown spoil heaps associated with nearby slant and shaft in south of proposed Penhydd Entrance construction compound location, viewed from northeast.

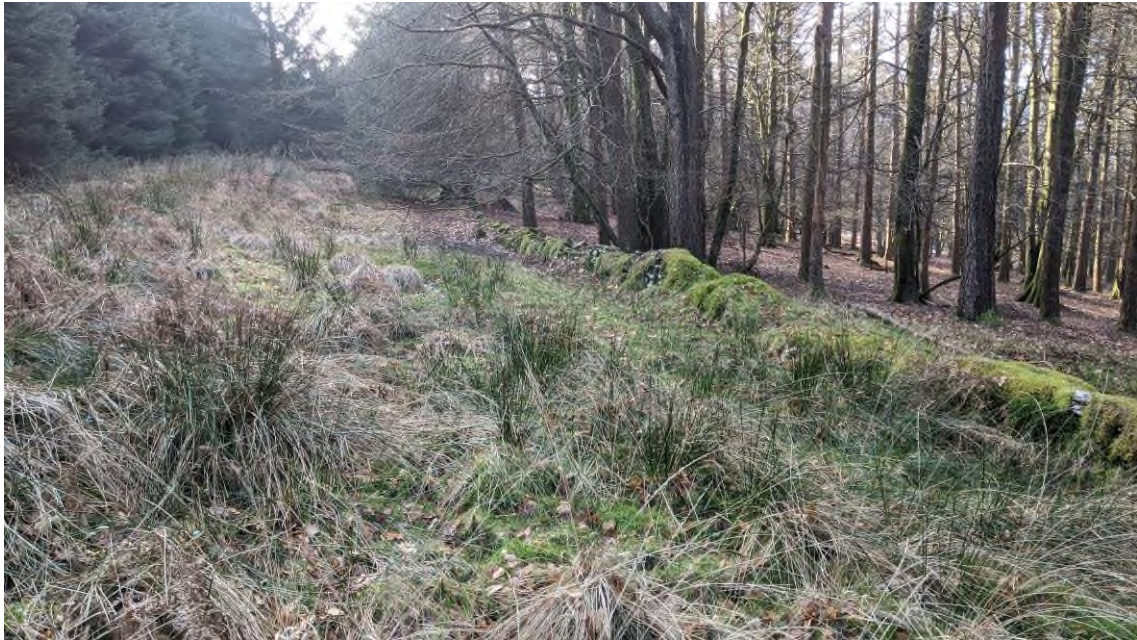
A slight break in slope (Plate 18) was observed to the north of T07, which may be a surface expression of an outcrop of the Brithdir coal seam, which is mapped to be present at this location.

Plate 18: Slight change in ground level (left of frame) possibly associated with Brithdir (Bd) outcrop to north of T07, viewed from the north.

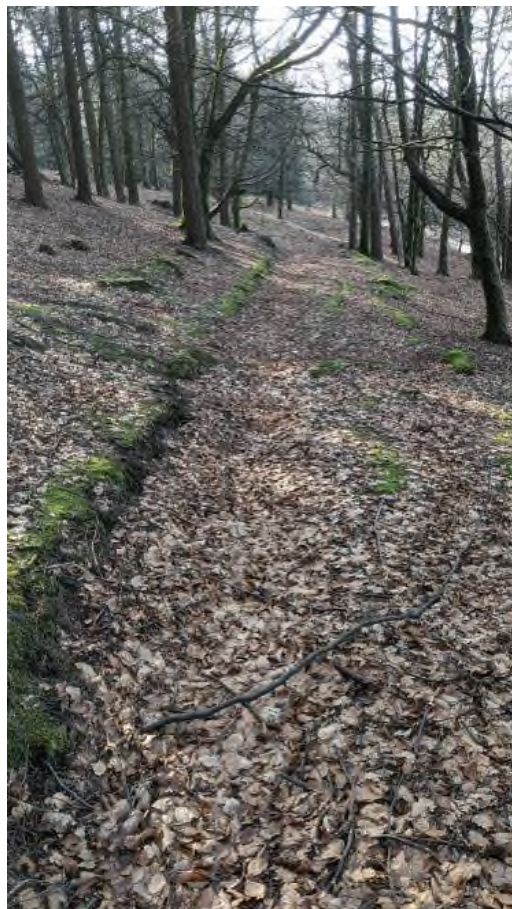
In addition, a potential historical access track (Plate 19) was observed to the north of T07. This feature may have been associated with historical surface workings of the abovementioned Brithdir coal seam.

Plate 19: Possible access track to west of Brithdir (Bd) outcrop to north of T07, possibly associated with historical workings, viewed from the north.

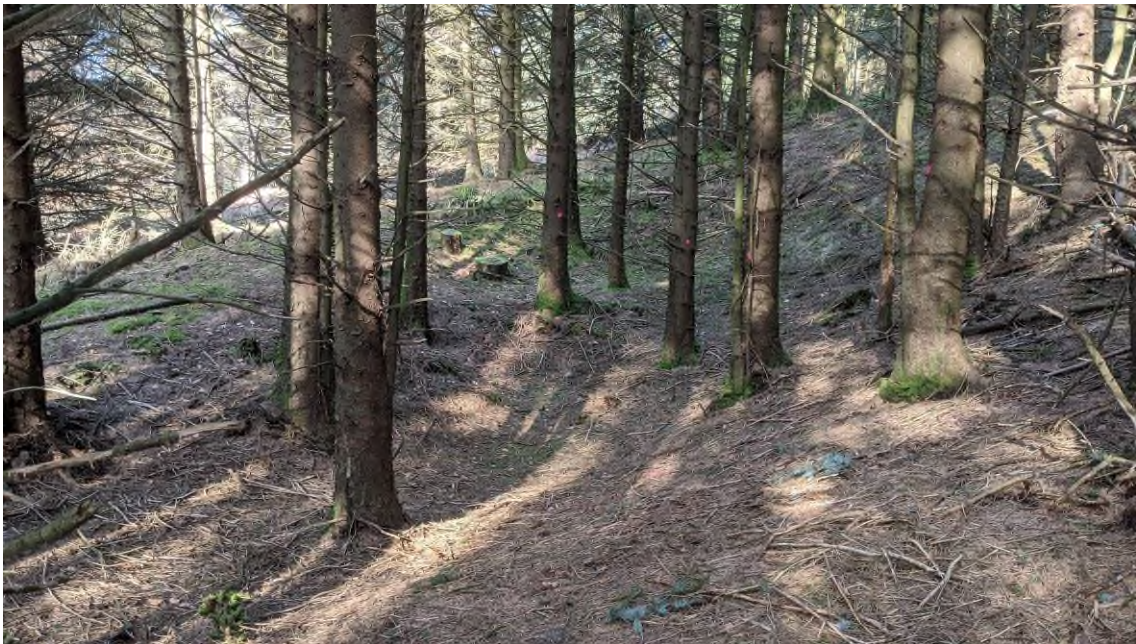
Possible crop workings (Plate 20), potentially associated with an outcrop of the Brithdir coal seam, were observed to be present to the south of T07. This feature appeared at the surface as a large depression (approximately 10m x 30m and up to approximately 3m

in depth). No evidence of recent significant ground movement occurring, such as fresh ground, bowed trees, etc, was noted. This feature may have been infilled following abandonment and further, currently unidentified, features may be locally present, especially along the mapped outcrop, which within 100m of T07.

Plate 20: Possible crop working associated with Brithdir (Bd) immediately south of T07, viewed from the southeast.

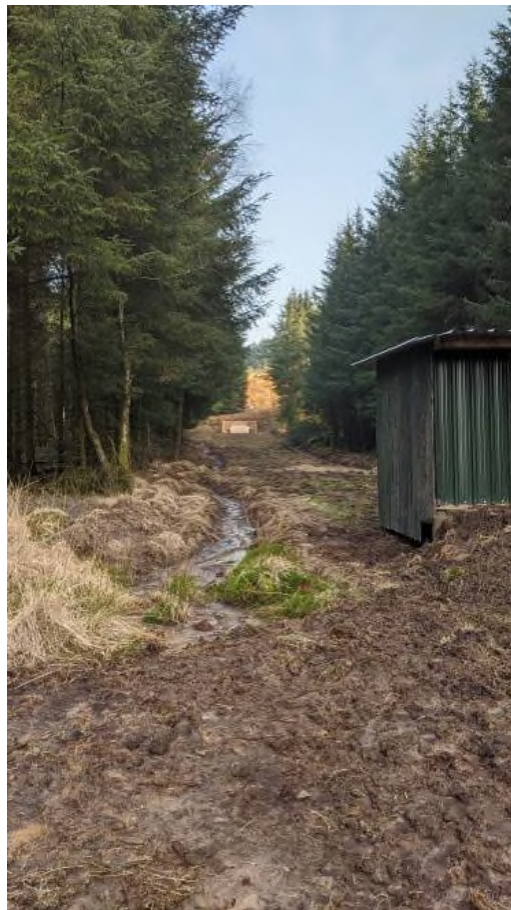
Plate 21: Change of topography (centre distance) to west of proposed T08 location, possibly associated with Brithdir (Bd) outcrop, viewed from the west.

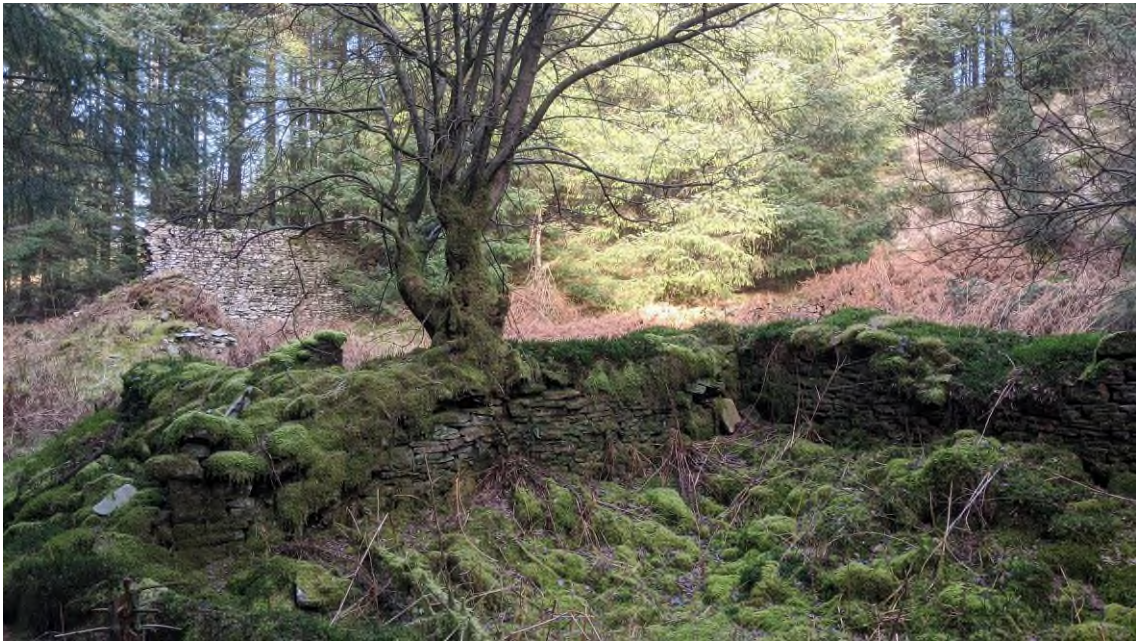
In addition, historical buildings (Plate 22) were noted to be present at the base of this break in slope and are considered likely to comprise the surface infrastructure associated with the recorded adit. The location of the adit entrance was not identified.

Plate 22: Historical buildings possibly associated with crop workings of Brithdir (Bd) to west of T08 location, change in elevation in east of frame, viewed from the southwest.

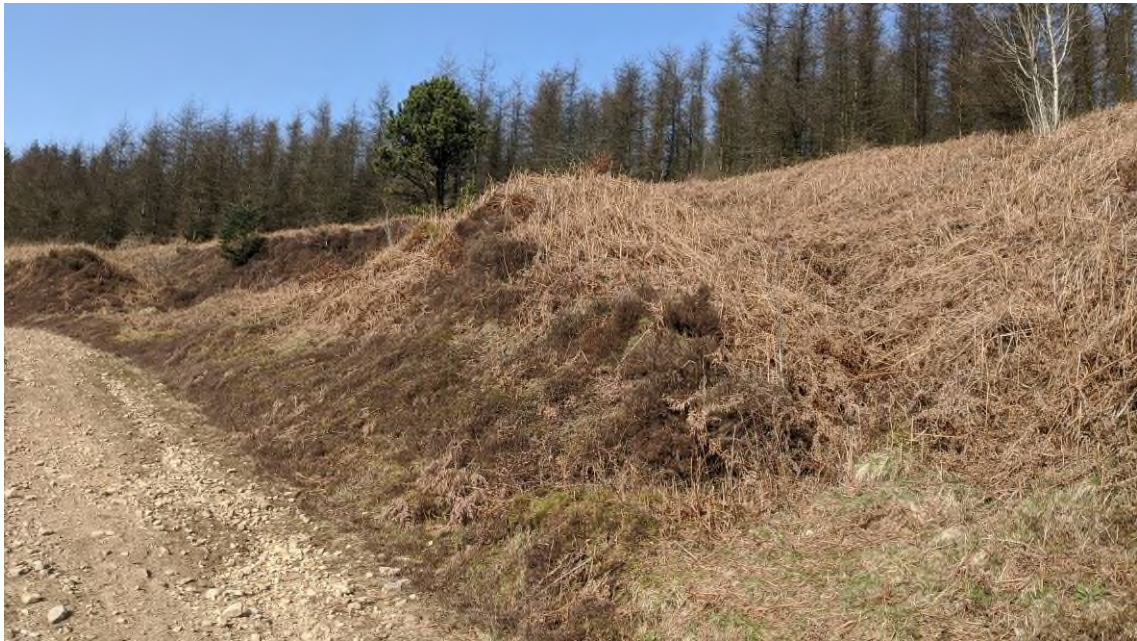
Plate 26: Possible historical coal levels (drifts/ adits) to the south of Bryn South construction compound, viewed from the south.
