# Maesteg Road

BS5837:2012 Tree Survey

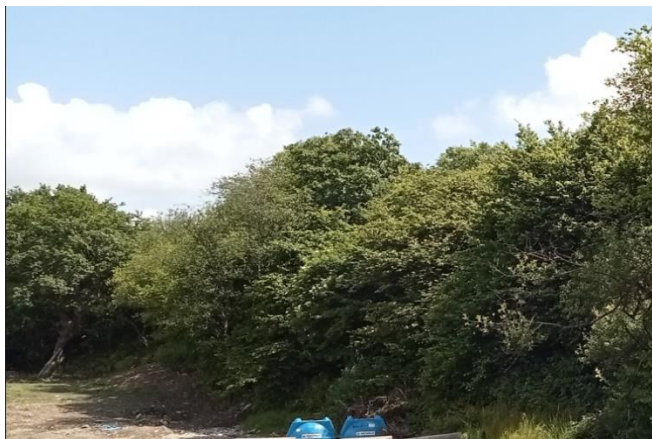
South boundary

2.2.2 The south boundary of the site is a disused railway embankment with a sparse cover of predominantly hazel (*Corylus avellana*) coppice with some semi-mature sessile oak (*Quercus petraea*) and goat willow (*Salix caprea*).

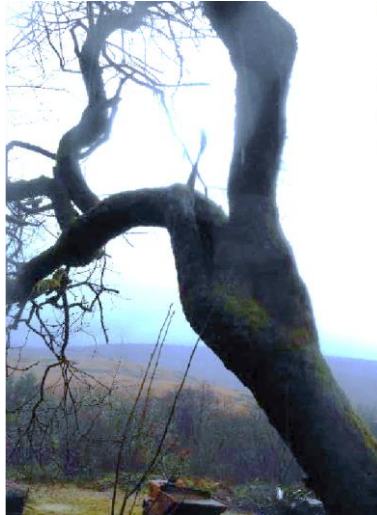
limb overhanging the site has split and needs to be removed. The remaining stem is leaning away from the site; this stem has split and will fail but will not impact on the site. This stem can be removed or retained as required. The hazel coppice on the embankment will not be affected by the development. The embankment is outside the curtilage of the site.

| BS5837:2012 Tree Survey | | | | | | | | | | | | RTAC | |
|---|---|---|---|---|---|---|---|---|---|---|---|---|--|
| | | | | S | 7 | 1 | | | | B: Poor | Large split in limb overhanging site - remove this limb. Stem leaning away from site has split at base - retain. | | |

T373 showing split limb

| Tree Number | Species | Works Required |
|---|---|---|
| T373 | Goat willow | Remove split limb |

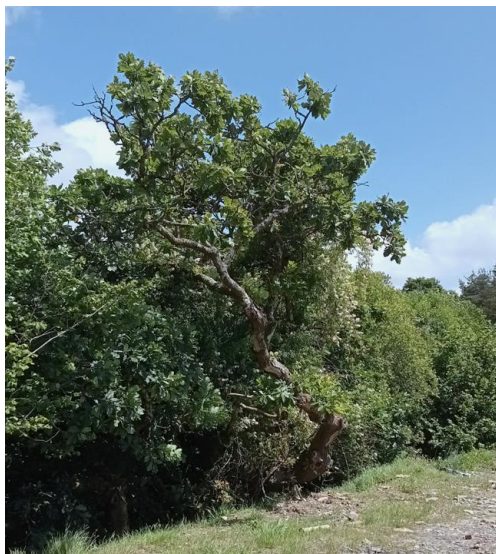
5.2.3 T375 is below the level of the development site; no roots from this tree will encroach into the site. The crown of the tree has a slight overhang into the site, but this will not be affected by the development.
