# Bat Survey Report

## Gorphwysfa Chapel, Skewen

| <b>Report title</b> | Preliminary Roost Assessment |

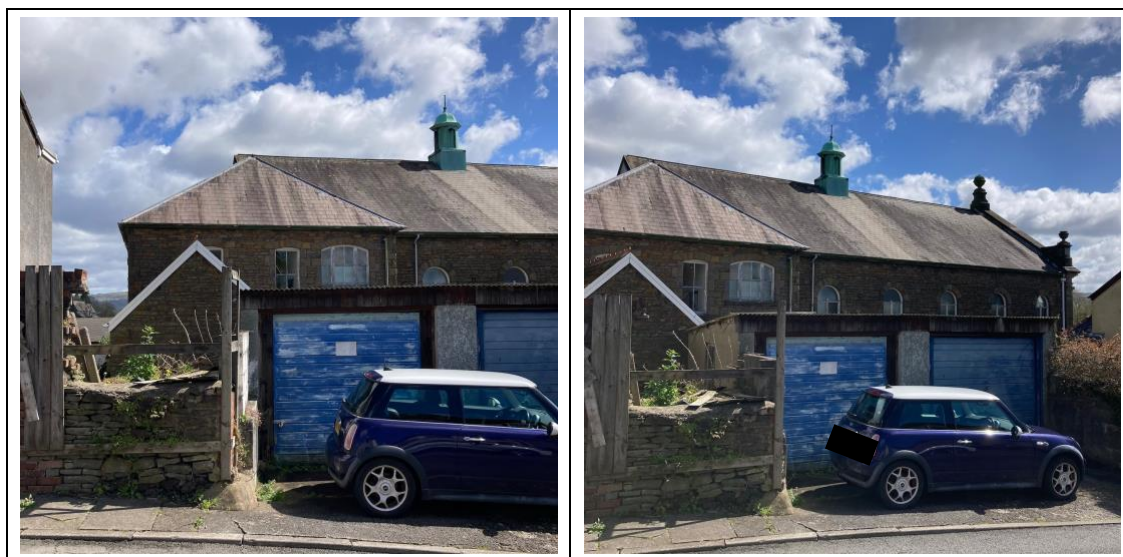
- 4.3.2 The building is built of stone in the classical style, with dressed stone window surrounds. The arches of the two main doors have prominent keystones and there are four pilasters on this front elevation, set between the windows and doors (Figure 9 below). The chapel roof is pitched with one of the gables forming the front of the building, and a low parapet wall is present with flat coping stones on top. The apex of the front gable has a finial, as do the corners of the building at the front, and there is a molded cornice where the roof joins the front façade. A cupola, which forms part of the building's ventilation system, is present on the ridge of the chapel (see Figures 10 and 11 below).

Figure 11. Western elevation, note finials and parapet wall on gable.

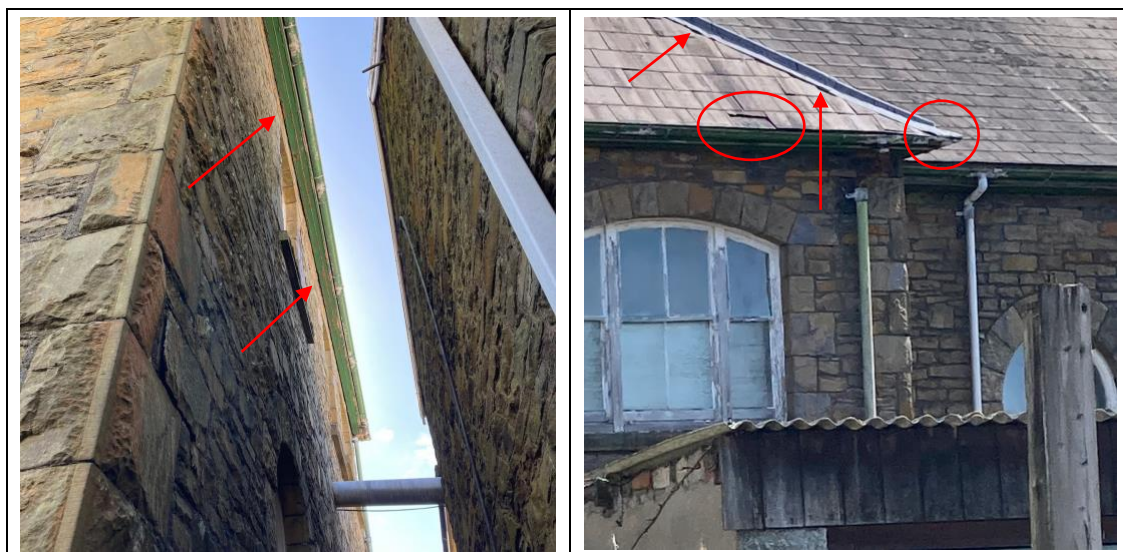
4.3.4 The roof covering of both the schoolroom and the chapel is slate and there is lead flashing where this joins the parapet wall at the front, along with the valleys previously mentioned. Ridge tiles are likely clay with mortar between them. Soffits and fascias appear to be of wood, and some gaps are present (see Figure 12 below). The roof generally appears to be in reasonable condition, largely remaining weathertight, although there are a number of lifted tiles with a few that are broken or slipped in places, and some gaps under lead flashing (see Figure 13 below). Mortar between and under ridge tiles is missing in places.

Figure 12. Example of gaps between walls and soffits.

Figure 13. Example of gaps under lead flashing, missing/slipped tiles.

4. **Replacement of sections of lead flashing, soffits/fascias and ridge/hip ridge tiles.** Full close-visual inspection by an appropriately competent ecologist using a torch and endoscope of any such features is recommended. It may be possible to rule out the presence of bats by way of these inspections alone, however if that is not possible and/or if any evidence of bats is found, measures outlined in Section 6.2 may be necessary.

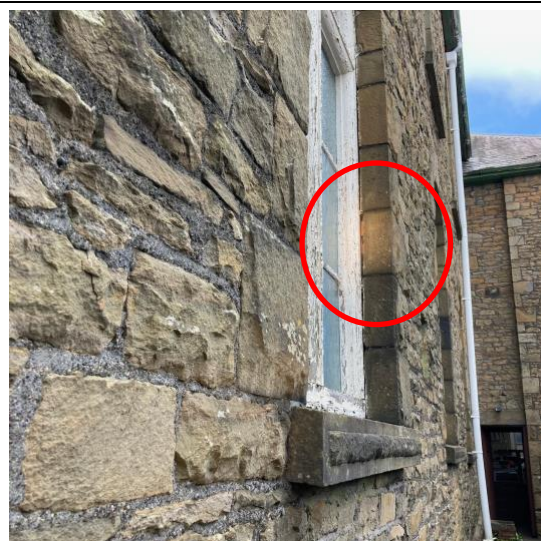
4.3.5 Windows on the western and eastern elevations of the chapel and the rear of the school room, are in two tiers. Window frames are wooden and there are a gaps between the frames and the stone work in places (see Figure 14 below). Guttering and downpipes appear to be a mix of metal and uPVC.

Figure 14. Example of gaps between stone & window frames.

2. **Repairs to windows.** It is understood that window repairs may be completed gradually by way of a scaffolding tower that is moved around the building. No evidence of bats was found around any of the windows inspected during the survey, and in most cases it was possible to see to the back of the gaps between the frames and the stone walls with a powerful torch. However, bats using shallow spaces like these may be individuals or in low numbers and very transient, i.e. using the space for only the odd night here and there, and the windows on the upper floors were not inspected in detail during the PRA due to the visual constraints already described. It is recommended that when window repairs take place, these features are inspected/re-inspected by a suitably competent ecologist prior to works commencing. If any signs of bats are found, or if their presence cannot be conclusively ruled out (for example if gaps extend further into the fabric of the

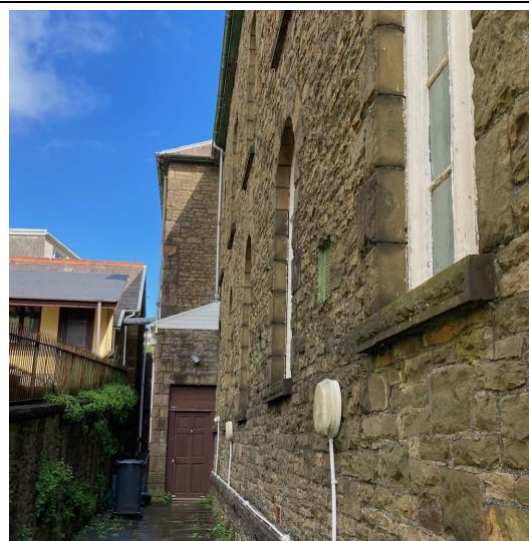
4.3.6 A small lean-to porch is present on the western elevation of the building, allowing access to the rear schoolroom (see Figure 15 below). uPVC cladding is present on the front gable.

Figure 15. Lean-to porch on western elevation.

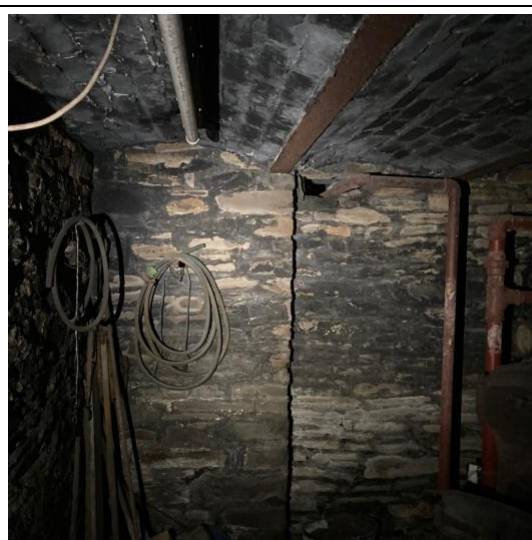
Figure 23. Below-ground room with old heating system.

4.4.3 A small cellar-like space is present below ground level at the south eastern corner of the schoolroom (see Figure 23 above). This is stone/brick lined and was previously used to house the original heating system, and is not accessible externally.

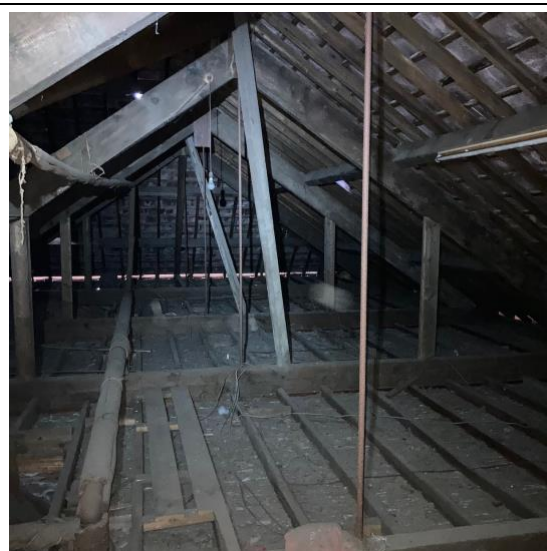
- 4.4.5 The loft of the building was accessed via a hatch in the first floor corridor. The roof void over the schoolroom is around 2.5m to the top of the ridge board and is supported by timbers of modified queen post construction, with additional steel posts and wooden timbers in places (see Figure 26 below). The loft over the chapel is of similar construction, with additional collar beams present, and the height to the top of the ridge board is around 3.5m. Large metal pipework that forms part of the heating/ventilation system is present in this area (see Figure 27 below).

Figure 26. Loft void above the school room. Note light at eaves.

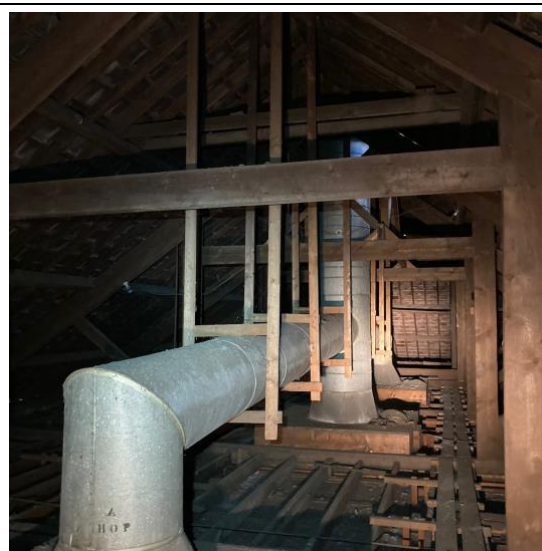
Figure 27. Loft void above chapel, showing ventilation pipework.

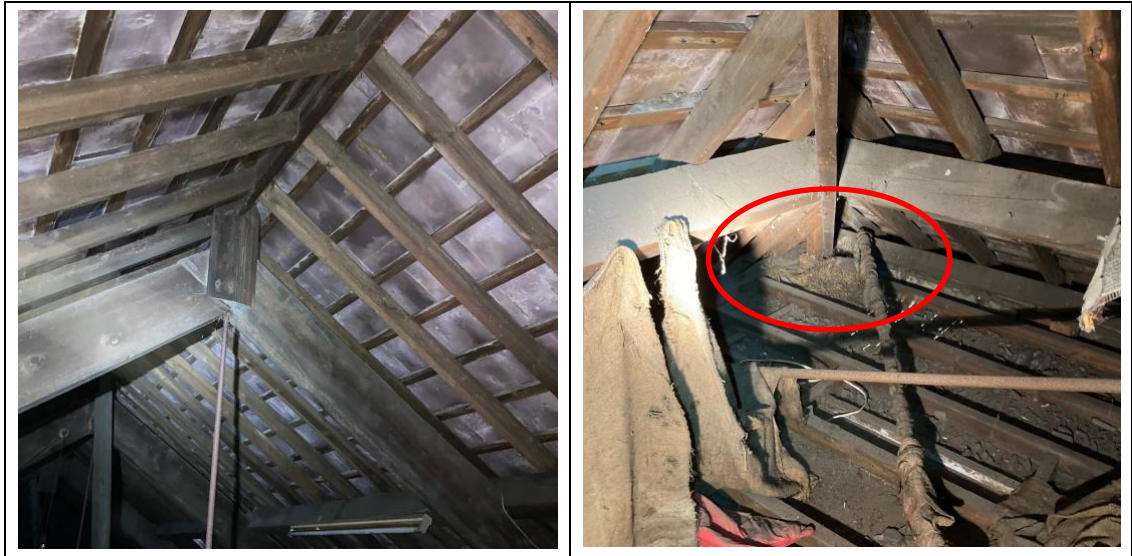
- 4.4.6 No insulation is present anywhere on the floor of the loft, leaving tie beams and ceiling supports visible. Walk-boards are present throughout the loft void, making it easy to access the majority of the space. No felt is present underneath any of the tiles (see Figure 28 below), and in places light is visible around slipped, lifted and missing tiles, as well as at the eaves.

Figure 28. There is no felt underneath any of the tiles.

Figure 29. Old bird nest in corner of loft void over schoolroom.

- 4.5.1 A single old nest (likely jackdaw or similar sized bird) was noted in the eastern corner of the schoolroom loft void, close to the eaves (see Figure 29 above) and there are multiple opportunities for future colonisation, in particular via gaps at the base of eaves and at the bottom of hip ridges.

- 6.3.1 Birds are mobile creatures and may move into areas where they have previously been absent. Any works to the building that may affect the eaves and the base of the hip ridges should therefore proceed with caution in relation to breeding birds, particularly between the months of March to August inclusive. If any signs of breeding birds are noted, all works must stop immediately and an appropriately experienced ecologist consulted. In such circumstances, the ecologist may recommend that works be suspended until young birds have fledged the nest, or the nest is no longer viable. Alternatively, works may be suspended within an appropriate exclusion zone.
