# Maesteg Road

BS5837:2012 Tree Survey

## Revision C - 09.08.2024

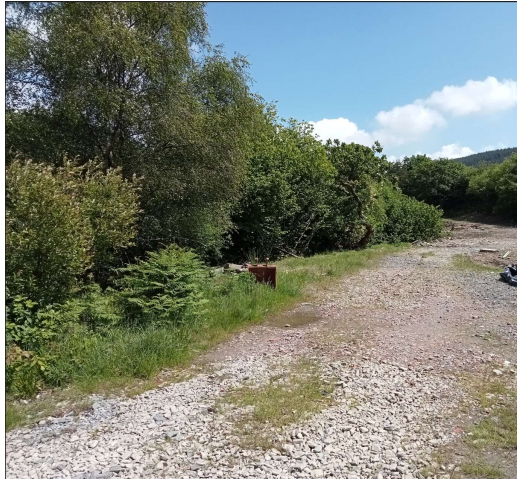
Site from entrance North Boundary

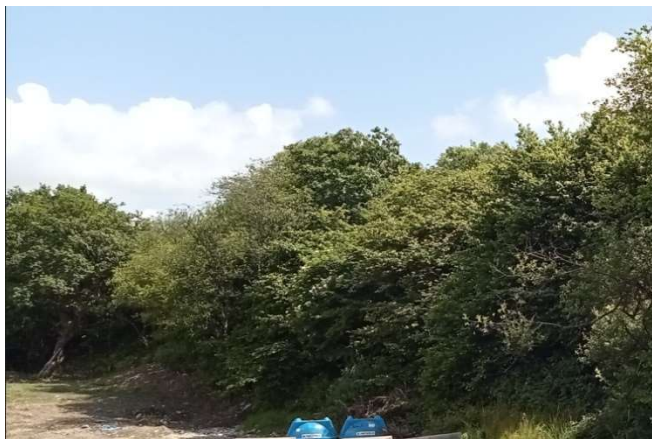
South boundary

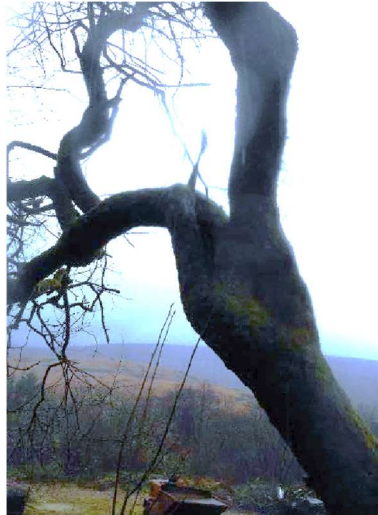
tree as it has an uninterrupted rooting area in every other direction and the embankment will be undisturbed by the development. T373 is in poor condition, the limb overhanging the site has split and needs to be removed. The remaining stem is leaning away from the site; this stem has split and will fail but will not impact on the site. This stem can be removed or retained as required. The hazel coppice on the embankment will not be affected by the development. The embankment is outside the curtilage of the site.

T373 showing split limb

| Tree Number | Species | Works Required |
|---|---|---|
| T373 | Goat willow | Remove split limb |

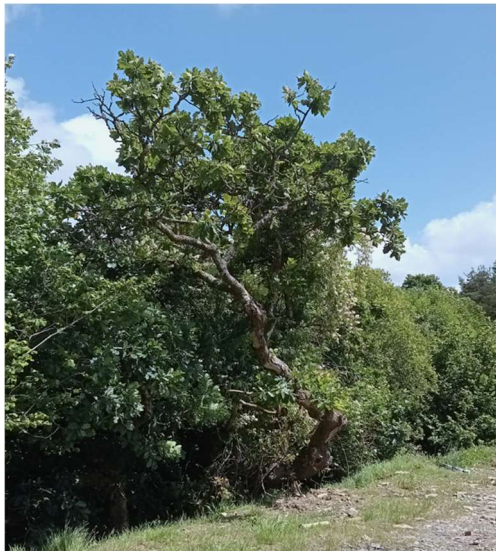
5.2.3 T375 is below the level of the development site; no roots from this tree will encroach into the site. The crown of the tree has a slight overhang into the site, but this will not be affected by the development.
