# Electric Arc Furnace

Water Vole and Otter Survey Report

2487033

MAY 2024

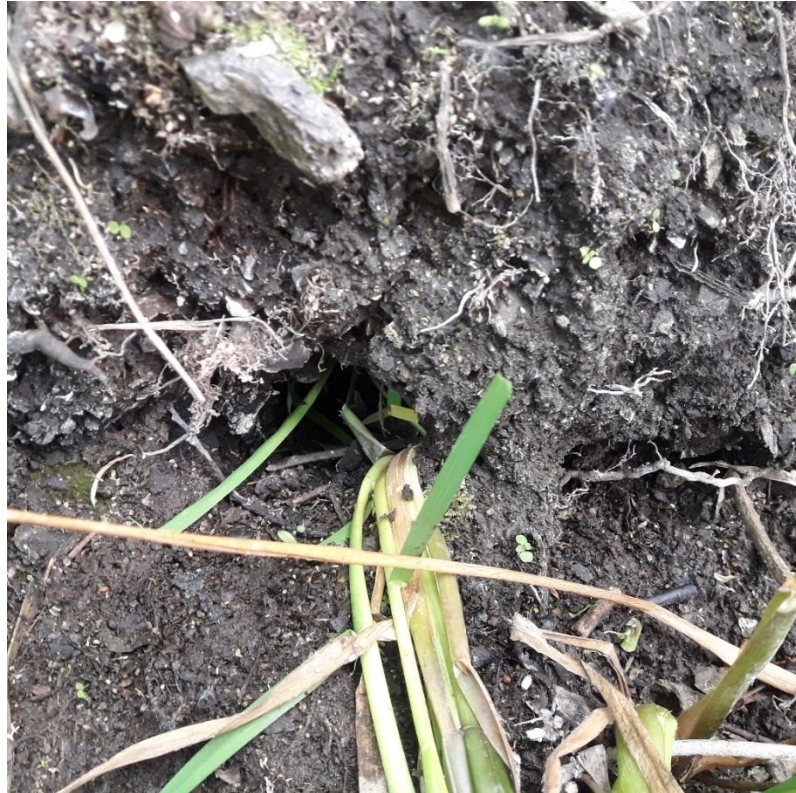
- 3.2.2 No definitive evidence of water vole e.g. latrines/ droppings were observed during the surveys on either Lower Mother Ditch (North) or the Lagoon. Small mammal evidence was however recorded on Lower Mother Ditch (north) in the form of a single burrow, 4-8 cm in width and oval in shape (Plate 1) and a chewed reed stem. This is considered evidence of the presence or bank or field vole and no evidence to suggest the presence of water vole.

Plate 1: Possible water vole burrow Lower Mother Drain (North)

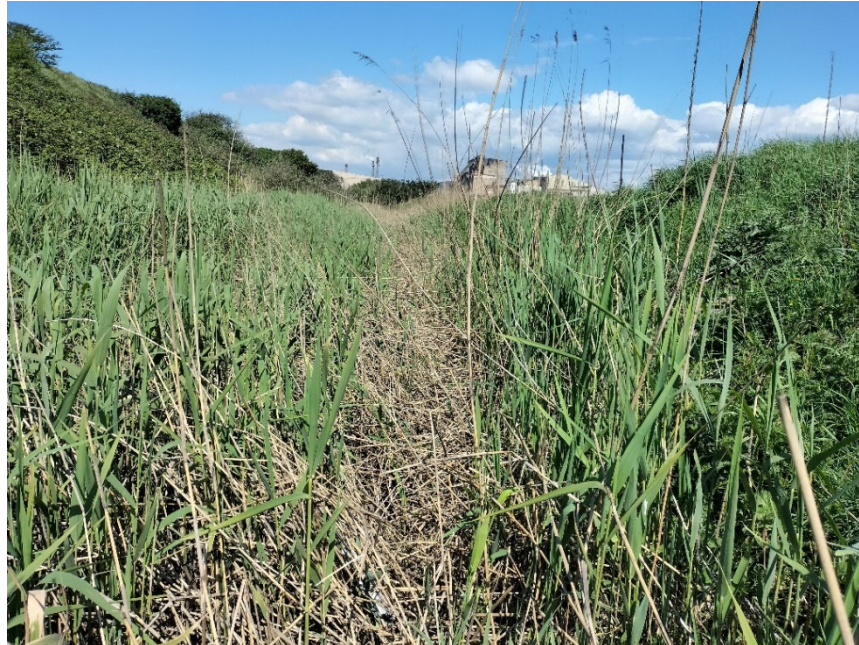
- 3.2.3 The survey of the Eastern Drains was undertaken from the bankside and where safe to do so by wading in the channel. At the time of the survey the emergent and bankside vegetation was dense and this restricted access to certain areas of the survey reach (Plate 2).

Plate 2: Dense bankside and emergent vegetation Eastern Drain

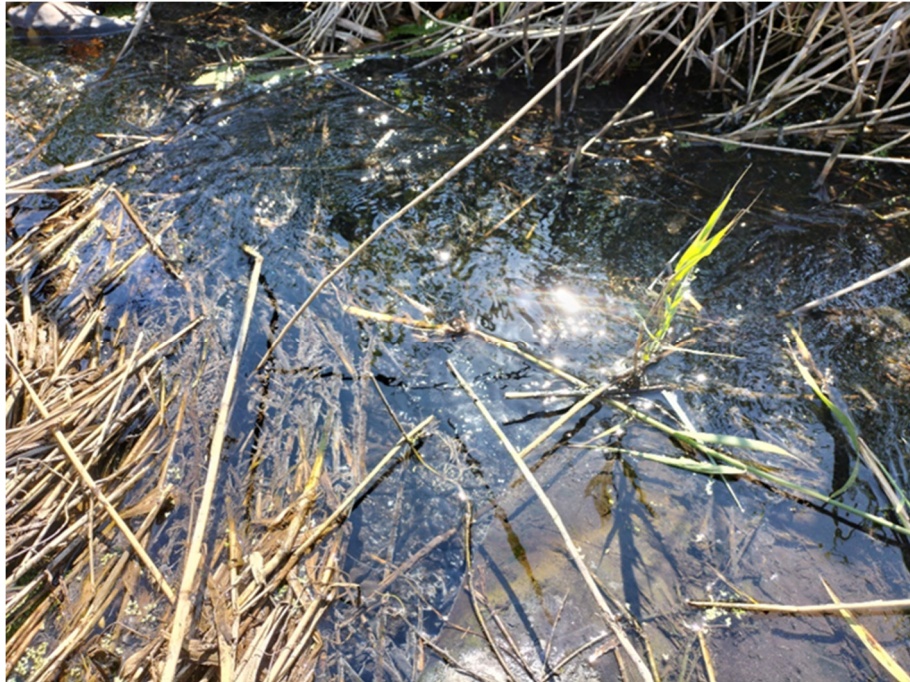
- 3.2.4 No definitive evidence of water vole e.g. latrines/droppings were observed during the surveys on the Eastern Drains.
- 3.2.5 A single dropping (which was similar to those of water vole) was collected from one of the survey rafts and sent for DNA analysis however this returned a positive identification for water shrew (see Appendix A).
- 3.2.6 During the survey a black oily tar like substance was recorded on the bed of the watercourse roughly 100 m upstream of the main road crossing (Plate 3). The survey team immediately reported the sighting to the site health and safety supervisor.

Plate 3: Black tar like substance on the bed of the watercourse

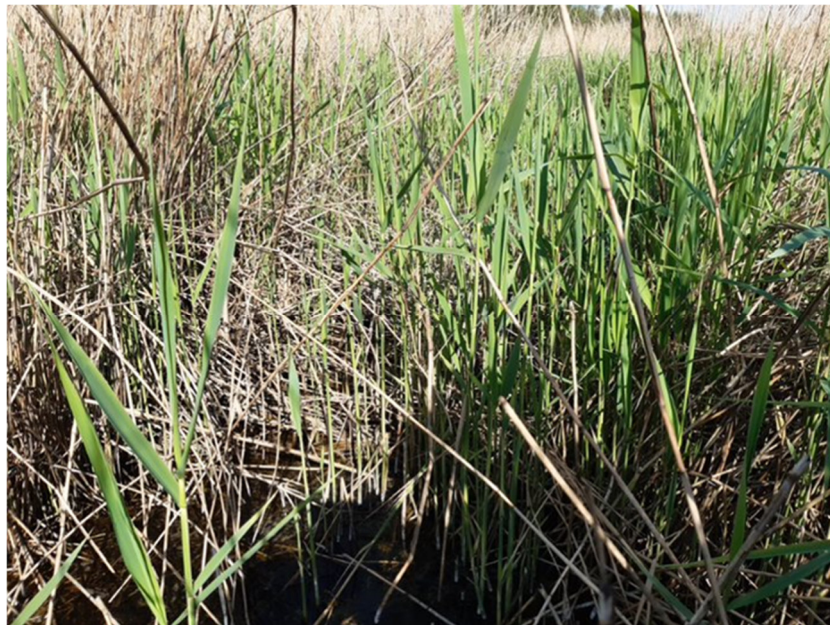
- 3.2.1 The survey on the ditches within the southern fields was undertaken on foot from the bankside and where safe to do so by wading in the channel. At the time of the survey the bankside/instream vegetation was extremely dense restricting access to large sections of the target watercourses (Plate 4). Additionally, many of the channels could not be waded due to the presence of deep water/silt.

Plate 4: Dense bankside and emergent vegetation which restricted access.

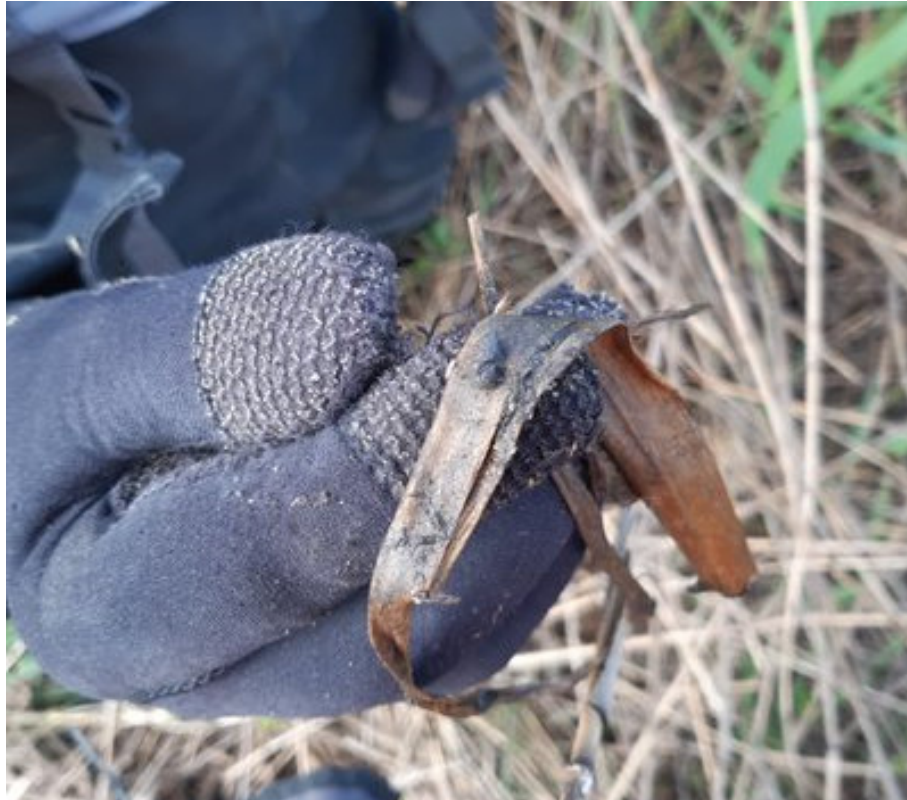
- 3.2.2 A single dropping (which was similar to that of water vole) was collected during the survey on bottom field from the drain which forms western border of the site (Plate 5). This was sent for DNA analysis which returned a negative result for water vole and was identified as water shrew (see Appendix A). Several other droppings and a latrine were recorded during the survey however these were characteristic of smaller/ larger mammal species such as bank vole and brown rat.

Plate 5: Water shrew dropping verified by DNA testing.
