Combined Arboricultural Impact  
Assessment/ Method Statement  
Land West of Mount Road  
Rhigos  
CF44 9YS

REVISION I

Conducted By: Ben Clark TechArborA

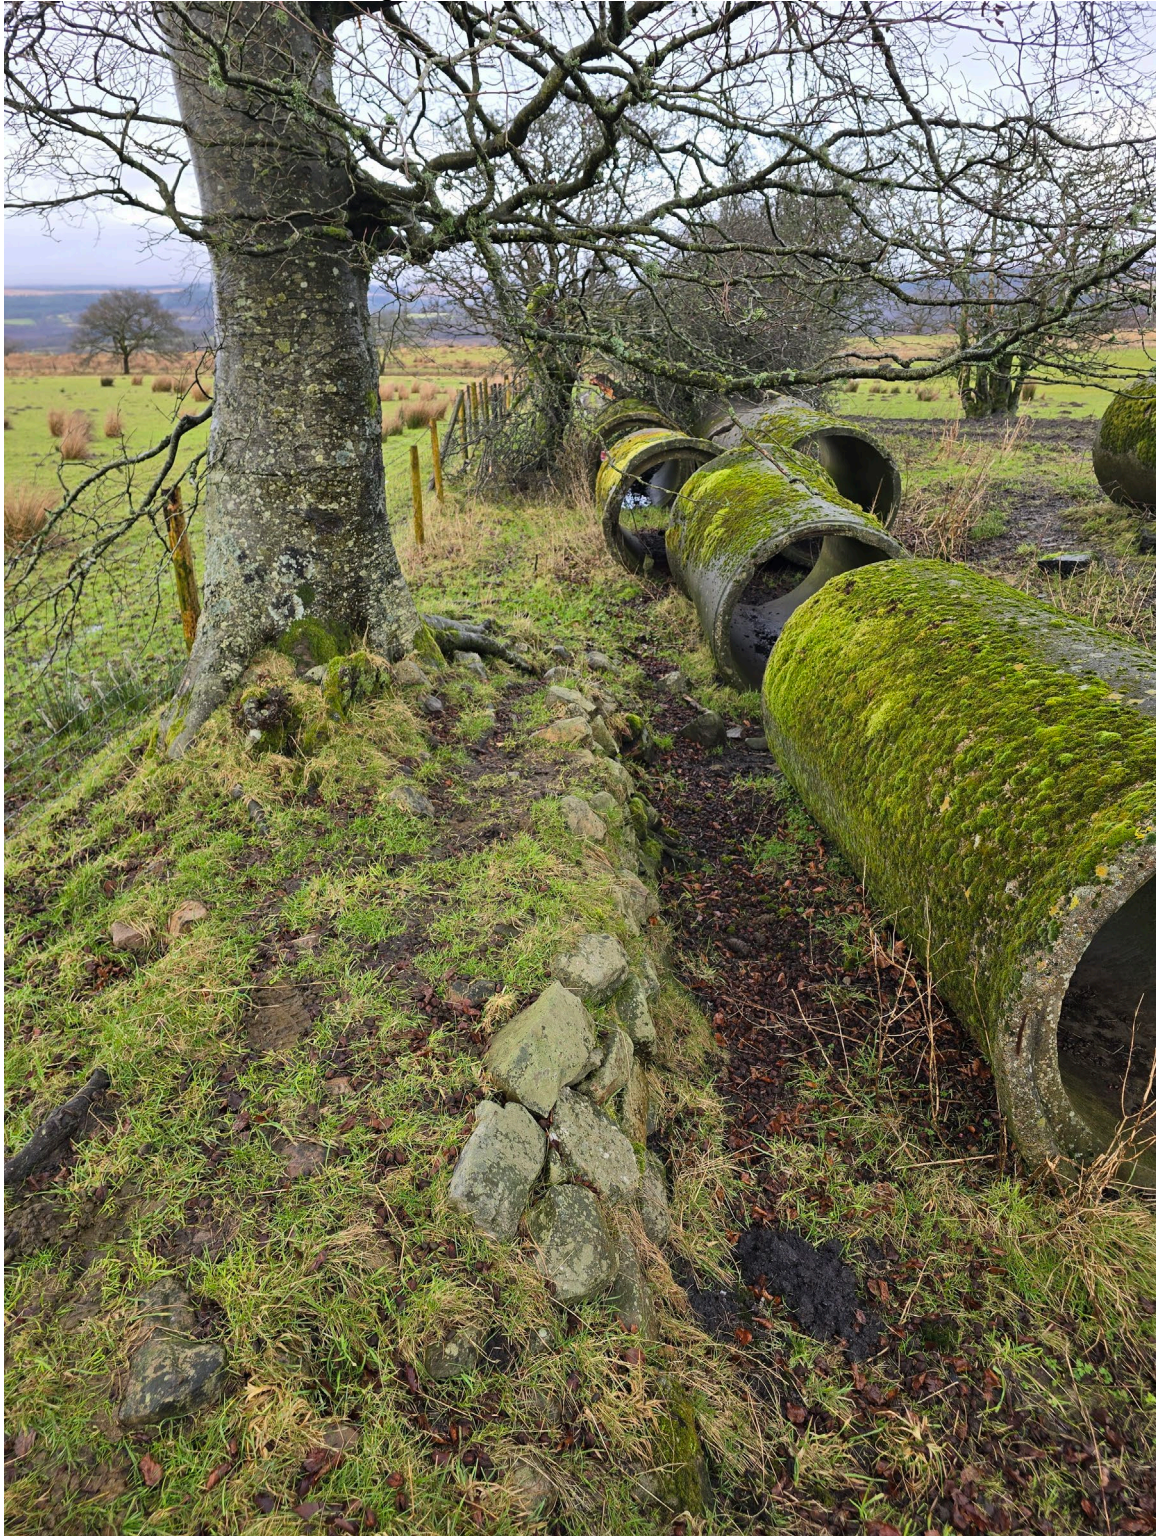
**Photo 1:** the rooting area of [T6](#) is separated from site by a water course.

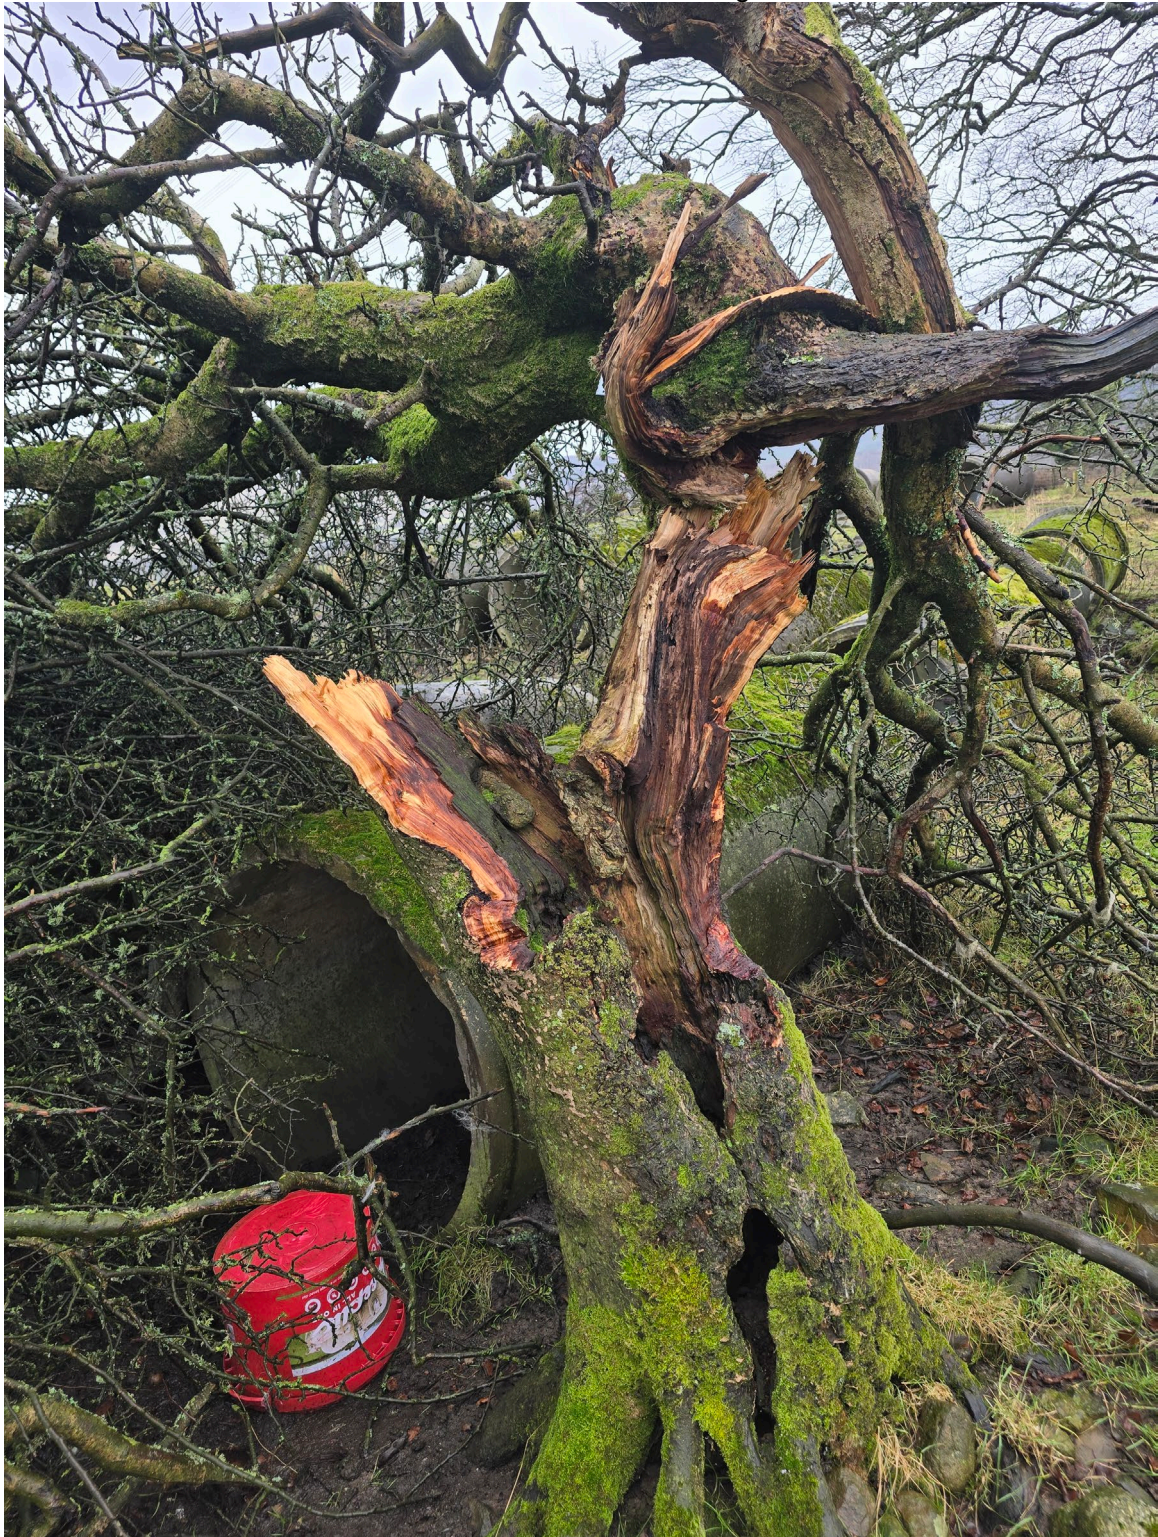
| Ref | Tag | Species | Height (m) | Stem Diameter (mm) | Crown Spread (m) | | | | Crown Clearance (m) | Lowest Branch (m) | Survey Notes | Recommendations | Life Stage | Life Expectancy (years) | Retention Category | RPA Area (m <sup>2</sup> ) | RPA Radius (m) | Photo |
|---|---|---|---|---|---|---|---|---|---|---|---|---|---|---|---|---|---|---|
| T7 | 357 | Crab apple<br>( <i>Malus sylvestris</i> ) | 6 | 450 | 2 | 4 | 2 | 0.5 | 0 | 0 | Stem failure at 1.5m above ground level. Remaining lower stem is extensively decayed with coalescing internal decay cavities observed. | If proposed development permits, retain the lower stem for habitat value and remove the failed section from site. | M | <10 | U | 0 | 0.0 | <a href="#">2</a> |

**Photo 2:** [T7](#) Stem failure at 1.5m above ground level

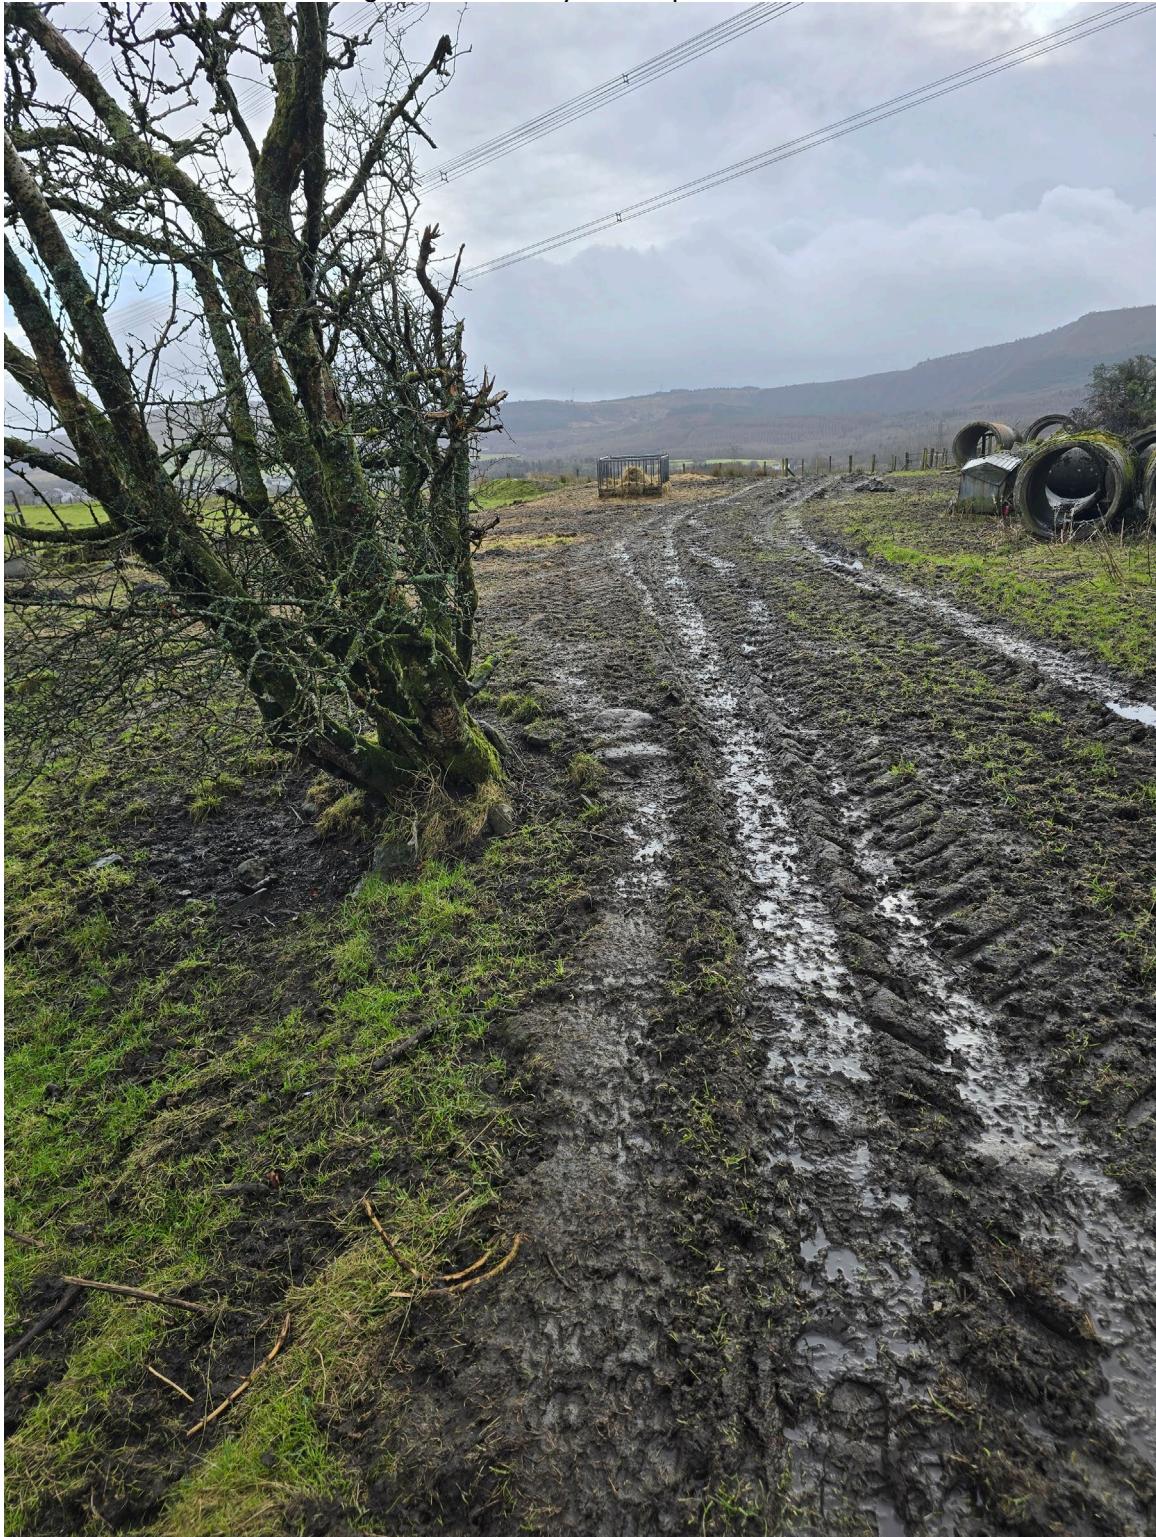
**Photo 3:** [T9](#) rooting area restricted by the compacted access road to the west.

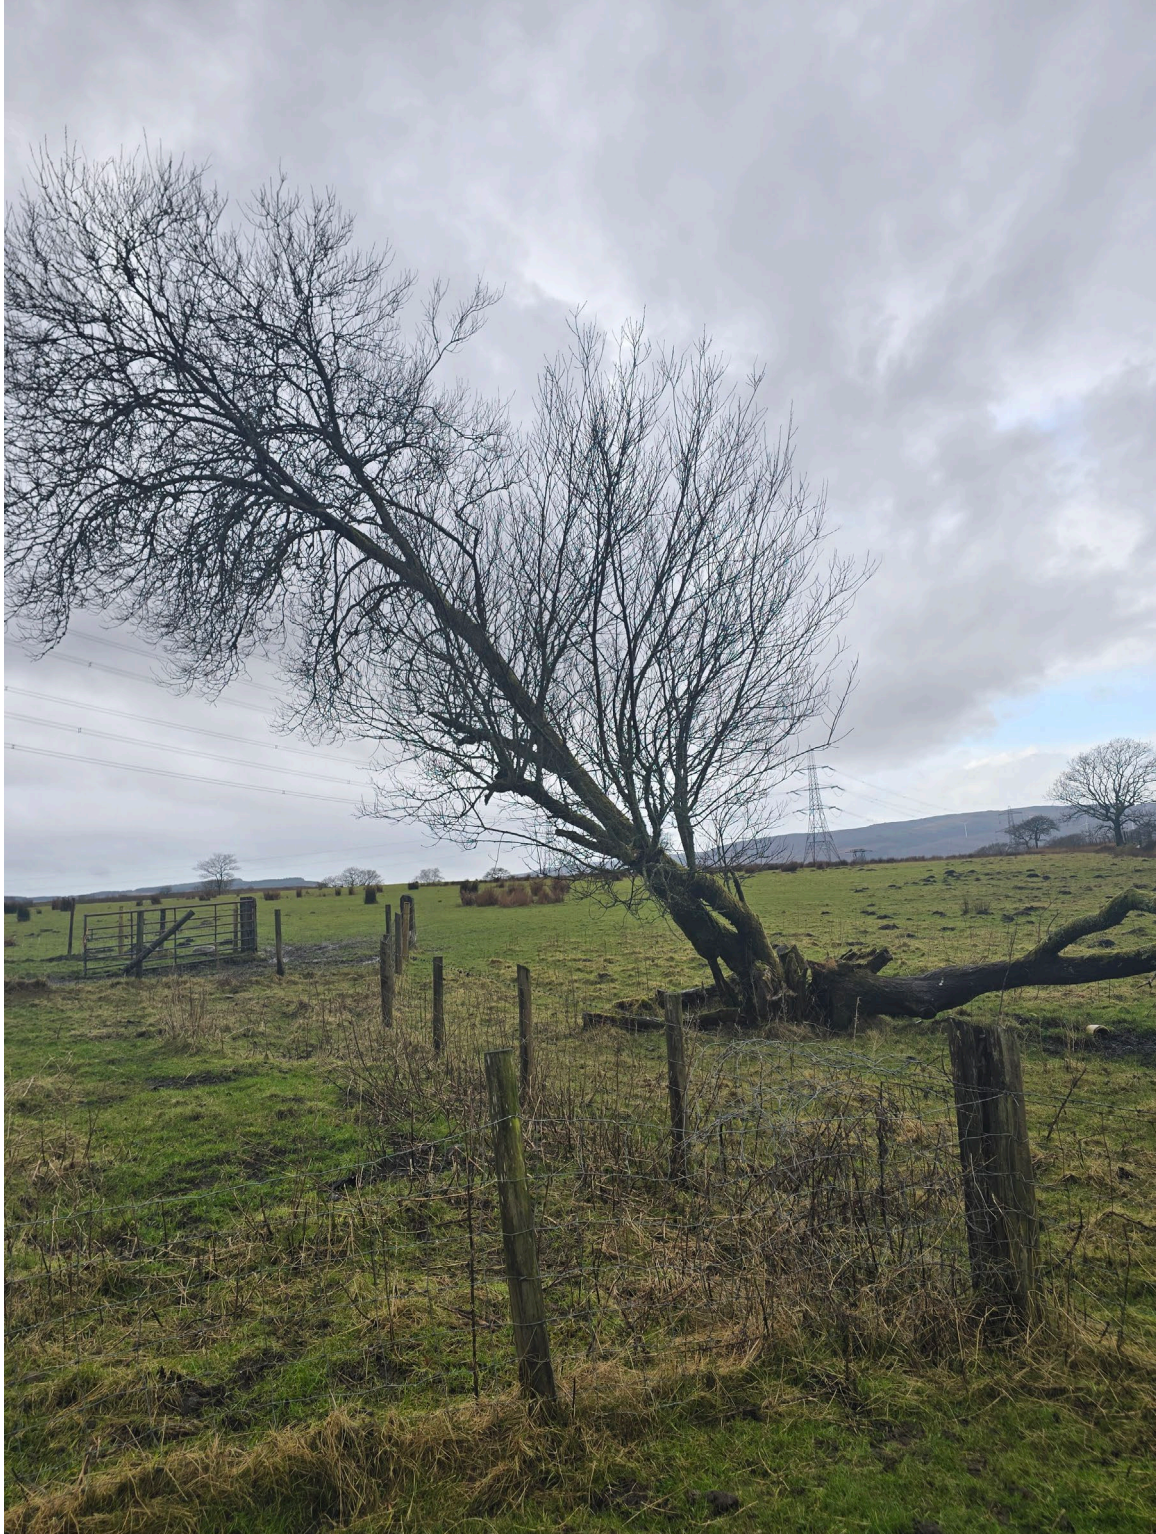
| Ref | Tag | Species | Height (m) | Stem Diameter (mm) | Crown Spread (m) | | | | Crown Clearance (m) | Lowest Branch (m) | Survey Notes | Recommendations | Life Stage | Life Expectancy (years) | Retention Category | RPA Area (m <sup>2</sup> ) | RPA Radius (m) | Photo |
|---|---|---|---|---|---|---|---|---|---|---|---|---|---|---|---|---|---|---|
| T15 | N/A | Goat willow<br>( <i>Salix caprea</i> ) | 13 | 300 | 8 | 5 | 5 | 0.5 | 0 | 0 | A twin stemmed tree outside of site but within potential influencing distance. Northern stem has failed leaving southern stem leaning towards site and poorly supported. | Fell to ground level. | M | <10 | U | 0 | 0.0 | <a href="#">4</a> |

**Photo 4:** [T15](#) Northern stem has failed leaving southern stem leaning towards site and poorly supported.
