# GROUND LEVEL TREE ROOST ASSESSMENT (GLTRA) FOR BATS 62 WOODLANDS PARK DRIVE, CADOXTON

| <b>TITLE:</b> | Ground Level Tree Roost Assessment (GLTRA) for Bats |

| <b>PROJECT REF:</b> | 415-01-01-25 |
| <b>REPORT No.:</b> | 415-01-01.R2 |

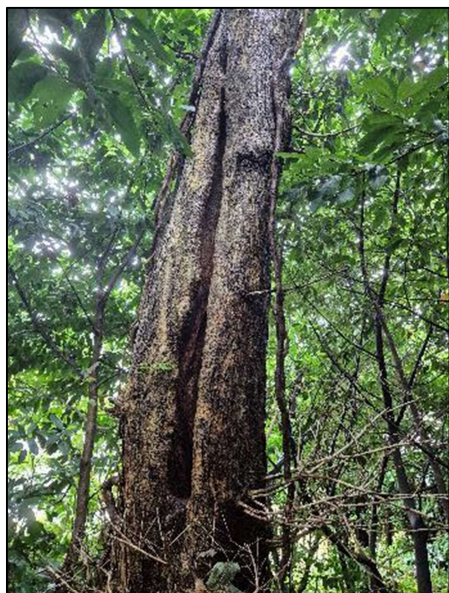
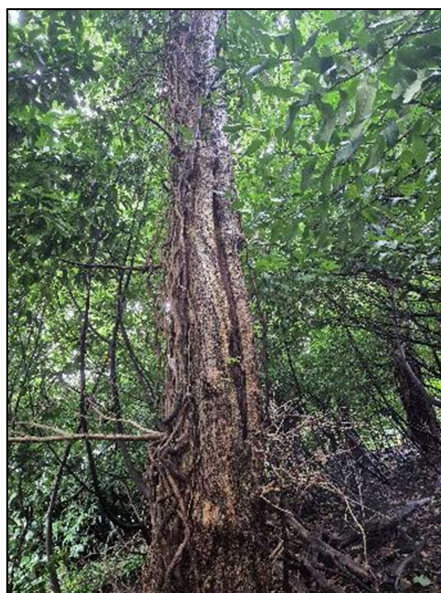
**Figures 4 & 5 – Bark Wound Identified on Tree #967 (Sessile Oak) During GLTRA Survey**

| 7<br>#967 | Sessile Oak | Very large tree in poor condition. 2m vertical bark wound present on (N) side of tree. The wound was inspected for evidence of bats, with none being identified. Although the wound appears to be of potentially sufficient size to provide space for multiple roosting bats (PRF-M), upon closer inspection, it was observed that the wound does not proceed into the core of the tree, and subsequently does not provide sufficient space or shelter to support a large number of roosting bats, due to being exposed to external elements. Ivy growth is present, but stops approximately 7m from the top of the tree. Condition of bark improves with height on the tree. | PRF-I | 1 - low | No | Crown reduction<br>(5m) | The proposed works will not directly impact upon the wound identified during the survey, with the top 5m of the tree being reduced. No evidence of bats was identified during survey and the wound appears to be superficial, and does not continue upwards or downwards further into the trunk of the tree.<br><br>No further survey work required |

One of the surveyed trees, namely #967 – Sessile Oak, possesses a large wound on the bark at 2.5m height above ground level. Images of this wound are visible in Figures 4 & 5 below: -

Although upon first appearance, the wound looks of sufficient size and space to enable multiple bats to roost within the tree (PRF-M), upon closer inspection, the interior of the wound does not continue upwards or downwards further into the core trunk of the tree. Subsequently, the wound does not provide sufficient space or shelter from external elements to be utilised by multiple roosting bats.

Inhabited cavities within trees are typically smooth, and bats require clean, dry cavities to utilise for roosting purposes (Bat Tree Habitat Key, 2023). The interior of the cavity was observed to be damp, and the walls were knobbly/spongy during the survey, further suggesting that the cavity is not suitable for use by multiple bats.

As such, based upon the results of the GLTRA, no further survey work is recommended, and the proposed arboricultural works can proceed without restriction.

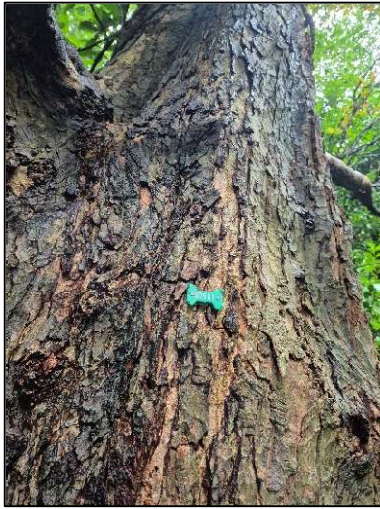
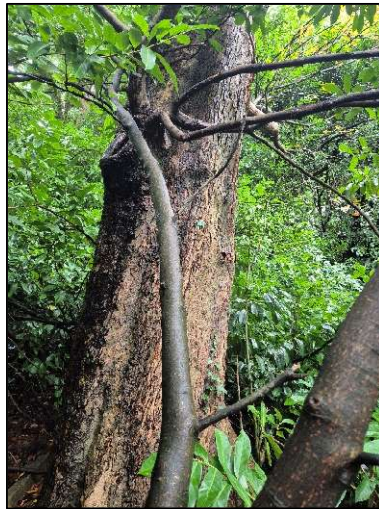
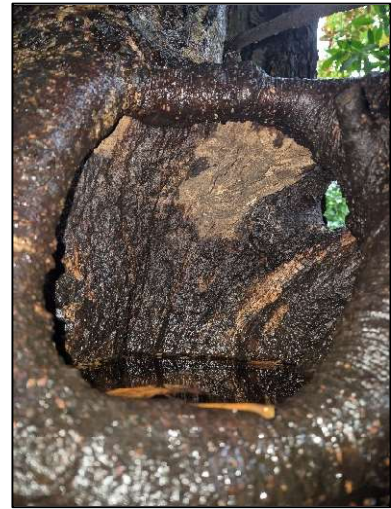
Tree 1 (#961) – Horse Chestnut – (M, VL, F, F, 2, H)

| Tree / Tag Number | Species | Notes | PRF-I / PRF-M / N/A | Roosting Potential (0-4) | Roost Found? | Proposed Works | Implications for Proposed Work |
|---|---|---|---|---|---|---|---|
| 1<br>#961 | Horse Chestnut | Possesses a tearout in one of the branches at approximately 2.5m which was inspected for evidence of bats, with none found. Bark in generally good condition, with some limited ivy growth being identified. | PRF-I | 1 - low | No | Upper crown reduction (2-3m) | No further survey work required |

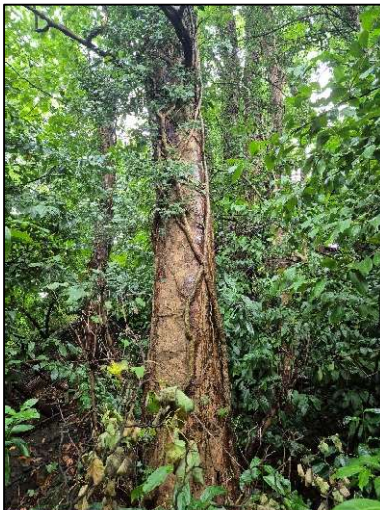
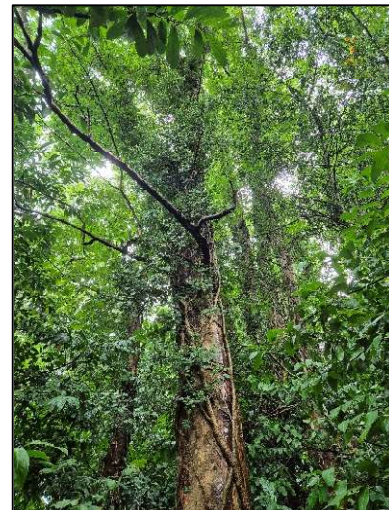
Tree 2 (#962) – Sycamore – (EM, VL, F, F, 2, H)

| Tree / Tag Number | Species | Notes | PRF-I / PRF-M / N/A | Roosting Potential (0-4) | Roost Found? | Proposed Works | Implications for Proposed Work |
|---|---|---|---|---|---|---|---|
| 2<br>#962 | Sycamore | Tree in generally good condition, with bark in good condition. Small amount of ivy growth which may be used by individual bats. | PRF-I | 1 - low | No | Upper crown reduction (2-3m) | No further survey work required |

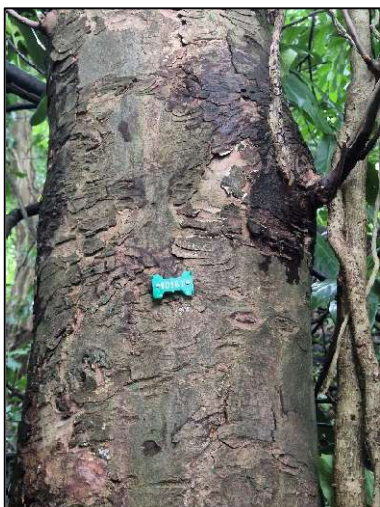
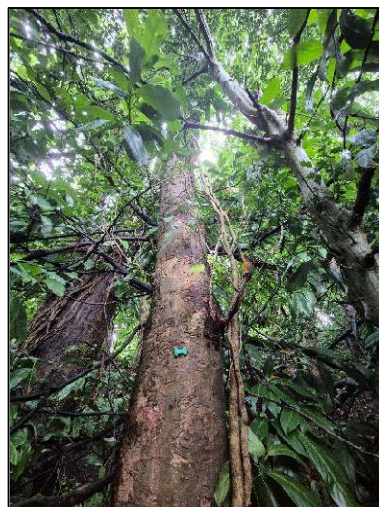
Tree 3 (#963) – Sycamore – (SM, L, F, P, 0, M)

| Tree Number | Species | Age | Size | PC | SC | Observations / Recommended Works | Cat. | Risk |
|---|---|---|---|---|---|---|---|---|
| #963 | Sycamore | SM | L | F | P | A whip type tree suppressed by the adjacent trees.<br><br>No recommended works. | | |

| Tree / Tag Number | Species | Notes | PRF-I / PRF-M / N/A | Roosting Potential (0-4) | Roost Found? | Proposed Works | Implications for Proposed Work |
|---|---|---|---|---|---|---|---|
| 3<br>#963 | Sycamore | Smooth bark with no cracks, lifting or damage. Small amount of ivy, but unlikely to be dense enough to be utilised by bats. | N/A | 0 - negligible | No | No Works | No further survey work required |

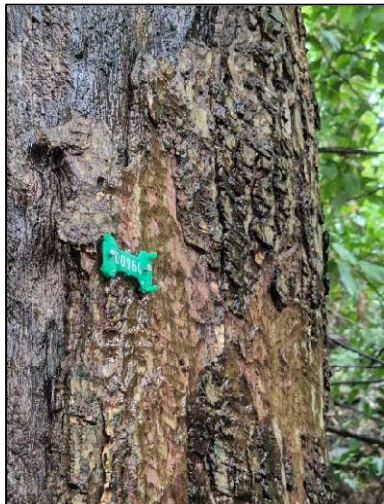
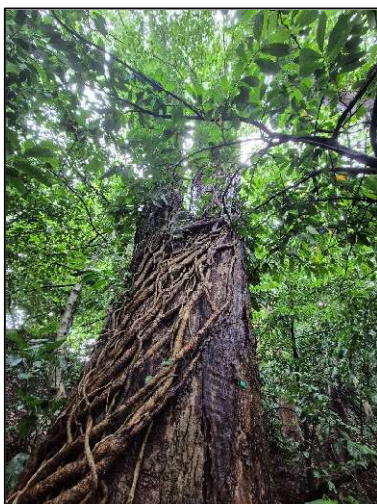
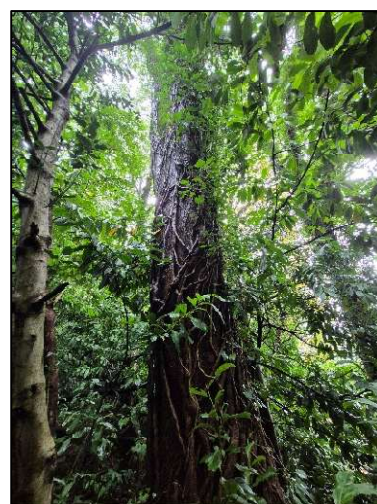
Tree 4 (#964) – Sycamore – (M, VL, F, F, 0, **M**)

| Tree Number | Species | Age | Size | PC | SC | Observations / Recommended Works | Cat. | Risk |
|---|---|---|---|---|---|---|---|---|
| #964 | Sycamore | M | VL | F | F | Main stem divides into two at 3m above ground level, with a large bark wound on the south side of the lower stem.<br><br>No recommended works. | | |

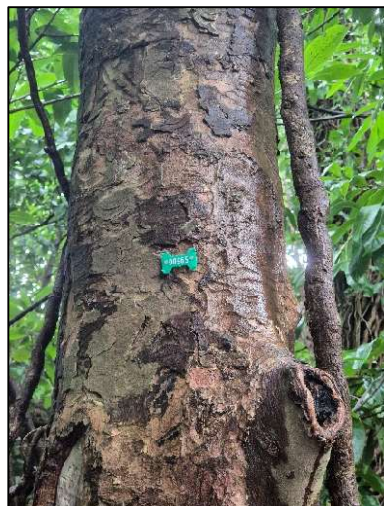
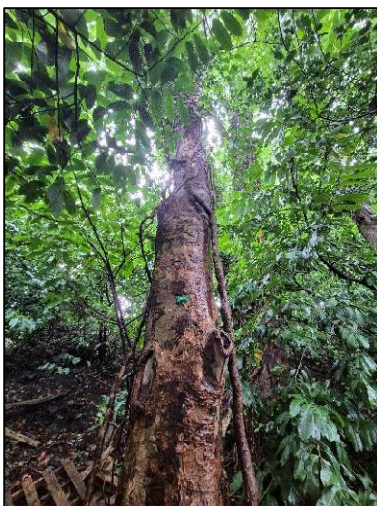
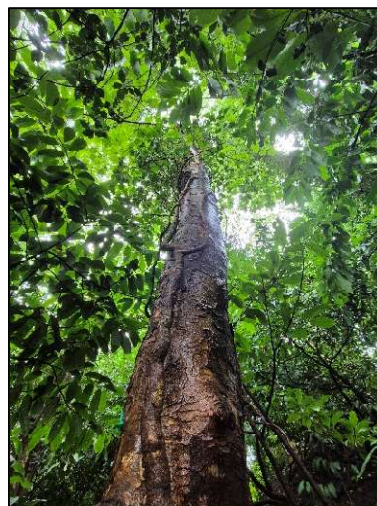
Tree 5 (#965) – Sycamore – (SM, L, F, P, 0, **M**)

| Tree Number | Species | Age | Size | PC | SC | Observations / Recommended Works | Cat. | Risk |
|---|---|---|---|---|---|---|---|---|
| #965 | Sycamore | SM | L | F | P | A whip type tree suppressed by the adjacent trees.<br><br>No recommended works. | | |

| 5<br>#965 | Sycamore | Bark of tree in good condition, with no lifting or cracks suitable for bats being identified. A small amount of ivy present, although this is too sparse to support bats. | N/A | 0 - negligible | No | No Works | No further survey work required |

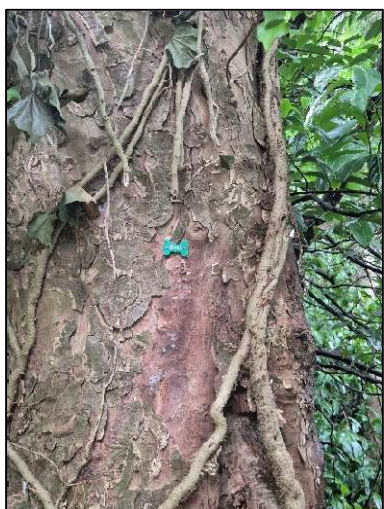
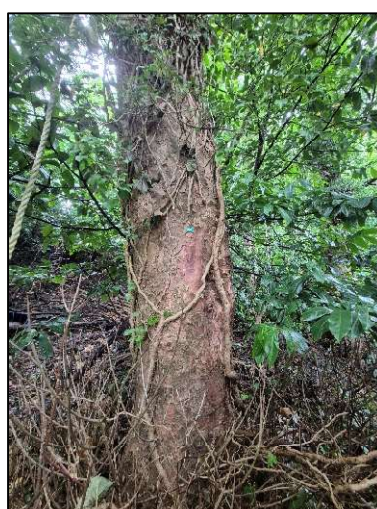
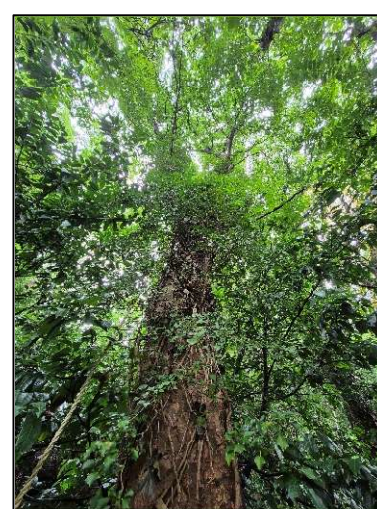
Tree 6 (#966) – Sycamore – (EM, VL, F, P, **2**, **H**)

| 6<br>#966 | Sycamore | Small wound present at 1.5m height. Wound was inspected for evidence of bats, with none being found, but the wound was assessed to provide potential roosting opportunity for individual opportunistic bats. Tree possesses a moderate amount of ivy, which stops approximately 4m from the top of the tree, and subsequently will not be impacted by the works. | PRF-I | 1 - low | No | Upper crown reduction<br>(2-3m) | No further survey work required |

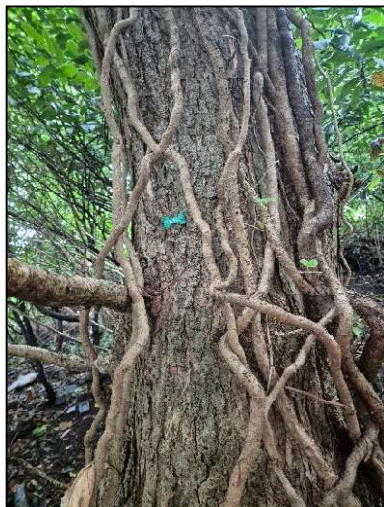
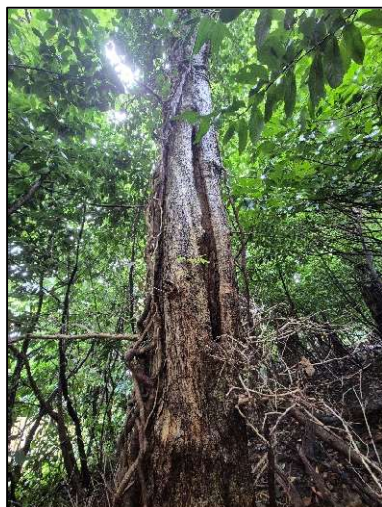
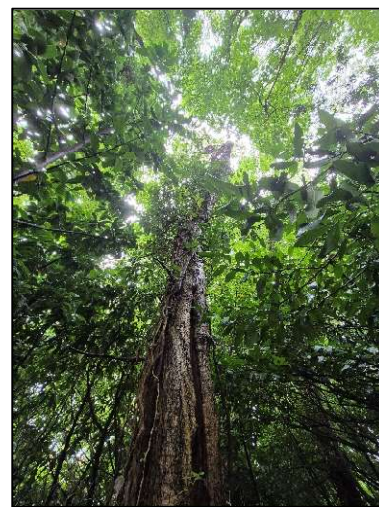
Tree 7 (#967) – Sessile Oak – (SM, VL, P, D, **1**, **H**)

| #967 | Sessile Oak | SM | VL | P | D | Sparse foliage and a very poor form. 2m vertical bark wound with decay on both side of the main stem at 2.5m above ground level<br><br>Reduce crown by 5m. | | |

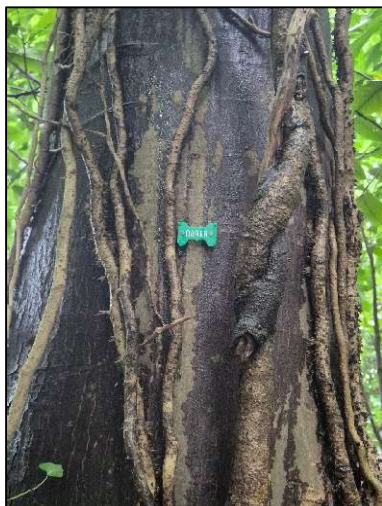
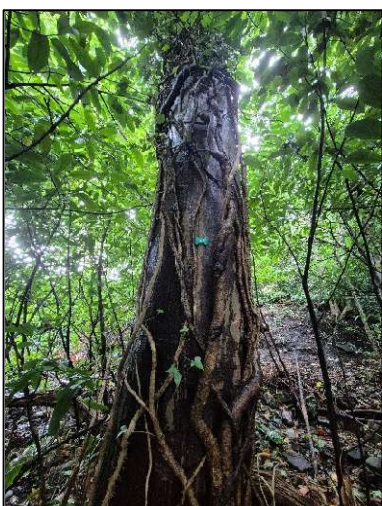
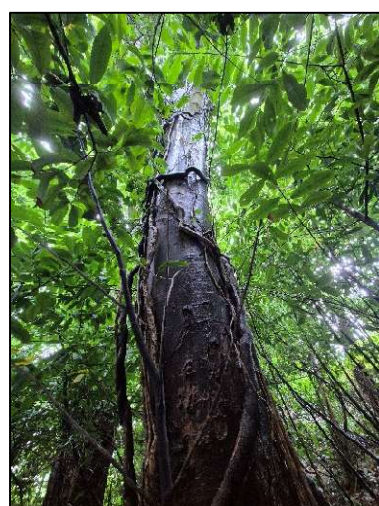
Tree 8 (#968) – Sycamore – (SM, L, F, P, 0, **M**)

| #968 | Sycamore | SM | L | F | P | No comments.<br><br>No recommended works. | | |

| 8<br>#968 | Sycamore | Tree in generally good condition, and possesses very smooth bark, with no areas of damage being recorded. The tree possesses a moderate amount of ivy, up to ¼ of the total height of the tree. | PRF-I | 1 - low | No | No Works | No further survey work required |

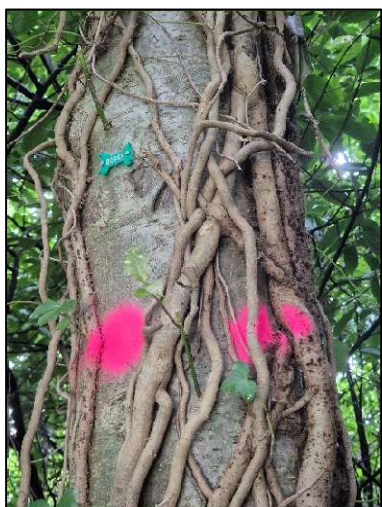
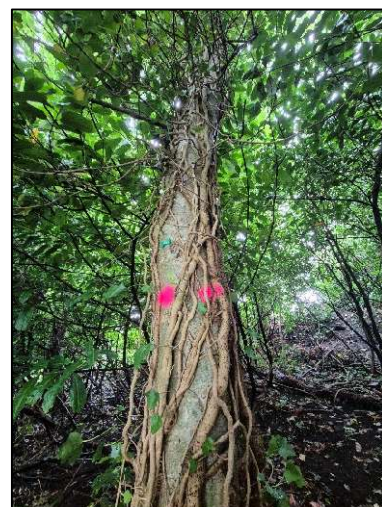
Tree 9 (#968) – Holly – (EM, M, D, P, **2**, **M**)

| 9<br>#969 | Holly | No significant areas of damage recorded to the bark or branches of the tree, and the tree possesses a smooth bark. Some ivy growth noted which may be utilised by individual bats.. | PRF-I | 1 - low | No | <b>REMOVE TREE</b> | No further survey work required |

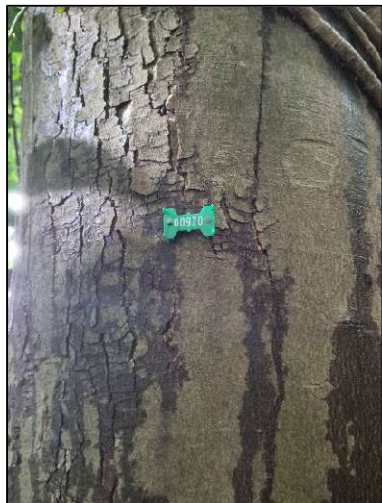
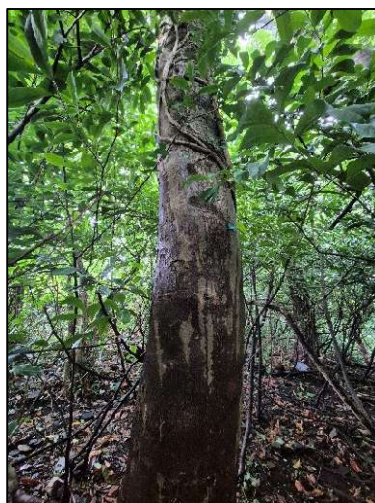
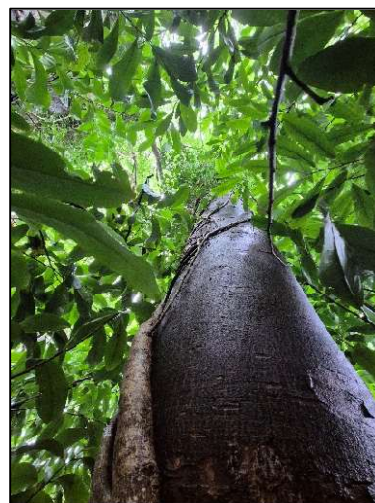
Tree 10 (#970) – Sycamore – (EM, M, F, P, **2**, **M**)

| 10<br>#970 | Sycamore | Very smooth bark with no areas of lifting, cracks or damage being recorded which may support roosting bats. Some ivy growth noted, but too sparse to support roosting bats. | N/A | 0 - negligible | No | (S) & (W) crown reduction<br>(2-3m) | No further survey work required |

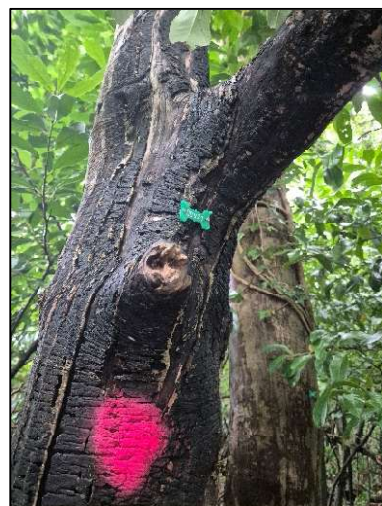
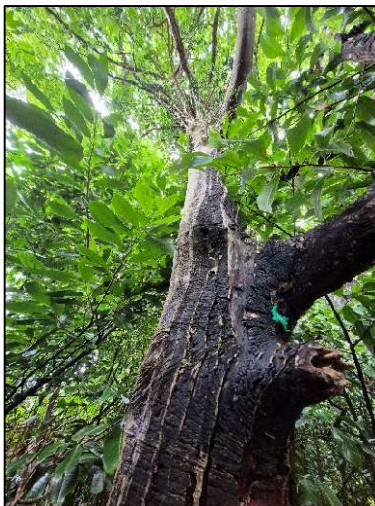
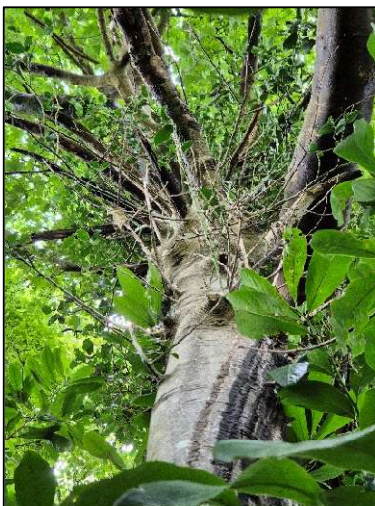
Tree 11 (#971) – Holly – (EM, S, D, D, **1**, **H**)

| 11<br>#971 | Holly | Bark in poor condition, with large areas of necrosis and some small cracks being noted. Limited ivy present on tree. | PRF-I | 1 - low | No | <b>REMOVE TREE</b> | No further survey work required |

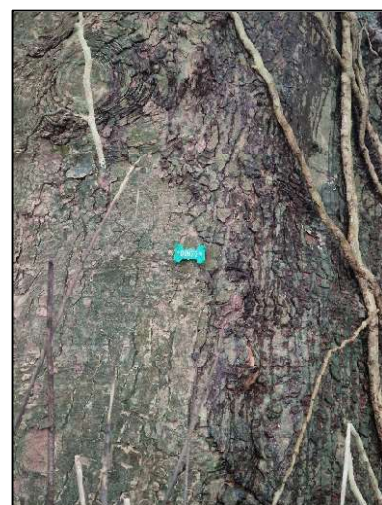
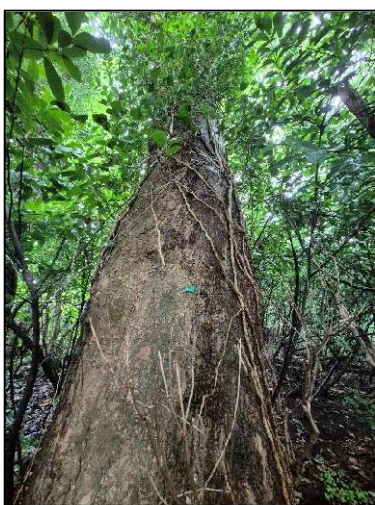
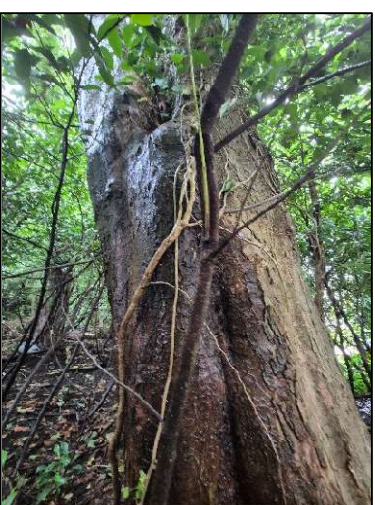
Tree 12 (#972) – Sycamore – (M, VL, F, F, **2**, **H**)

| 12<br>#972 | Sycamore | Slight gnarling of bark noted, with stem dividing into 2 at 2.5m height, but tree in generally good condition. No evidence of bats recorded. Some ivy is present on the tree, but not within the proposed working area toward the top of the tree. | PRF-I | 1 - low | No | Crown reduction<br>(2-3m) | No further survey work required |

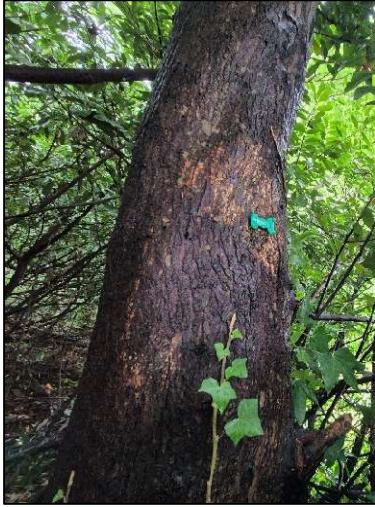
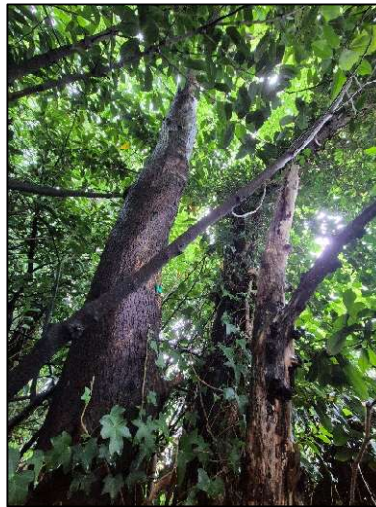
**Tree 13 (#973) – English Elm – (SM, M, F, P, 2, M)**

| 13<br>#973 | English Elm | Ridged bark, and tree in poor condition, but no sufficient areas suitable to support roosting bats. No ivy present on tree, and no suitable PRFs recorded. | N/A | 0 - negligible | No | Reduce (S) branches<br>(2m) | No further survey work required |

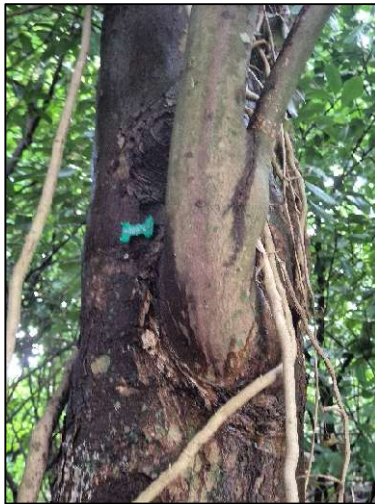
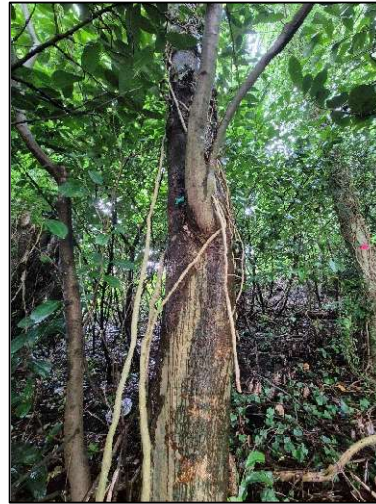
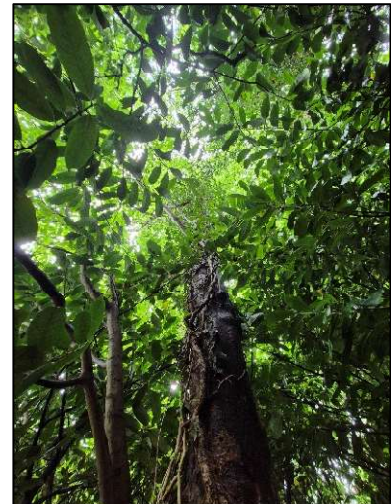
**Tree 14 (#974) – Sycamore – (SM, L, F, P, 2, M)**

| 14<br>#974 | Sycamore | Tree in generally poor condition, although no suitable areas of damage, cracks or lifting of bark being identified which may support roosting bats. Small amount of ivy present on the tree, which may be utilised by individual bats. | PRF-I | 1 - low | No | Crown reduction<br>(2-3m) | No further survey work required |

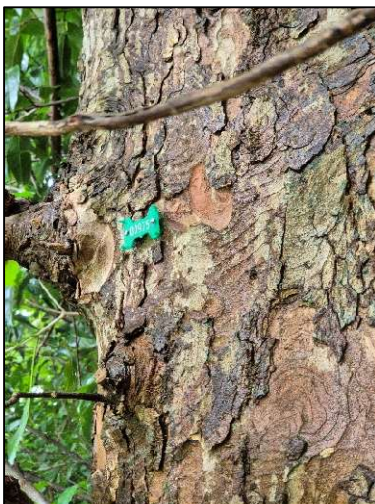
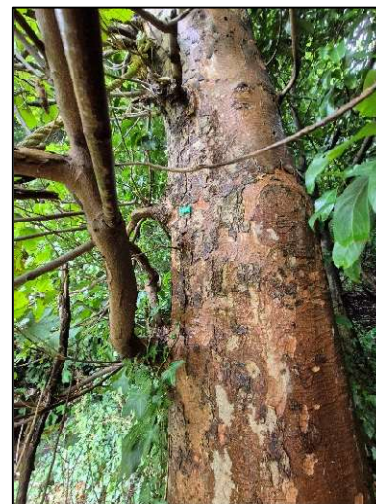
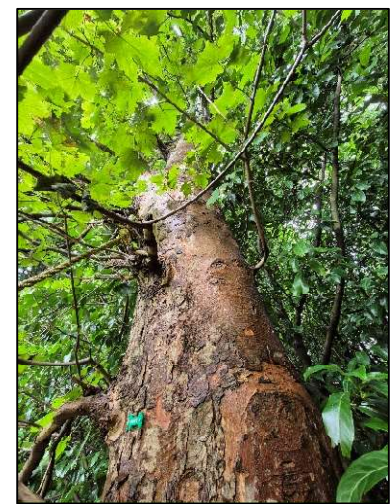
**Tree 15 (#975) – Sycamore – (EM, L, F, D, 2, M)**

| #975 | Sycamore | EM | L | F | D | A regrown pollard with an asymmetric crown and a very poor form. Branch shedding occurring due to decay around the old pruning wounds, small diameter branch suspended in the lower crown on south side.<br><br>Re-pollard and remove all decayed sections. | | |

| 15<br>#975 | Sycamore | Very little ivy, and bark in generally good condition, with no suitable PRFs being identified. | N/A | 0 - negligible | No | Re-pollard & Remove Decay | No further survey work required |

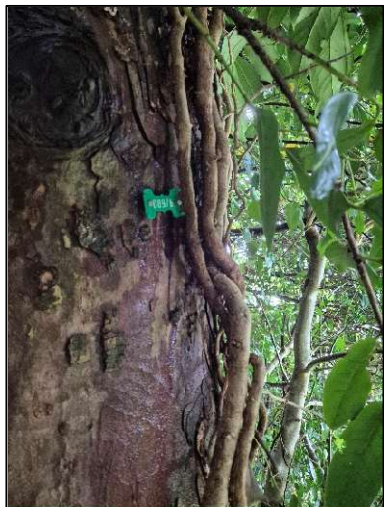
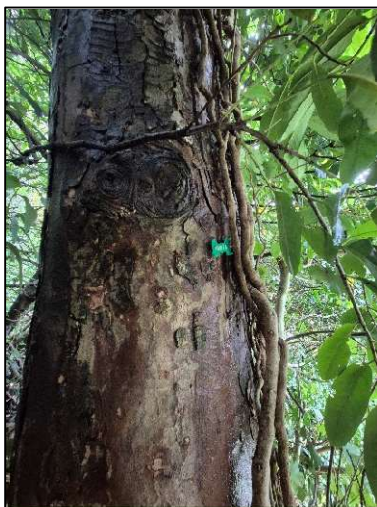
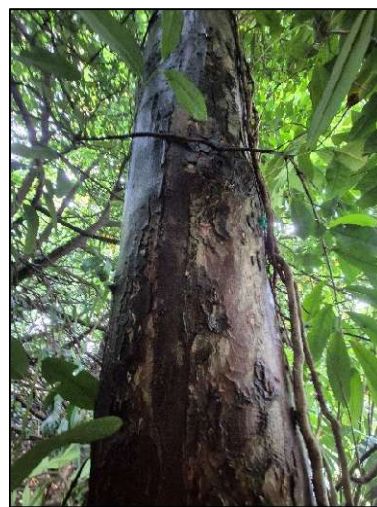
Tree 16 (#976) – Sycamore – (SM, L, F, D, **1**, **H**)

| #976 | Sycamore | SM | L | F | D | A regrown pollard with an asymmetric crown and a very poor form. Branch shedding occurring due to decay around the old pruning wounds.<br><br>Re-pollard and remove all decayed sections. | | |

| <b>16</b><br>#976 | Sycamore | Generally smooth bark with no holes or suitable cracks being recorded. Very sparse ivy growth on trunk with no suitable PRFs for bats being recorded. | N/A | 0 - negligible | No | Re-pollard & Remove Decay | No further survey work required |

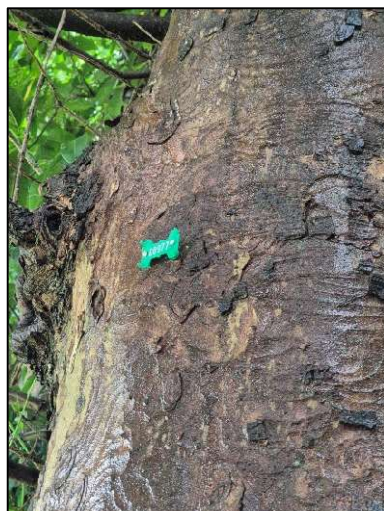
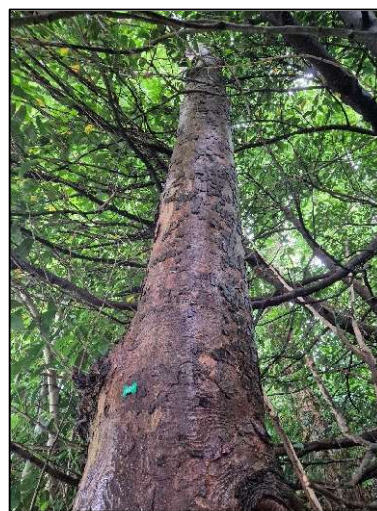
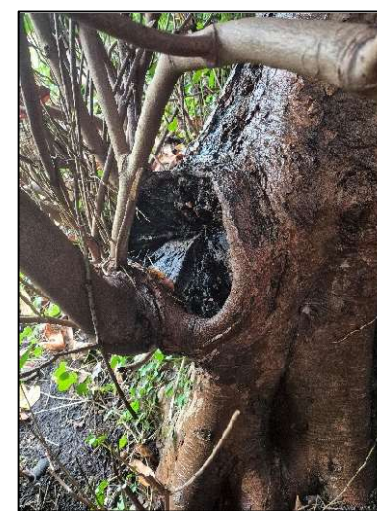
Tree 17 (#977) – Sycamore – (SM, L, F, D, **1**, **H**)

| #977 | Sycamore | SM | L | F | D | A regrown pollard with an asymmetric crown and a very poor form. Bark necrosis and a small compartmentalising basal cavity on the south facing side due to previous branch removal. Branch shedding occurring due to decay around the old pruning wounds.<br><br>Re-pollard and remove all decayed sections. | | |

| <b>17</b><br>#977 | Sycamore | Generally smooth bark with no holes or suitable cracks being recorded. Very sparse ivy growth on trunk. Small area of tearout / necrosis at low level on south side was assessed for potential to support roosting bats, with no suitable PRFs for bats being recorded. | N/A | 0 - negligible | No | Re-pollard & Remove Decay | No further survey work required |

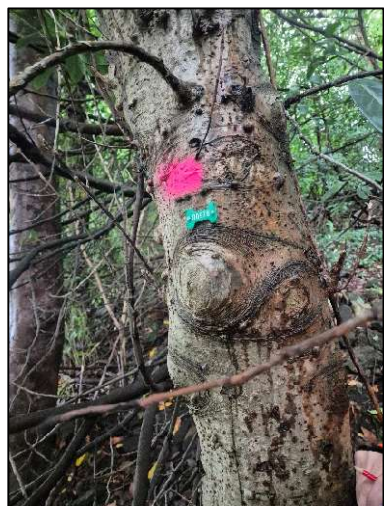
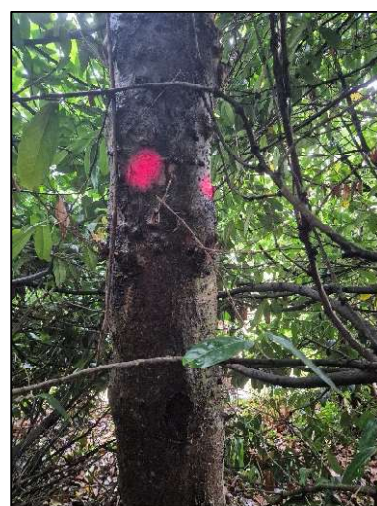
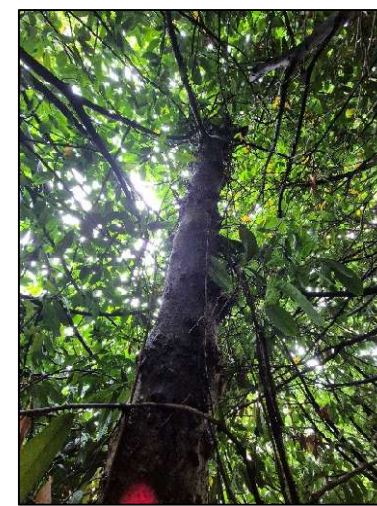
Tree 18 (#978) – Holly – (EM, S, D, D, **1**, **M**)

| <b>18</b><br>#978 | Holly | Tree is dead, but no areas of rot were recorded, and the bark is in good condition considering the overall condition of the tree. No ivy growth recorded on the tree, and no suitable PRFs for bats identified. | N/A | 0 - negligible | No | <b>REMOVE TREE</b> | No further survey work required |
