# **HERITAGE IMPACT STATEMENT**

**In Support of an Application for Listed Building Consent for: Opening the Gates at the Gnoll Gatehouse. Grid Reference: 275642, 197320**

Lloyd Killick, Outside Works Officer, NPTCBC  
July 2025.

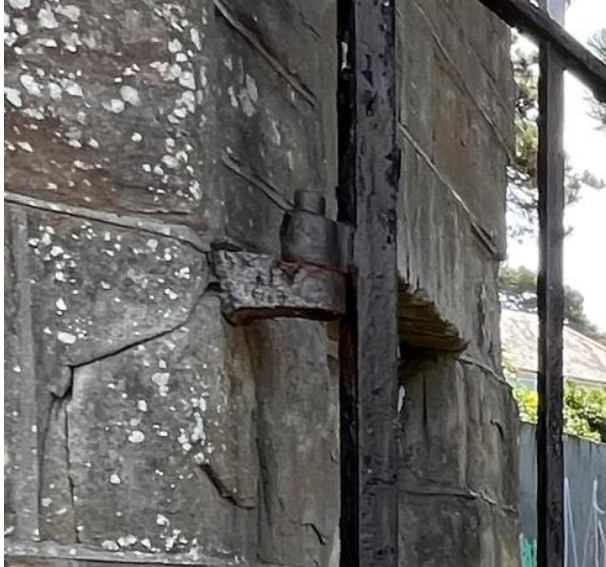
- 4.1 A steel hoop has been added between the top corners of the gates to restrict the width of opening and prevent vehicle access. This constant 'part opening' has possibly contributed to excess stress at the hinge location and subsequent damage to masonry.

Figure 3, Damage at Hinge Location

- Paint with Rust Oleum Combicolour Metal Paint, to match the existing.
- 5.2 New hinge eyes in masonry to be extended through the masonry walls with a threaded end and internal Pattress Plate: galvanised steel or painted to match gates, size to be agreed to overlap mortar joints.

- 5.3 Masonry repairs and repointing to secure existing loose stones by a specialist Heritage Masonry company using appropriate lime based mortars and method statements to be approved.

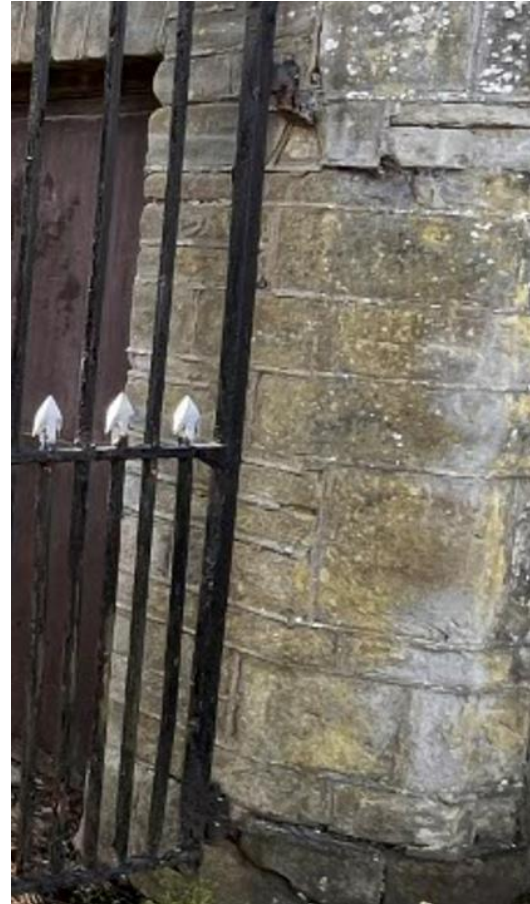
Figure 4, Damage at Hinge Location
