*Report No. BC/MB/06.26.01.*

**Coal Mining Risk Assessment:  
Land at the Former Tirbach Washery,  
Ystalyfera.**

## **Coal Mining Risk Assessment: Land at Former Tirbach Washery.**

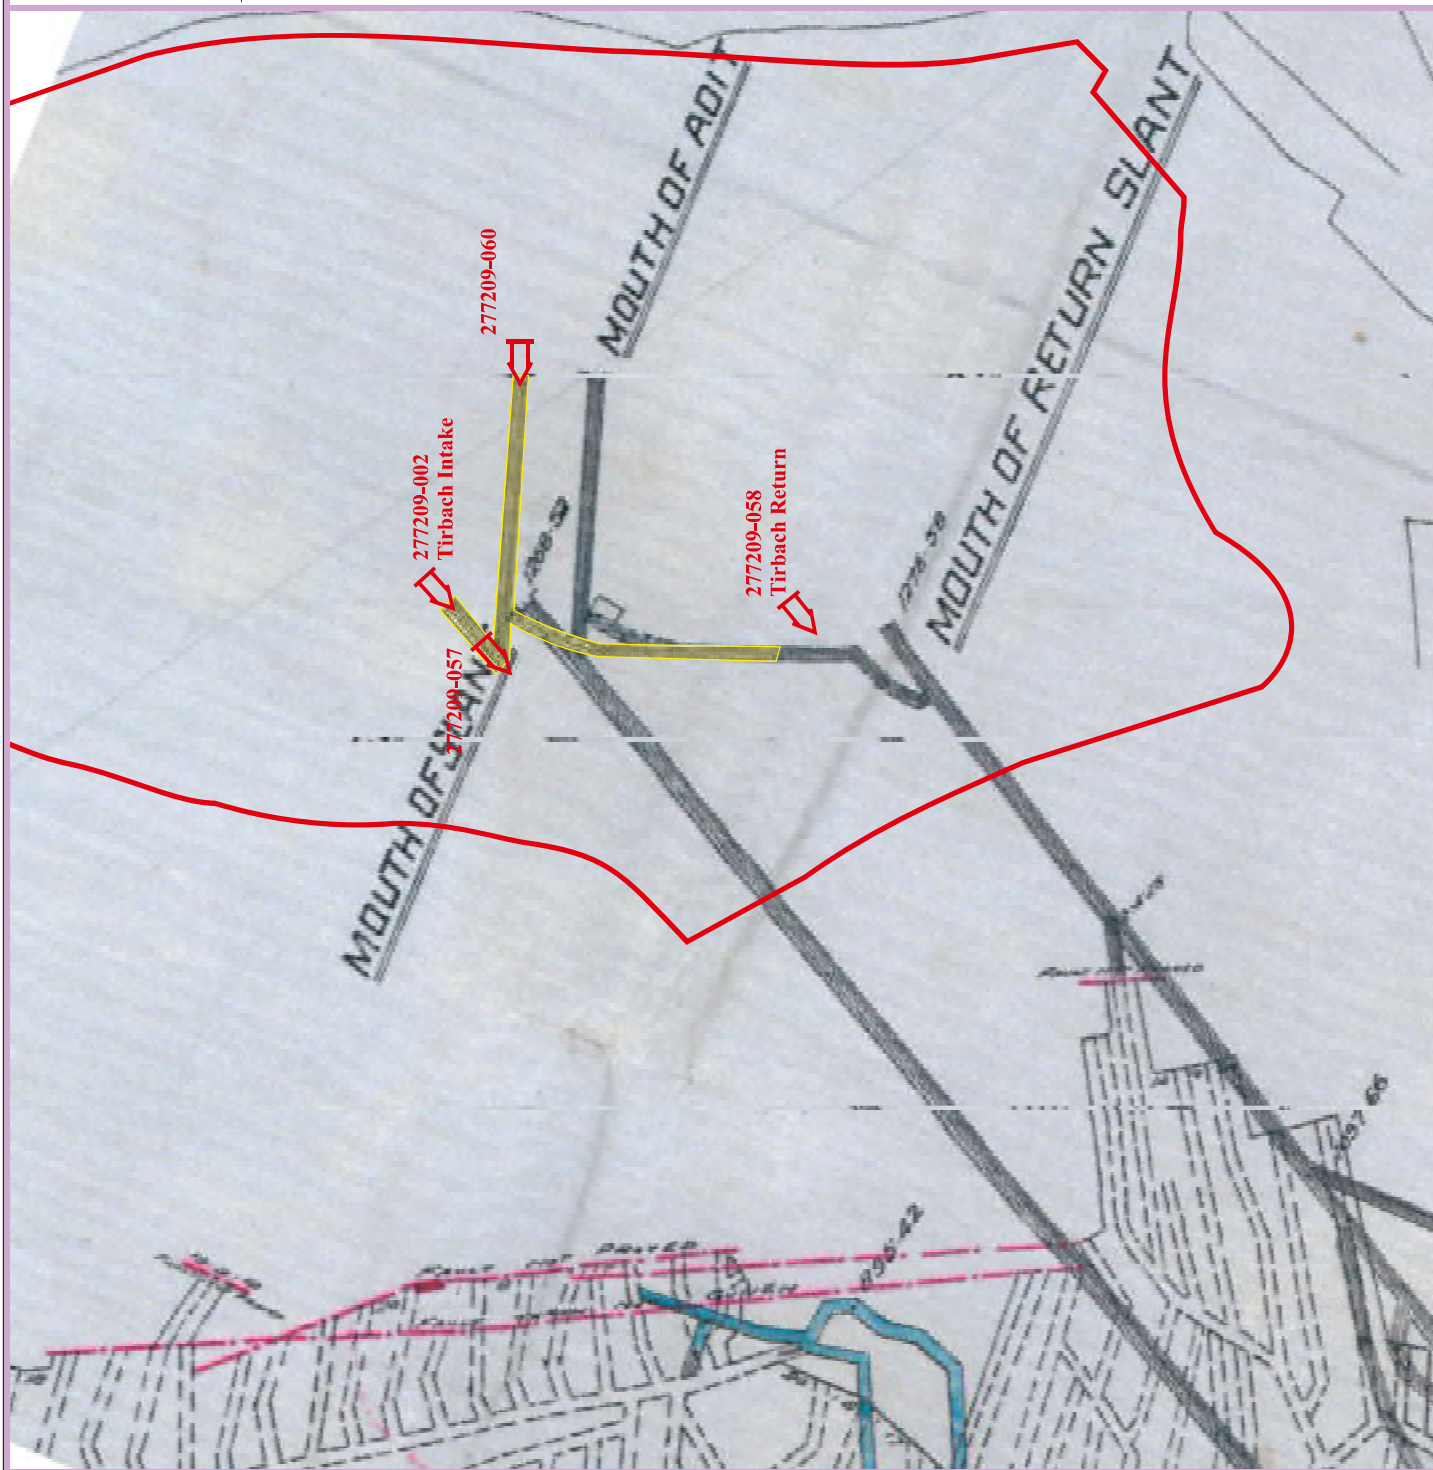
Drawing No: BC/MB/06.26.01.04.

The general area has experienced extensive underground mining for both coal and ironstone since at least the earliest part of the nineteenth century. The workings were prosecuted from a large number of adits driven into the valley sides at or near the outcrops of coal seams or ironstone veins, or elsewhere for water drainage purposes. A number of shafts were also sunk into the coal measures in the general area. Our searches identified that the Site is in a surface area that could be affected by old workings in two coal seams at depths of 40m to 70m and last worked in 1938. The old workings in question lie to the west of the Site, on the west side of the Palleg Fault, there are no old workings underlying the Site (see *Extract from Tirbach*

There is no risk to the development from recorded nor from ‘potential’ shallow mine workings, there are no old workings underlying the Site. No further study is required in this respect.

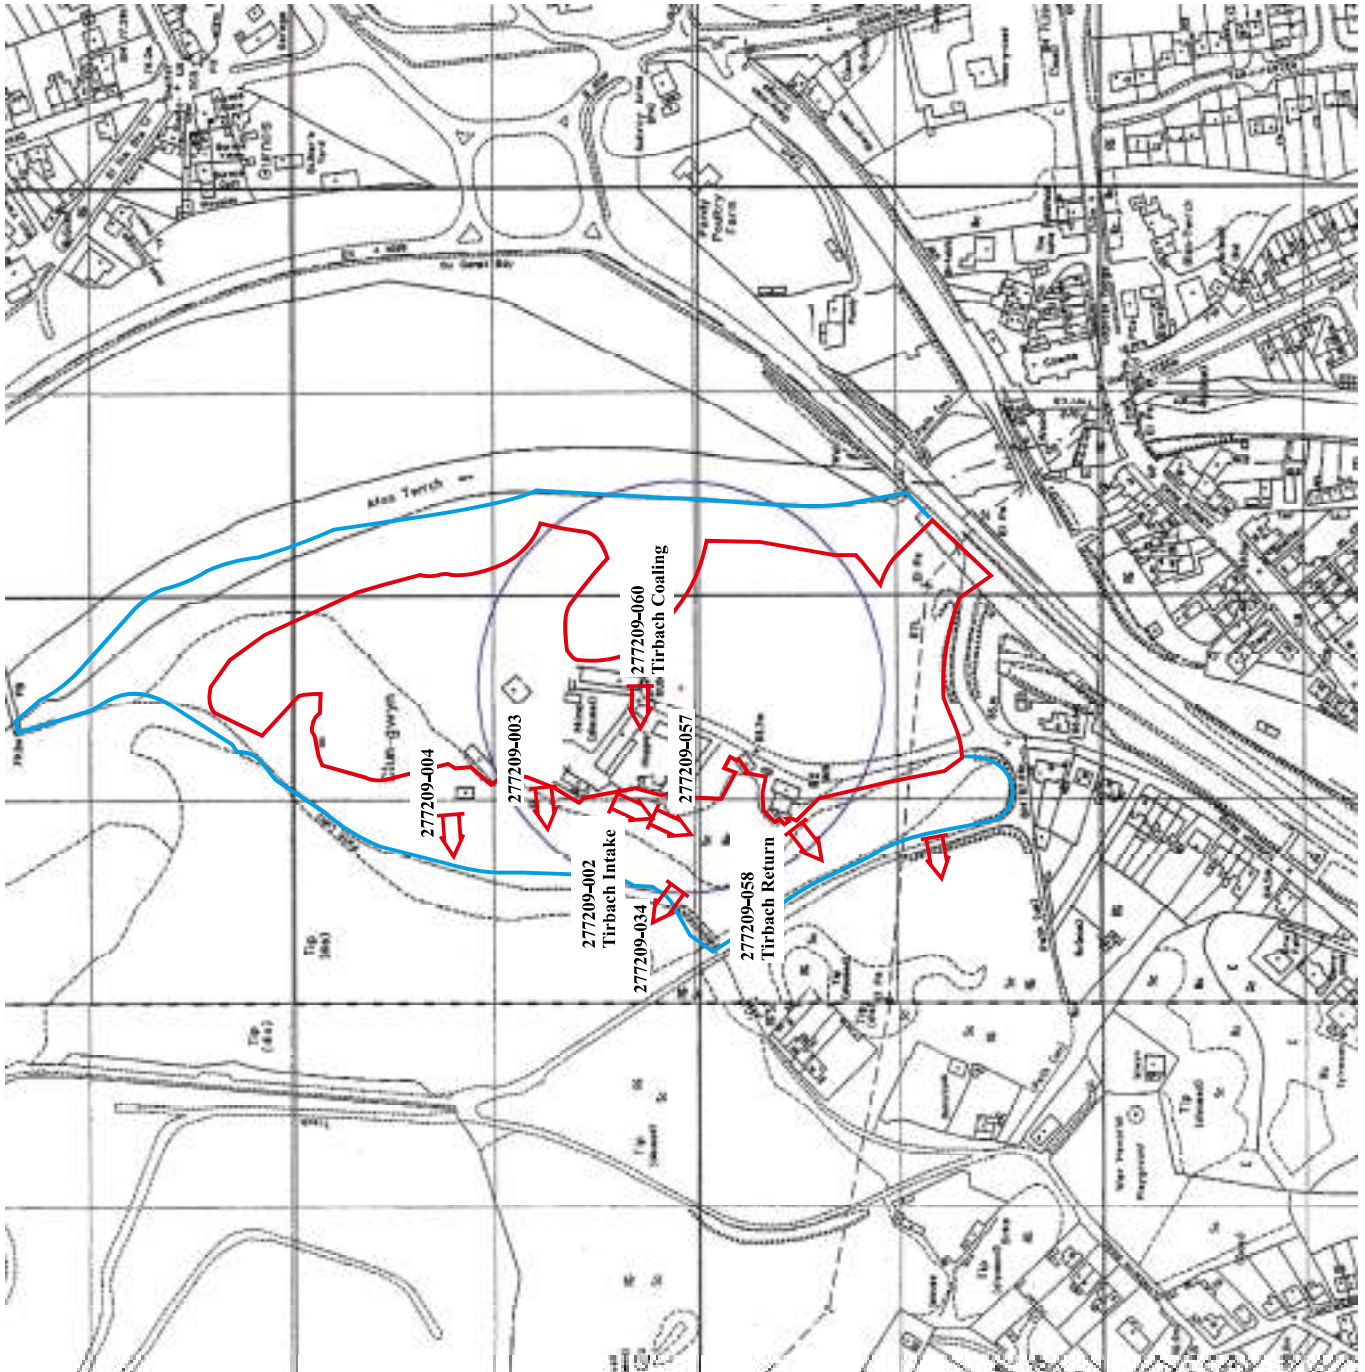
## Plan of Recorded Disused Mine Entries.

The Coal Authority has no record of what steps, if any, have been taken to stabilise adits 277209-004, 277209-002 and 277209-060. A hole in the brick portal of Adit 277209-057 was made good with blockwork to secure the mine entry; the works were carried out by consultants acting on behalf of The Coal Authority. Adit 277209-058 has been sealed to an unknown specification approximately 5 metres inbye of the entrance. In 2001 the adit portal was secured with blockwork by Wardell Armstrong acting on behalf of The Coal Authority. A hole in the brick portal of Adit 277209-002 was made good with blockwork to secure the mine entry; the works were carried out by consultants acting on behalf of The Coal Authority.

There are seven recorded disused mine entries within the confines of the Site or within 20m of it, all are adits. Only one adit, 277209-060, is within the Site, The Mining Remediation Authority has no record of what steps, if any, have been taken to stabilise the adit. The remaining six adits are beyond the western boundary of the Site. A hypothetical collapse zone with a radius of 10m has been calculated for each of the adits, for those adits outside the Site none of the hypothetical collapse zones impinge onto the Site and are considered to pose no risk to the development (see *Proposed Housing Layout Plan, drawing no. BC/MB/06.26.01.06*).

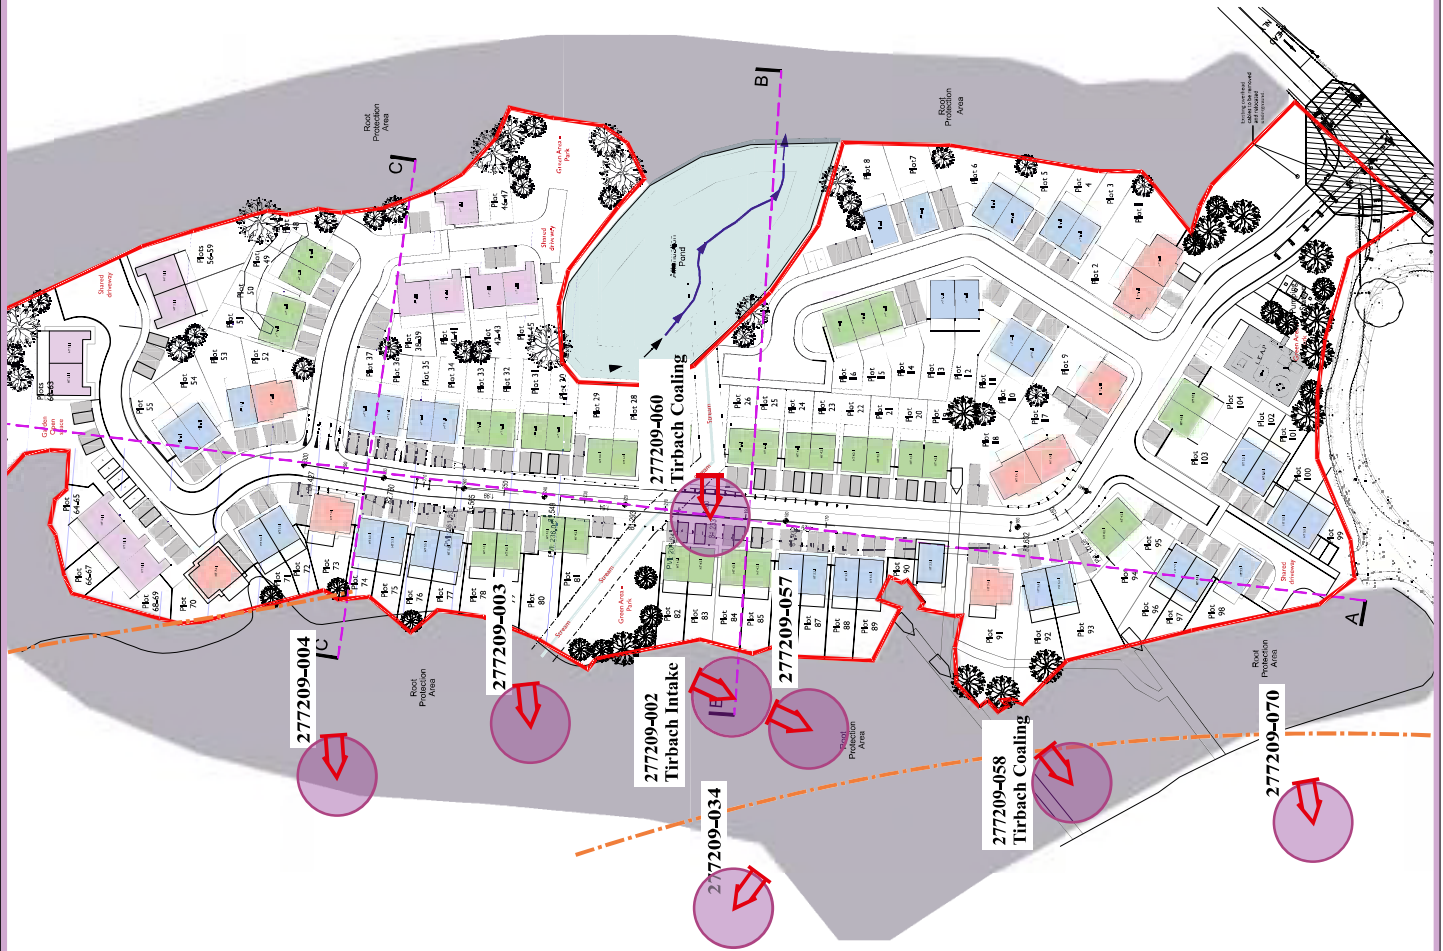
Drawing No: BC/MB/06.26.01.06.

The hypothetical collapse zone for Adit 277209-060, the former Tirbach Coaling Adit, impinges onto Plots 82 to 85 and 26. Before any construction work takes place the precise location and condition of the adit should be determined by intrusive site investigation and appropriate remediation undertaken to stabilise the adit. The investigation and remediation should be designed and supervised by a consultant geologist and will require a permit from The Mining Remediation Authority.

A disused adit is located centrally within the Site and poses a potential risk from subsidence that may affect a number of plots.

Before any construction work takes place the precise location and condition of adit 277209-060 should be determined by intrusive site investigation and appropriate remediation undertaken to stabilise the adit. The investigation and remediation should be

designed and supervised by a consultant geologist and will require a permit from The Mining Remediation Authority.
