**Re:** Results of tree/bat survey completed on areas A-D within the Grandison Brook area.

This letter is an account of the and bat roosting survey undertaken on the 2<sup>nd</sup> of October 2025

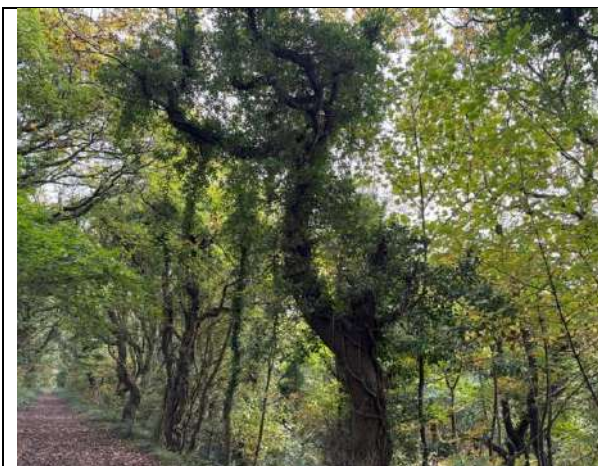
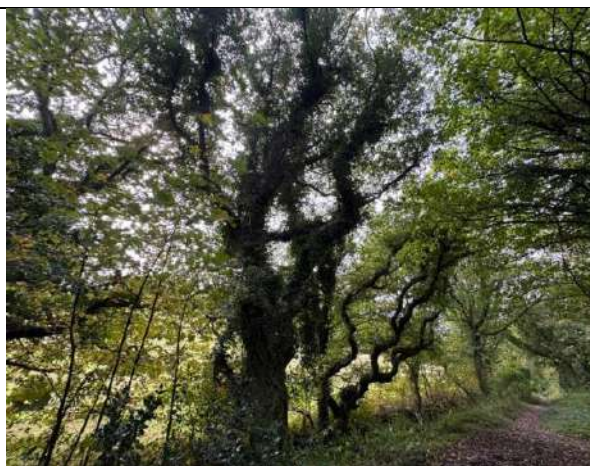
Several of the trees were heavily covered in ivy, a full and clear assessment of those trees could not be carried out.

*Example of ivy-covered trees*

Only area A had trees that needed a closer inspection. Of those trees several were heavily covered in ivy making a full assessment of them difficult. However, from the inspections that were able to be made there were no visible features noted.

Recommendations are to proceed with caution when removing the trees that are covered in ivy. Removing the ivy prior to felling would allow for a full and thorough inspection of the trees making any PRF's present visible. If trees with the noted PRF's are to be removed then advice should be sought and/or an inspection by a competent person should be made before proceeding with any tree works.

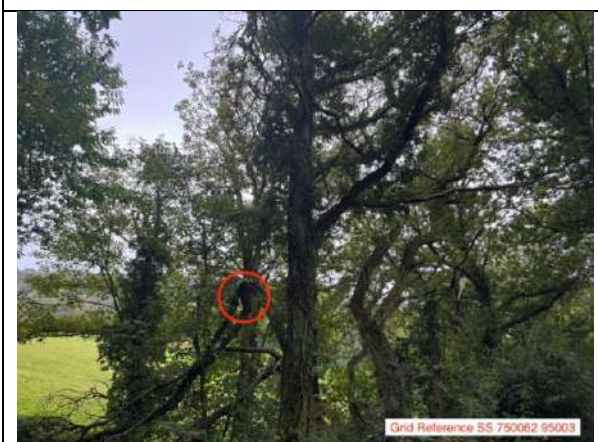
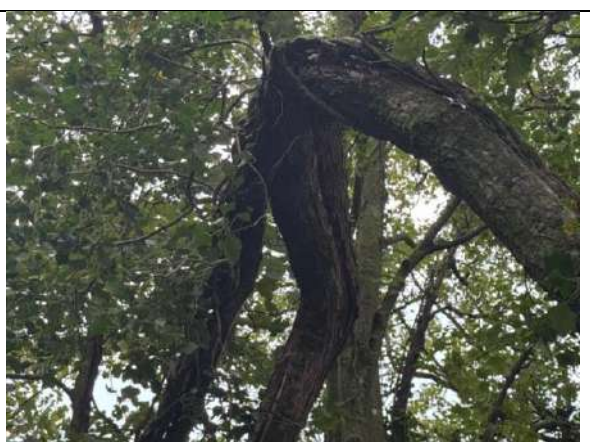
*Tree 1*

| Grid Reference | Tree Species | Photo/Tree |
|---|---|---|
| SS 75062 95003 | Oak | 1 |

There were also several trees with potential features that could be exploited by roosting bats. Following closer inspection of all these features no bats or evidence of bats using these features was found.

All except one of the trees noted with features seem to be on the southern side of the pathway known as the incline, it is currently understood that this part will remain unaffected by the works. If the trees on this side are also to be removed, then any trees with potential features should be inspected again immediately prior to felling. Any trees heavily covered in ivy should also have the ivy removed to allow for a full and clear visual inspection prior to felling.

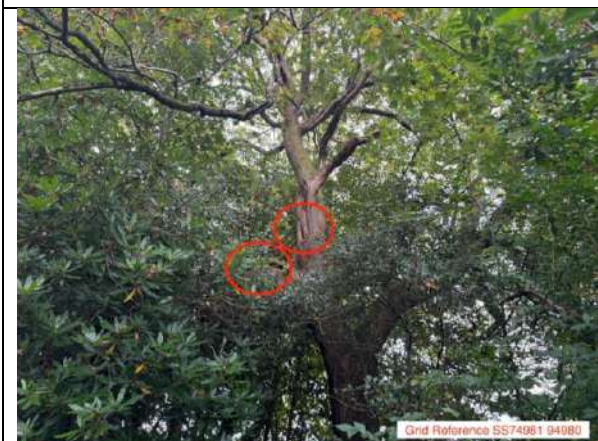
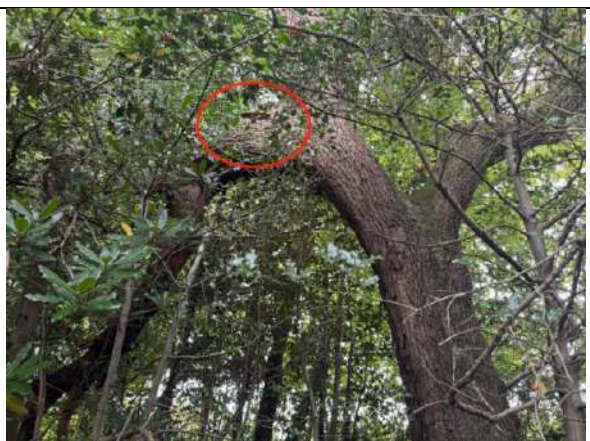
*Tree 2*

| Grid Reference | Tree Species | Photo/Tree |
|---|---|---|
| SS 74981 94980 | Oak | 2 |

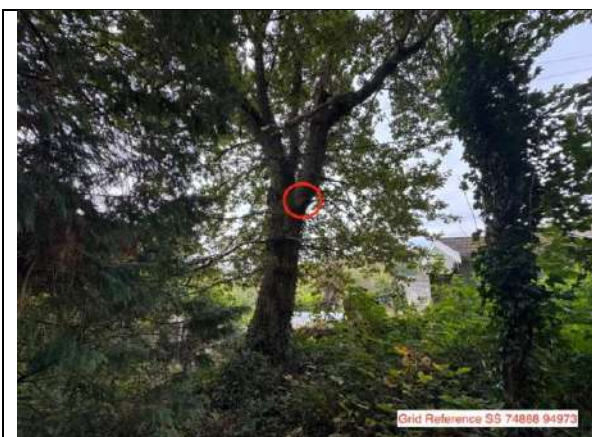
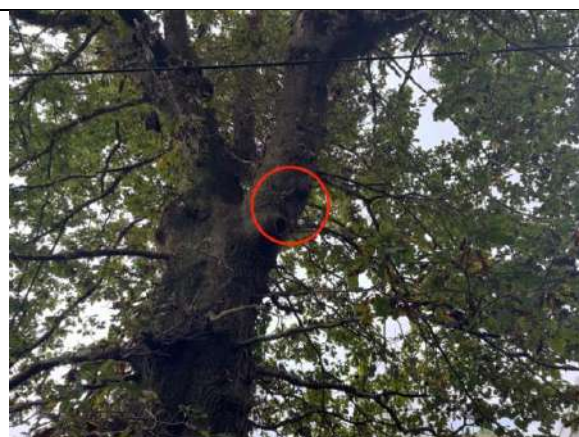
*Tree 3*

| Grid Reference | Tree Species | Photo/Tree |
|---|---|---|
| SS 74888 94973 | Oak | 3 |

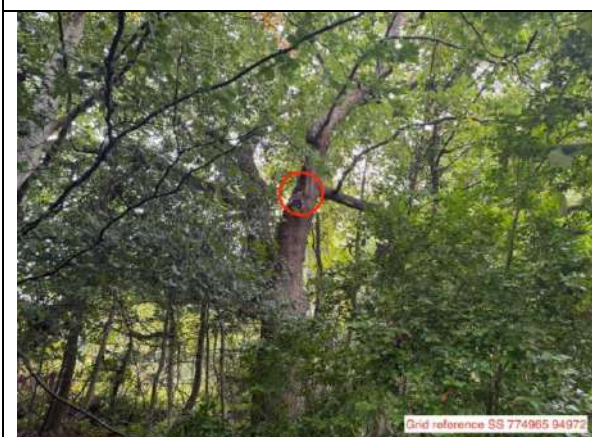
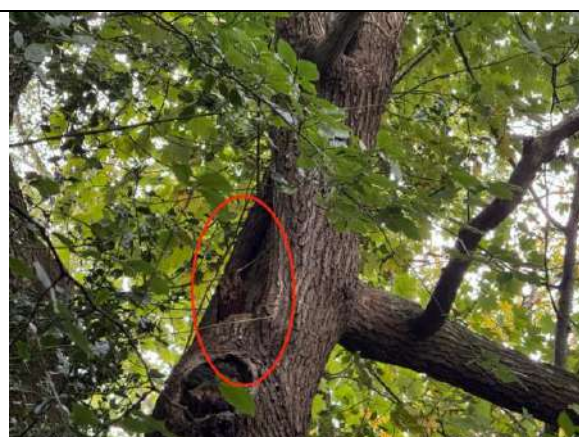
*Tree 4*

| Grid Reference | Tree Species | Photo/Tree |
|---|---|---|
| SS 74965 94972 | Oak | 4 |
