## Green Infrastructure Statement (GIS)

**Site Address:** 20 Ty'n Yr-Heol Road, Bryncoch, Neath, SA10 7EA

**Proposed Development:** Two storey rear extension to provide an enlarged kitchen and living area at ground floor with two additional bedrooms and a family bathroom at first floor, internal alterations, replacement front door and new entrance canopy, a widened driveway, and a detached single storey garden room ancillary to the main dwelling at the rear of the garden with a surrounding path.

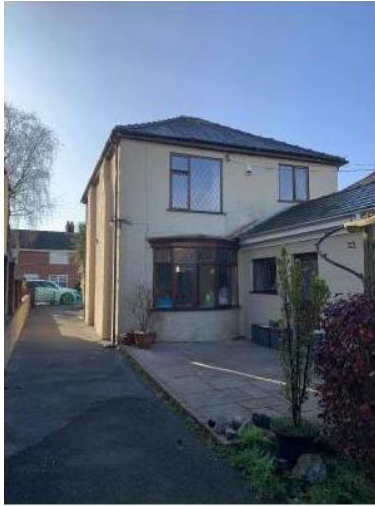
*Photo 1: Front driveway and elevation, pre-clearance condition*

**Site Description:** Detached two storey dwelling on a long rectangular plot with the highway frontage to Tyn yr Heol Road. Prior to current ownership, the front garden comprised a lawn, a hard surfaced driveway, and established specimen planting including mature and ornamental shrubs adjacent to the front bay window (see Photos 1 and 2). Part of the front lawn has been reduced with one specimen removed to allow space for off-road parking, completed in 2025.

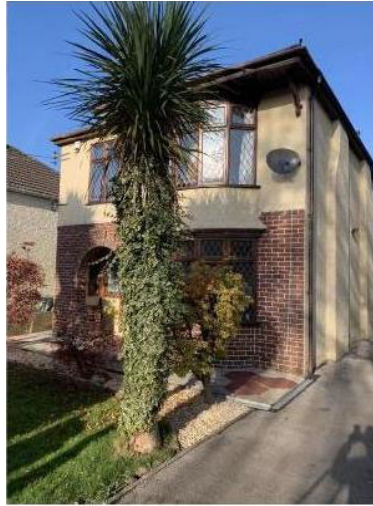
*Photo 2: Front garden showing the mature Cordyline specimen prior to clearance. One specimen of this type is retained, potted*

**Development Impacts:** One mature specimen will be retained and will be potted and repositioned within the new driveway layout, clear of vehicle movement. The front garden lawn is replaced in full by a widened driveway, sized to provide off street parking for two vehicles and a touring caravan, with limited additional allowance for the household's children reaching driving age. The driveway build-up is a permeable weed-control membrane, a compacted crushed stone sub-base, and a tarmac surface course; as the finished tarmac surface does not itself allow water to pass through, surface water run-off is directed to a permeable area within the site rather than to the highway, with the final detail confirmed on site by the contractor. Drainage systems exist beneath the surface which will be expanded.

| <b>Step 1 – Avoid</b> | One mature Cordyline specimen is retained, repotted and repositioned within the new driveway layout, clear of vehicle movement, rather than removed. Boundary fences are retained in full. |

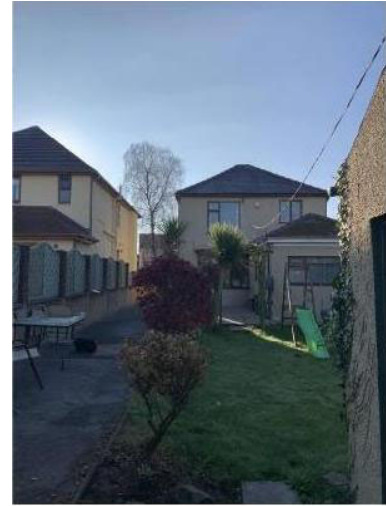
*Photo 3: Rear garden lawn prior to the proposed hard landscaping works*

The rear garden comprises a patio adjacent to the house and a large amenity lawn extending to the rear boundary (see Photo 3). Side and rear boundaries are close boarded timber fences. There are no ponds, hedgerows or protected trees recorded on the site. Some specimen have already been removed from the rear garden to accommodate a young, active family space.

The rear garden lawn is replaced in full by artificial grass, chosen as a durable, low maintenance surface to support an active family of three boys, with patio retained either side adjacent to the kitchen extension and the garden room, and a path around the garden room. No boundary fences are removed.
