# Mynydd Ty-talwyn Energy Park - Environmental Statement Volume III

Appendix 5.1: Preliminary Risk Assessment

Project Reference: 663870

**Title:** Preliminary Risk Assessment: Mynydd Ty-talwyn Energy Park

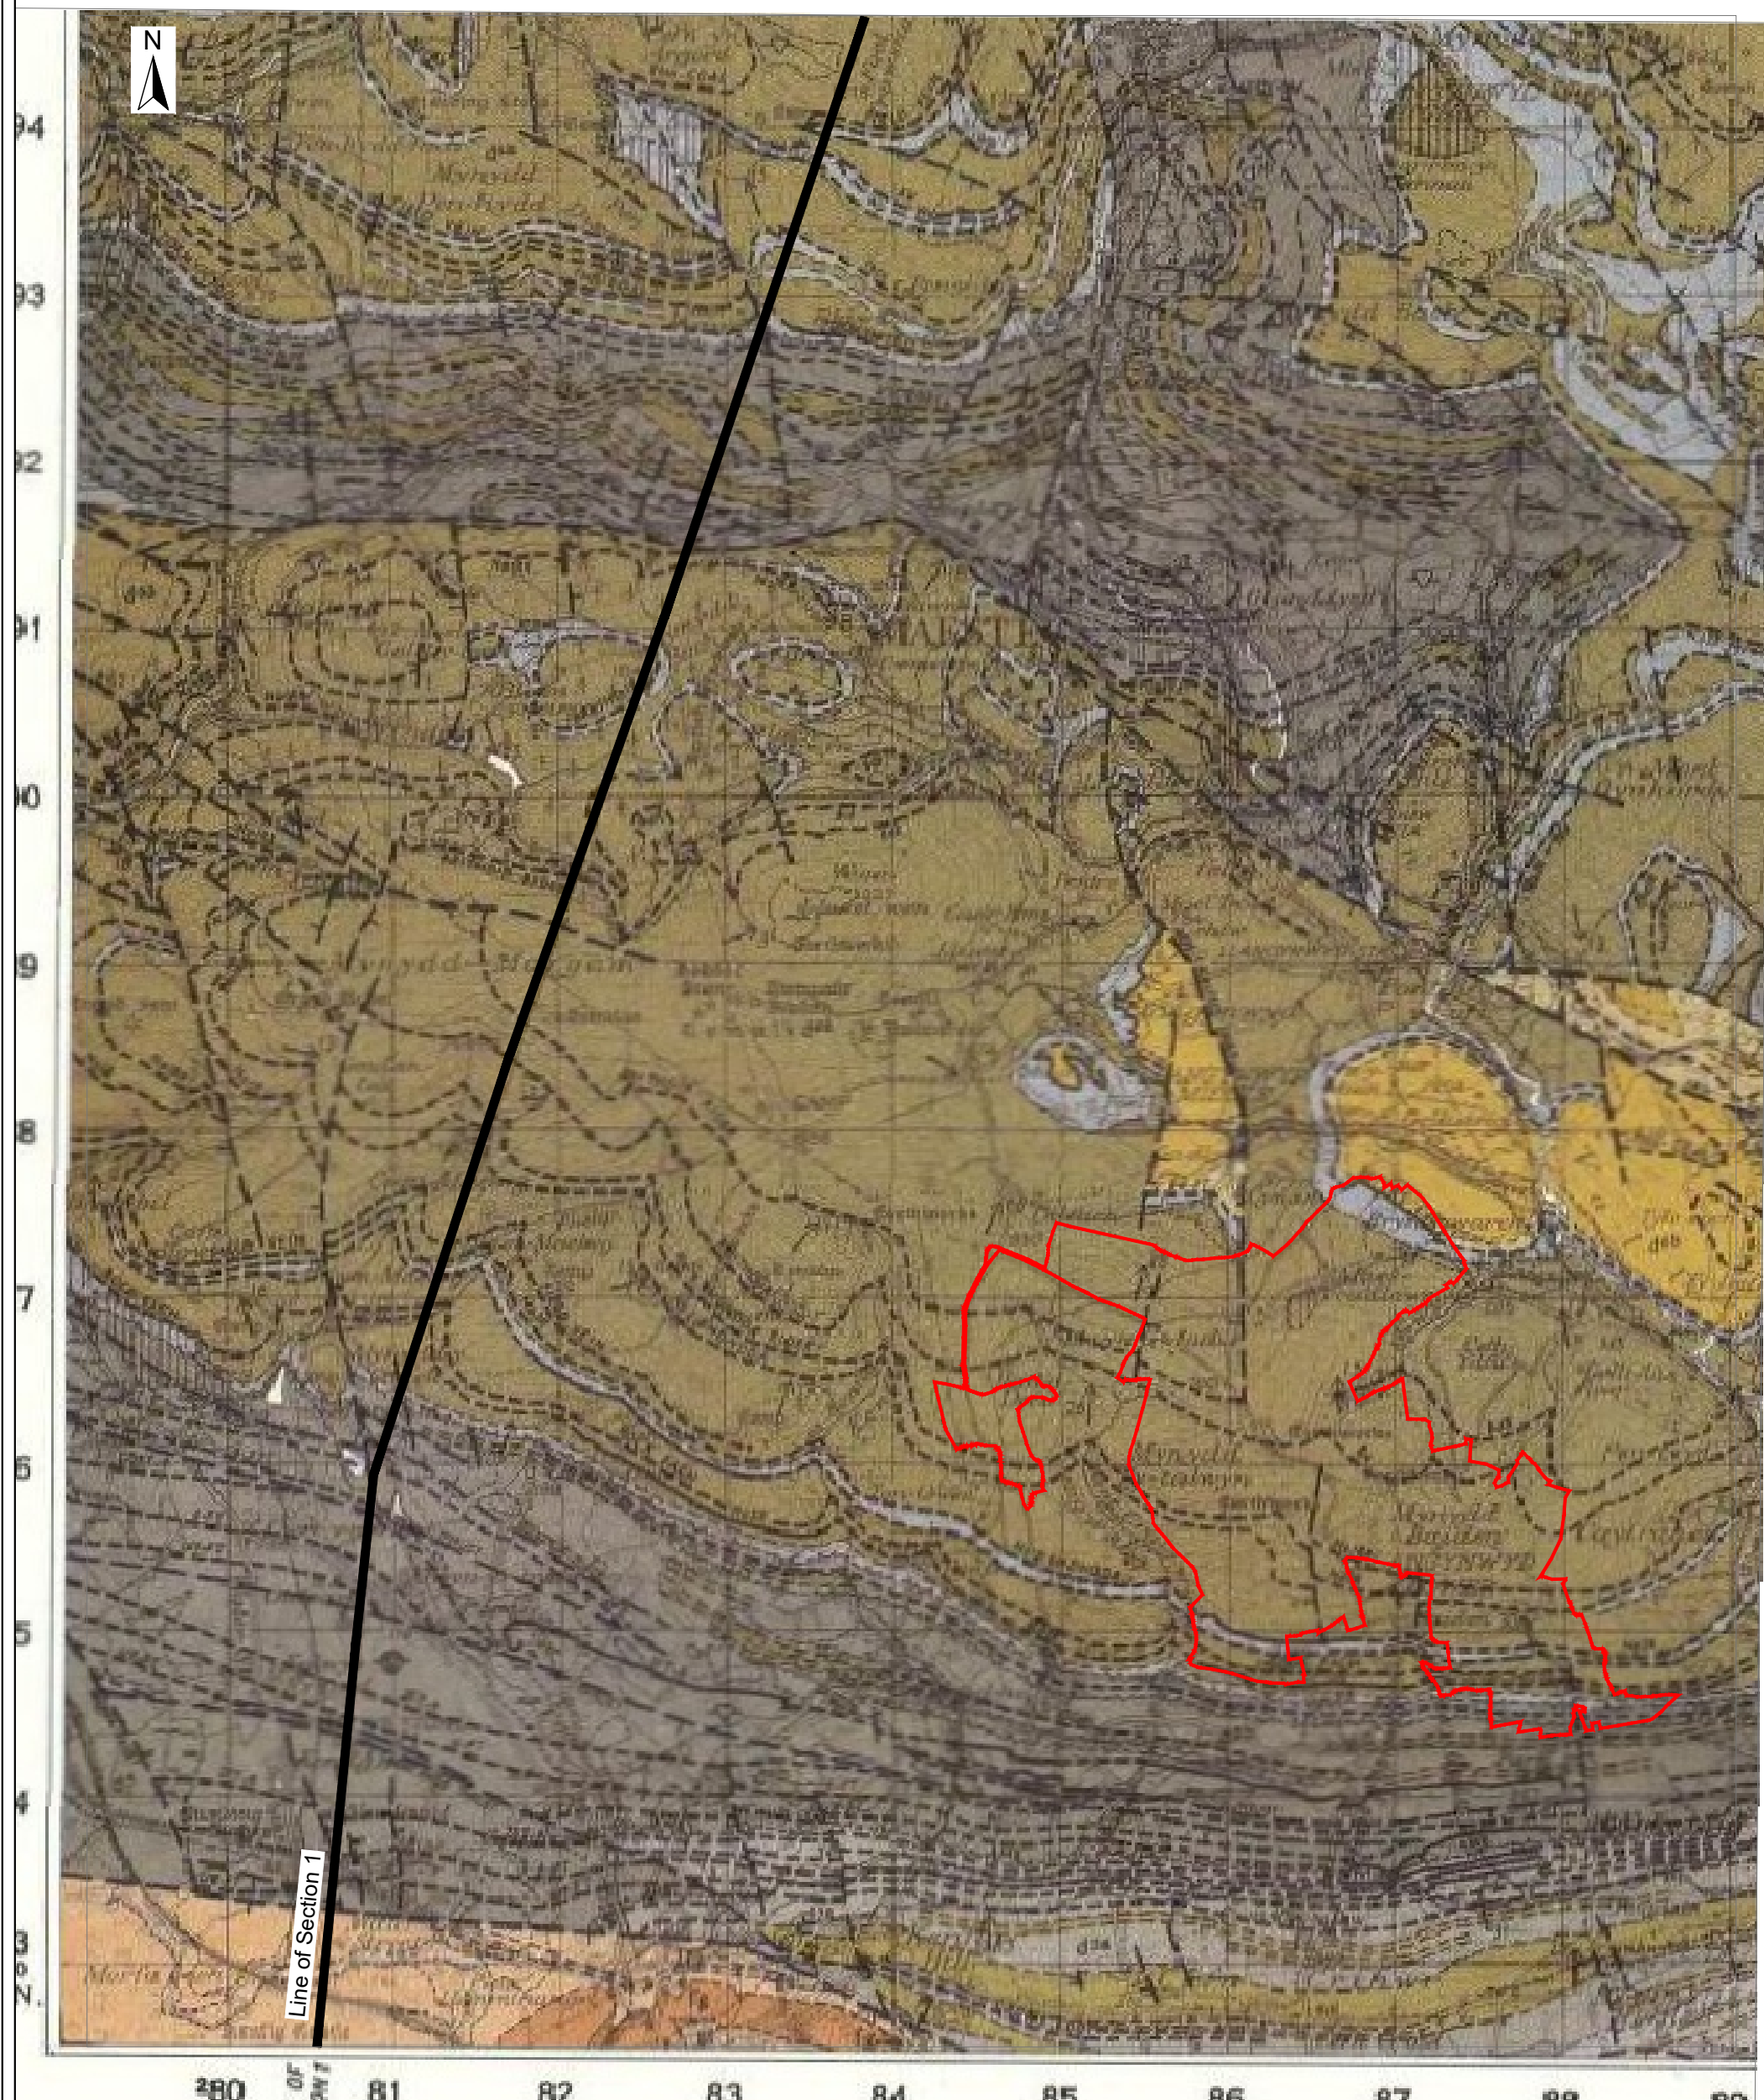
| Description<br>Geology Plan with Line of Section 1 Location | | | | | | | | | |

Site wide geology extracted from: British Geological Survey (BGS) map 1-63,360 scale, Sheet 248, Pontypridd, 1963 (SOLID)

For 'Line of Section 1 Cross Section Extract', refer to Drawing no. 21203  
(File name: 323200-HE-212-SS-D-C-21203)

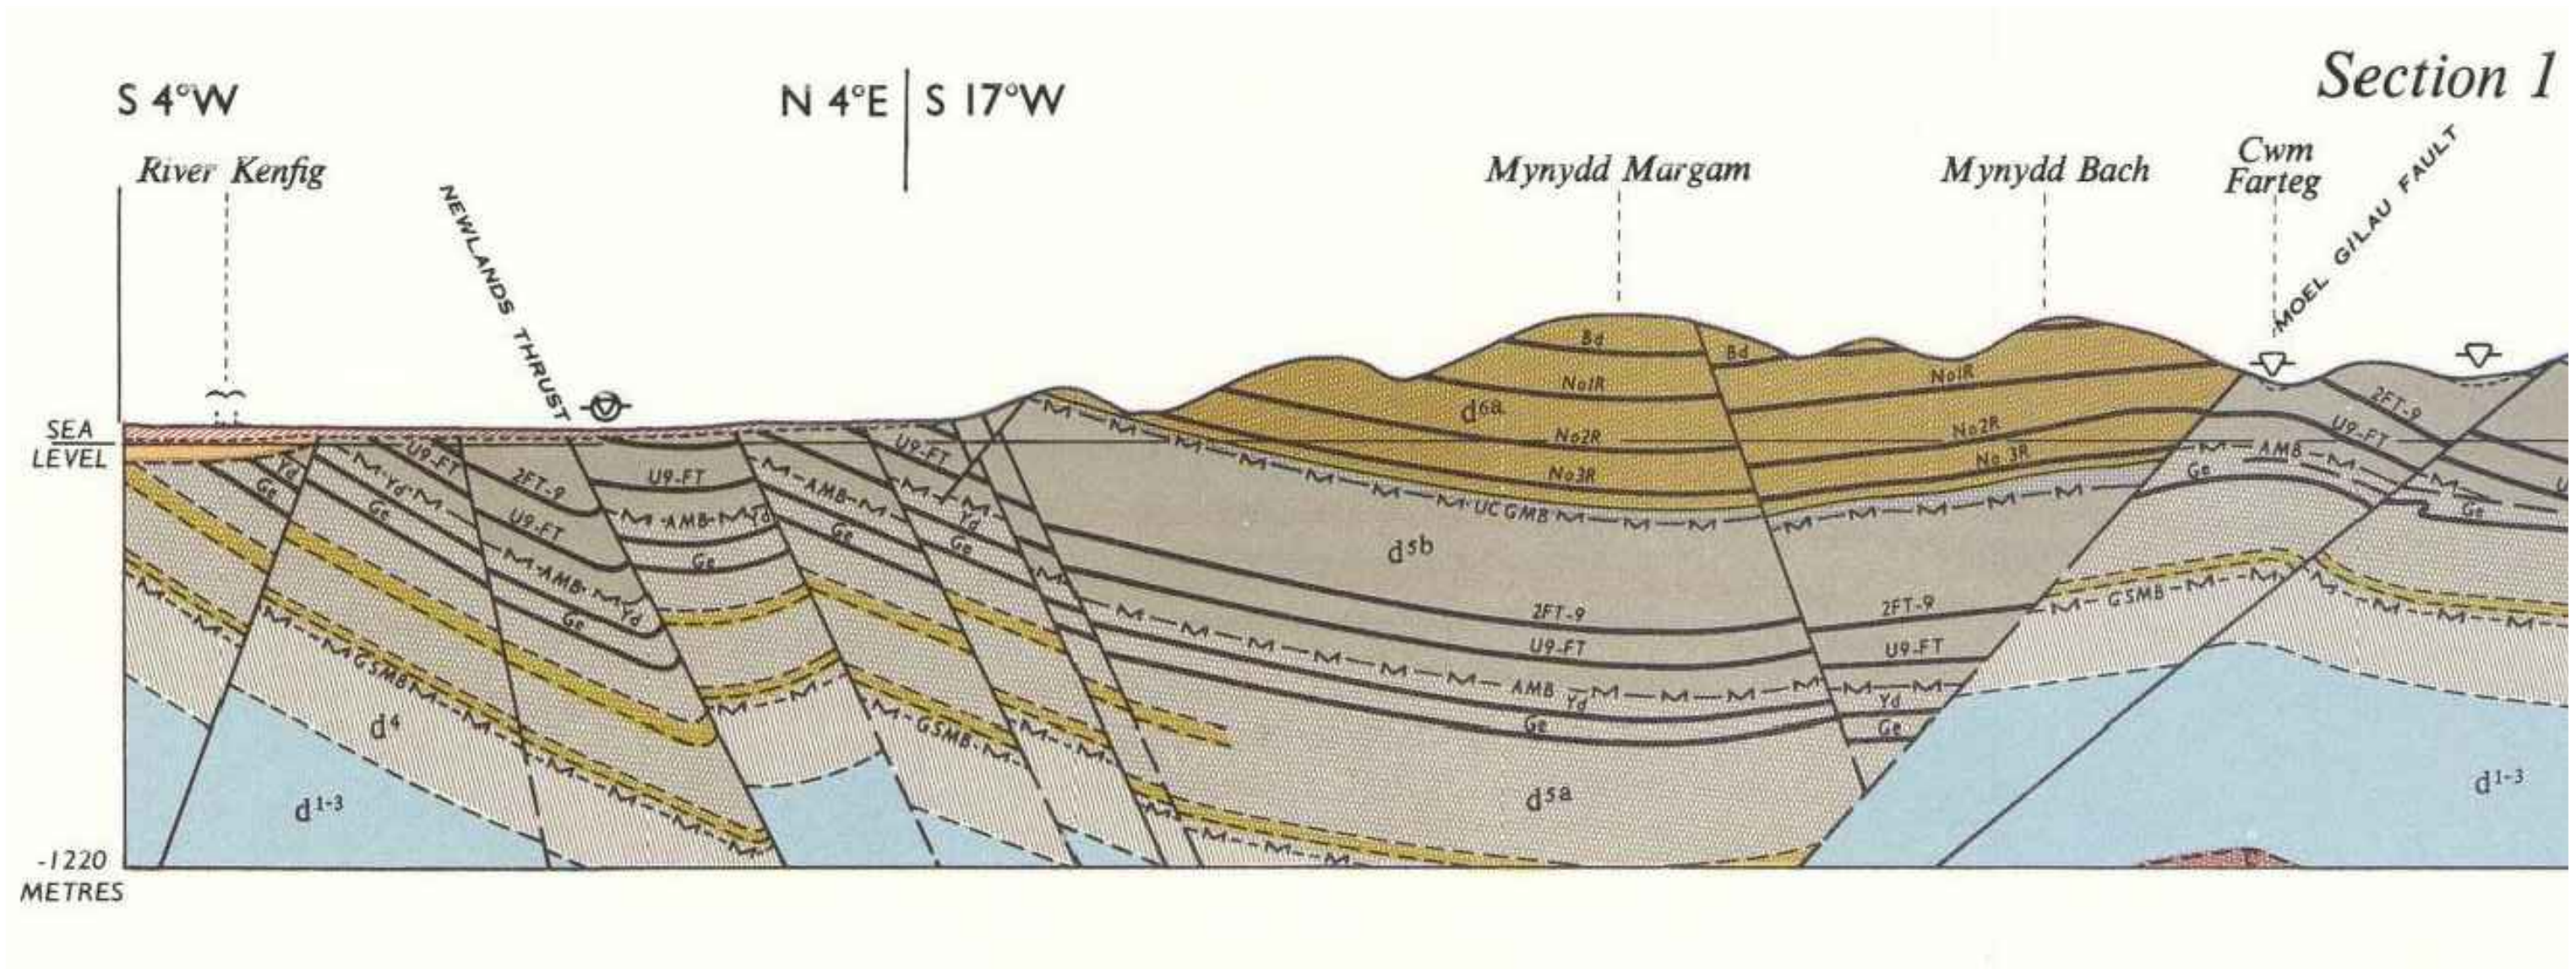
Cross section extracted from: British Geological Survey (BGS) map 1-63,360 scale, Sheet 248, Pontypridd, 1963 (SOLID).
