## METAL BOX GARAGE

EC2023 016

Bat Emergence Survey Report

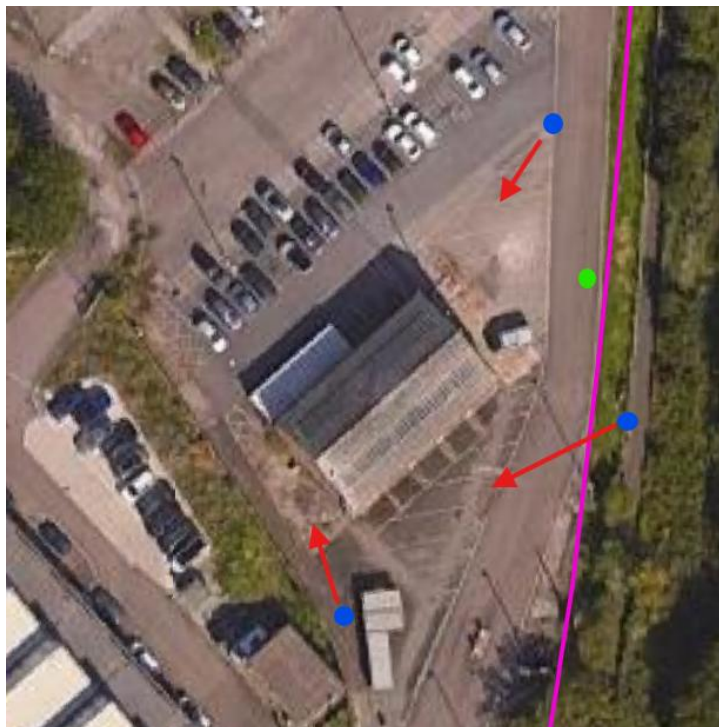
Three thermal imaging cameras were positioned to cover the whole building. The camera-position plan shows the thermal camera locations as blue dots with red arrows indicating the direction of view, and the surveyor position as a green dot. Three cameras were necessary because the site geometry and awkward viewing angles prevented reliable coverage from fewer positions. Two Anabat Scout detectors were used to record bat calls and support species identification and interpretation of activity. The detectors were positioned at either end of the building to provide full acoustic coverage.

**Figure 2 Survey coverage plan showing thermal camera positions and viewing directions, surveyor position and acoustic detector coverage.**
