| 25061/R3 | June 2026 |
| Project<br><b>COED D'ARCY – PHASE 3 SOIL VERIFICATION REPORT: PLOTS 22 TO 25, 27<br/>TO 29 AND 36</b> | |

As part of the regeneration of the former BP Llandarcy oil refinery site, URS were commissioned by BP to develop a remediation strategy and validation for the site known as Area 1 (the site). The site location is shown in Figure 1.

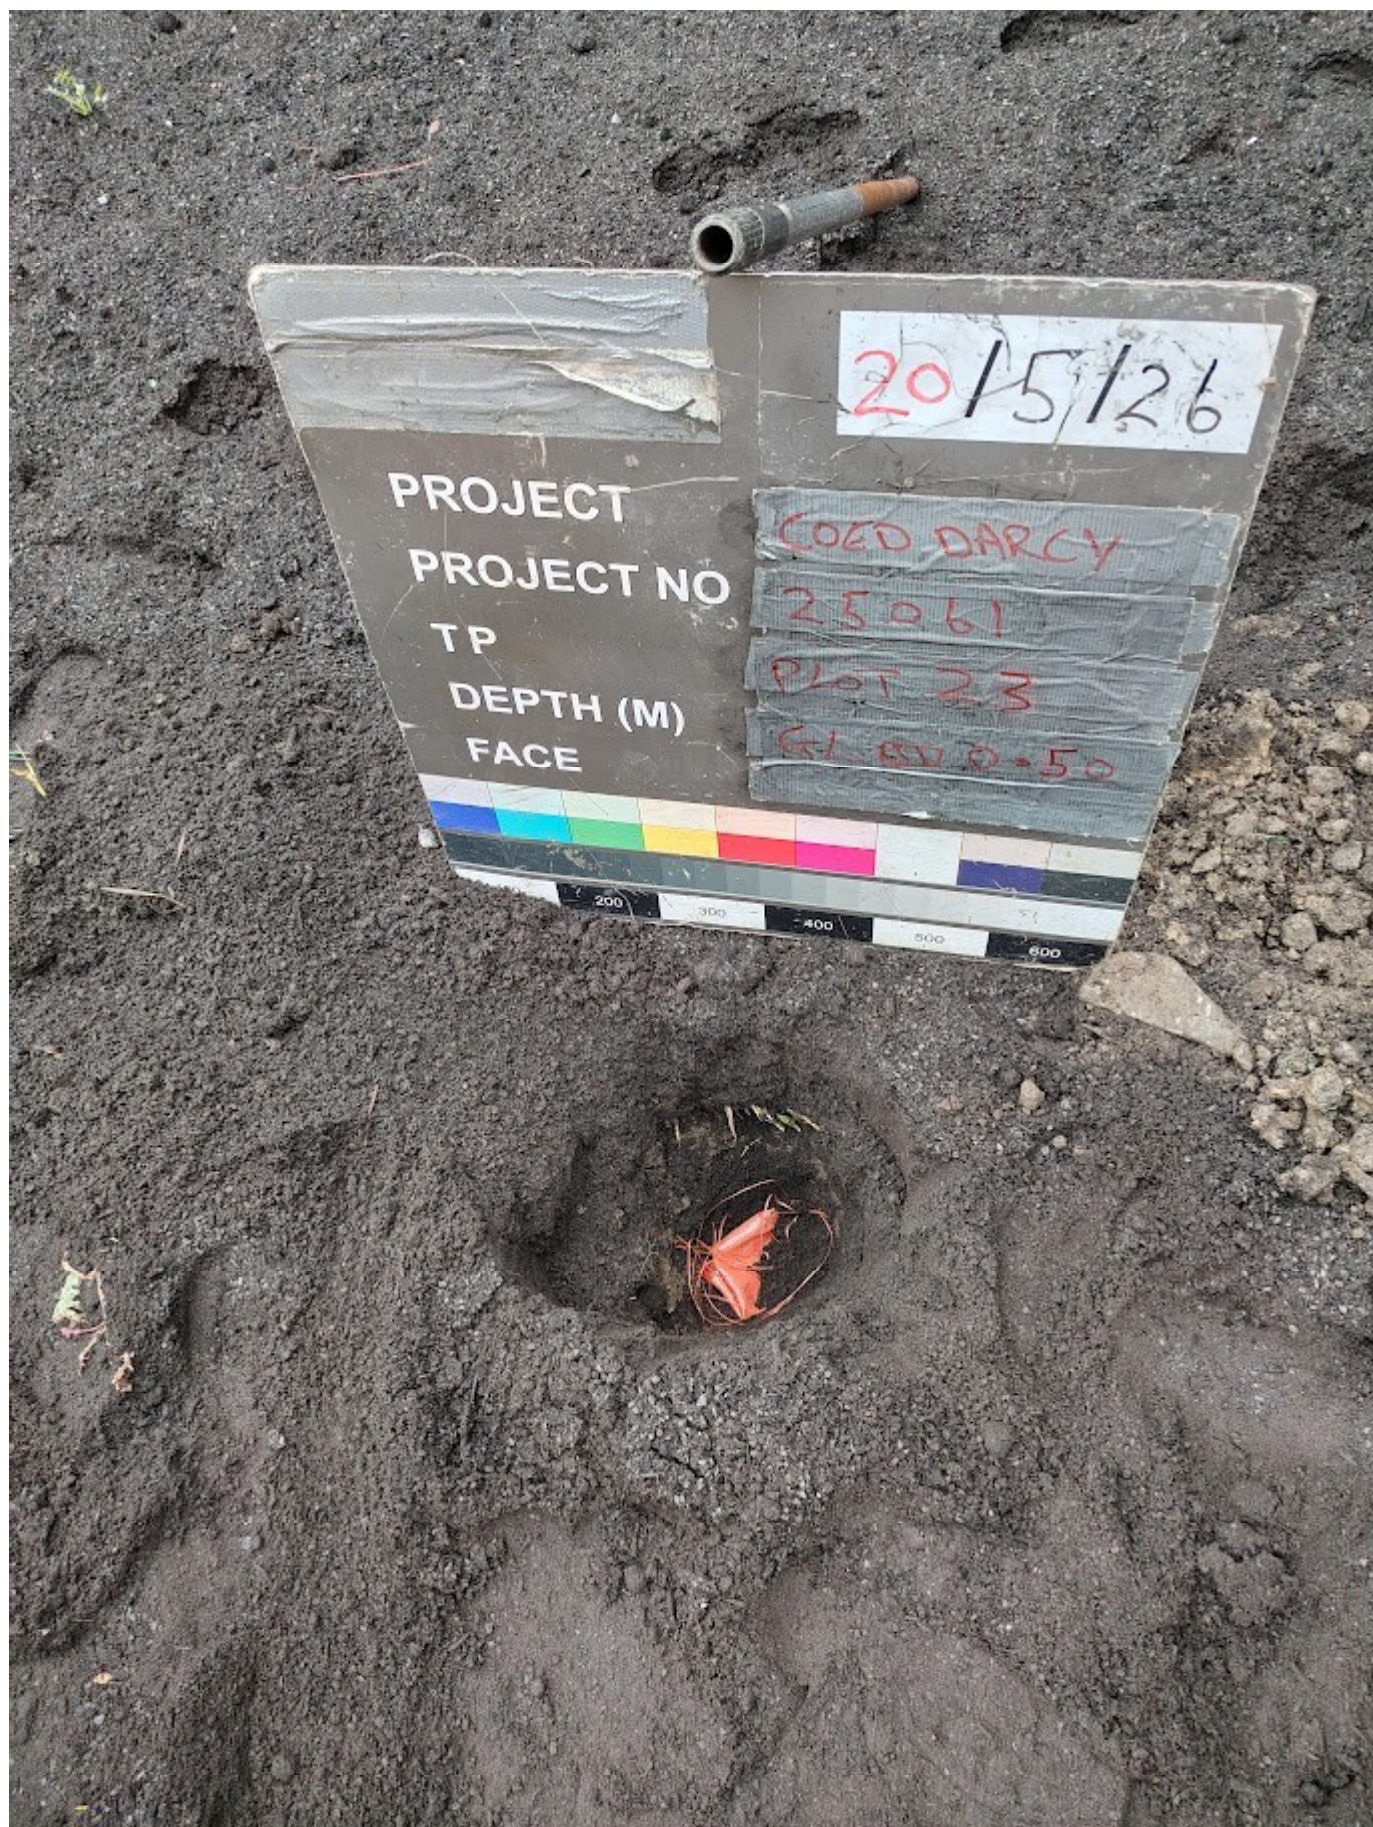
PLOT 23

| Date | | 20.05.2026 | | Sheet No | | 1 of 1 | |
| 0.10 - 0.20 | ES | | GL - 0.20 | 1 | MADE GROUND: Grey and black silty SAND AND GRAVEL. Sand is fine to coarse. Gravel is angular fine to medium of limestone. Fill. | | |
| | | | 0.20 - 0.50 | 2 | MADE GROUND: Brown and grey slightly sandy clayey subangular to subrounded fine to coarse GRAVEL of sandstone with low cobble content of subangular to subrounded sandstone. | | |
| | | | | | Possible bedrock at 0.50mbgl | | |
