## **BAT ROOST METHOD STATEMENT**

**MELYN CLOSE,**

**NEATH PORT TALBOT.**

# **PRELIMINARY ROOST ASSESSMENT AND OBSERVATION SURVEY, MELYN CLOSE, NEATH.**

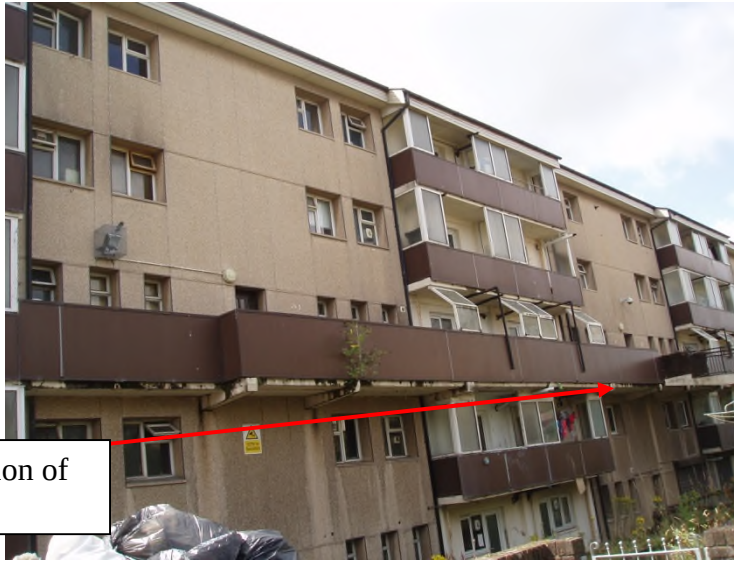
The rear elevation showing first floor open balcony (allowing level access from of St Helen's Street to the rear)

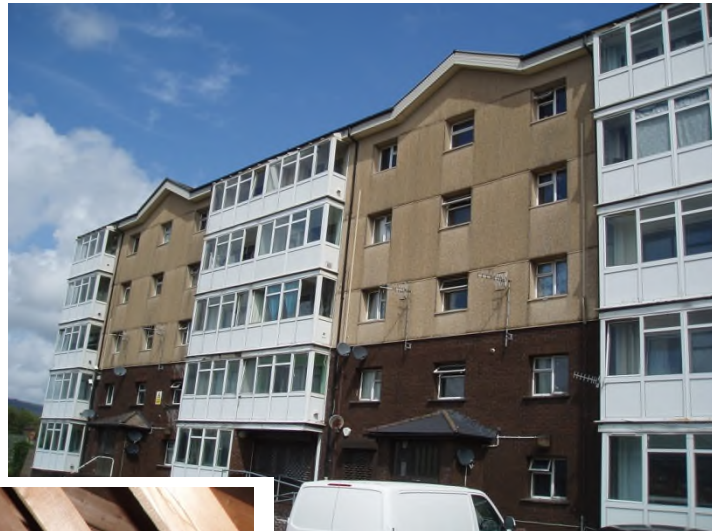
The Melyn Close road frontage.

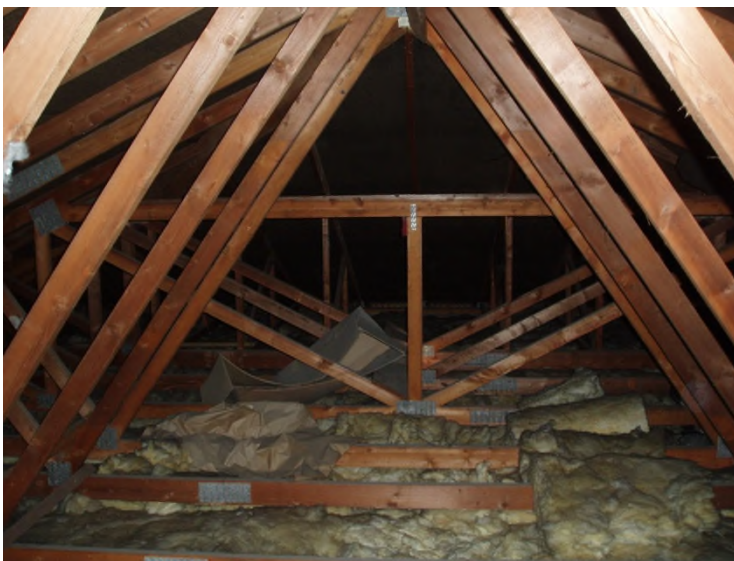
Inside the new roof, glass fibre insulation laid over the original flat roof.

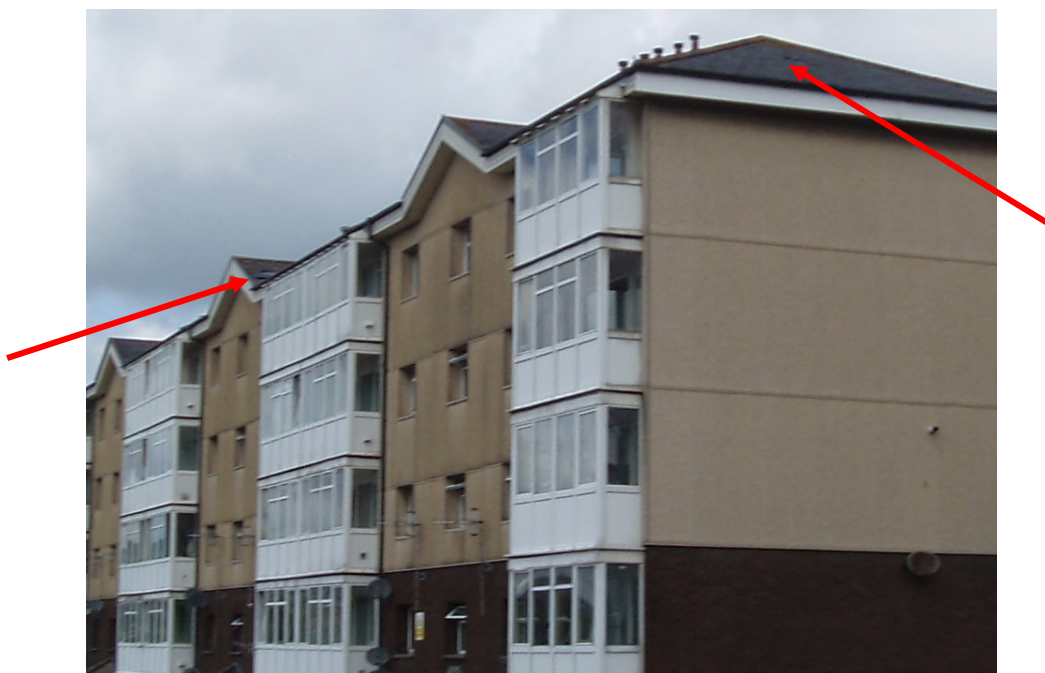
- C7.7 No direct evidence of bats using the building was found during the PRA. The only potential for bats to access the building that was noted was a small number of broken slates on one of the new gables at the front of the building and on the south eastern elevation.
- C7.8 Due to the well sealed nature of the building and the exposed nature of the proven roost location, the building is not considered to be a suitable structure for hibernating bats. However, pre-commencement inspections will take place whatever time of year to ensure bats are not present.

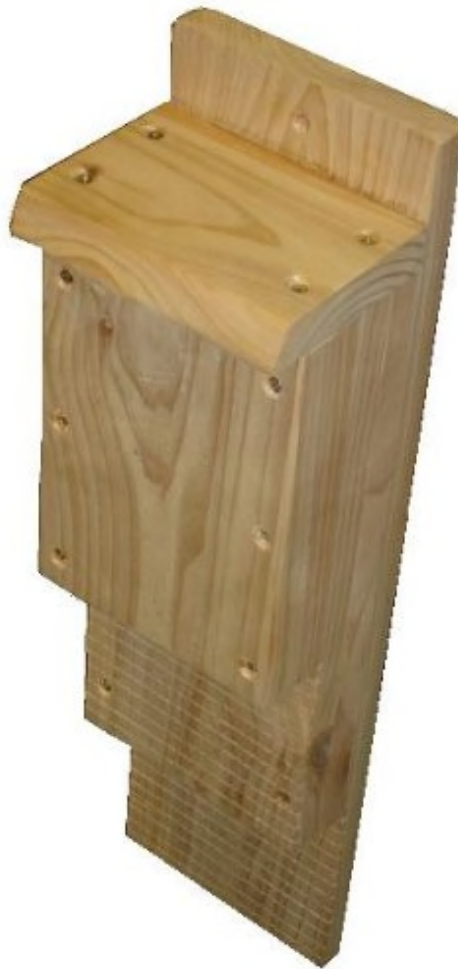
E2.3.2 A Kent bat box or suitable equivalent box will be erected. The bat box location will be agreed with the ECW. Access to the box will not be blocked or obstructed during the works.

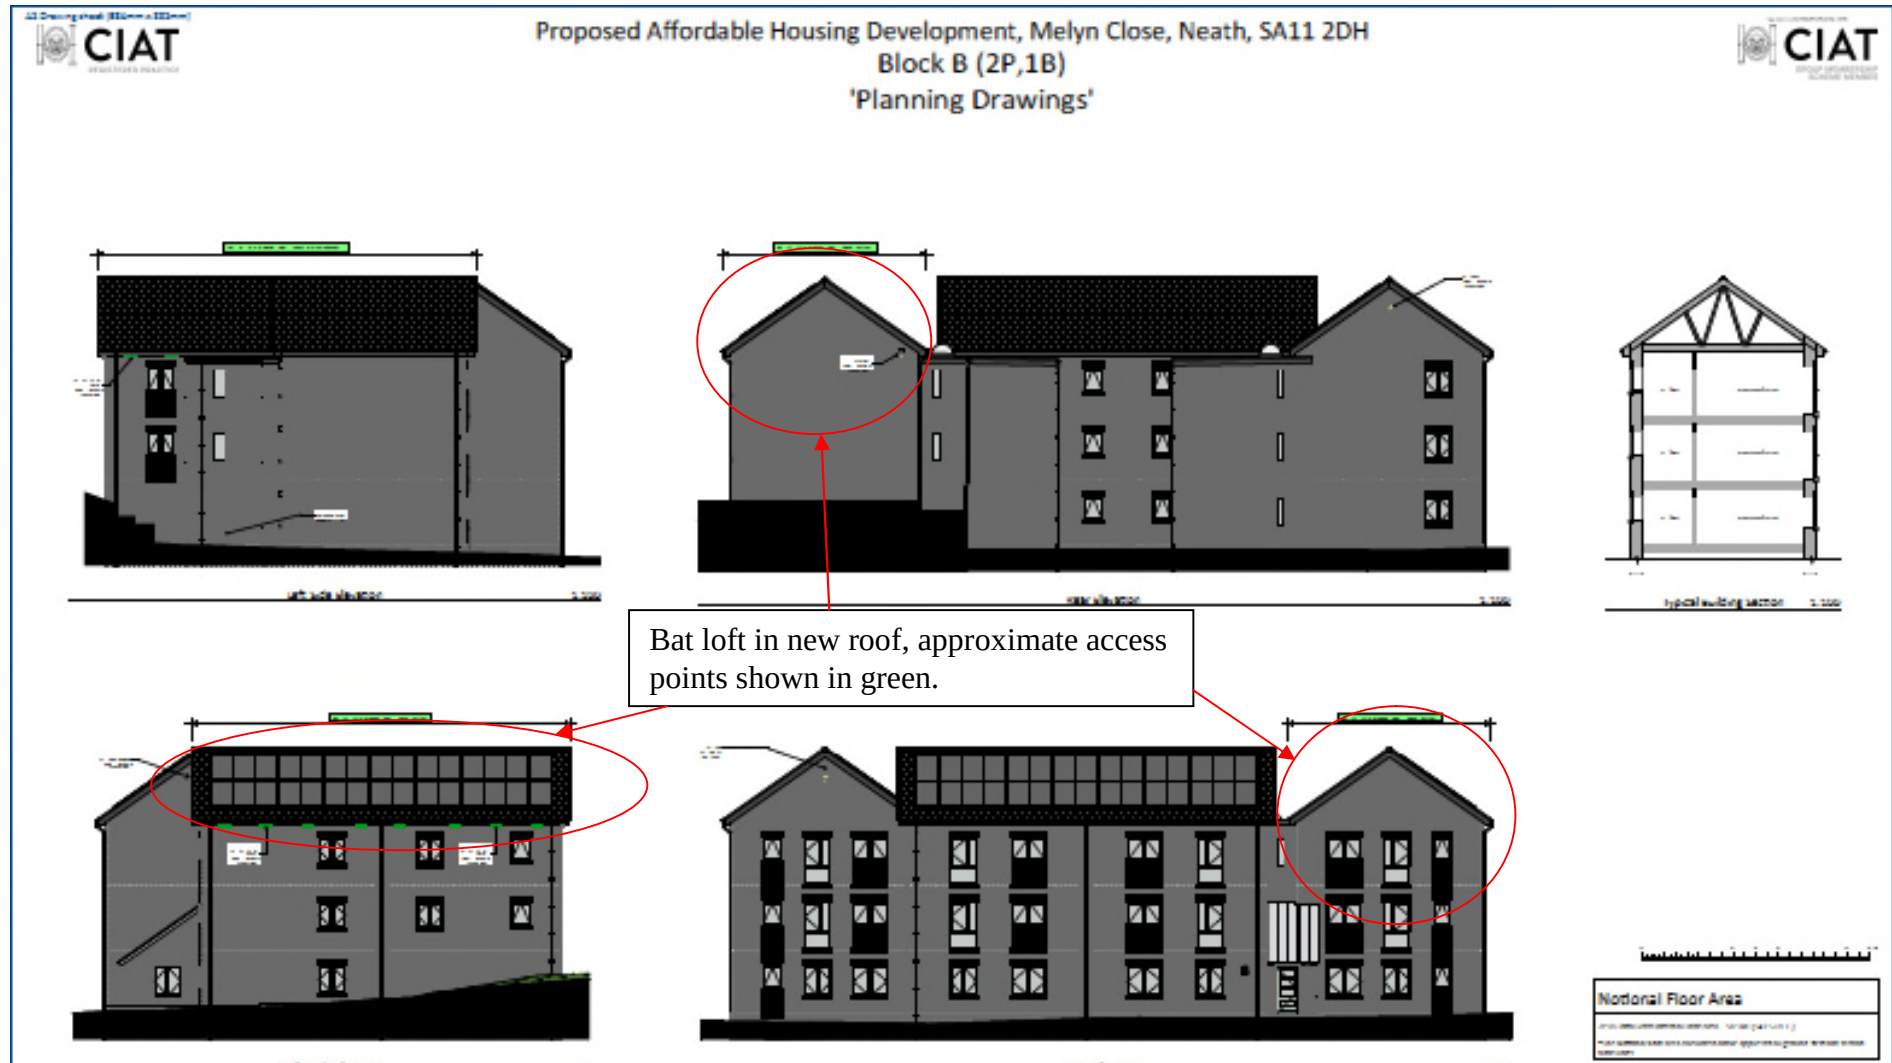
E2.5.1 Plan of block B showing details of bat loft - drawing number 19.12.17 R481-P-10D Block B (elevations and section)

E2.3.3 New roof roost provision will consist of a whole roof section given over to bats. This is shown in drawing number 19.12.17 R481-P-10D Block B (elevations and section) – See paragraph E2.5.1 below. This will consist of access points into the soffit and to the wall top provided at approximately 1.5 to 2 metres spacings; these will be fitted to avoid positions over windows.

E2.3.4 The roof will be underfelted with bitumen type 1F underfelt only. No Breathable Roofing Membranes (BRM) will be used in this roof at any point. Soffit access points will be approximately 12.5 – 20.00mm deep and 75 to 100mm in length and will be positioned so that bats can crawl into the soffit. See paragraph 2.5.2.

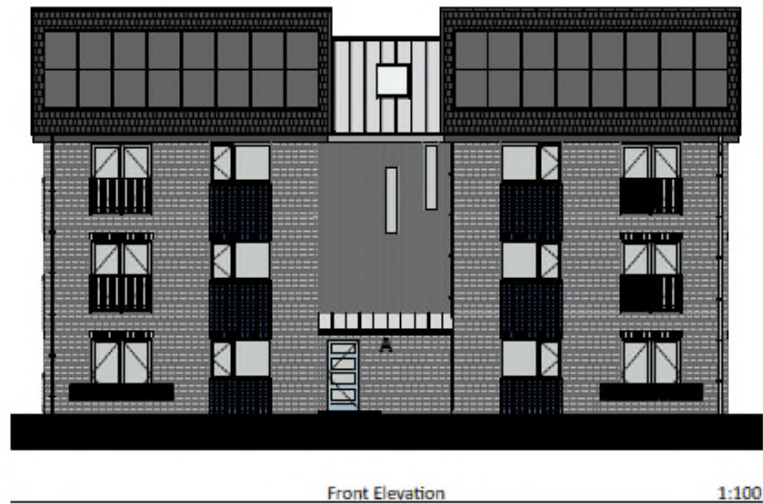
E2.5.3; Detail from drawing number 19.12.16 – R481 – P-08D Block A Plans, elevations and sections showing location of integral bat tubes

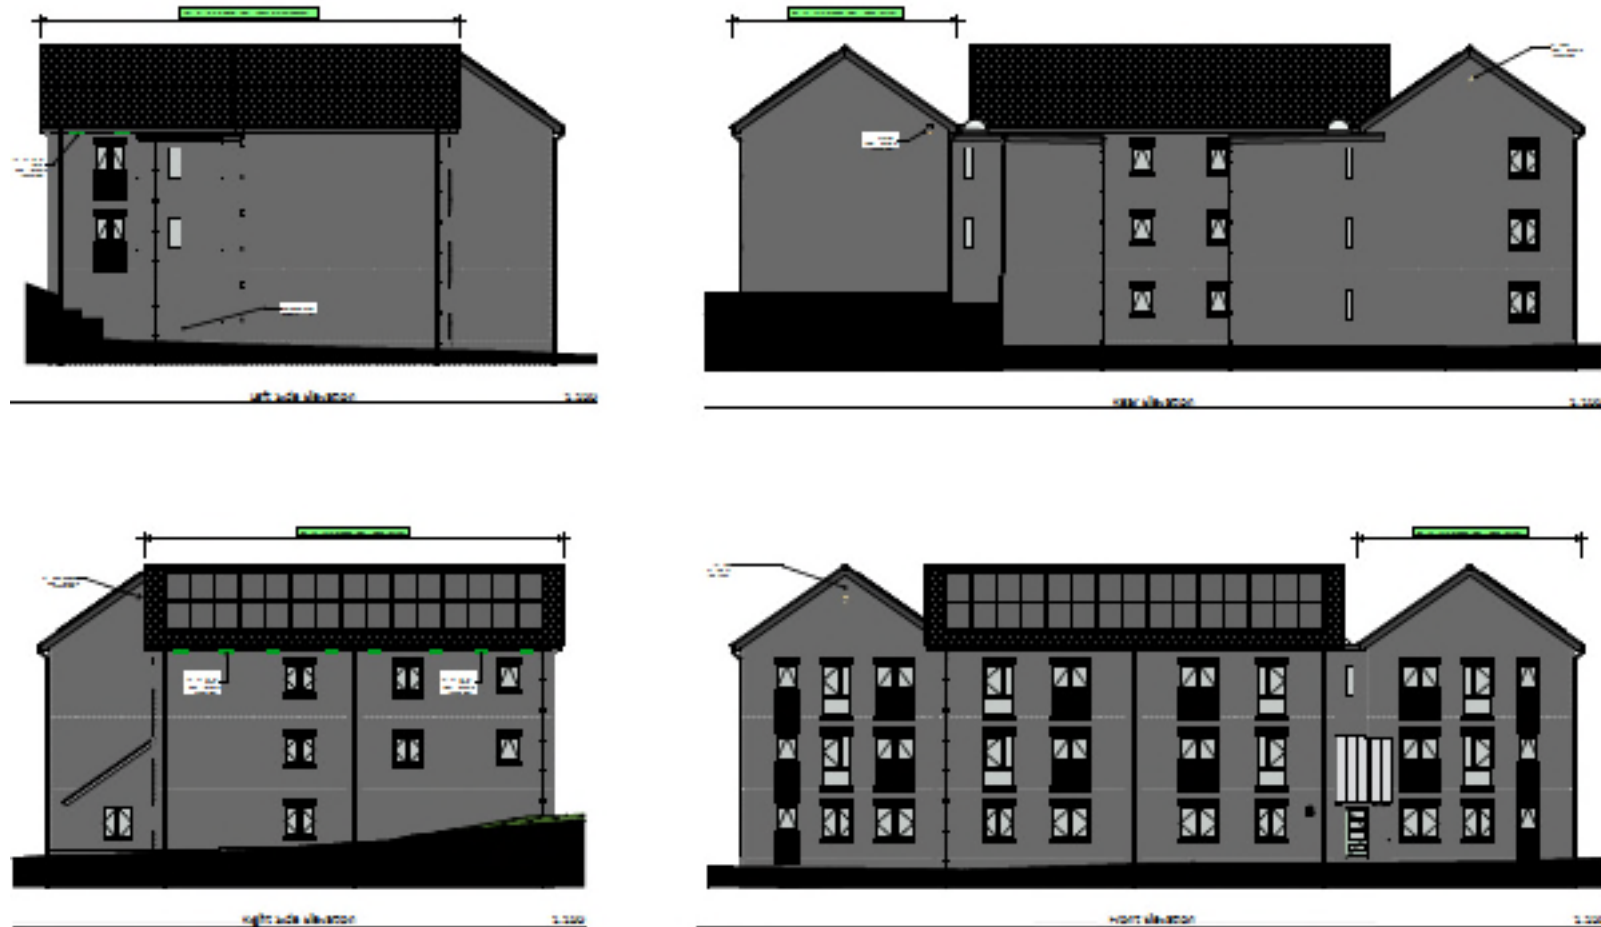
E2.5.4; Detail from drawing number 19.12.17 R481-P-10D Block B (elevations and section) showing location of integral bat tubes

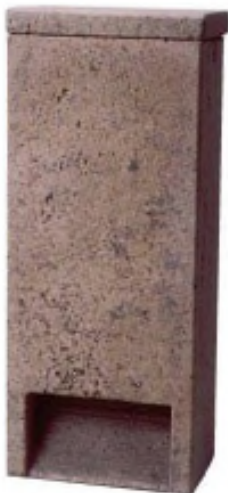
#### **1FR Bat Tube**

The bat tube meets the characteristic behavioral requirements of the types of bats that inhabit buildings. The durable wooden rear panel maintains excellent climatic conditions and provides a surface which they can cling on to. The tube system requires no cleaning or maintenance.

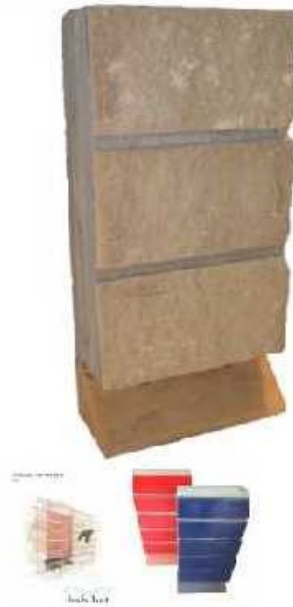
### Habitat 001 - Bespoke Facing

Figure 2, Typical Integral Bat Boxes,  
a, Habitat Custom Stone faced box

**Dimensions:** 215 mm wide x 440 mm high x 102 mm deep

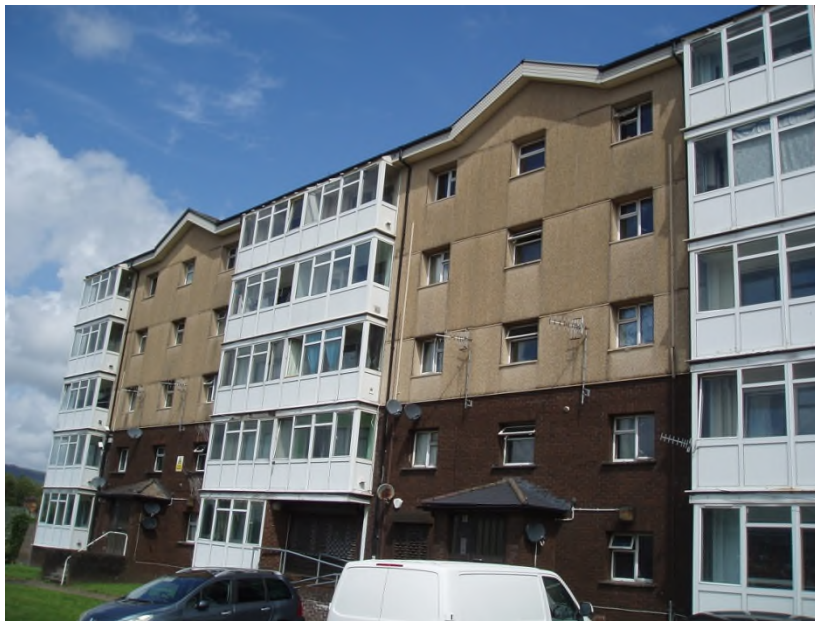
The front of the building from Melyn Close

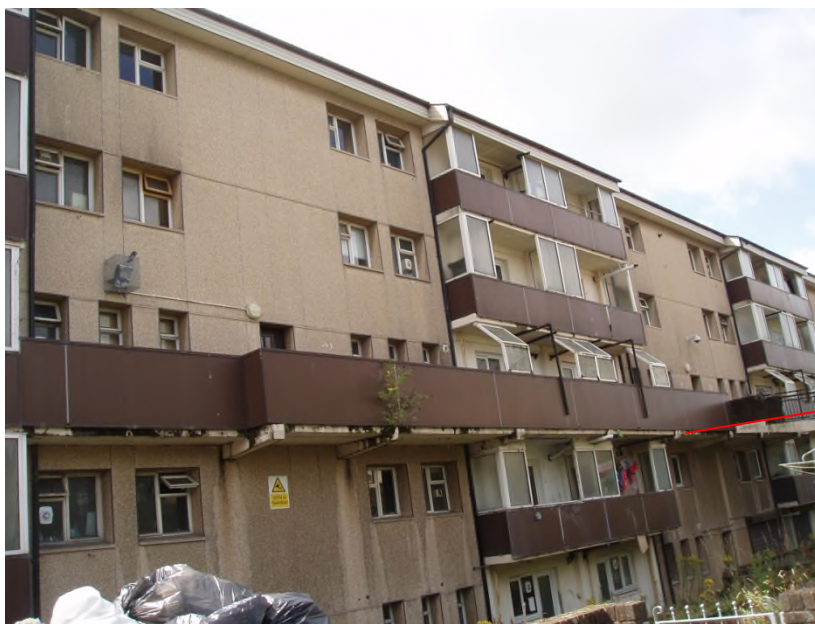
**A soprano pipistrelle was observed emerging from the pier support of the lower walkway balcony at the rear of the building (see report text).** No other activity was recorded to suggest use of the building by roosting bats and it is considered that this represents an opportunistic roost for a solitary animal. Such is the building construction that such roosts may be present between the cantilever supports to the balcony and the concrete balcony base itself in this part of the structure. No significant roost is considered present and the roost is an opportunistic day roost for a single or possibly small number of animals. However, due to timing constraints with the survey, particularly the lateness of the observation survey, a worst case scenario has been adopted where an assumption of a high status roost being present has been considered and compensated for.

The rear of the building showing location of roost

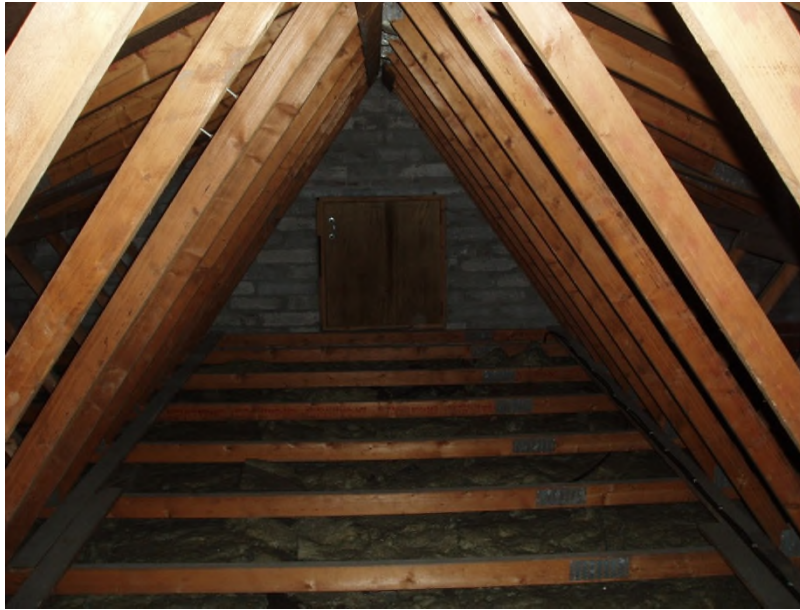
Inside the double itch loft space, built over the original flat roof structure

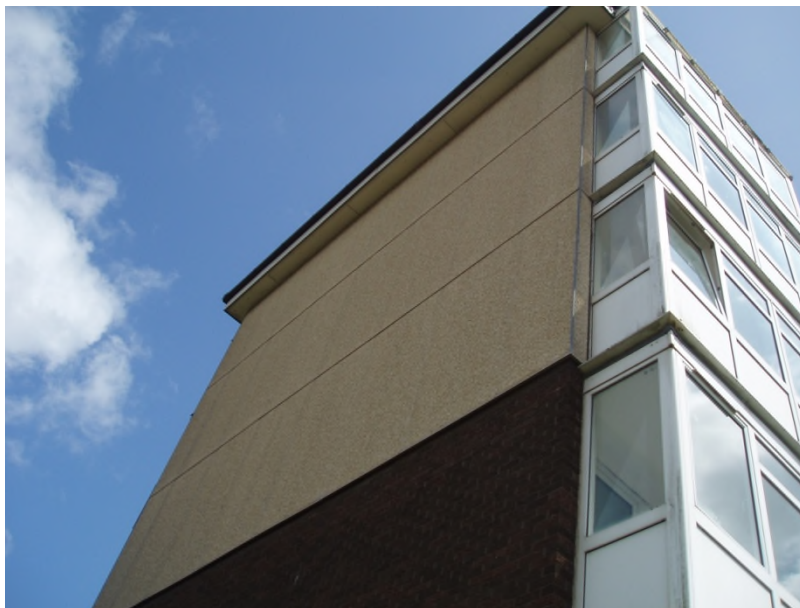
A view of the western gable showing cladding and tight soffits
