**SARON VESTRY  
PEN Y CAE RD  
PORT TALBOT**

**BAT SURVEY  
July 2019**

- 1 survey at the request of-**  
Mr Martyn Jones, owner.
- 2 proposed works**  
Conversion of former chapel vestry to-dwelling use.
- 3 site: name/grid ref**  
Saron Vestry, Penycae Road, Port Talbot SA13 2EP  
SS772903
- 4 nature & date of survey**  
09<sup>th</sup> July 2019- assessment of bat-use *via* external/internal search  
09<sup>th</sup> July 2019- roost-emergence/activity watch/survey.  
24<sup>th</sup> July 2019- roost-emergence/activity watch/survey
- 5 objectives-**
  - to assess the likelihood of any bat (or other protected species) use of the building
  - to identify any constraints consequent upon the discovery of bats (or other protected species) in the building.
- 6 surveyors**  
*Rob Colley Associates; 4-5 Waterfall Terrace, Resolven, Neath SA11 4EE  
01639 710239 rob.colley@ecosurveys.uk.com*

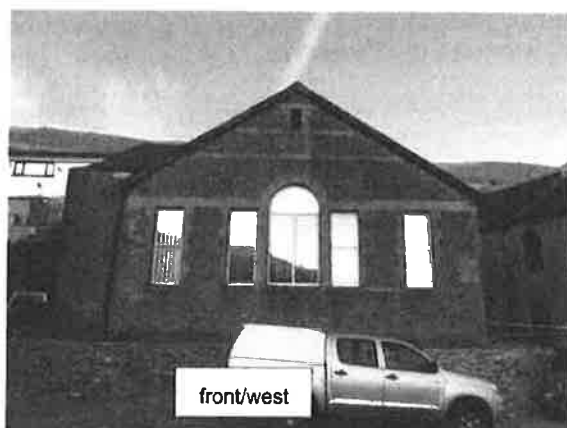
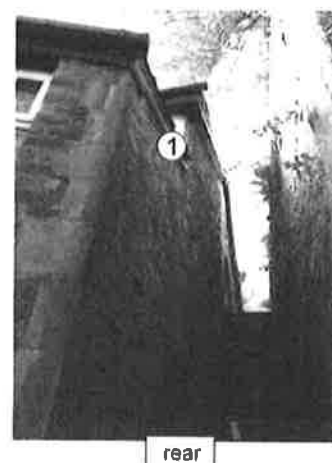
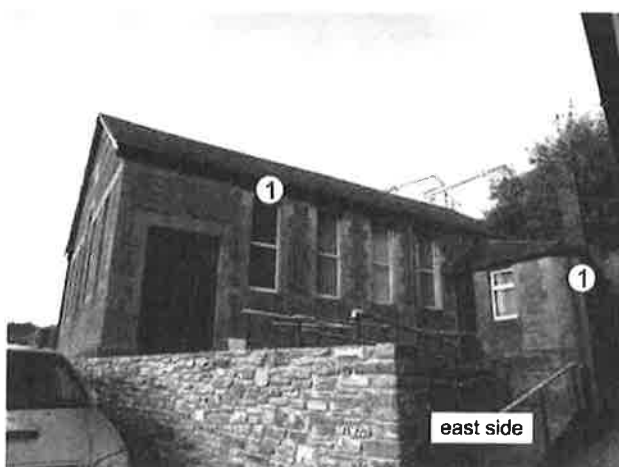
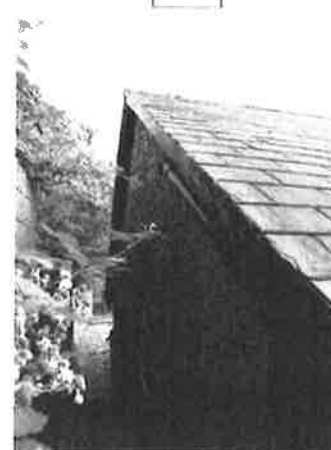
Walls are dressed stone, with cement rendering at the north gable; all are in good repair, with no potential intra-masonry bat-access; all doors/windows are intact and tight fitting, giving no fly-in bat access opportunity. Open louvres at a rectangular vent, high at the west gable, give potential attic access for (eg. *Plecotus* sp.) bats.

At walltops, there are bat accessible gaps between wall masonry and-soffits/fascias at west and north gable barges and at the small south east extension longwalls (1, sketch plan/photo); rear (east) gable barges are mortar sealed.

All roofs are slate clad; all are in good repair, with no visible from ground bat-access opportunity; a (red brick) chimney stack at the small south-east (kitchen, cuddy) extension is good repair/sealed.
