Issued by: Swan Environmental Services Ltd  
Cedars Business Centre  
Barnsley Road  
Hemsworth  
WF9 4PU

Client: EuroGarages

| <b>Overview</b> | Swan Environmental Limited (Swan) undertook Validation at the Neath PFS and KFC construction project on behalf of EuroGarages. A location layout is presented in Appendix A. |

Swan Environmental Limited was retained by EuroGarages to validate the remediation measures, as per the Remediation Strategy prepared by Geo2 – ref: 19/0776

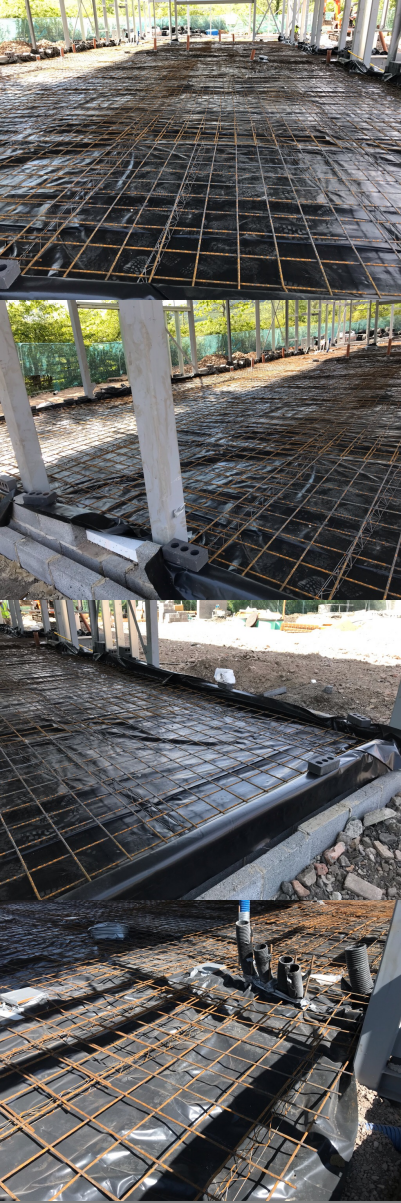
| Site Notes | <p>Floor slab inspection - 75mm insulation base has been placed over type 1 fill - 1200 gauge DPM has then been placed with adequate spacers above to allow for coverage of a393 mesh - DPM has been double taped at joints and lapped over dpc at wall level to provide continuous moisture barrier.</p> <p>No further comments</p> |

| Photos | |
|---|---|
| | Floor slab photos |
