# FORMER GAS WORKS, VICTORIA ROAD, PORT TALBOT

## Ground Investigation Geoenvironmental Report

Report No. Q0151/IR

January 2020

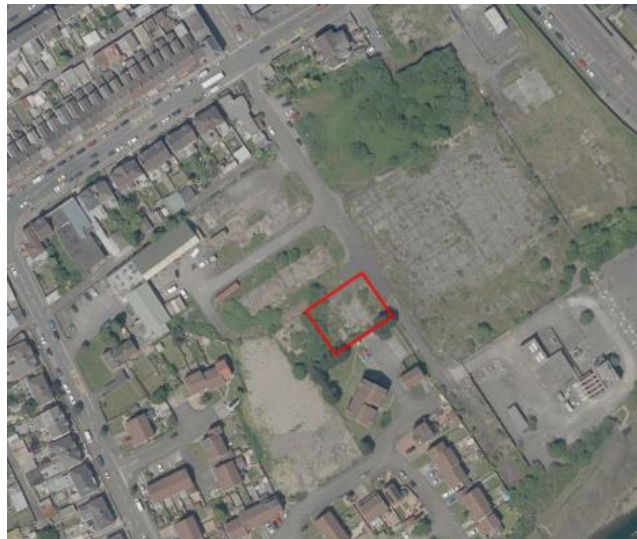
Figure 1: Site Ariel View

The site is relatively flat area with small vegetation and rough hardstanding. The site is approximately 400m<sup>2</sup> and rectangular in plan shape. To the northeast is wasteland whilst a combination of commercial, industrial and residential land uses are to the south east, south west and north west.

An aerial view of the site from current on-line mapping is presented below. The site has not been visited as part of this desk study assessment.
