**GWAUN IARLL  
SEVEN SISTERS****BAT EMERGENCE WATCH/ACTIVITY SURVEY  
&  
PRELIMINARY ECOLOGY ASSESSMENT****July-August 2019****1 survey at the request of-**

Demolition of empty/disused house.

**3 site: name/grid ref**Gwaun Iarll, Seven Sisters, Neath SA10 9EW  
SN811083**4 nature & date of survey****25<sup>th</sup> July 2019-** assessment of bat-use *via* external/internal search**25<sup>th</sup> July 2019-** emergence watch/activity survey**08<sup>th</sup> August 2019-** emergence watch/activity survey**09<sup>th</sup> August 2019-** emergence watch/activity survey**5 objectives-**

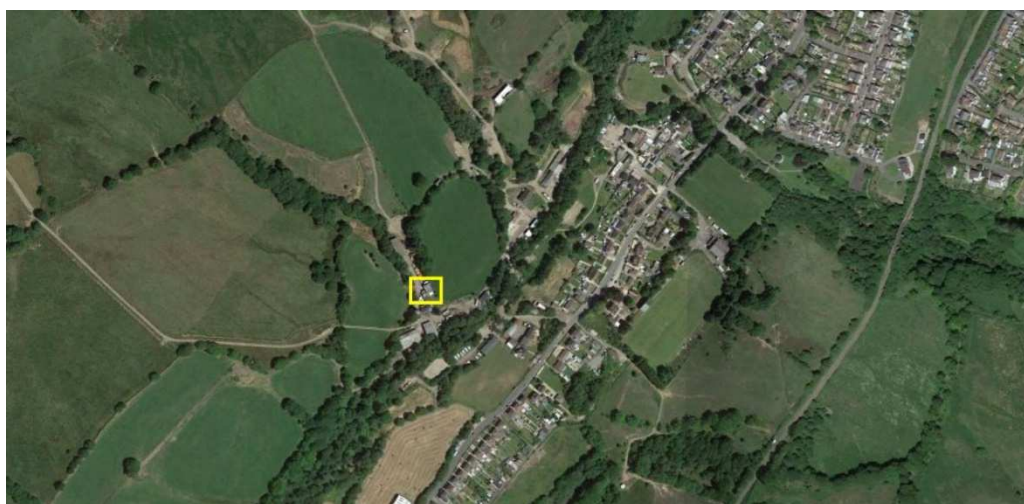
### 9.1 site location, adjacent habitat:

The site is c.100m north of the river Dulais riparian tree line; a well grown hedge/tree line runs down to the river at the immediate east perimeter of the site; a (cattle grazed) field is immediately to-east, over perimeter wall/bank. At the wider area, field boundary hedgelines extend to the north/west of the site; there are valley bottom fields, with housing beyond, over-river to the south/east.

This river corridor and field boundaries give foraging opportunity for a wide range of bat species, and any "Welsh species" might be expected here: pipistrelle (two spp) day roosting is known at two in-village sites <1km of the site; Noctule *Nyctalus noctula* overflight and *Myotis* activity is recorded at the wider area.

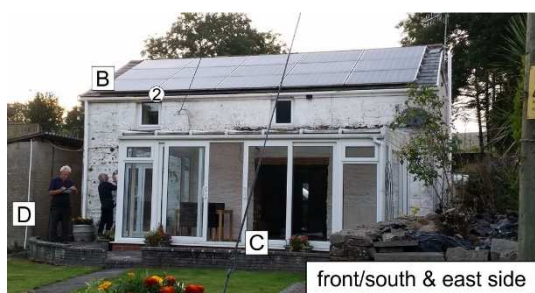
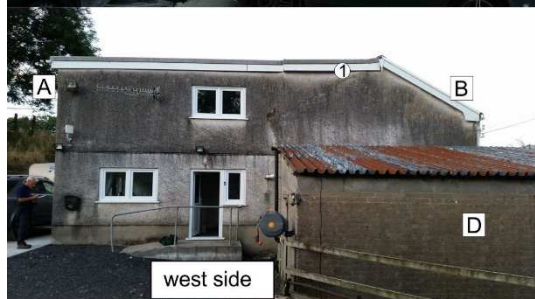
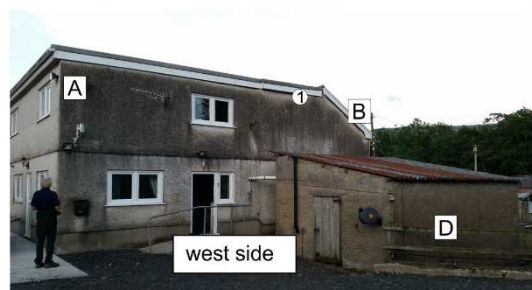
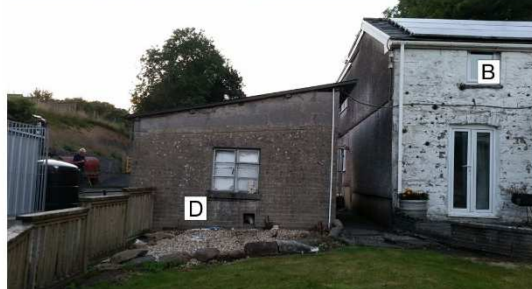
The survey building is a detached, unoccupied, two storey, house in good repair, in recent use but unoccupied at the time of survey; a detached single-storey outbuilding stands c.2m to-west.

The (original?) front section of the house (B) has a pitched, south facing roof, behind this, to north, a flat roof (A) covers the greater part of the house, including any (original?) rear pitch to B; a single storey conservatory (C) is built to 75% of the width of the front (south) wall. A detached single storey outhouse (D) stands c.2m to-west of the west longwall. Externally, the stone front wall is limewashed and all others walls are dashed/ rendered, in good repair and with no potential bat-access intra-masonry; all (uPVC) doors/windows are intact/tight fitted, with no potential fly-in bat access.

Walltops are render sealed to uPVC fascias above, but with potentially bat accessible gaps at several points on the two longwalls of section A (1, sketch plan/photo); the rear/north longwall top is sealed. A wooden fascia at the front wall top at B has potentially bat accessible gaps at its western end (2, sketch plan/photo); no evidence of use could be seen on the walls below A or at the conservatory roof below the walltop of B.

The slated front roof pitch above B is largely covered/obscured by solar panels: no potential bat access was seen at the visible parts of the roof (including the ridge). The flat roof above A is felt (or f-g?) covered; roof edges are in good repair, with foldover-edges securely sealed to fascias, giving no bat-access opportunity.

The single storey outhouse (D) has brick walls, with some high course of end wall blockwork to give the high-low slope of the monopitch roof). The walls are in good repair and have no potential bat-access intra-masonry; a north end door and a south end window are intact/sealed. The monopitch roof has wriggly tin sheeting, with an internal panel lining. Internally the outhouse is clean store/workshop, with a clean

concrete floor. Potential bat access at the outhouse is limited to under-corrugations at the edges of the metal roof sheets.

No evidence of bat (or owl) use was found, internally or externally, at the house or outhouse.

To avoid the offence of disturbing nesting birds, *either* demolition should be timed to avoid the March-July inc. nesting season *or* behind-fascia bird access should be blocked, in-winter/ahead of the nesting season.
