# Land off Neath Abbey Road, Neath

## 12740\_R01\_Bat Survey & Assessment

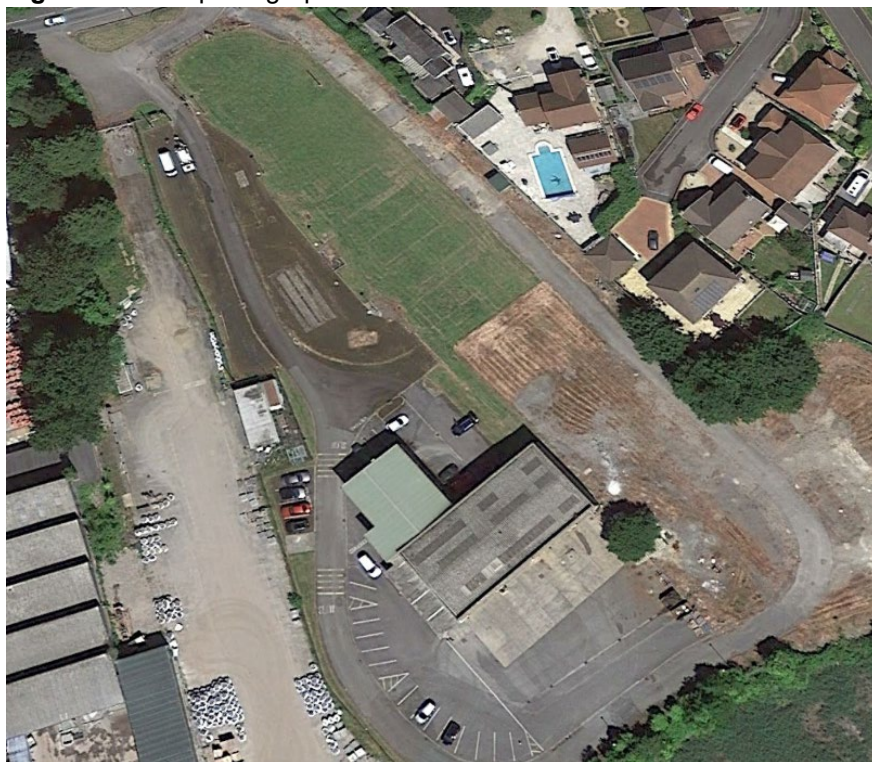
**Figure 2:** aerial photograph

- 3.1. The site supports predominantly hardstanding and close-mown grassland (refer to figure 2, below). Celtic Stone is a small building on the western boundary. Outside of the site, there are industrial buildings to the south, some mature trees to the west, with residential housing to the east.

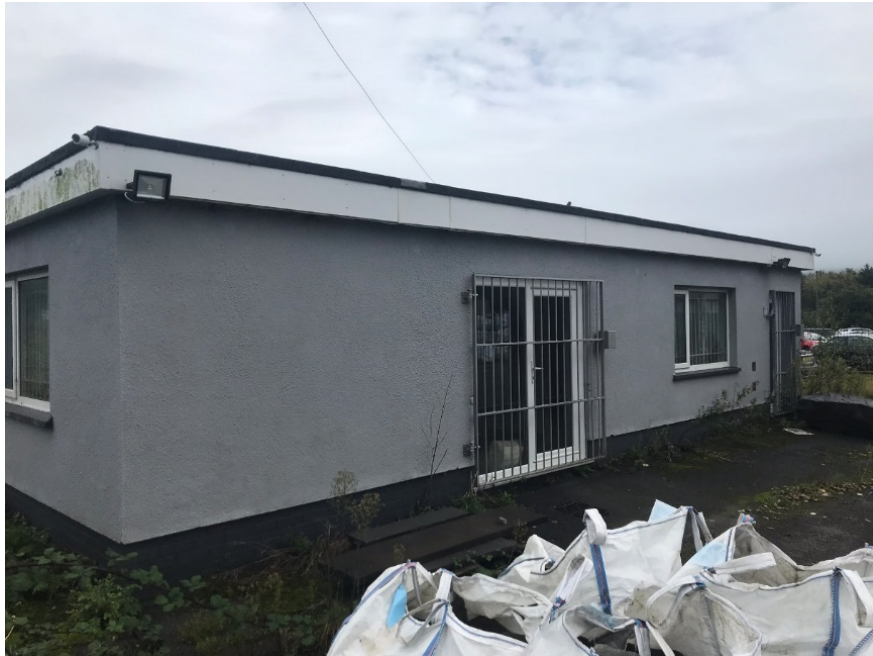
**Photograph 1:** Single storey building

- 3.2. The building is a single storey disused office with a flat roof. The building is in good condition with no visible damage to the soffits or facias (Photograph 1). There is a gap of approximately 3cm between the roof felt and roof deck on the southern and western aspect of the building (Photograph 2). This gap was investigated using an endoscope and no signs of bats were observed, although access was not available along the entire length of feature.
- 3.3. The interior of the building was evidently recently in the process of renovation. Bare plasterboard with holes for light fittings were exposed. The interior of the building and holes in

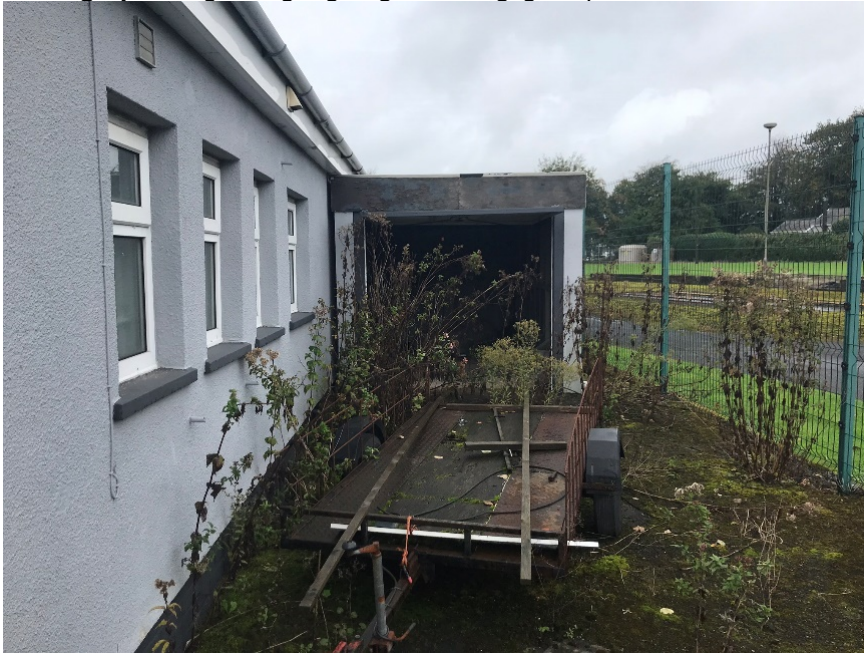
**Photograph 3:** lightweight garage has negligible potential for bats

- 3.4. A lightweight garage structure is open-fronted and too light and airy to be used by bats (Photograph 3).

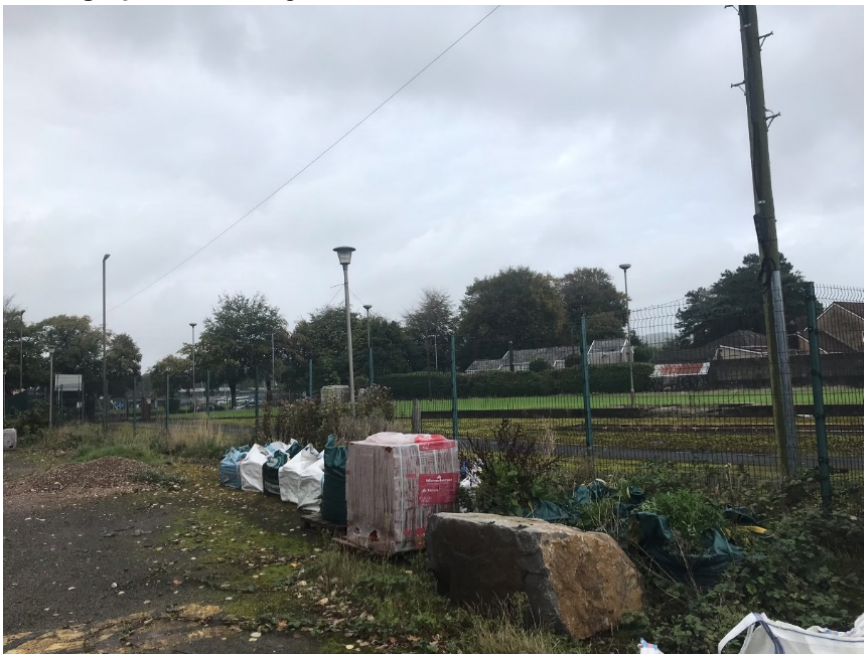
**Photograph 4:** Street lights north-east of the site.

- 3.5. In terms of the surrounding habitats, the building is surrounded by hardstanding and is not linked to habitats that would be likely to be well used by bats for commuting or foraging. There are some street lights to the north-east (see Photograph 4) that are likely to render the night-time light levels too light for some bat species. The roads to the north and south of the site are also well-lit at night.
