**JULIAN TERRACE, PORT TALBOT**

**Site Investigation Report**

12603/JJ/20/SI

**PROJECT:** Julian Terrace, Port Talbot

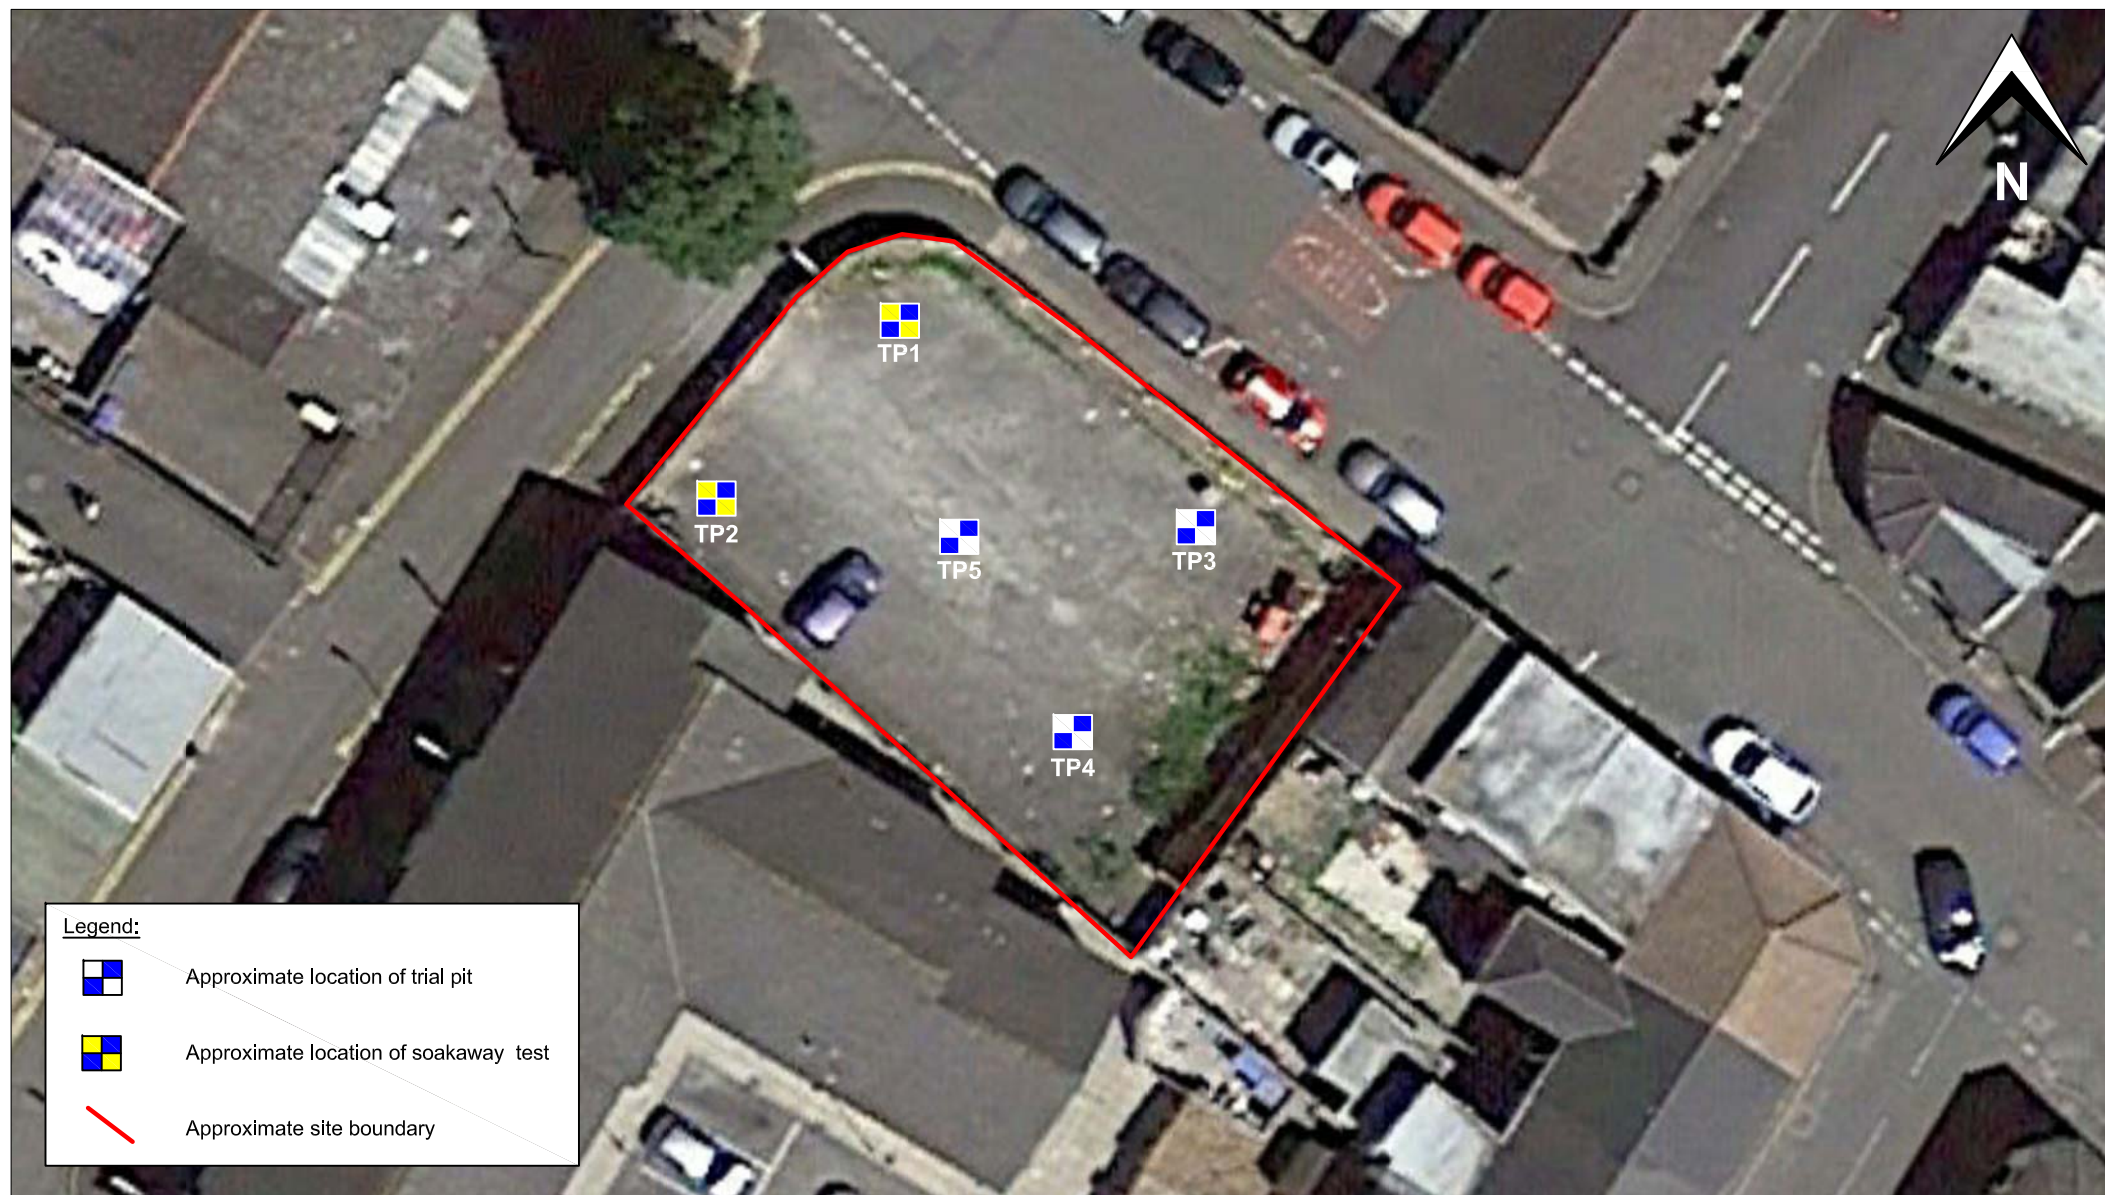
Figure 2: Exploratory Hole Location Plan

The trial pits (referenced TP1 to TP5) were positioned across the site and excavated to a maximum depth of 3.2m below existing ground level using a JCB 3CX backhoe excavator. The purpose of the trial pits was to prove the shallow ground conditions, allow an assessment of the most appropriate foundation type for the proposed development, and obtain shallow soil samples for laboratory analysis.

The approximate locations of the trial pits are shown on Figure 2, while their logs are presented in Appendix D. The results of the soil infiltration tests are presented in Appendix E.
