## Scoping Survey for Bats

August 2019

**Survey Address:** Cwmamman Farm, Lower Brynaman, Ammanford SA18 1SN

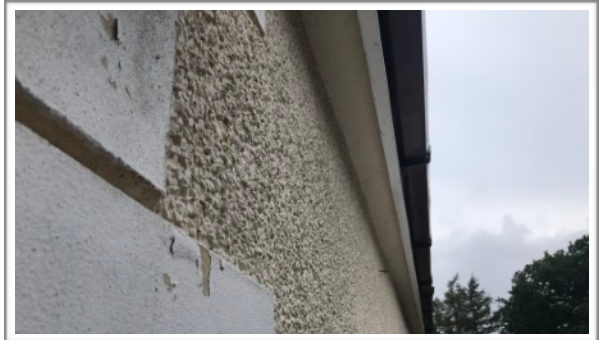
**Photo 2:** North-east facing tight soffits/fascia boards

No evidence was seen during the building inspection to indicate bat usage. All fascia were uniformly tight to the walls offering no cavity entrances for bats to use as roosting spaces. The clay roof tiles offer no spaces as they are uniformly tight as are the ridge tiles.

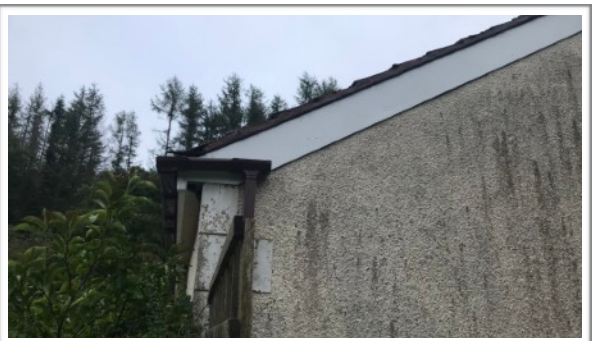
**Photo 4:** View of the roof/fascia interface

- Moulded clay roof/ridge tiles are tightly fitting (see Photos below) and presented no gaps for bat entry.
- No bat guano was found on any external walls, floors, ledges etc.,
- The internal elements of the garage did not present any evidence of bat occupation whatsoever, supporting the view that this property does not have current or past use by bats.
