Report No

2012/R1

**BRITON FERRY GARAGES– SITE INVESTIGATION**

**Swansea Garage Storage**

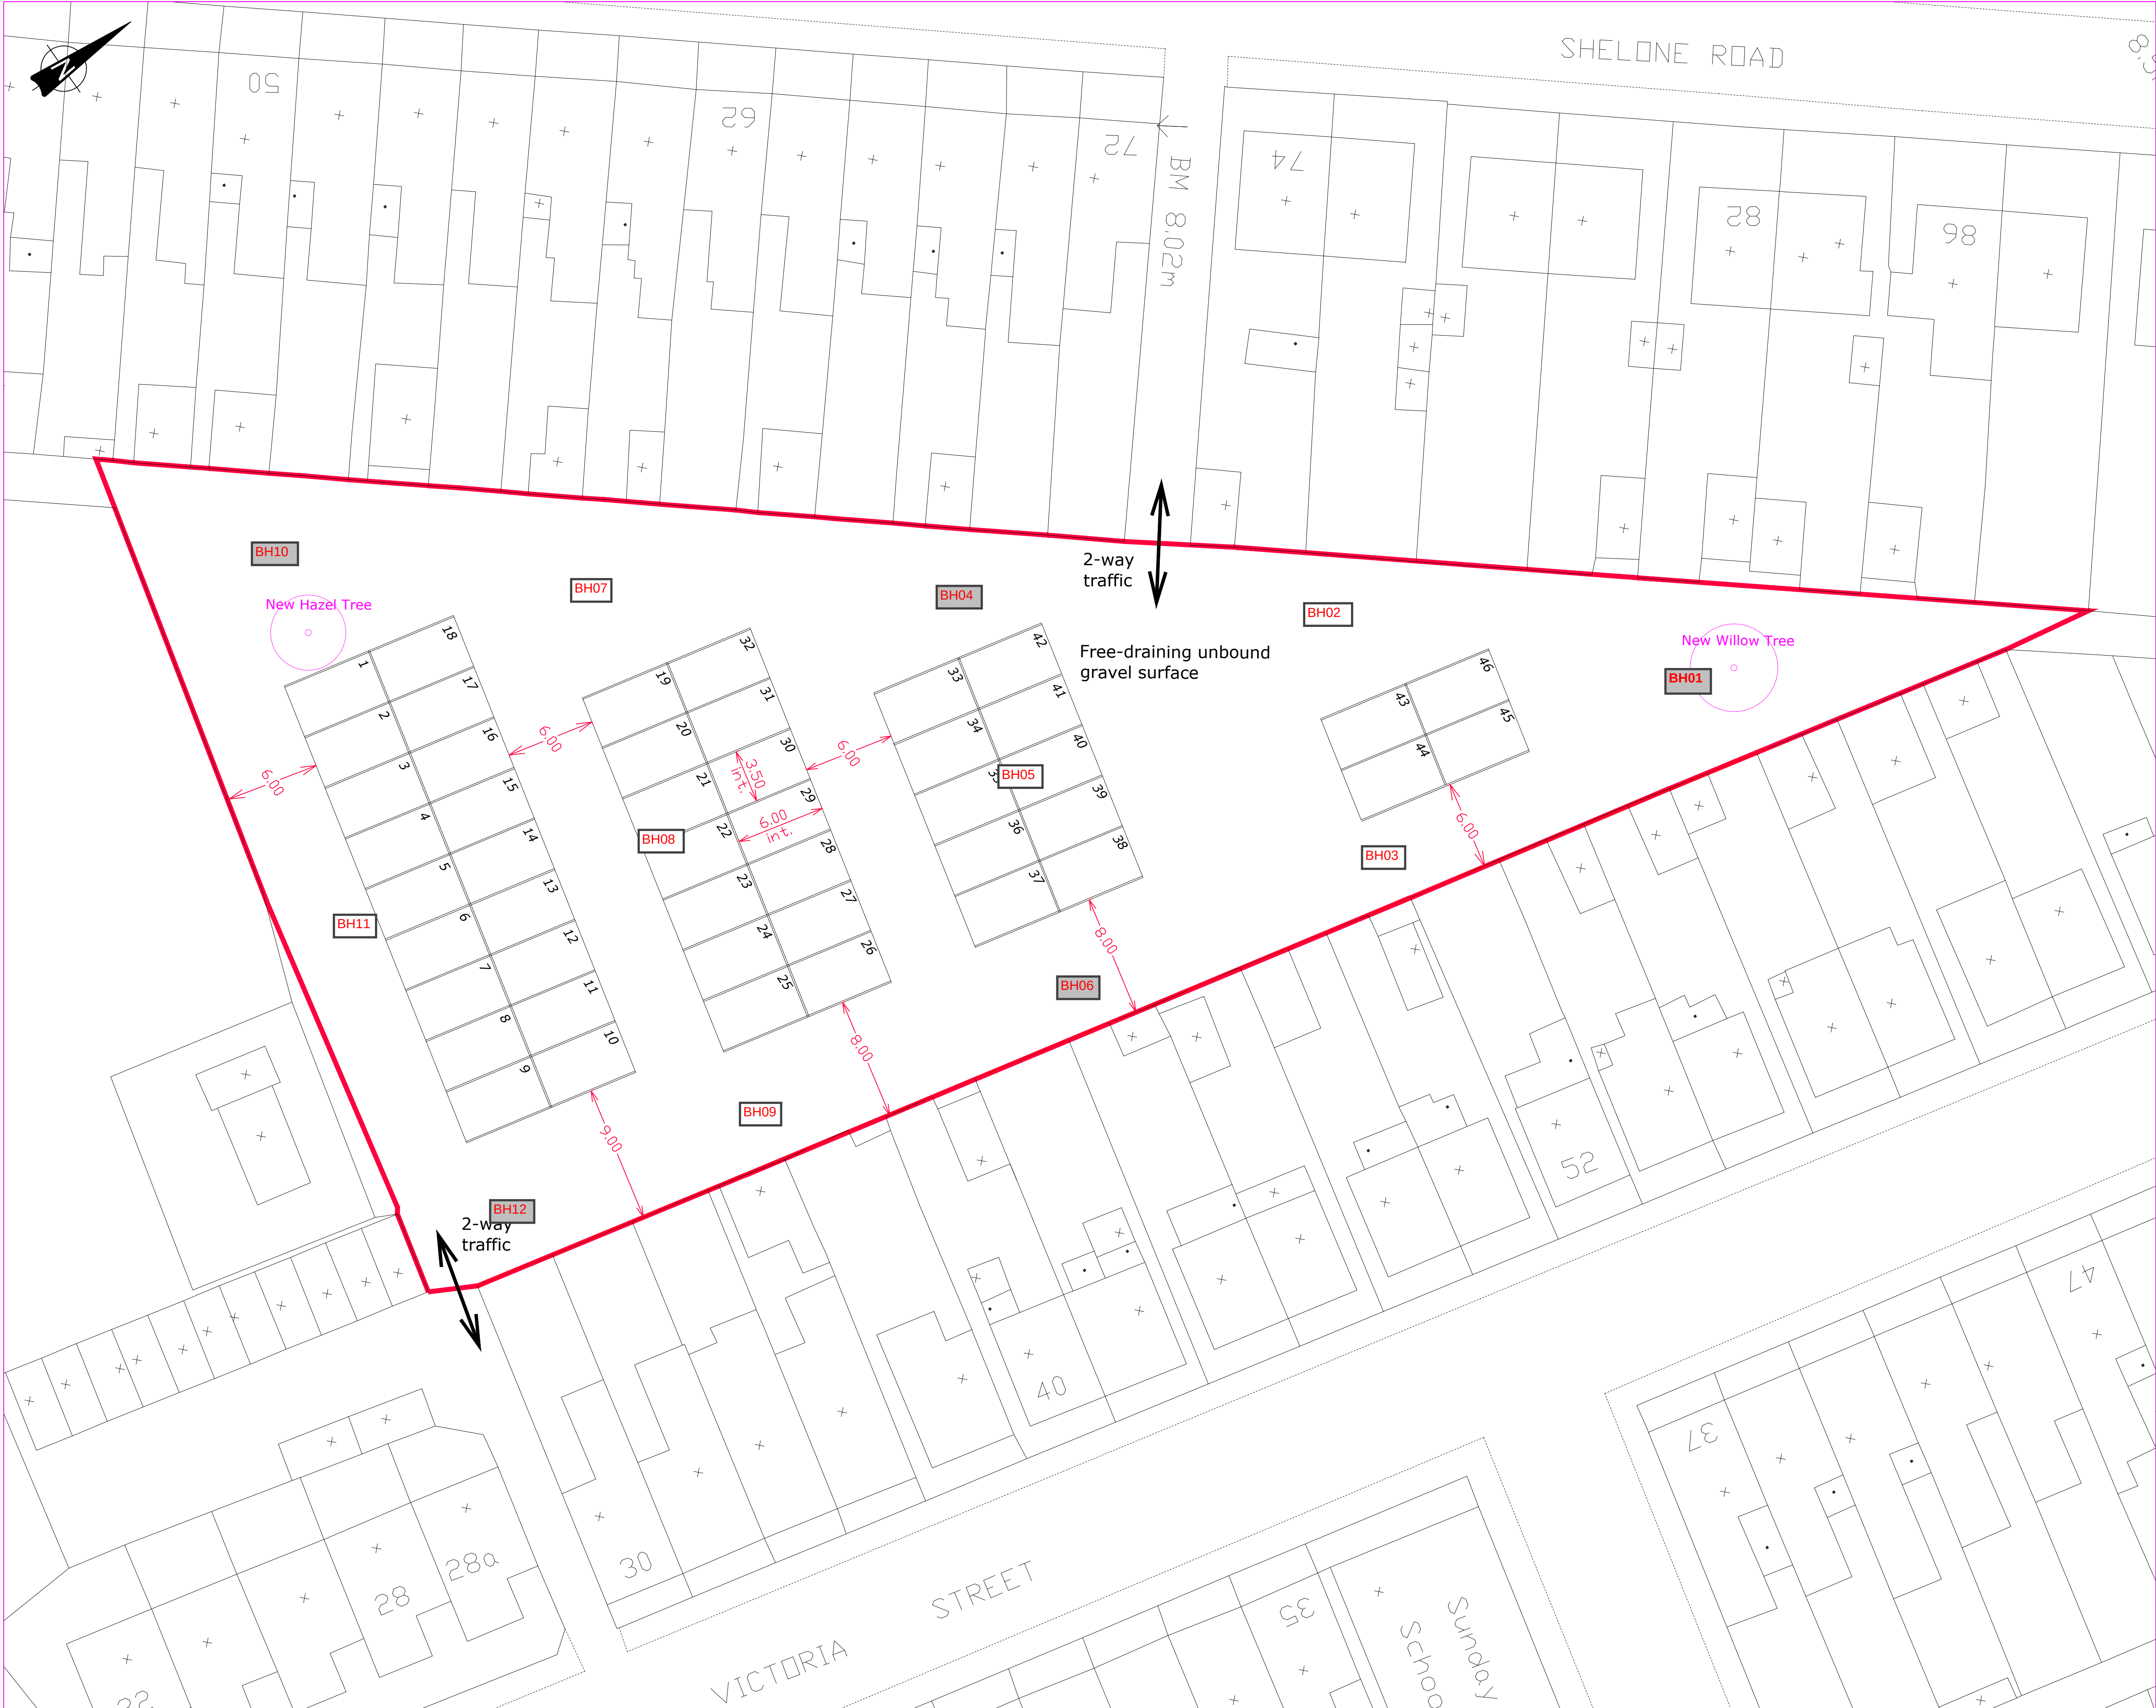
Drawing SGS/2012/02

Site works comprised 12 Window Sample holes, which was undertaken on 09 and 10 March 2020. Conditions during the fieldwork were mostly wet. The positions are shown on Drawing SGS/2012/02.

Exploratory Hole Location Plan

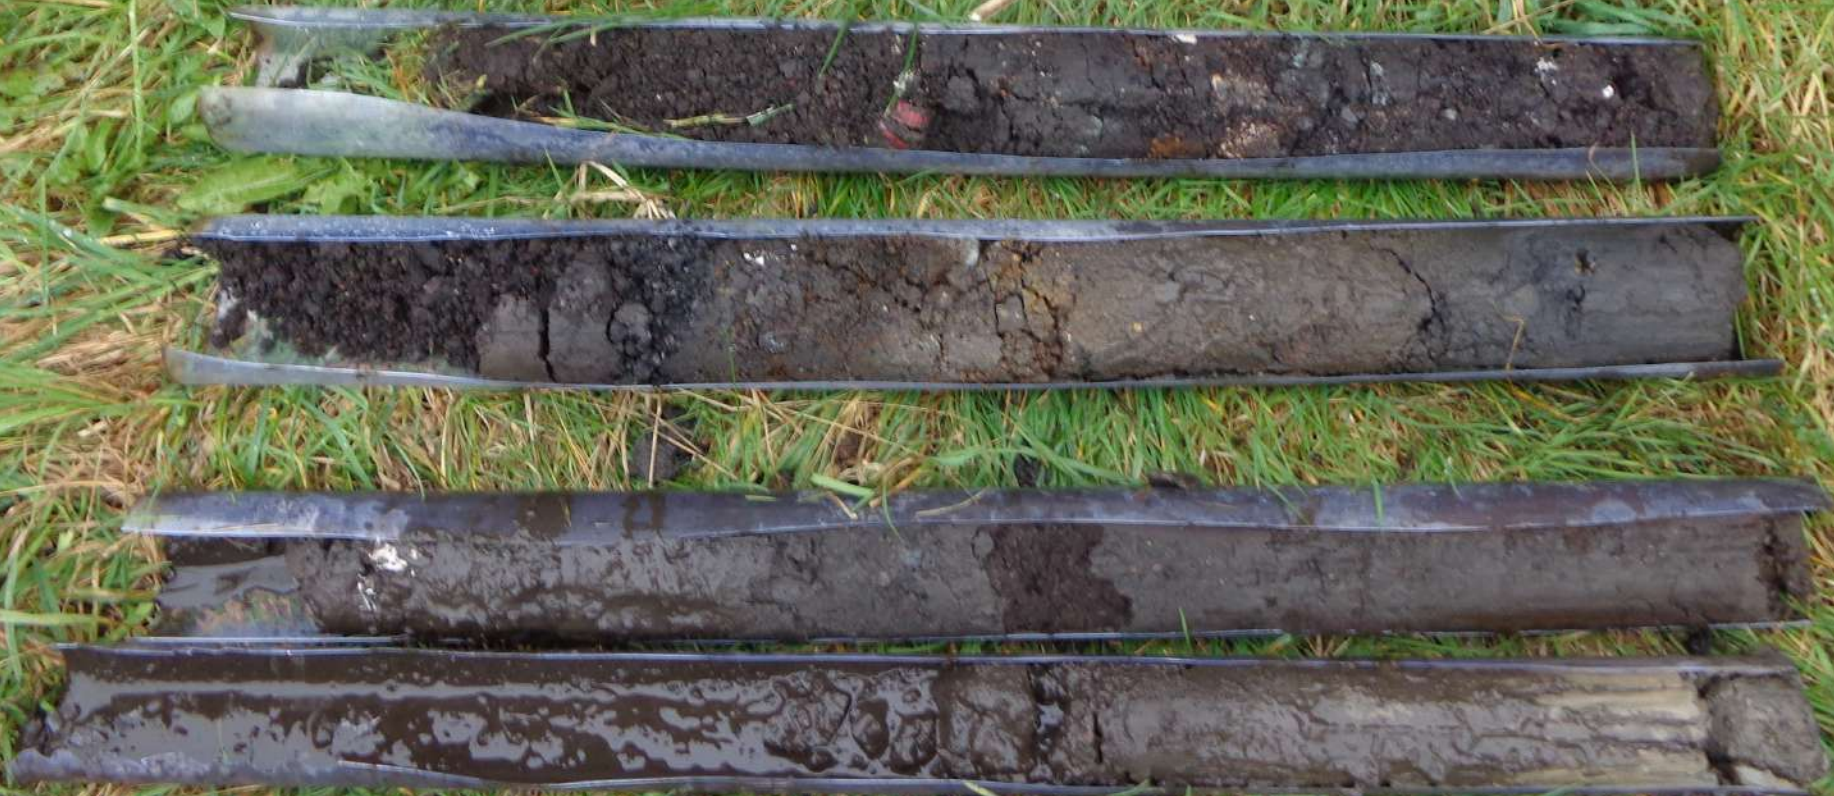
WS 05

GL-4.00

The test results indicate that contamination of the water is not site-wide and appears to be in perched zones. Indeed, given the direction of groundwater flow, the elevated values at WS05 would be expected at the southern boundary – which has not been found to occur. Thus, it is likely to be a discrete perched water with little chance of lateral migration.

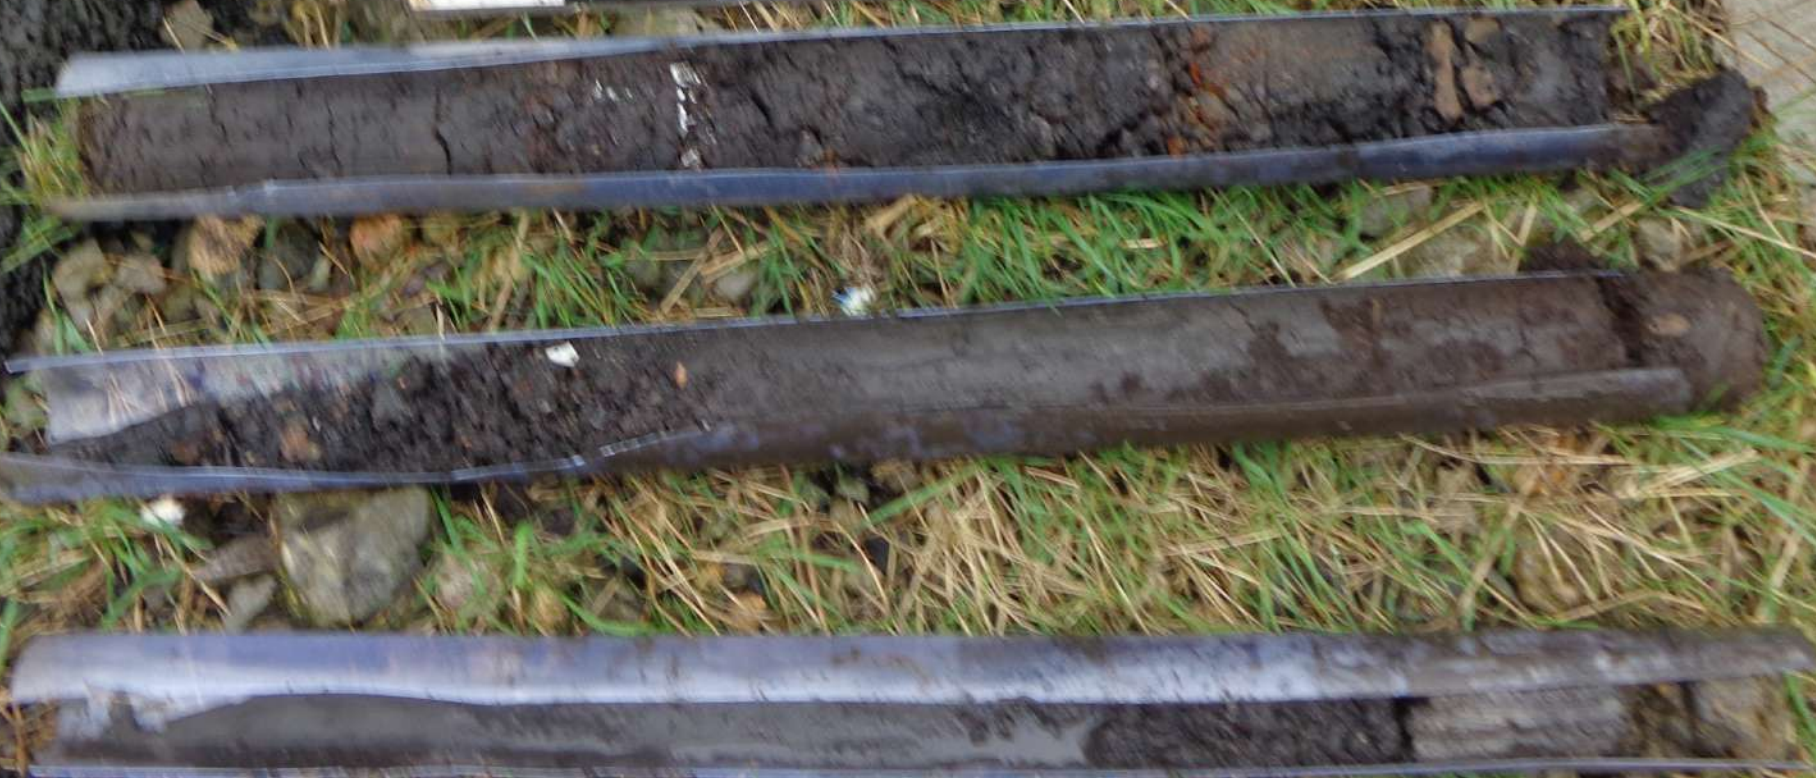
WS 10

GL-3.50

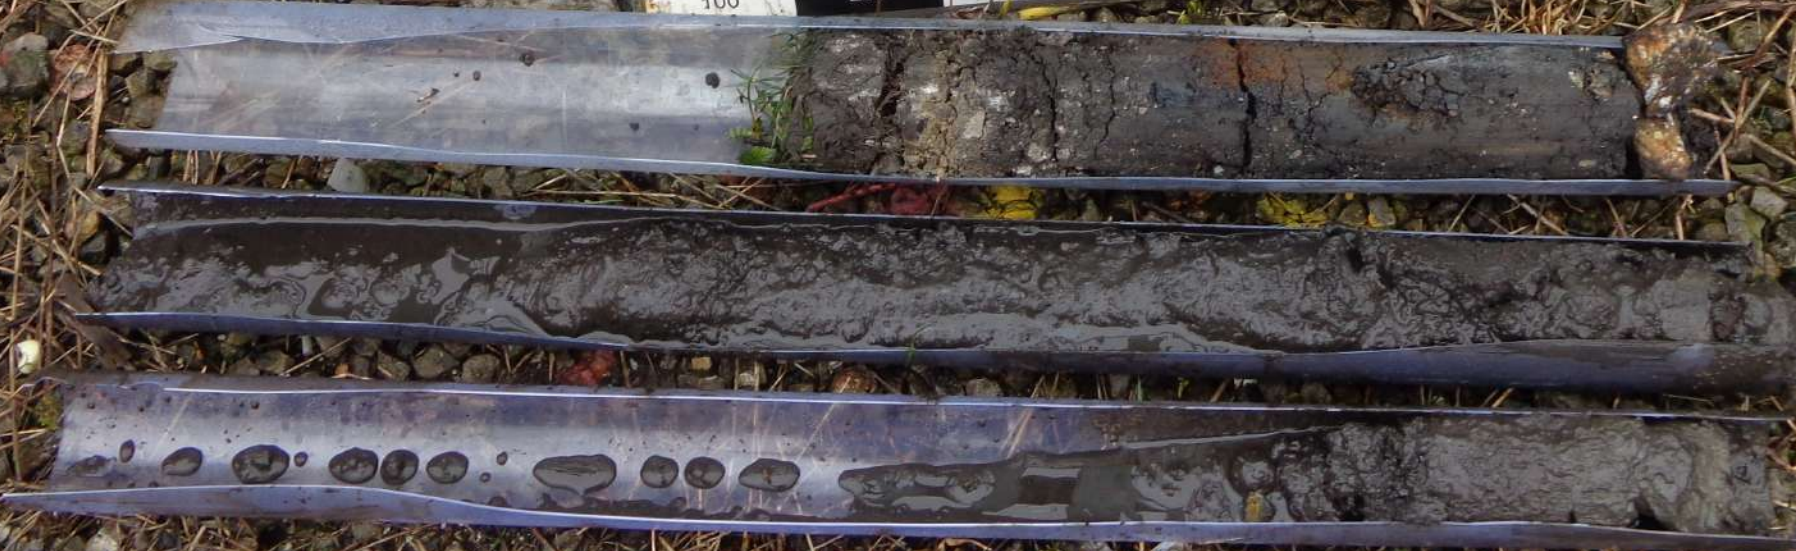
WS 12

However, a single sample from WS12A (at the south eastern corner of the site) contained loose fibres of Chrysotile asbestos.

WS12A noted elevated dissolved cyanide and arsenic and “heavy aromatics”. Similarly to WS05 total Aromatics do not exceed guidelines. In general these would be classed as “mineral oils”.

GL-3.30

Thus, as the occurrence was localised, a hotspot removal is recommended, together with an asbestos management plan for ongoing groundwork, due to the potential for re-occurrence at the site.
