# **BS5837:2012 ‘TREES IN RELATION TO DESIGN, DEMOLITION AND CONSTRUCTION - RECOMMENDATIONS’**

## **INITIAL ARBORICULTURAL SURVEY REPORT**

| <b>SITE OF SURVEY</b> | Pine Valley Cwmavon Neath Port Talbot |

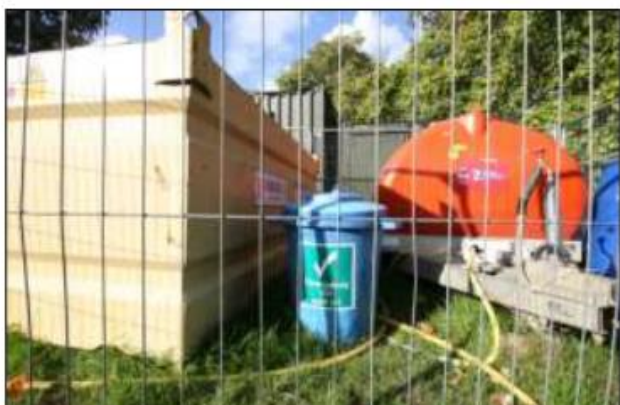
**Pollution image 1:** Where fuel or other chemicals are stored on site, it is now standard practice to have emergency spillage kits available to restrict the environmental impact of accidents.

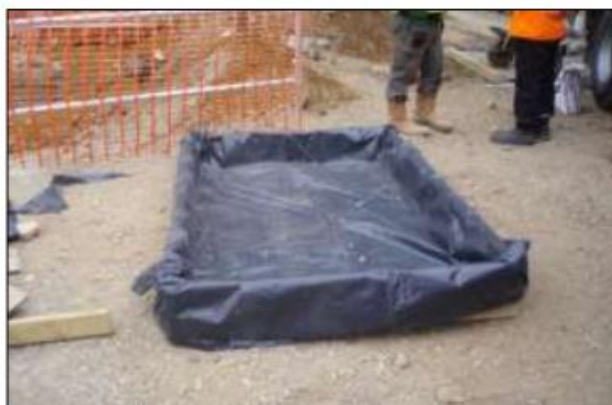
**Pollution image 2:** Soil bunding or a supporting framework covered in heavy-duty plastic sheeting is essential where there is a risk of spillages contaminating RPAs. This specifically applies to cement mixing areas and vehicle washing facilities.

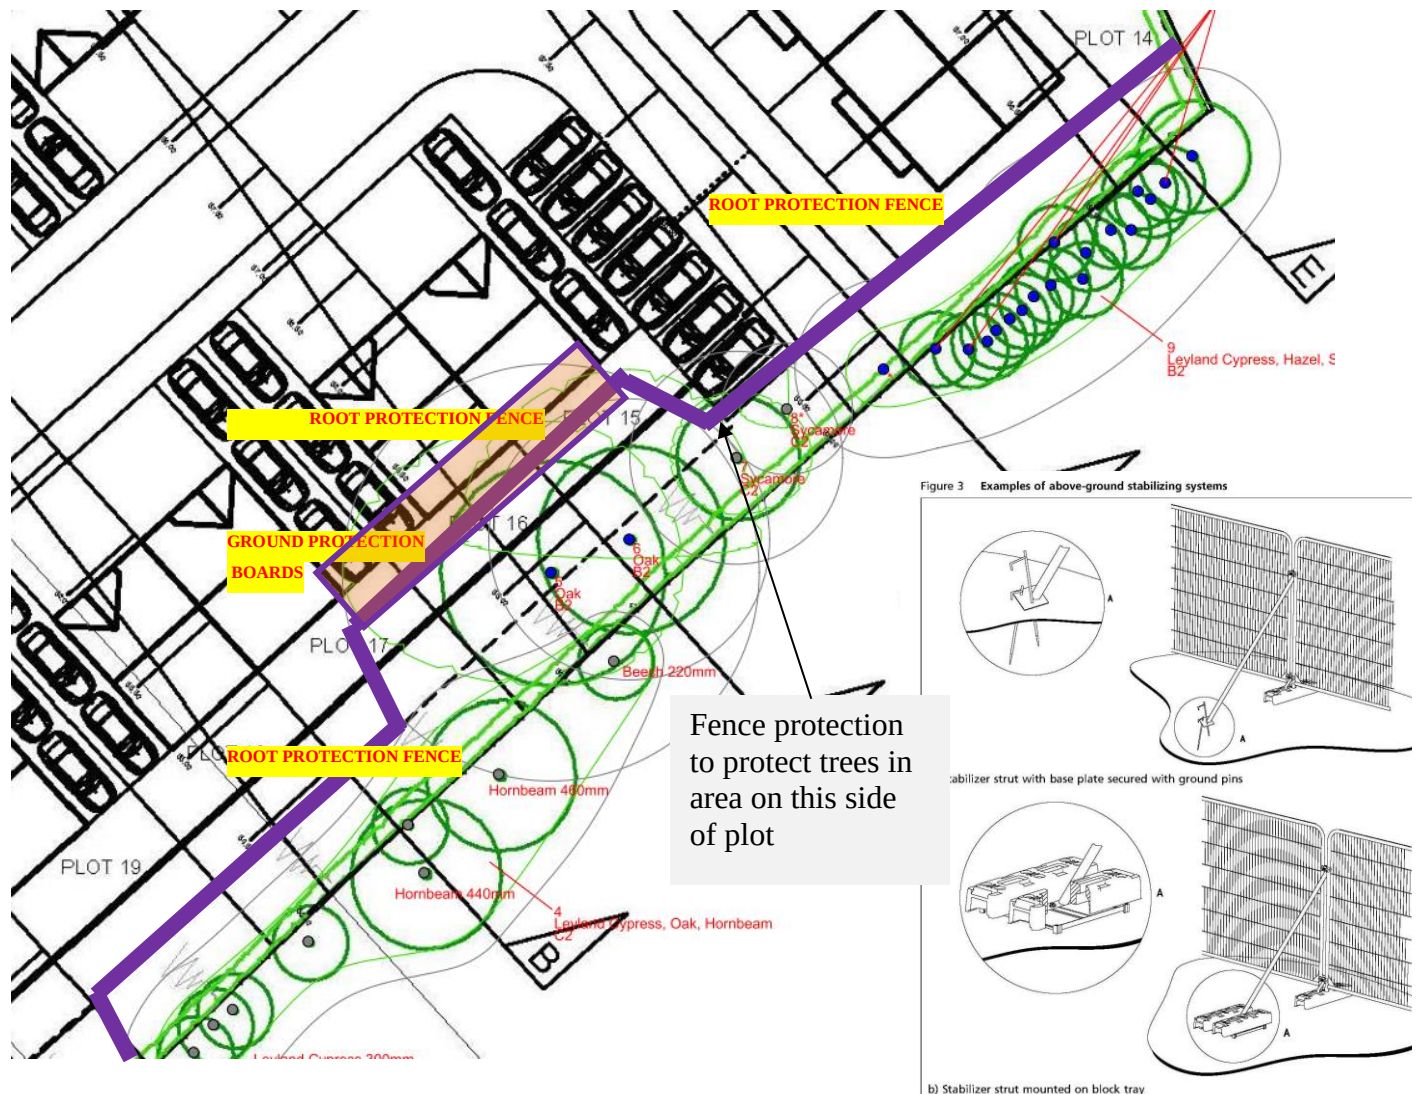
Potential causes of damage to trees on development sites.

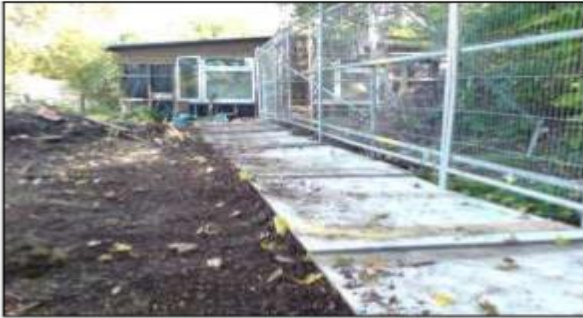
**Ground protection image 1:** Heavy-duty plywood set onto a compressible woodchip layer and pinned into position is suitable to spread the loading from pedestrian access.

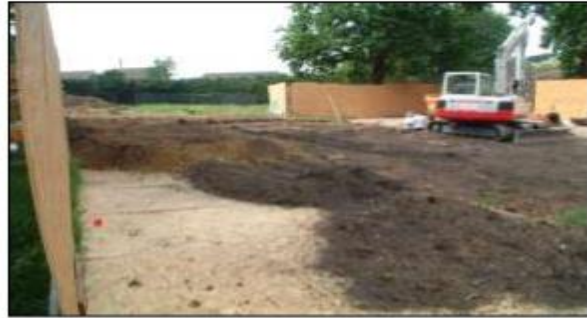
**Ground protection image 2:** Spreading soil excavated from footings is an effective way of buffering the plywood surface from the wear of light vehicles.

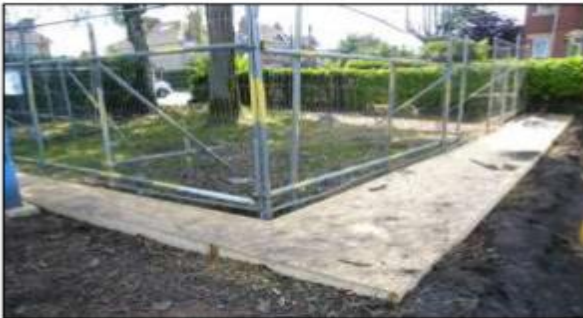
**Ground protection image 3:** Plywood fixed to a wood frame is another effective method of protecting soil from pedestrian compaction.

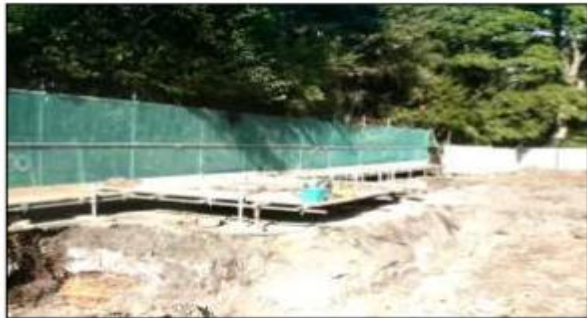
**Ground protection image 4:** A scaffold framework attached to the main scaffold fencing can be used to support either scaffold planks or plywood to create an elevated platform with a gap beneath.

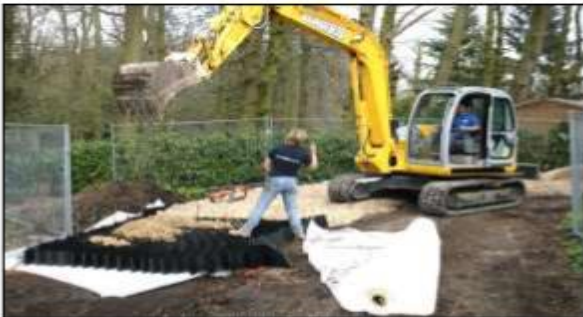
**Ground protection image 5:** Cellular products are a very effective means of providing ground protection where heavy vehicle use is expected. Here, it is being used to temporarily widen an existing road, to be removed once the construction is finished.

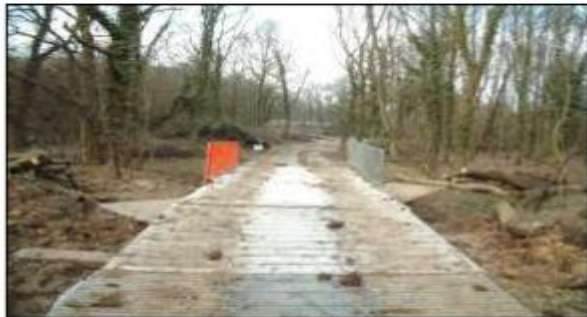
**Ground protection image 6:** Custom designed sectional tracks can be joined to support very heavy traffic use through sensitive areas.
